## Targeted Germanium Ion Irradiation of Aluminum Gallium Nitride/ Gallium Nitride High Electron Mobility Transistors

DISSERTATION

Melanie E. Mace, Major, USAF  
AFIT-ENP-DS-19-S-025

***AIR FORCE INSTITUTE OF TECHNOLOGY***

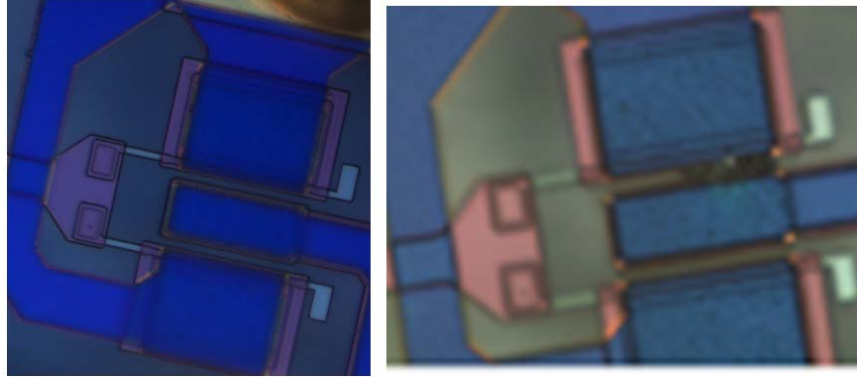
**Figure 32.** Same part pre-irradiation (left) and post-irradiation (right). The burn mark (blackened area) appeared during post-irradiation in the on state output measurements, when the gate voltage was held constant and the drain voltage was swept from 0 to 20V.
