Fatigue Behavior of an Advanced Melt-infiltrated SiC/SiC Composite with Environmental Barrier Coating at 1200°C in Air and in Steam

THESIS

Thaddeus M. Williams, B.S.

AIR FORCE INSTITUTE OF TECHNOLOGY

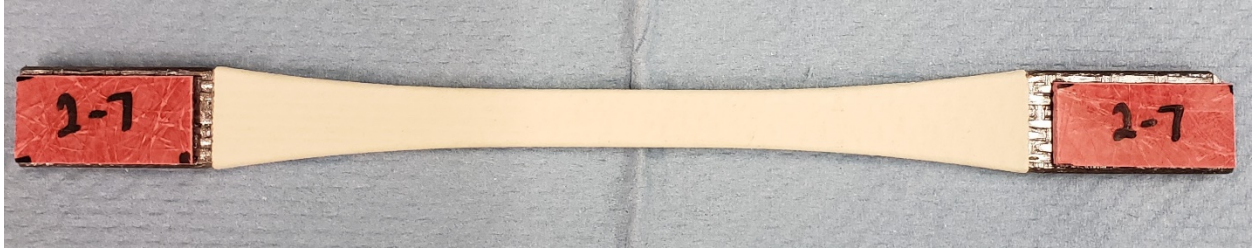
Figure 1.3: Dog bone shaped specimen used in fatigue testing.

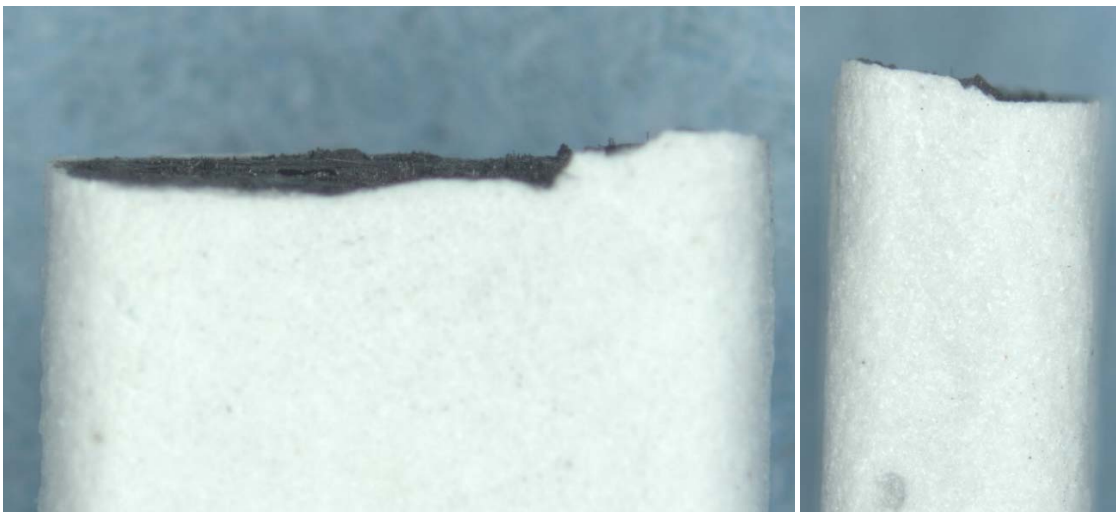
Figure 4.18: Optical micrograph of specimen P15002-7 subjected to tension-tension fatigue testing to failure at 1200°C in air. $\sigma_{\max} = 130$ MPa, $N_f = 8,869$ cycles

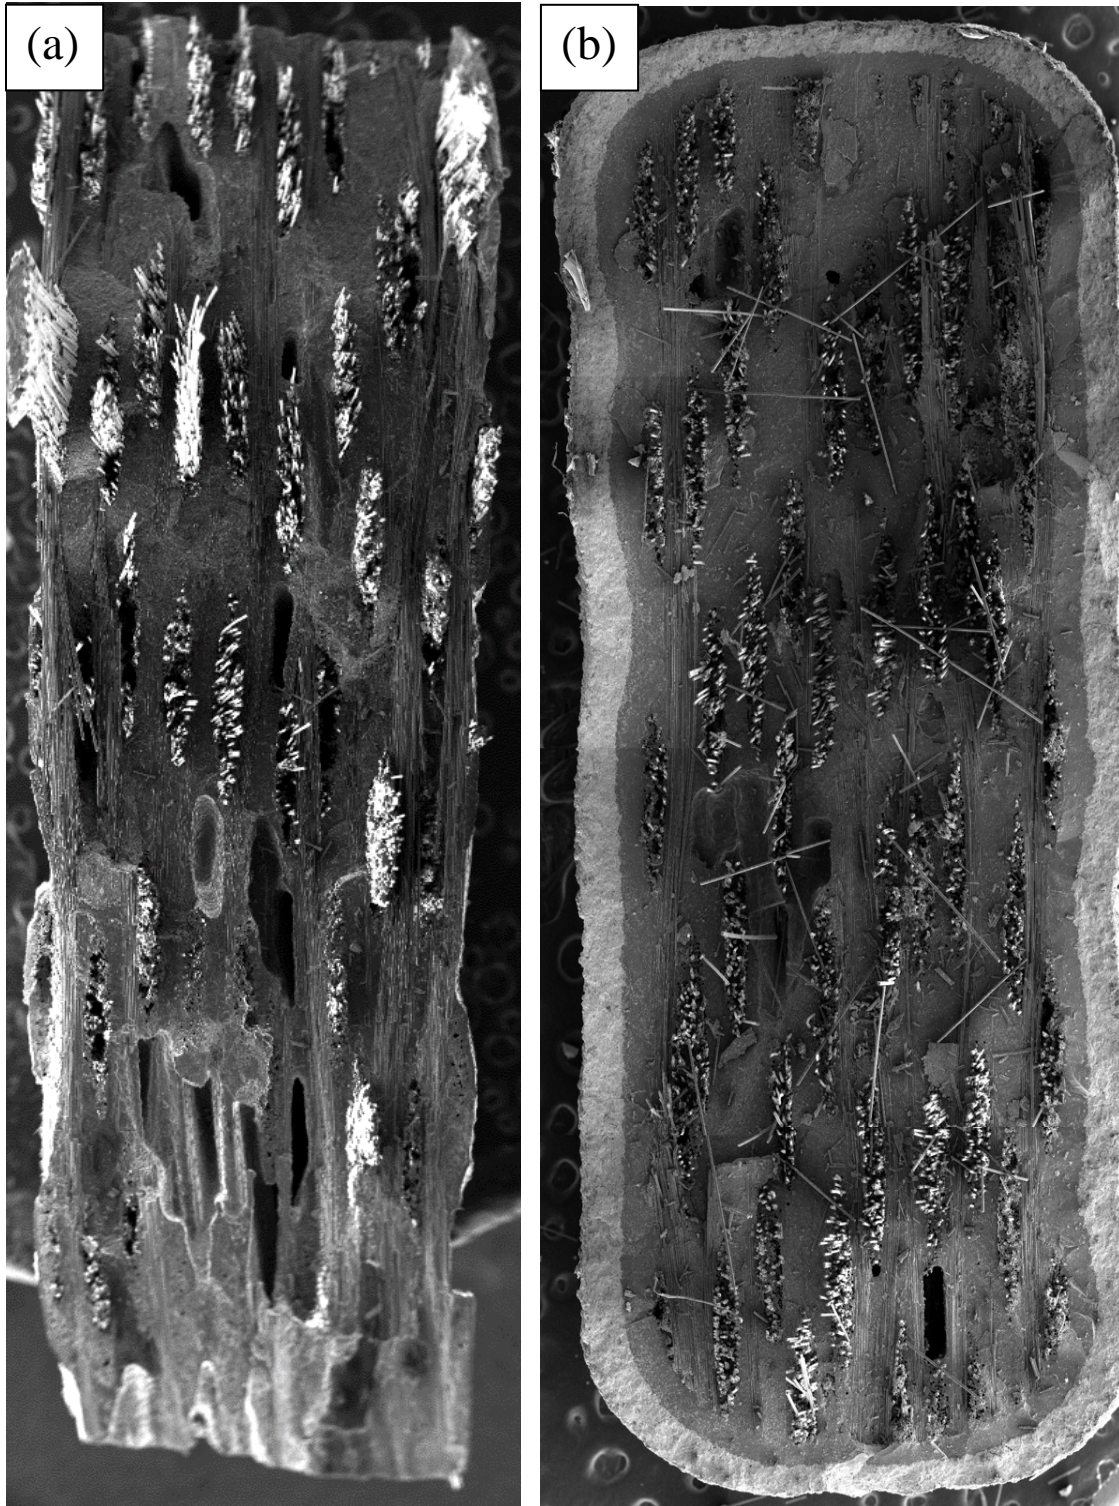
Figure 4.28: Micrographs of uncoated Hi-N/MI-SiC (a) compared to EBC/Hi-N/MI-SiC (b). Both specimens were subjected to fatigue testing at 1200°C and reached run-out ($N_f > 200,000$ cycles) in steam

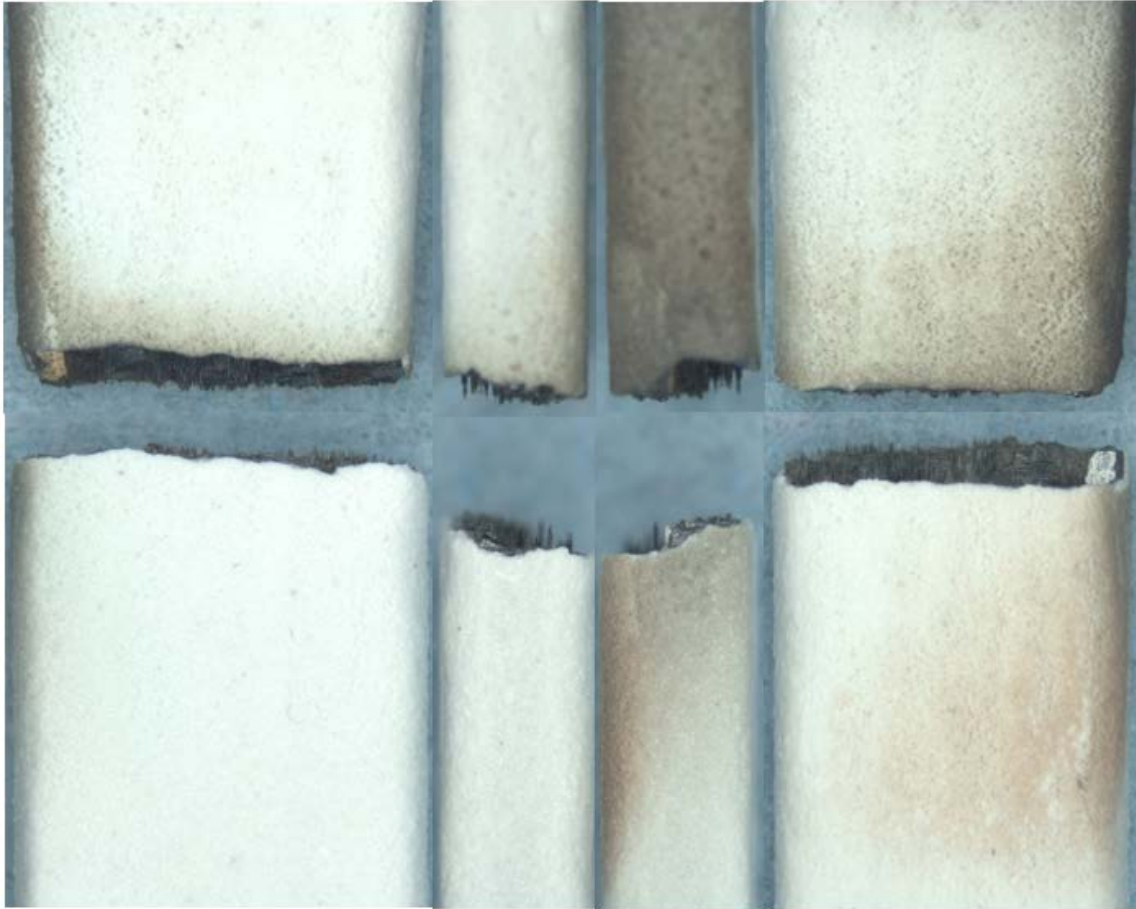
Figure A 1: Fracture surfaces of specimen P15002-5, tested in fatigue at 1200°C in air.
 $\sigma_{\max} = 120 \text{ MPa}$, $N_f = 100,128$ cycles
