Creep-Rupture Behavior of a Woven Ceramic Matrix Composite at Elevated Temperatures in a Humid Environment

THESIS

Jennifer L. Ryba, 2nd Lieutenant, USAF
AFIT/GMS/ENY/06-M02

AIR FORCE INSTITUTE OF TECHNOLOGY

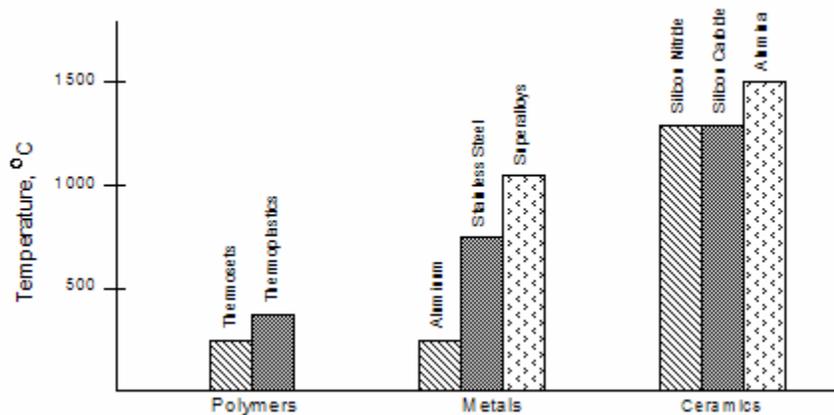
Figure 1: Service Temperature Limit of Polymers, Metals, and Ceramics [5]

For high temperature applications, ceramics are the best option, as they are the only class of material (between ceramics, metals, and polymers) that can be used at extreme temperatures. Figure 1 shows the service temperature limit of polymers, metals, and ceramics [5].

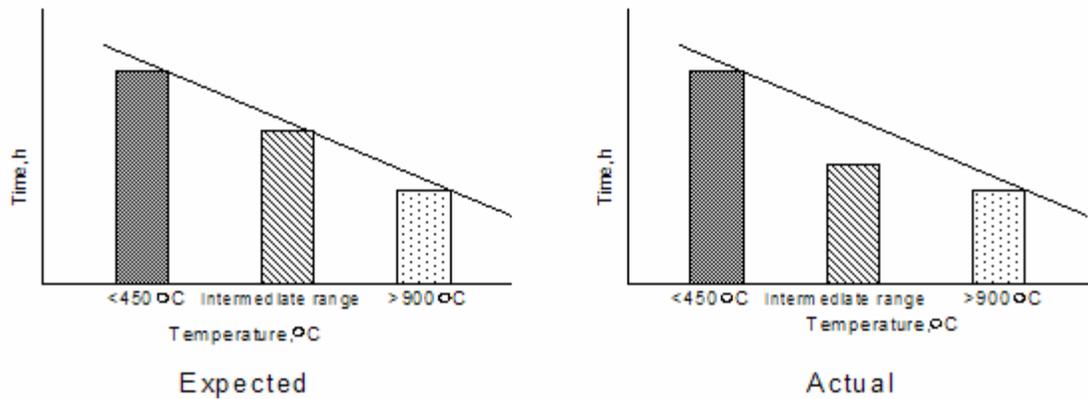
Figure 2: General Expected vs. Actual Specimen Performance

According to previous research, SiC/SiC CMCs work effectively outside the intermediate range (<450 °C and >900 °C), and within the intermediate range experience embrittlement [9, 10, 11]. More accurately, all temperature ranges might experience some embrittlement/ degradation, but it occurs most rapidly or significantly in the intermediate range [12]. So, while one might expect the degradation of the SiC/SiC to be proportional to the temperature, it instead performs worse than would be expected in the intermediate temperature range. The following figure explains this schematically (Figure 2).

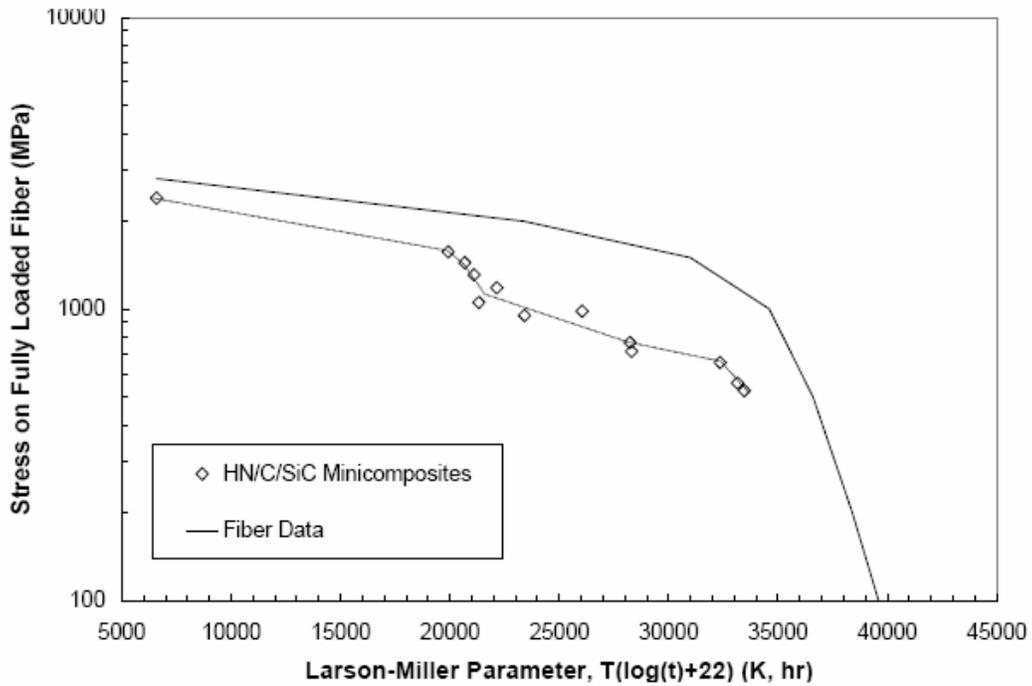
Figure 3: Larson-Miller Plot of HN/C/SiC [4, 9]

Some of the data from the previously discussed studies with HN/SiC systems are summarized in Figure 3 and Figure 4. The stress in these plots was calculated by dividing the composite stress by the volume fraction of fibers in the loading direction so that the results could be compared with data for the as-produced fibers [4]. The Figure depicting the results for a carbon interphase test show a slightly lesser slope in the HN/C/SiC experimental data compared with the as-produced HN fiber data. This shows the material initially experiences minor embrittlement, and as the temperature increases above 700°C, more embrittlement occurs with longer times and higher temperatures [4]. Figure 4 shows that the HN/BN/SiC system failed at similar fiber stresses as the as-produced HN fibers. A comparison of Figure 4 to Figure 3 shows the superior performance of the BN interphase to the carbon interphase. These figures indicate that the BN is more durable in oxidizing environments than the C.

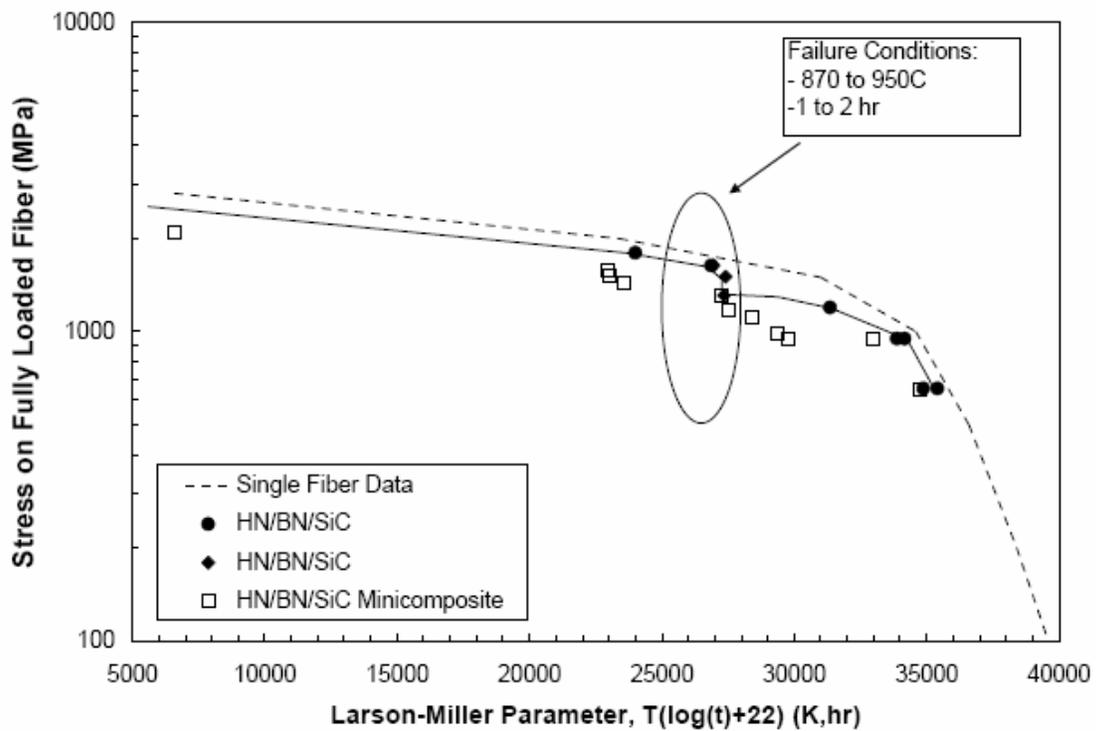
Figure 4: Larson-Miller Plot of HN/BN/SiC [4, 9]

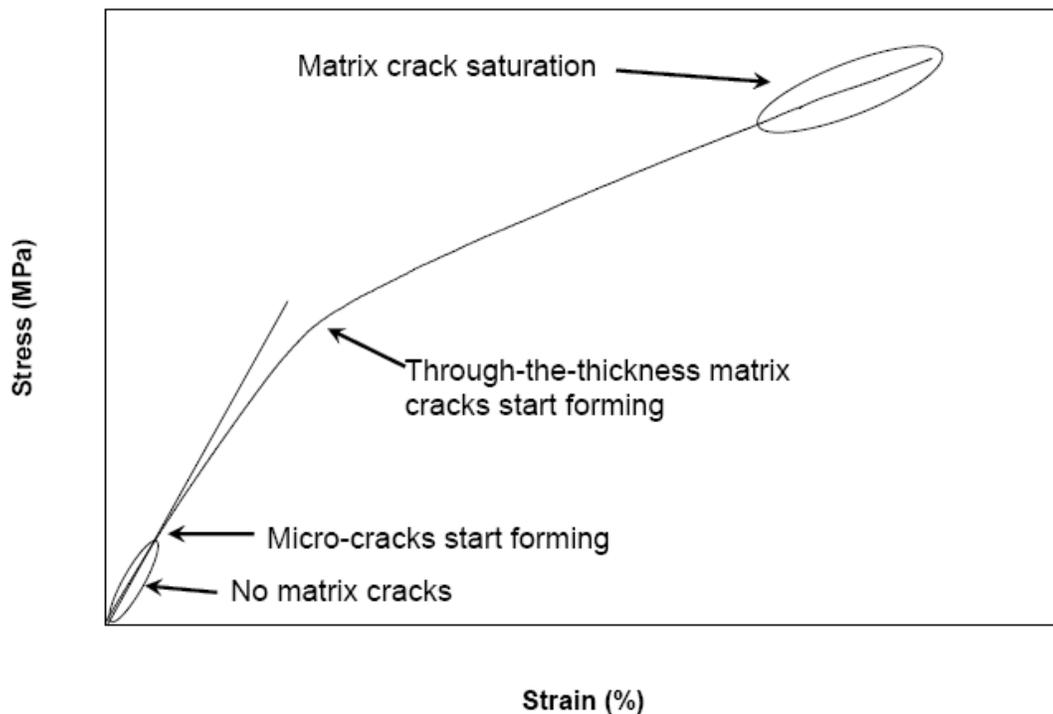
Figure 5: Typical Stress Strain Curve for a CMC Material [4]

matrix (pull-out), and relieving the stress concentration at the crack tip. These fibers become bridging fibers, and effectively stop the crack propagation. When the bridging fiber fails, the stress concentration at the crack tip increases, and if enough fibers fail, the stress increases enough that the crack continues to propagate [4]. This process repeats as the cracks continue to propagate through the matrix and encounter other fiber tows. A typical stress strain curve for a CMC material is shown in Figure 5.

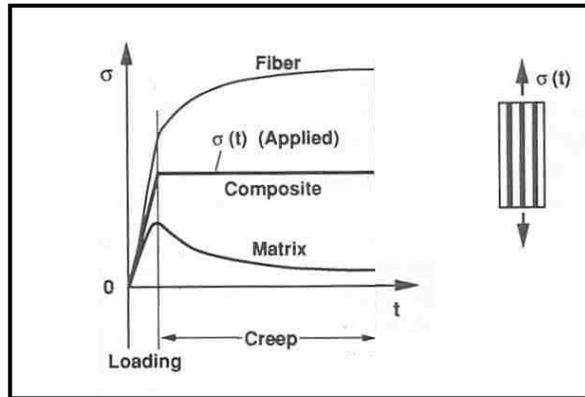
Figure 6: Stress Redistribution during Creep [13]

A common problem in composites is the disparity between the creep strength of the fiber and the strength of the matrix. However, in a strongly bonded fiber/matrix system, the axial stresses in the fiber and matrix equilibrate, as shown in Figure 6.

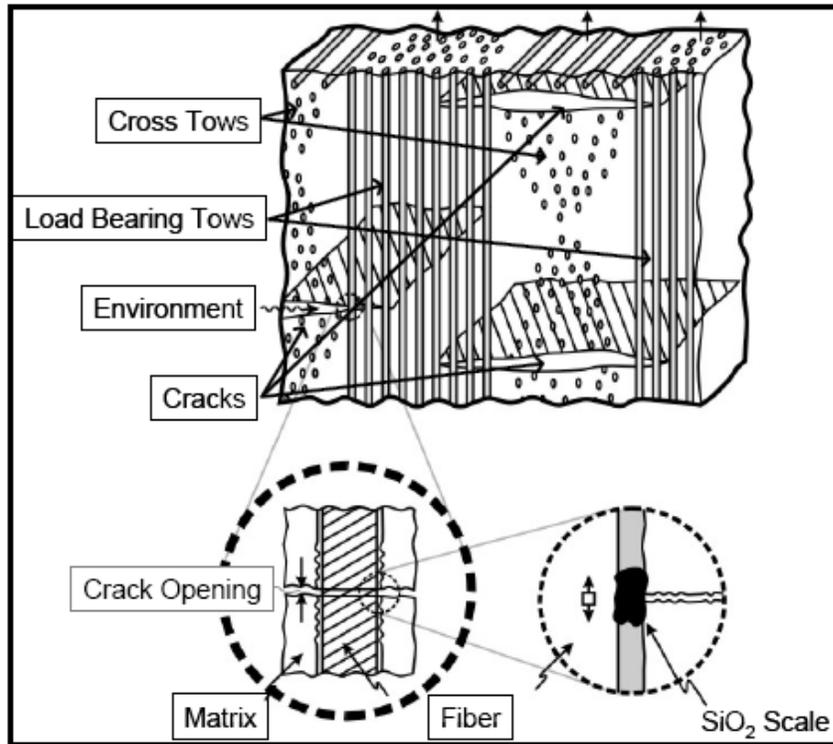
Figure 7: Model of Environmentally Assisted Embrittlement of CMCs [4]

As previously discussed, the presence of O_2 and H_2O in a testing environment severely degrades the performance of the SiC/BN/SiC CMC, if cracks form in such a way that the load-bearing fibers and interphase material are exposed to that environment. Figure 7 [4] is a schematic of the embrittlement of CMCs.

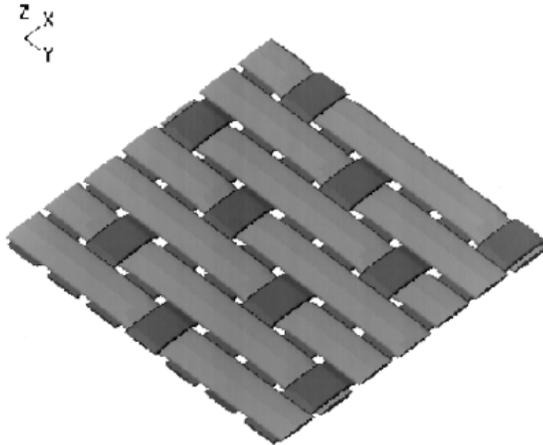
Figure 8: Five-harness Satin Weave [3]

The material tested in this experiment was a non-oxide fiber/non-oxide matrix ceramic composite. The Syl-iBN fiber performs were provided to Honeywell Advanced Composites, Inc. for manufacturing by NASA Glenn Research Center. Six panels were produced, with 15 specimens cut from each panel. The technique used to apply the BN interphase layer to the in-situ BN performs, and a thin layer of SiC to the BN layer was Chemical Vapor Infiltration (CVI) [4]. In the CVI process a solid material is deposited from gaseous reactants onto a heated substrate. A CVI technique provides good mechanical properties at high temperatures, but takes a long time to complete the process, and can be expensive. The addition of the BN layer to the fiber preform resulted in a $10.64 \pm 0.34\%$ weight gain. The layer of SiC added a $53.40 \pm -5.99\%$ weight gain [4]. The bulk of the matrix was SiC, which was infiltrated by slurry into the preform. This caused a $30.10 \pm 1.50\%$ weight gain. A $13.92 \pm 0.80\%$ weight gain resulted from the melt infiltration of molten Si. The final material was a mostly nonporous composite comprised of 8 piles of woven Syl-iBN tows, with each tow having 800 fibers [4]. The fibers are woven in a five-harness satin weave. Figure 8 depicts a five-harness satin weave.

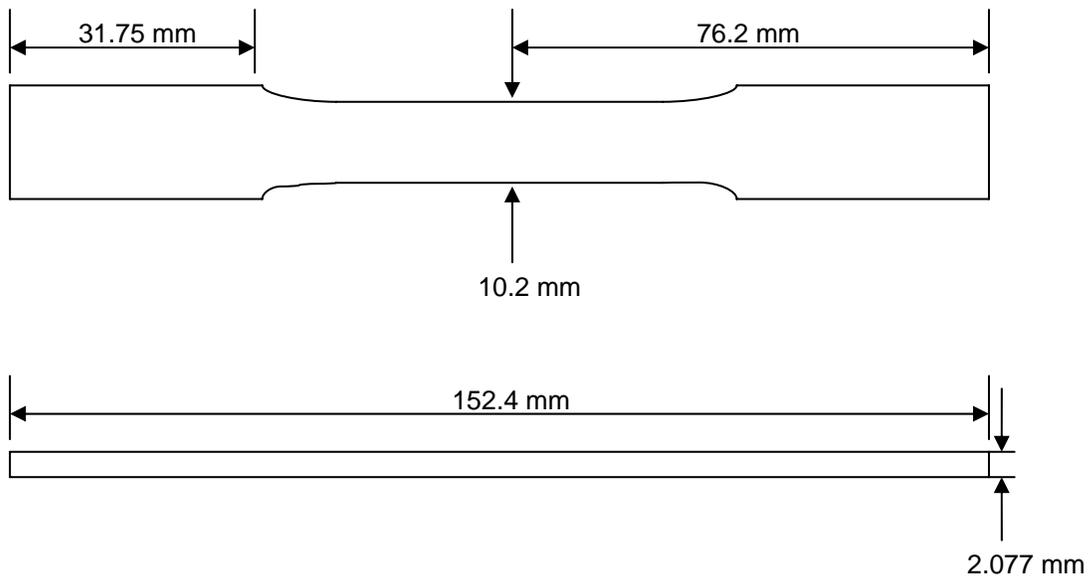
Figure 9: Specimen Dimensions

The specimens were cut in a dog-bone configuration to encourage failure within the gage section of the specimen. Figure 9 depicts the specimen dimensions.

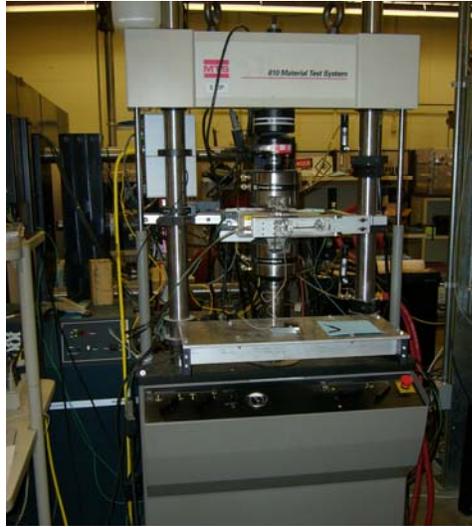
Figure 10: Experimental Test Set-Up

The test specimens were secured using a pair of MTS 647.02B-03 Hydraulic Wedge Grips. The grips consisted of a pair of interchangeable wedges coated with a layer of a surf alloy to provide a better surface for gripping the specimens. To maintain a suitable grip temperature, each grip wedge had an inlet and outlet to allow cooling to water to pass through. It was important to maintain a moderate grip temperature so an extreme temperature condition at the gripped section of the specimen did not adversely affect the specimen outside the test section. The grips were cooled using a NESLAB HX-75 Refrigerated Recirculator. Distilled water was kept at a temperature of 14°C and continuously circulated through the grips during the test. The grip pressure was controlled by an MTS 685.53 Hydraulic Grip Control attached to the test stand, capable of exerting pressures up to 20.7 MPa (3000 psi). The grip pressure used during the test was 8 MPa. The grip pressure could not be too high, or it would damage the specimen, possibly causing it to break in the grips, instead of the test section. If the pressure were too low, the specimen would slip in, or out of, the grips, affecting the test data. Figure 10 shows the test stand with the servo-hydraulic machine, the furnace, and the extensometer assembly.

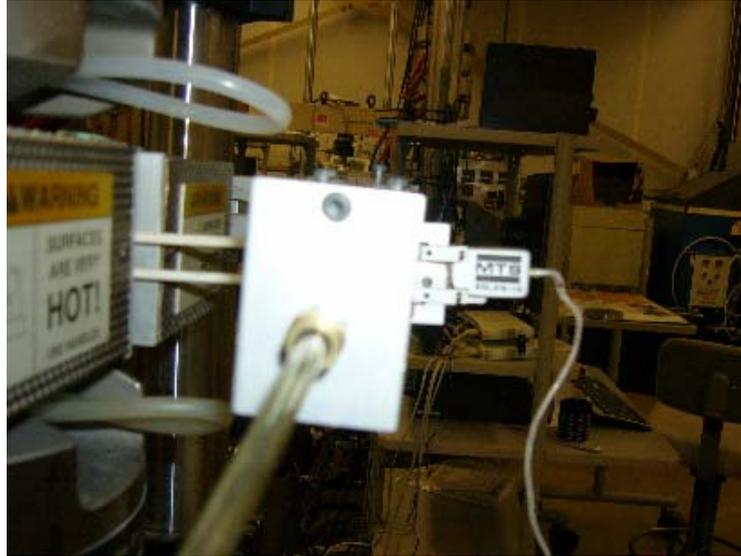
Figure 11: Extensometer

The strain on the specimen was measured using an MTS High Temperature Axial Extensometer, model number 632.53E-14. The extensometer had two 3.5 mm diameter alumina rods, with a 12.7 mm gage length that extended from the sensor to rest on the specimen. Each rod had a cone-shaped tip, for mounting on flat specimens. The extensometer maintained contact with the specimen using constant spring pressure. To protect the extensometer and its electronics from the heat radiating from the oven, it had a heat shield and constant air flow over the body of the extensometer. The airflow was regulated by a valve, and held at about 20 psi. Maximum extension of the rods was 16.8 mm, although the test specimen never stretched enough to test this parameter. The extensometer could measure strains between +20 and -10% for a maximum specimen temperature of 1200°C, and could provide up to 300g of contact force through spring tension. The accuracy of the extensometer results was tested by periodically testing the Young's Modulus of aluminum samples. Figure 11 shows the extensometer set-up.

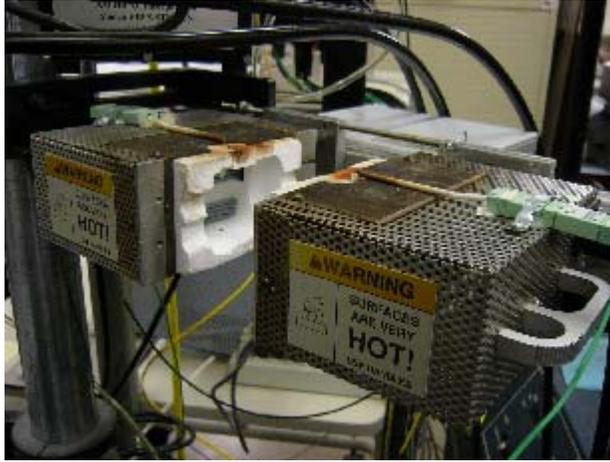
Figure 13: Furnace

The environmental equipment included a furnace, an external temperature controller, a steam generator, and a ceramic susceptor. The furnace used to heat the specimen was a two-zone AMTECO Hot-Rail Furnace System. It was made up of two halves, each containing one silicon carbide heating element, mounted to either side of the specimen. Temperature feedback control was achieved using two R-type thermocouples, one for each half of the furnace. They extended slightly below the interior wall of the furnace, and were exposed to the heated air within the chamber. The furnace was controlled by two MTS model 409.83B temperature controllers, one for the left element, and one for the right element. To reduce heat loss from the furnace, the furnace insulation was carved to fit around the extensometer rods, and the inlet tube for the steam. Figure 13 shows a close-up of the furnace.

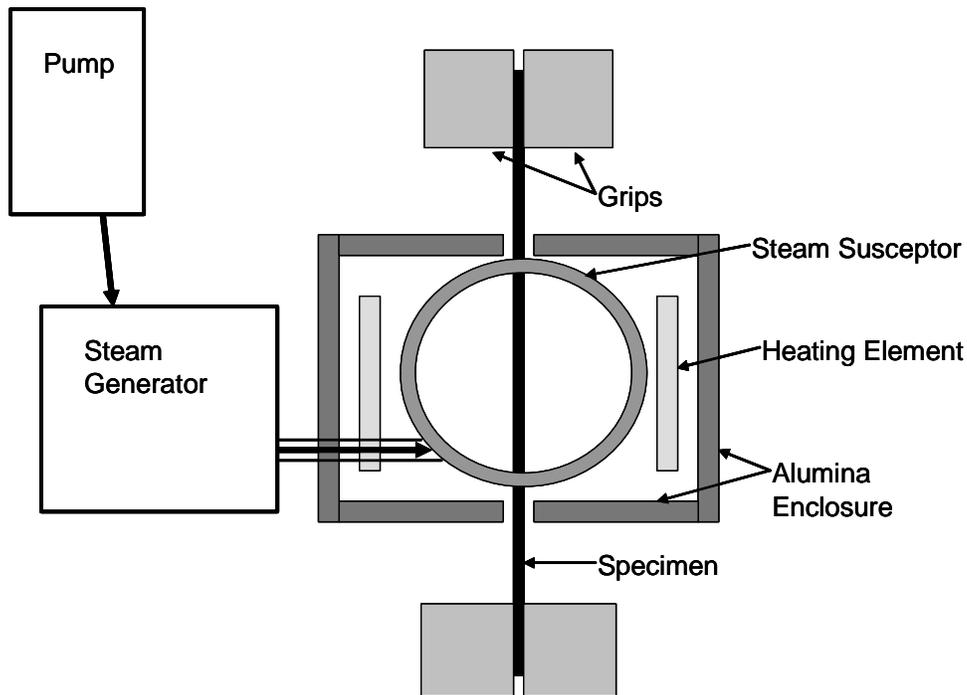
Figure 14: Schematic of the Heating Chamber with Susceptor

Tests in the steam environment required an alumina susceptor to maintain high humidity around the test section of the specimen. The furnace chamber was designed to fit around the susceptor, and the inlet tube for the steam. The susceptor consists of 6 parts; two halves of a tube, an end with holes for the extensometer, and end with a hole for the steam inlet tube, and two rings that fit over the chamber to keep it together. The susceptor is assembled around the specimen once the specimen is in the grips. The susceptor is approximately 56 mm long, with a 36 mm diameter. For purposes of this experiment, it was assumed that the use of the susceptor helped enable the 100% steam environment around the test section of the specimen. A schematic of the humid environment assembly is shown in Figure 14.

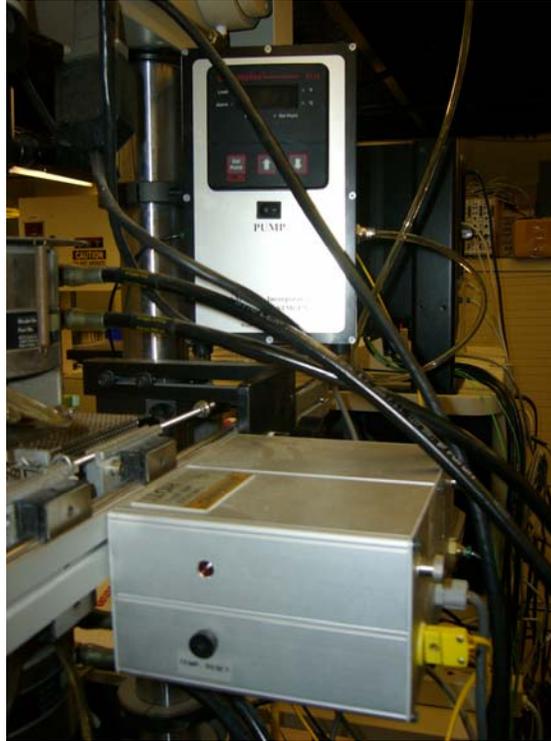
Figure 15: Water Pump and Steam Heating Unit

Two components were required to provide steam for the test, a water pump, and a steam heating unit. These components made up the AMTECO HRFS-STMGEN Steam Generation System. The unit pumped approximately 30 mL/h into the susceptor. The system used distilled water contained in a jug set above the testing unit. The water traveled first through the pump, then the steam heating unit, and from that unit through a ceramic feed tube into the susceptor. A slight positive pressure removed the dry air from the susceptor, and allowed for a 100% steam environment. Figure 15 shows the water pump and steam heating unit.

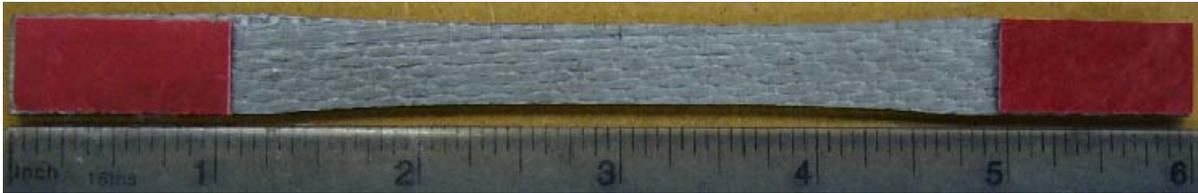
Figure 16: Tabbed Specimen

specimen ends induced by the grips. The tabs also protected the specimen from surface damage caused by the grips. The tabs consisted of a glass fabric/epoxy material. The tabs were glued to the specimen using M-Bond Catalyst. 3 drops were applied to each surface, and then pressure was applied for about a minute, to ensure good contact between the tab and the specimen. Figure 16 shows a tabbed specimen.

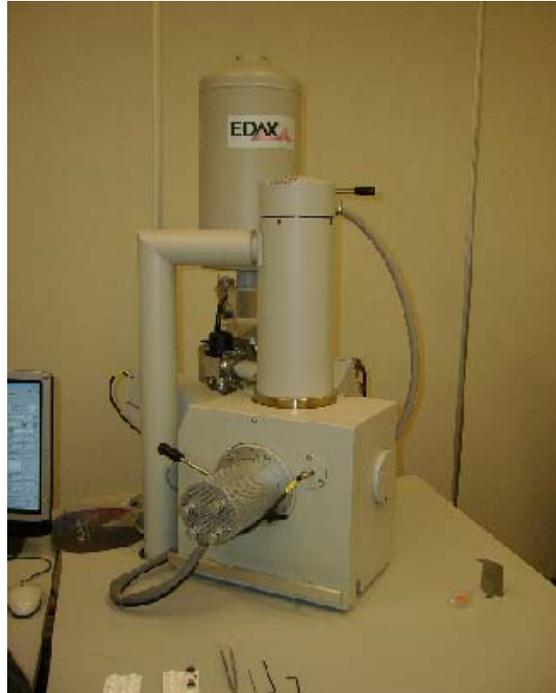
Figure 17: Scanning Electron Microscope

The SEM used to analyze the specimens for this experiment was a FEI FP 2011/11 Quanta 200 HV Scanning Electron Microscope shown in Figure 17. The SiC/SiC specimens were relatively good conductors, and while the pictures did show some charging in the specimen, the results were not distorted enough to require coating the specimens.

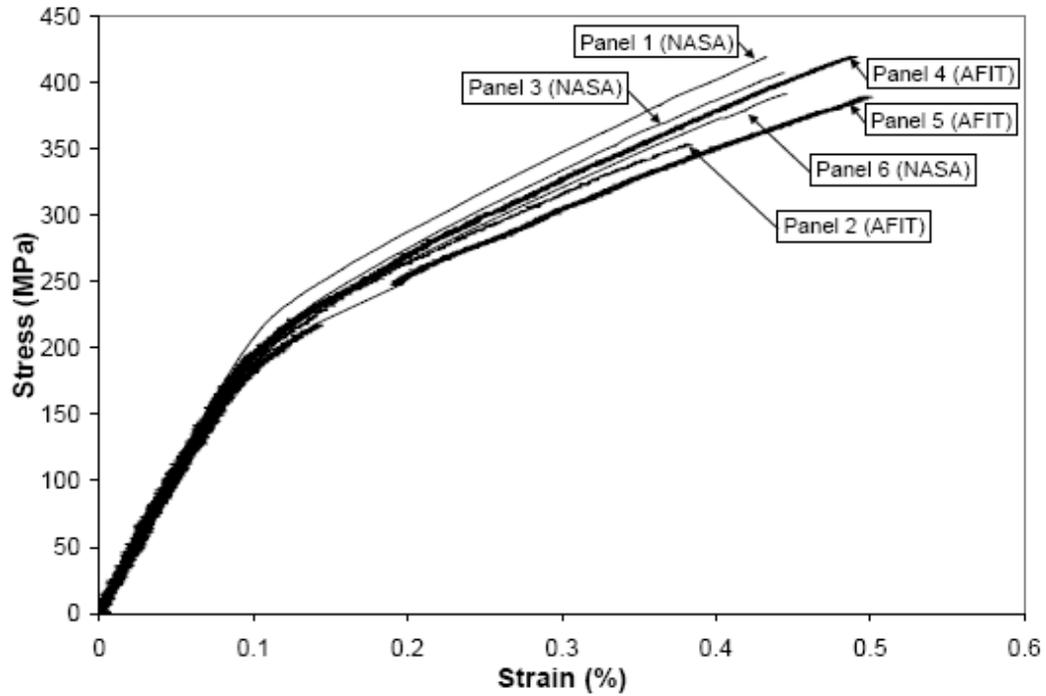
Figure 18: Stress Strain Curves for Six Panels [4]

The procedure for the monotonic test consisted of loading the specimen at a rate of 3333 N per minute. Each panel displayed slightly different material properties due to the inherent scatter introduced by the current manufacturing process of SiC/SiC CMCs, for example fiber spacing and voids. To ensure that the variations in material properties were acceptable when compared to the properties of previously produced specimens, one specimen from each of the six panels was tested in a room temperature monotonic tension test. Three of the specimens were tested by the NASA Glenn Research center, and three were tested by LaRochelle [4]. As the specimens used in LaRochelle's [4] research and the experiments presented here are from the same panels, they were assumed to have the same material properties. Figure 18 is a plot of the stress strain curves for each of the six panels.

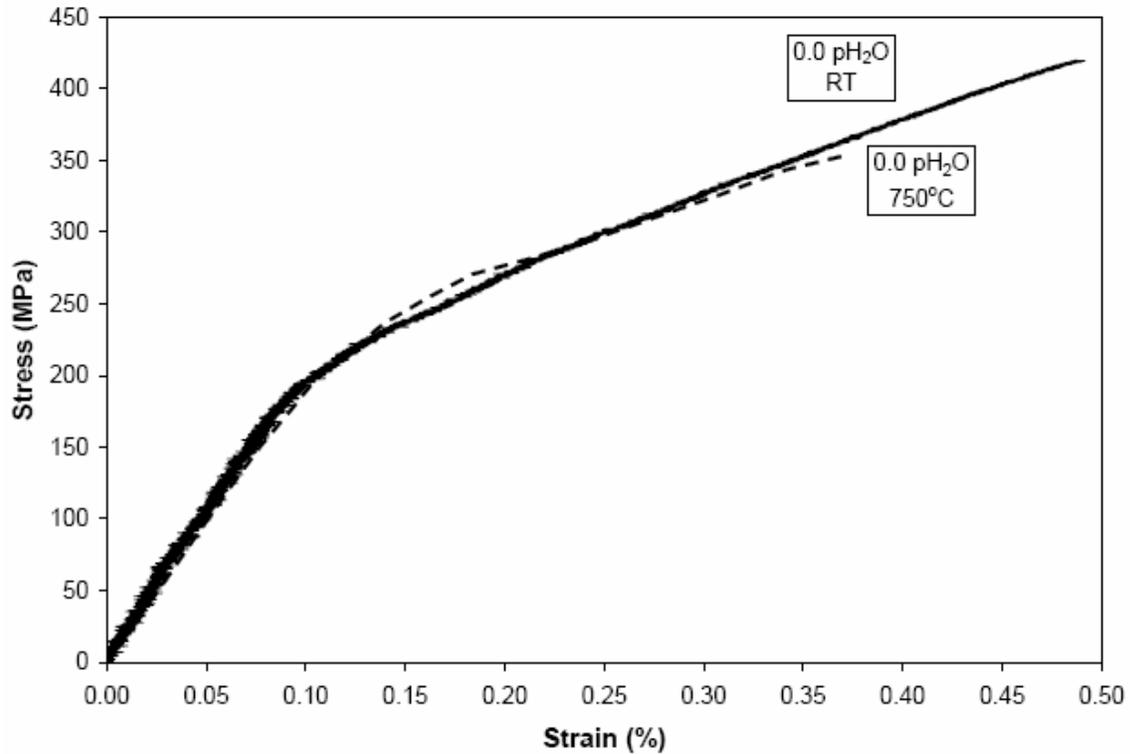
Figure 19: Temperature Effect on Stress Strain Curve [4]

the moisture in the environment in the elastic range. In this research, two monotonic tests were performed at 400°C and 950°C. A difference is not noted until the specimen is close to failure, and even then, the effect is mild. Figure 19 is a representative stress strain curve of the temperature effects on the properties of a specimen.

Figure 20 depicts the effects of moisture on the mechanical properties of a specimen. In comparing Figure 19 to Figure 20, it is shown that the ultimate strength and failure strain reductions show no correlation with the moisture content level.

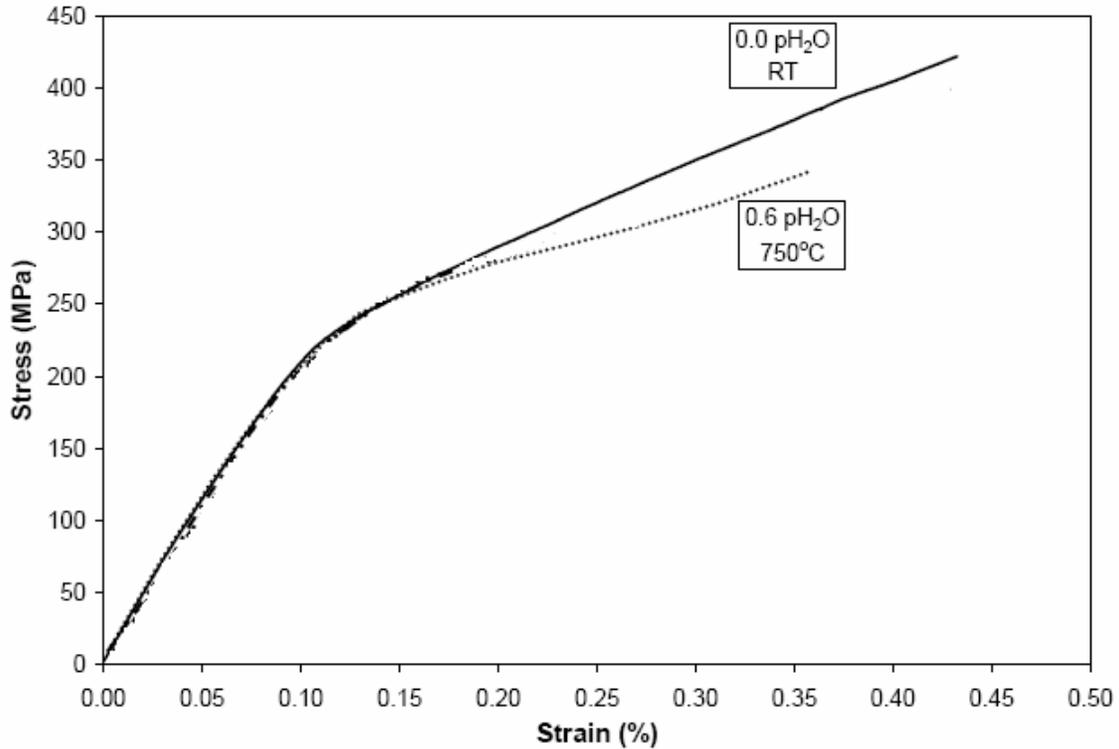
Figure 20: Moisture Effects on Stress Strain Curve [4]

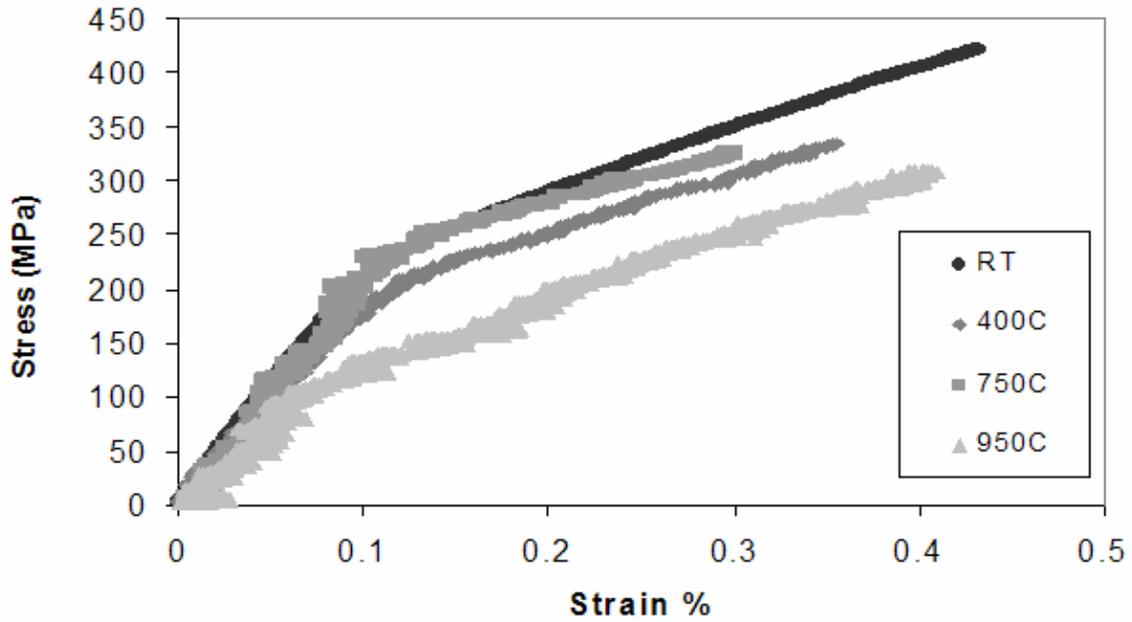
Figure 21: Environmental Monotonic Stress Strain Curves

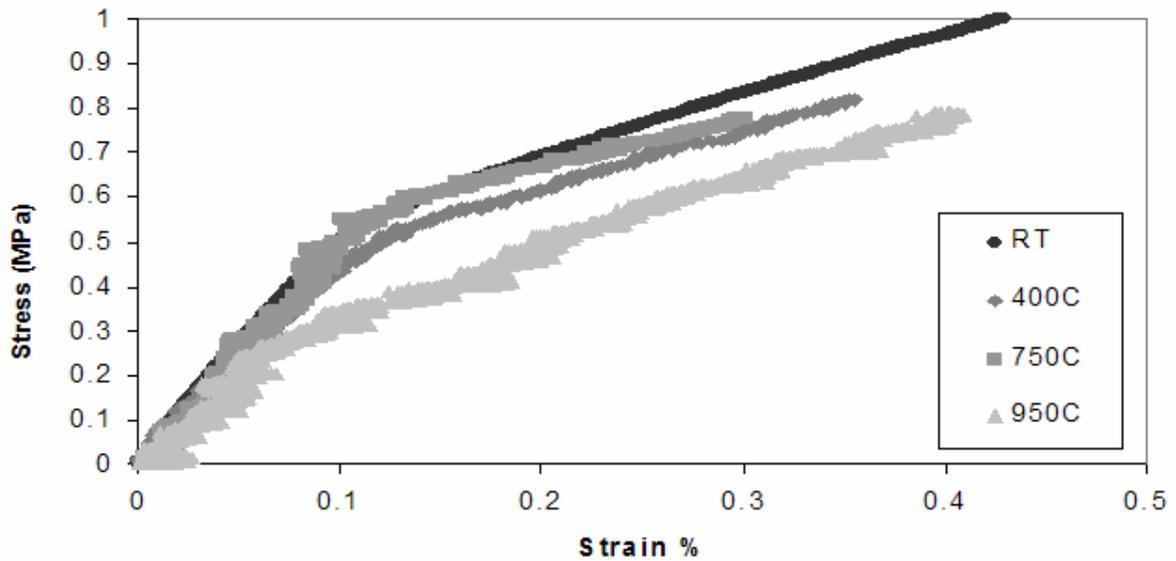
Figure 22: Environmental Monotonic Stress Strain Curves Normalized with respect to Room Temperature Ultimate Strength

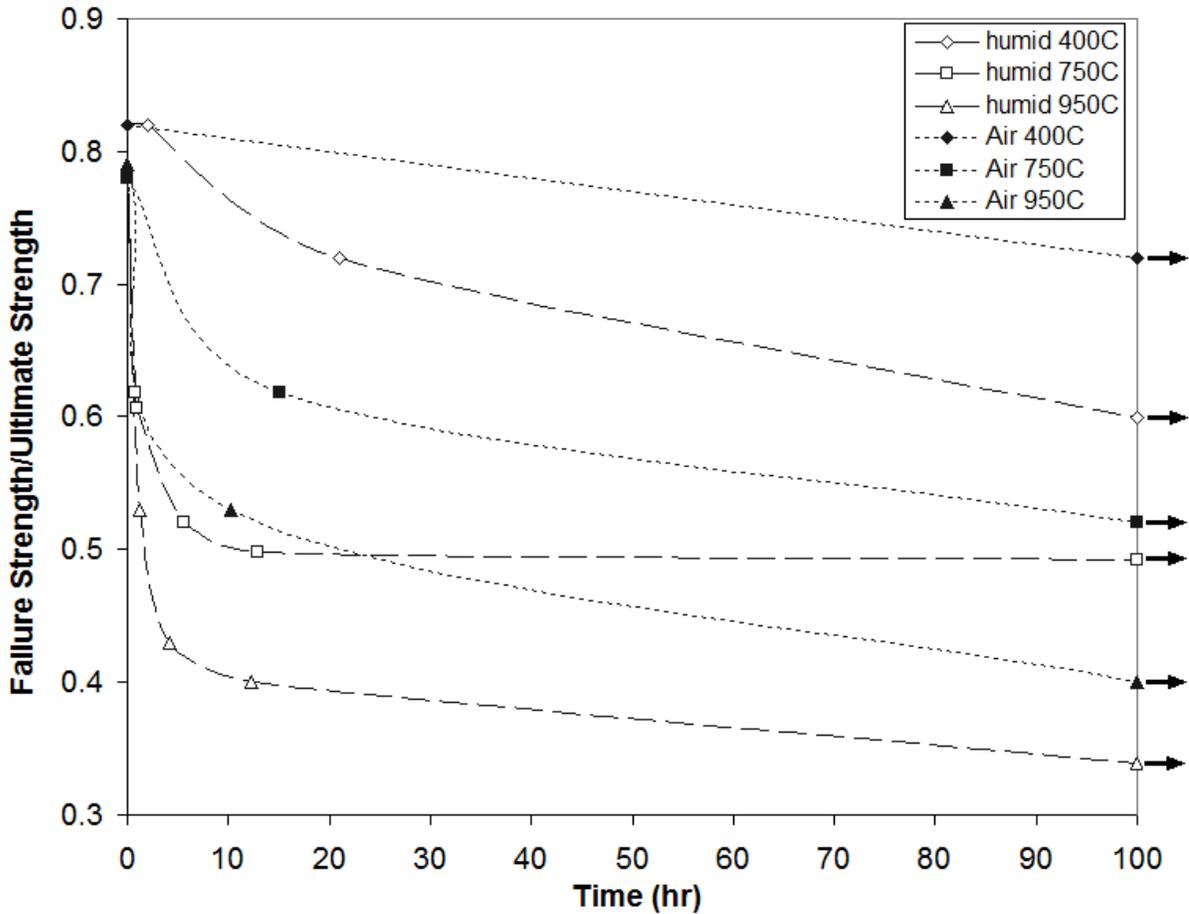
Figure 23: Stress Rupture Curves Normalized with respect to Room Temperature Strength

The stress rupture tests consisted of allowing the specimen to reach the testing temperature, then applying the load to the desired amount over a period of five minutes, where it was maintained for the remainder of the test. This research collected data from fifteen stress rupture tests. Figure 23 summarizes the results of the stress rupture tests, including data from the monotonic tests, and from LaRochelle [4]. Open and closed symbols denote humid and dry conditions, respectively. The diamond, square, and triangle symbols represent 400°C, 750°C, and 950°C, respectively. The data points at 0 hours are the monotonic test results. The data points at 100 hours are the experiments where the specimen did not fail. Figure 24 and Figure 25 break down the results for the stress rupture tests into humid conditions and ambient air conditions.

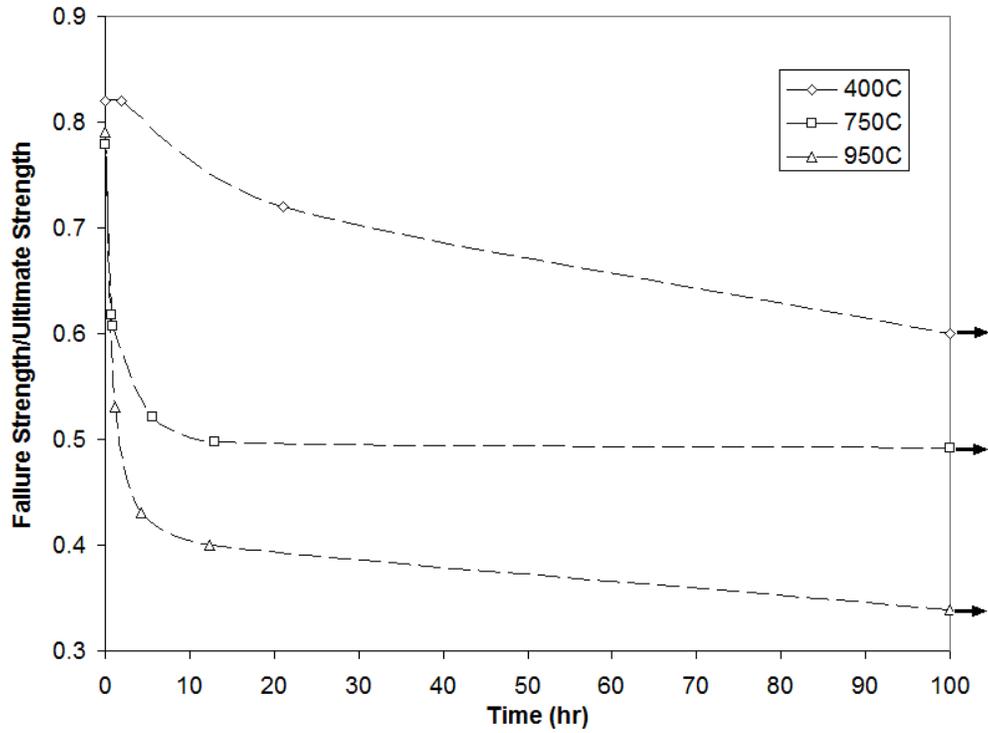
Figure 24: Stress Rupture Data for Humid Conditions Normalized with respect to Room Temperature Strength

Normalizing the data by the room temperature ultimate tensile strength shows how the test environment affects the CMC life. The lines in the plots merely show the trend of the data, they are not curve fits. Due to the limited amount of specimens, there are not a lot of data points, so there is not much scatter in the plots. The majority of the data for the humid 750°C tests was from LaRochelle [4]. A test was run under humid conditions at 750°C to verify the assumption that the data from this test is comparable with the data from LaRochelle [4]. The data point obtained from this test fit the trend for the humid 750°C data. At times less than two hours, little distinction can be made in the data, as time progresses, the curves become distinct. It is apparent in Figure 23 that the data for humid and dry conditions show the same trends, although there is more strength degradation under humid conditions.

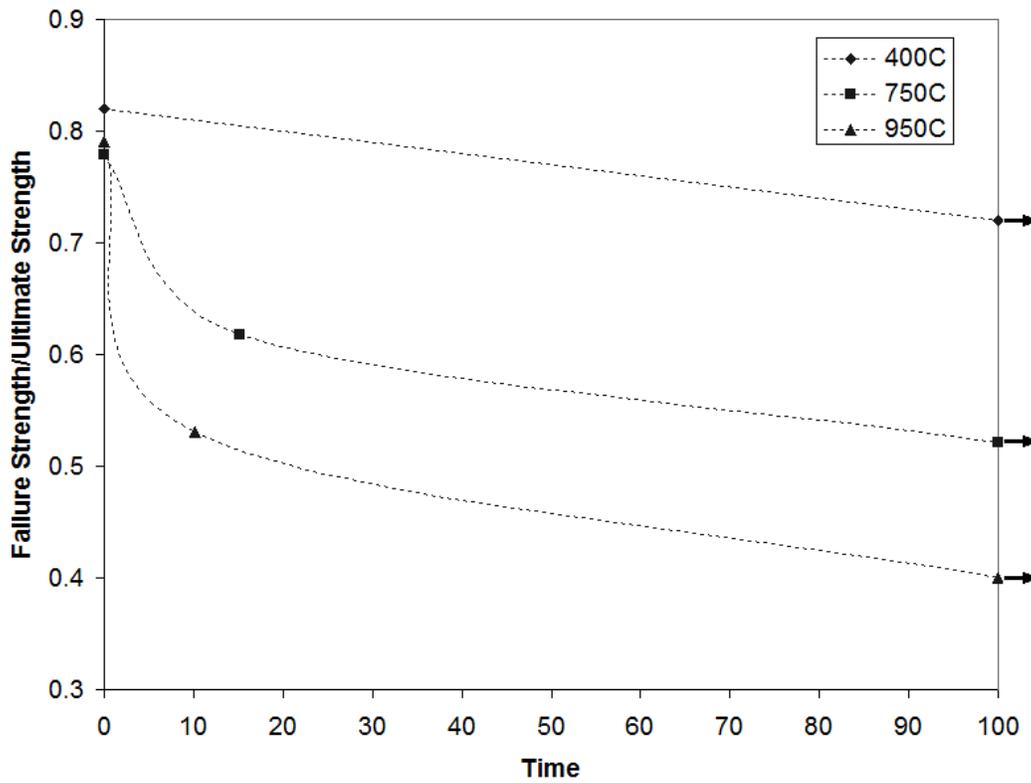
Figure 25: Stress Rupture Data for Ambient Air Conditions Normalized with respect to Room Temperature Strength

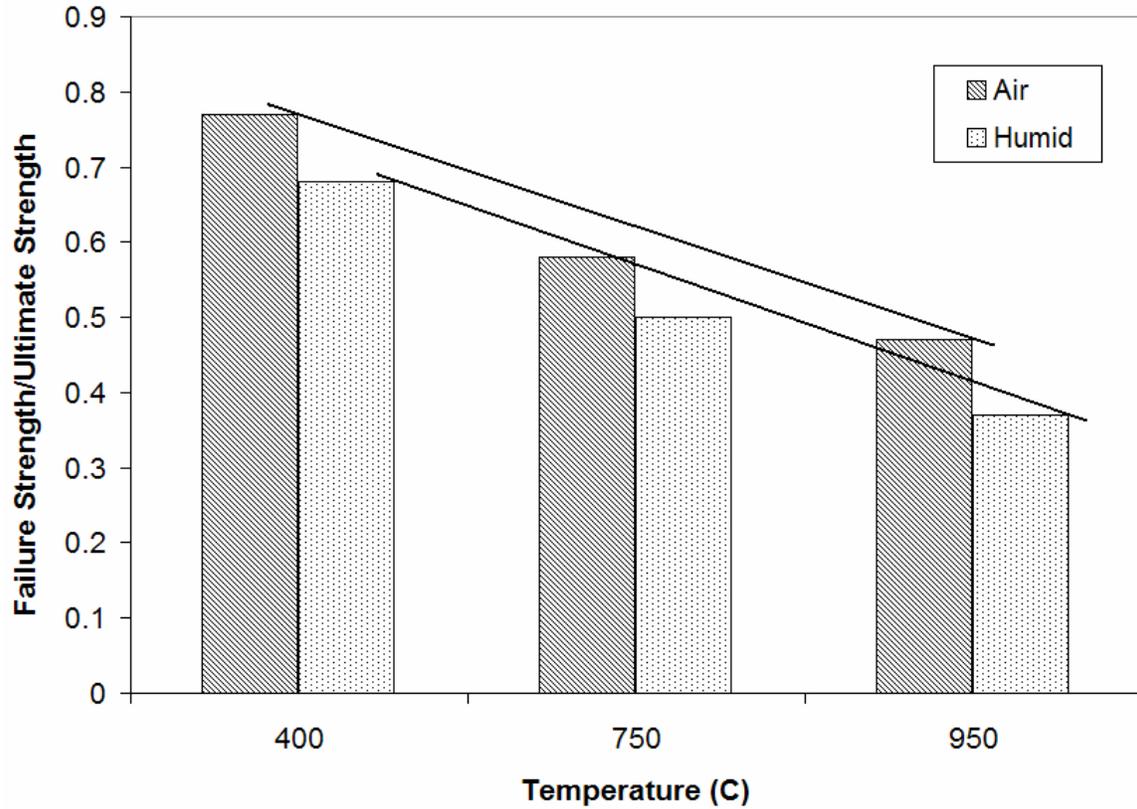
Figure 26: Normalized Failure Stress at 50 hours Estimated from Normalized Stress vs. Time Curves

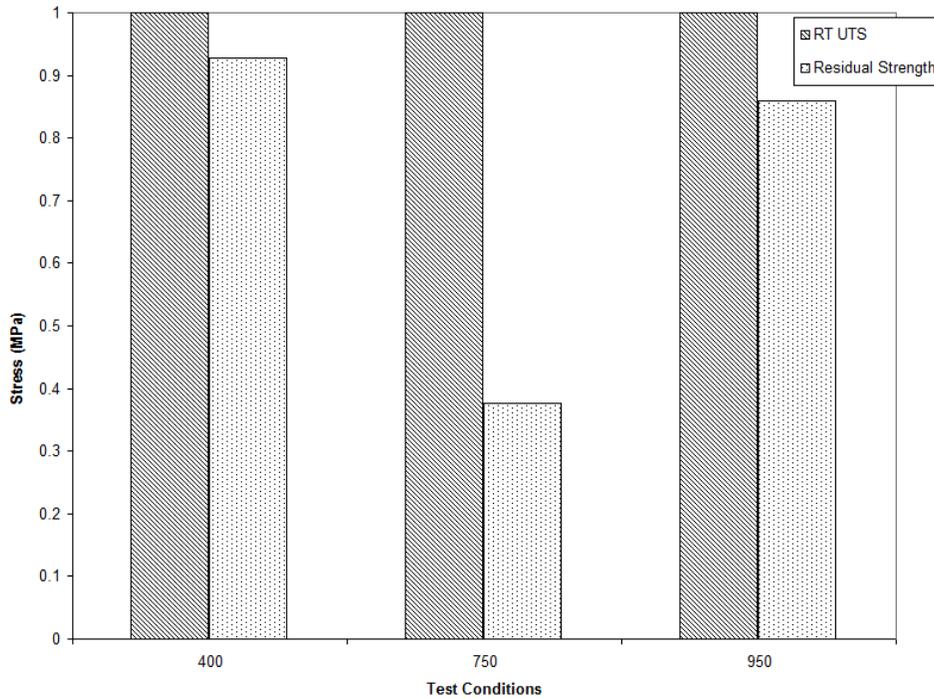
Figure 27: Humid Test Residual Strength with respect to Room Temperature Ultimate Strength

One can see that the residual strength performance is much worse for the intermediate ranges, both in air and humid conditions. The high percentage of residual strength for the humid tests can be attributed to the low value for the room temperature strength. As one can see in Table 4, it is much lower than the ultimate strengths of the other panels. The increase in the ultimate tensile strength in the 400°C test can be attributed to scatter.

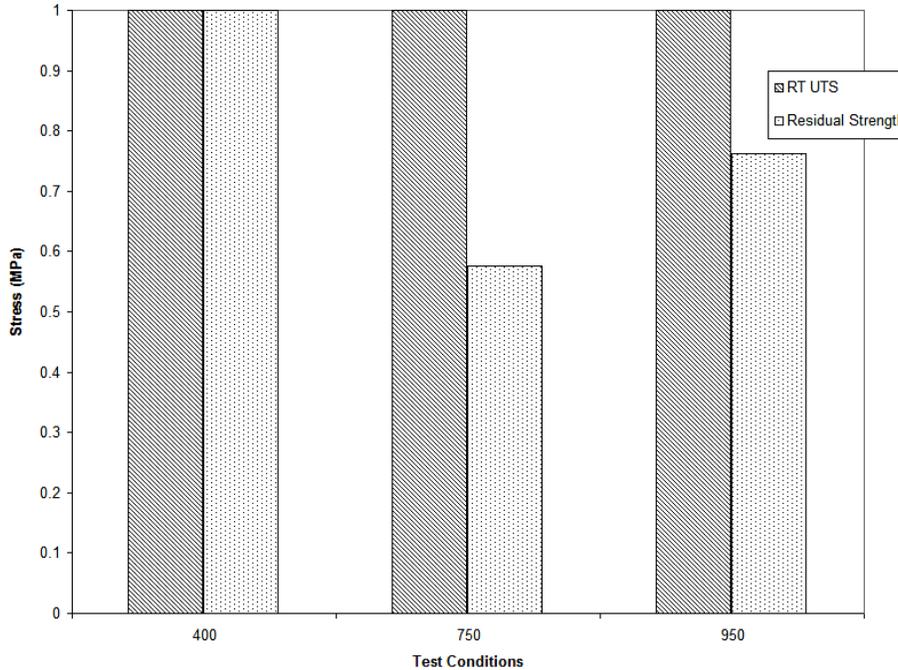
Figure 28: Residual Strength in Air with respect to Room Temperature Ultimate Strength

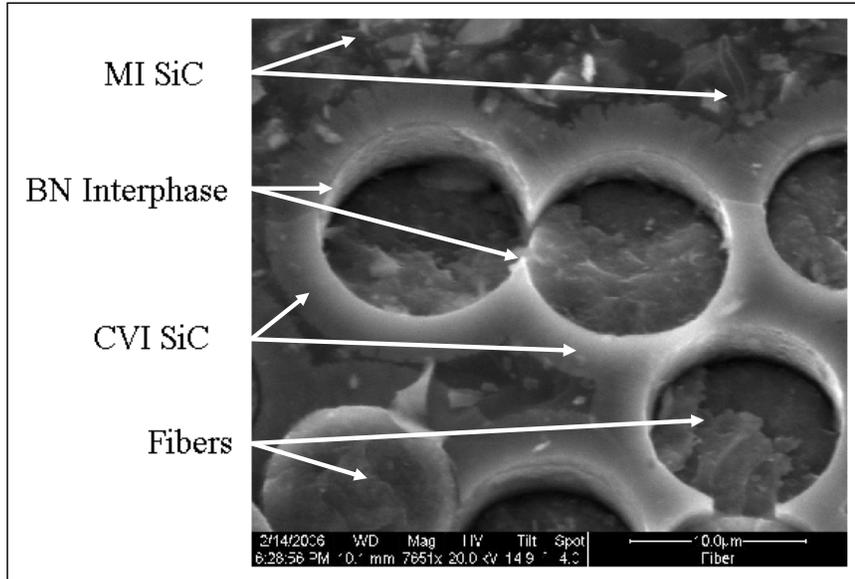
Figure 29: CMC Constituents

In discussing the SEM analysis the terms used to describe the constituents of the CMC are SiC fibers, the CVI SiC layer, the MI SiC matrix, and the BN interphase. Figure 29 shows these constituents. Each fracture surface has a different appearance: the MI SiC has a random orientation around the fibers, while the CVI SiC seems to radiate out from each fiber with a fairly consistent thickness, the fibers fracture mostly flat and smooth.

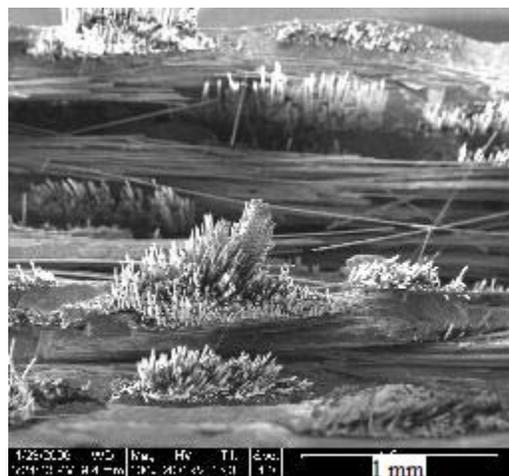
Figure 30: Fiber Pullout

Figure 30 demonstrates fiber pullout. The fiber that “pulls out” of the matrix is one that has separated from the interphase, and so diverted a crack until the fiber finally failed. Figure 31 demonstrates fiber debonding, with interior debonding happening when the interphase remains with the matrix, and exterior debonding, when the interphase remains on the fiber.

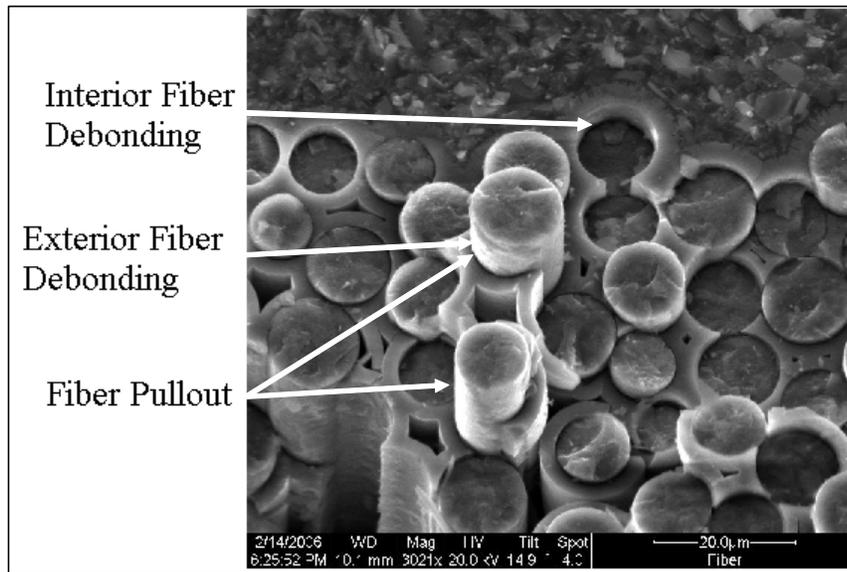
Figure 31: Fiber Debonding

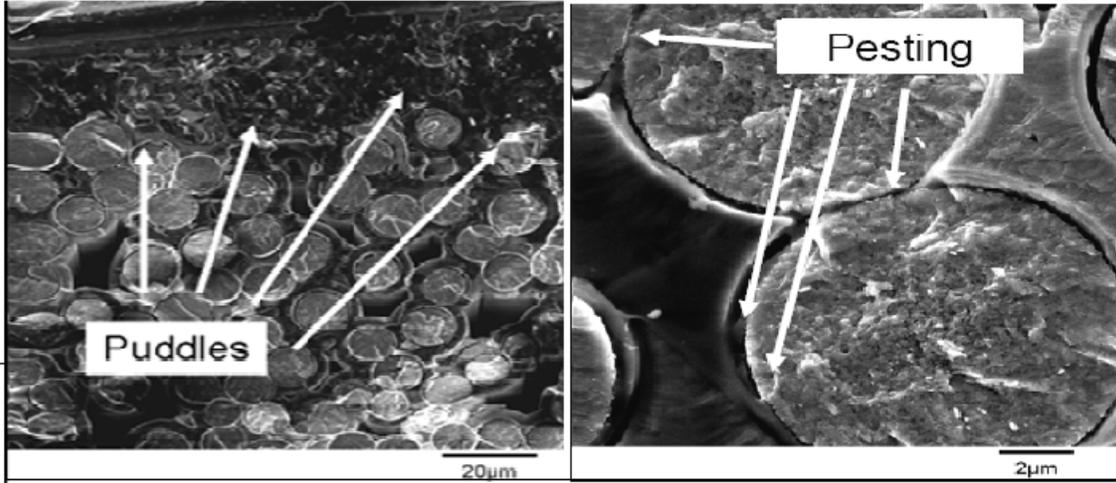
Figure 32: Embrittlement Features: Puddles and Pesting

The final terms that will be used in discussing the SEM analysis are puddling and pesting. Puddling and pesting are results of embrittlement. Puddling is when massive BN oxidation occurs, resulting in boria [4]. Pesting of the fibers is the effect of the embrittlement, when the liquid borosilicate solidifies into a silicate glass, bonding the fibers to each other and to the matrix. This prevents the fiber from slipping from the matrix to distribute stress and prevent crack propagation, resulting in the crack continuing across the solidified bundle of fibers. Figure 32 [4] shows puddling and pesting, respectively
