Creep-Rupture Behavior of a Woven Ceramic Matrix Composite at Elevated Temperatures in a Humid Environment

THESIS

Jennifer L. Ryba, 2nd Lieutenant, USAF
AFIT/GMS/ENY/06-M02

AIR FORCE INSTITUTE OF TECHNOLOGY

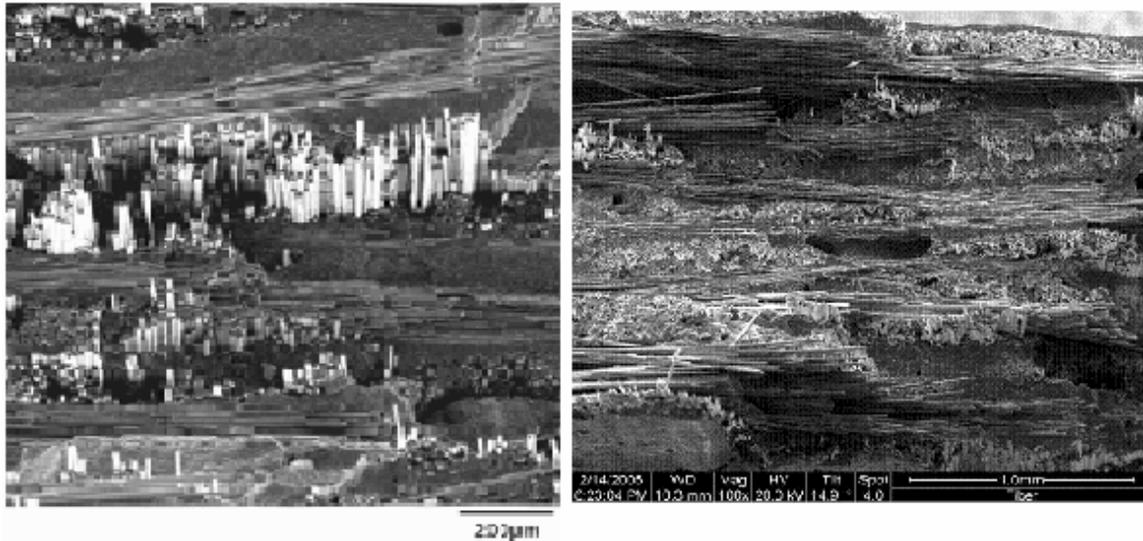
Figure 33: Fracture Surface Comparison - Room Temperature vs. 400°C - 100x

The following figures compare the room temperature specimens from the previous study [4] with the 400°C monotonic test specimen from the current study. The similarity in the images shows that at low temperatures, the damage mechanisms are comparable to those at room temperature.

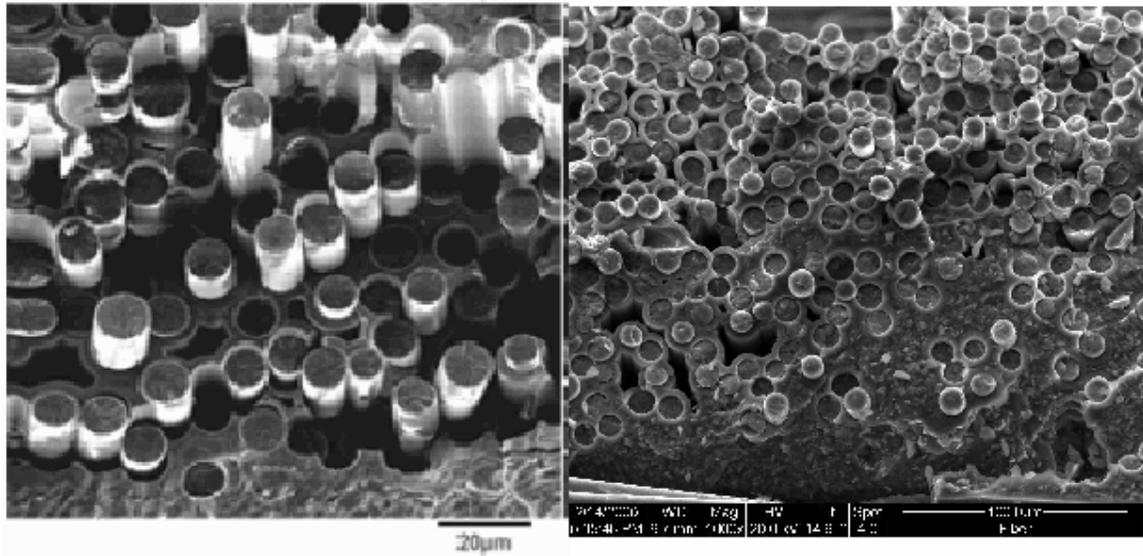
Figure 34: Fracture Surface Comparison - Room Temperature vs. 400°C - 1000x

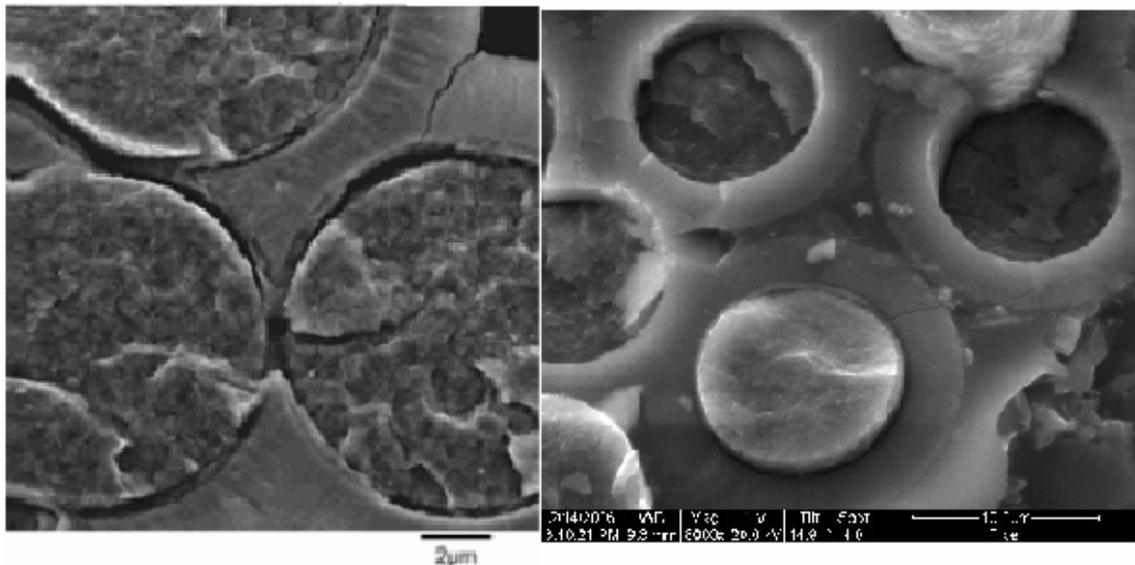
Figure 35: Fracture Surface Comparison - Room Temperature vs. 400°C - 8000x

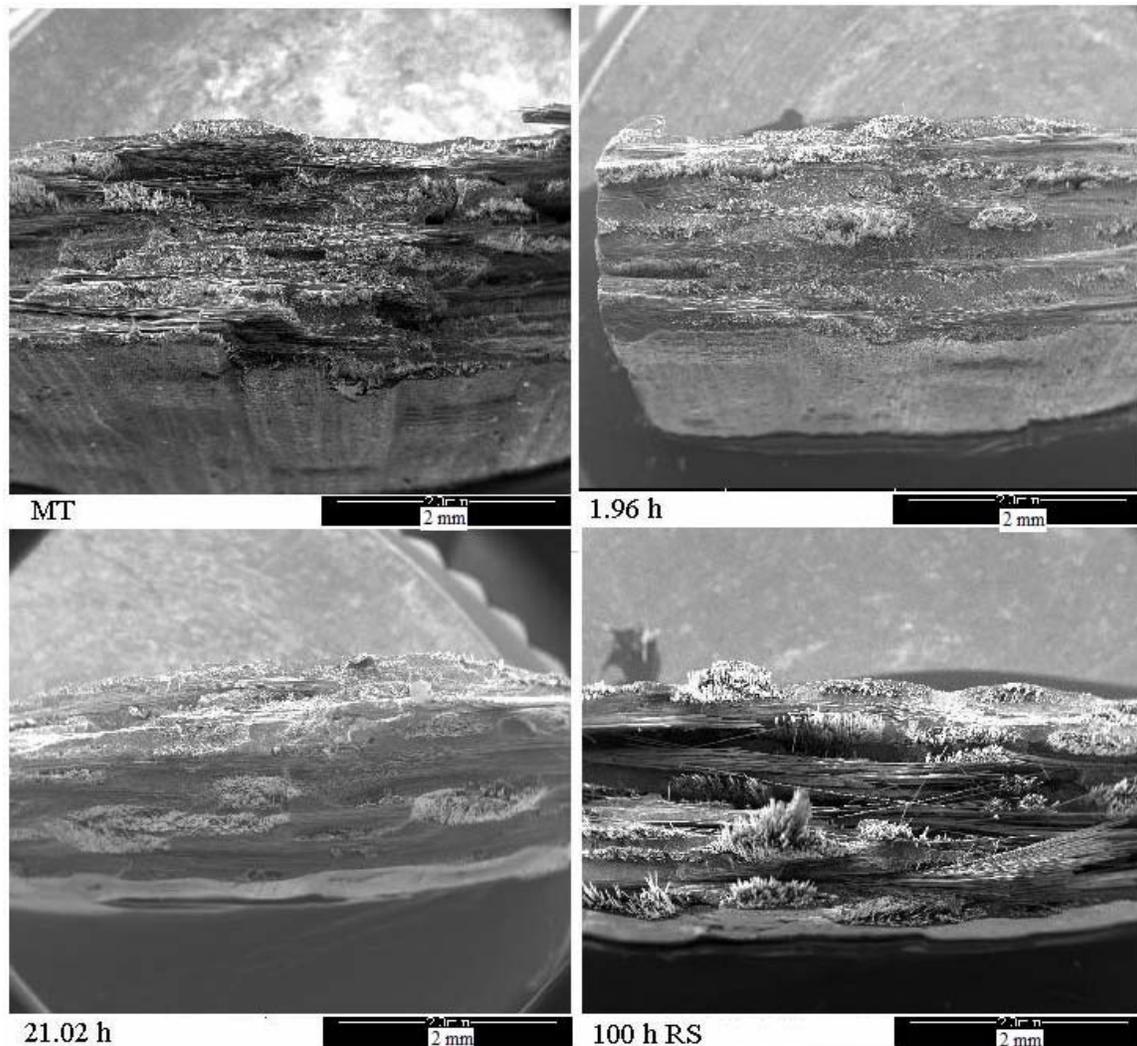
Figure 36: Stress Rupture Tests - Humid Conditions 400°C - 50x

The first analysis is of the tests run at 400°C (Figure 36 through Figure 45). The initials MT in the figures indicate a monotonic test. The initials RS in Figure 36 mean that the fracture surface is the result of a test run out in the environmental condition followed by a residual strength test. Comparison of the fiber pullout lengths of the different samples does not show much variation. At 50x, the samples seem to have very similar pullout, both in humid and air tests.

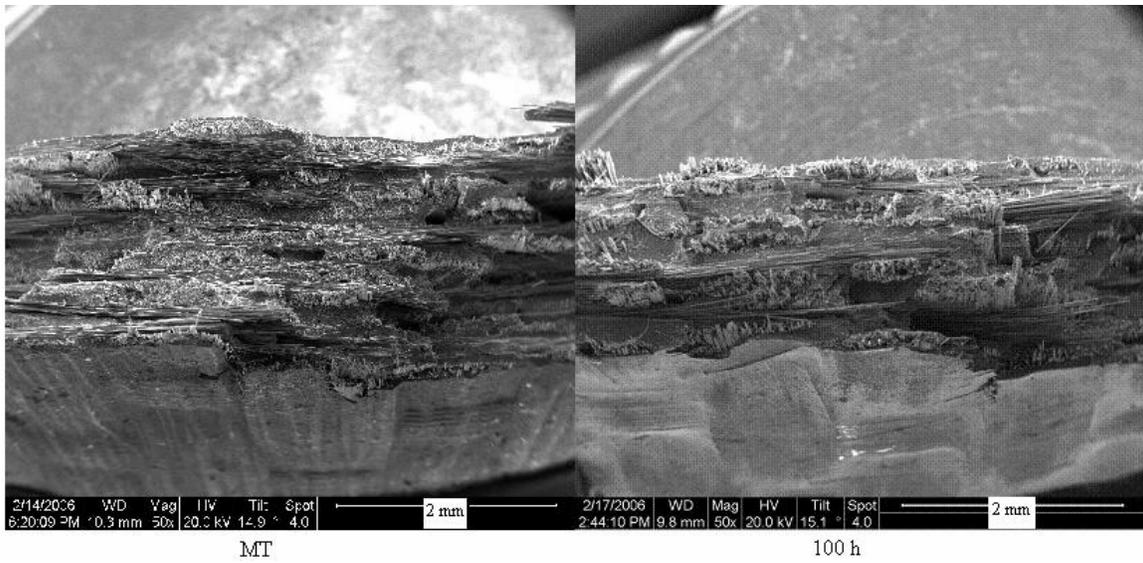
Figure 37: Stress Rupture Test - Ambient Air - 400°C - 50x

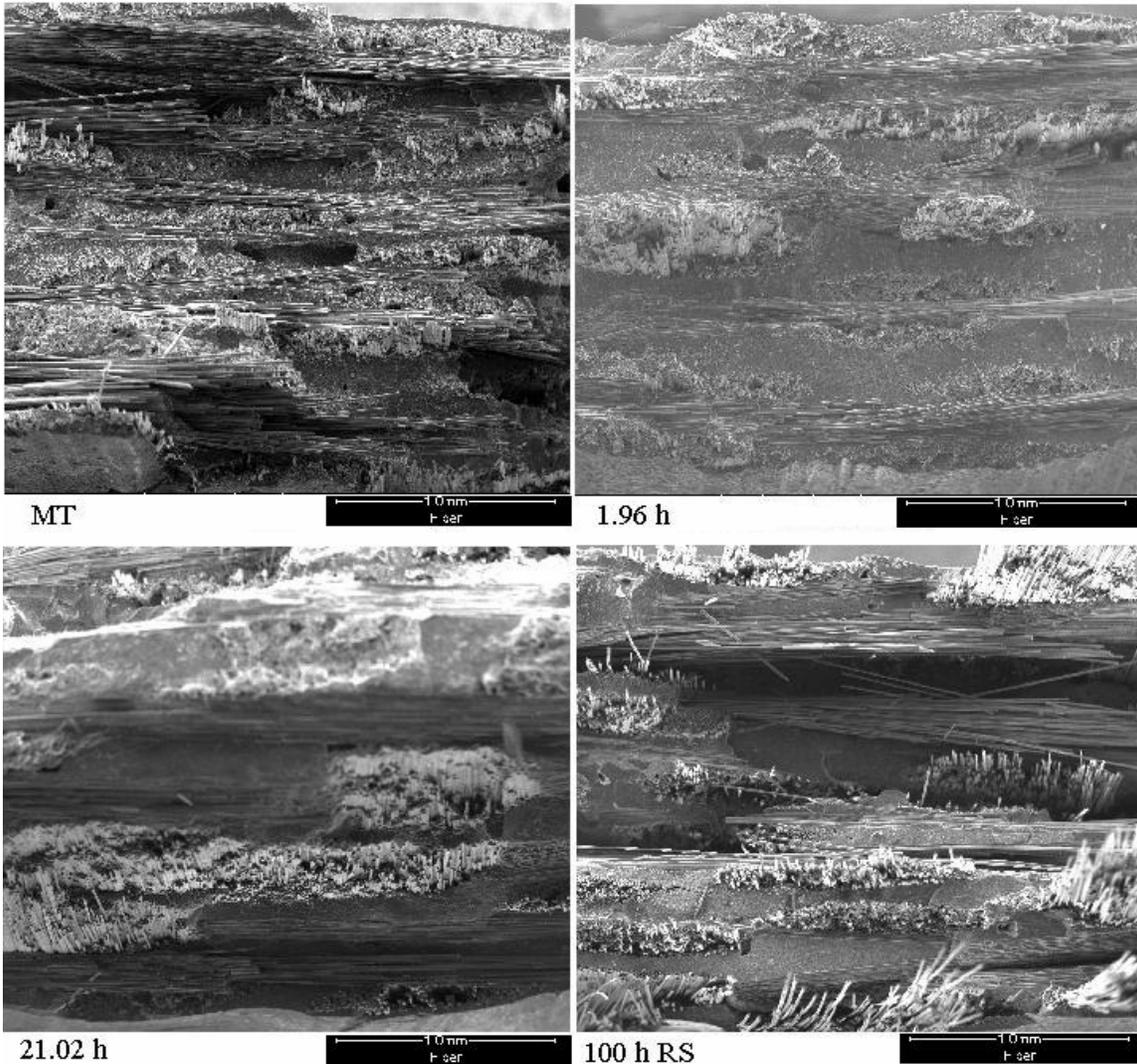
Figure 38: Stress Rupture Test - Humid Conditions - 400°C - 100x

The 100x images still maintain a consistent fiber pullout length between the specimens. Within each specimen there is a wide range of pullout lengths, but similar pullout lengths in tows. The residual strength specimen has a rather brushy appearance compared to the other three samples. The images (Figure 38 and Figure 39) from the ambient air and moisture tests are similar in appearance.

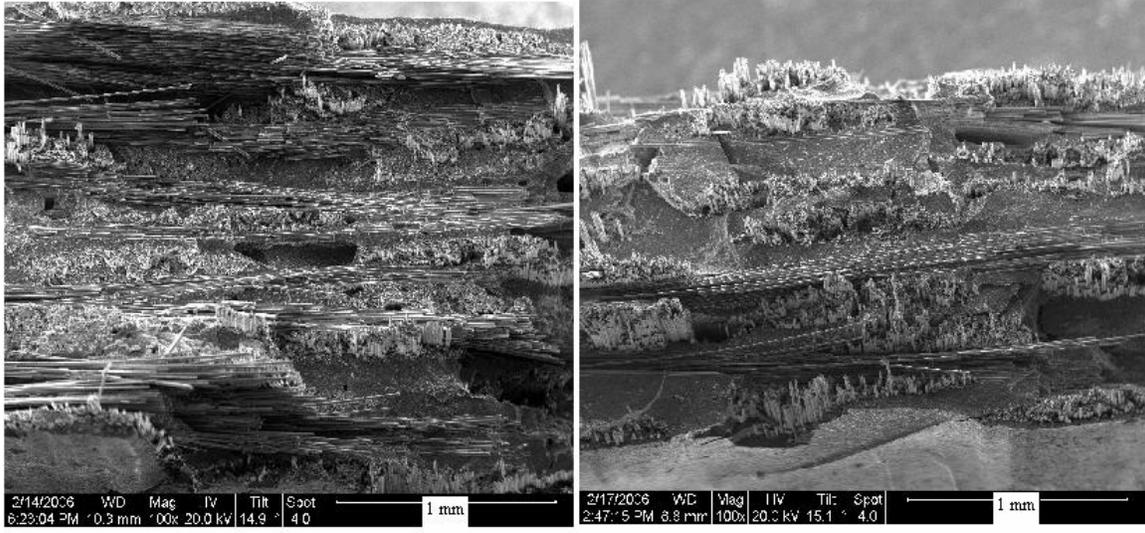
MT
100 h
Figure 39: Stress Rupture Test - Ambient Air - 400°C - 100x

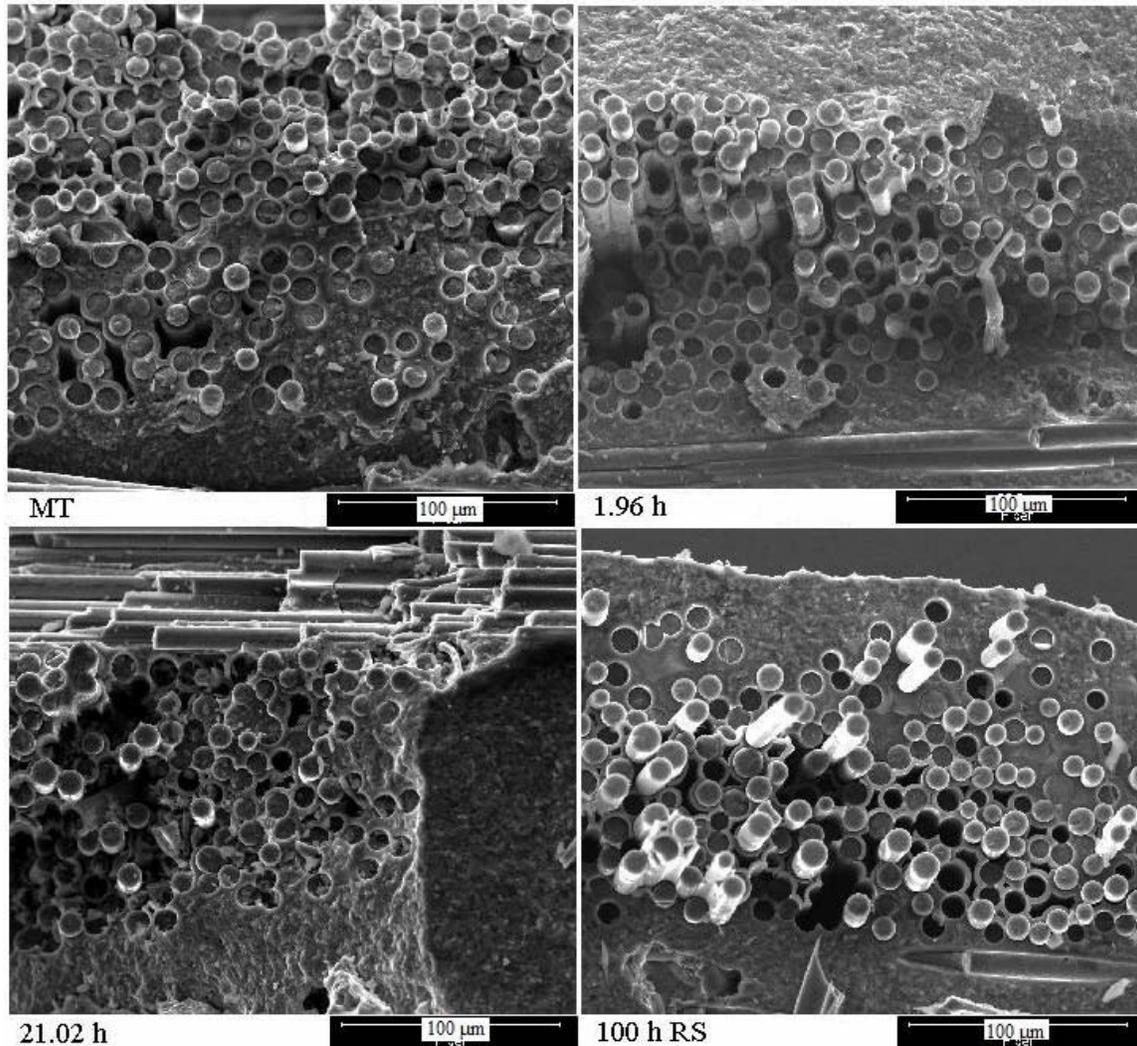
Figure 40: Stress Rupture Test - Humid Conditions - 400°C - 1000x

Comparison of the 1000x images in Figure 40 and Figure 41 show that the fibers are experiencing interior and exterior debonding. The fibers are failing at different lengths, and there is no evidence of puddling.

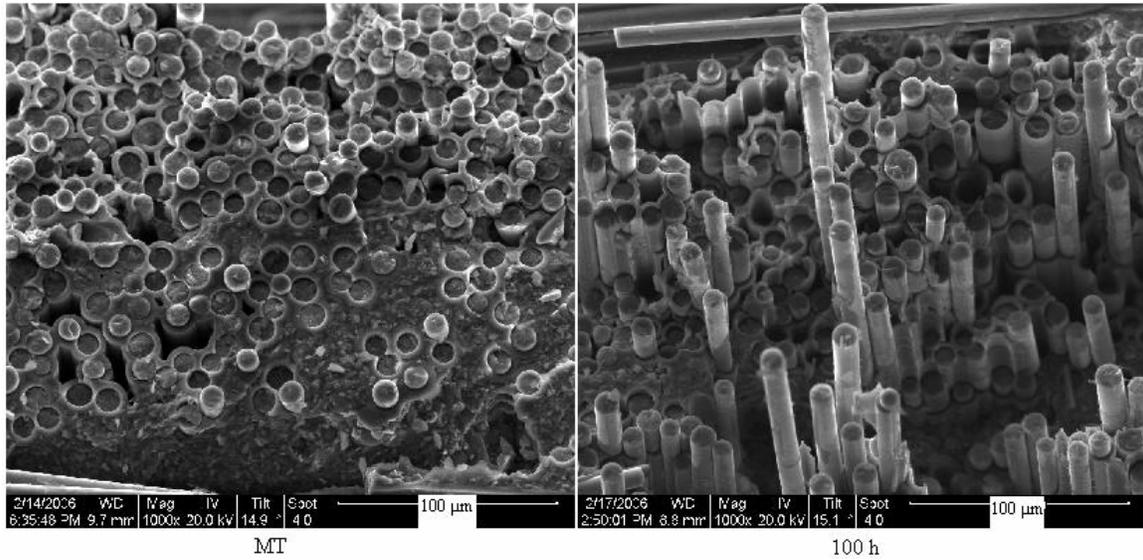
Figure 41: Stress Rupture Test - Ambient Air - 400°C - 1000x

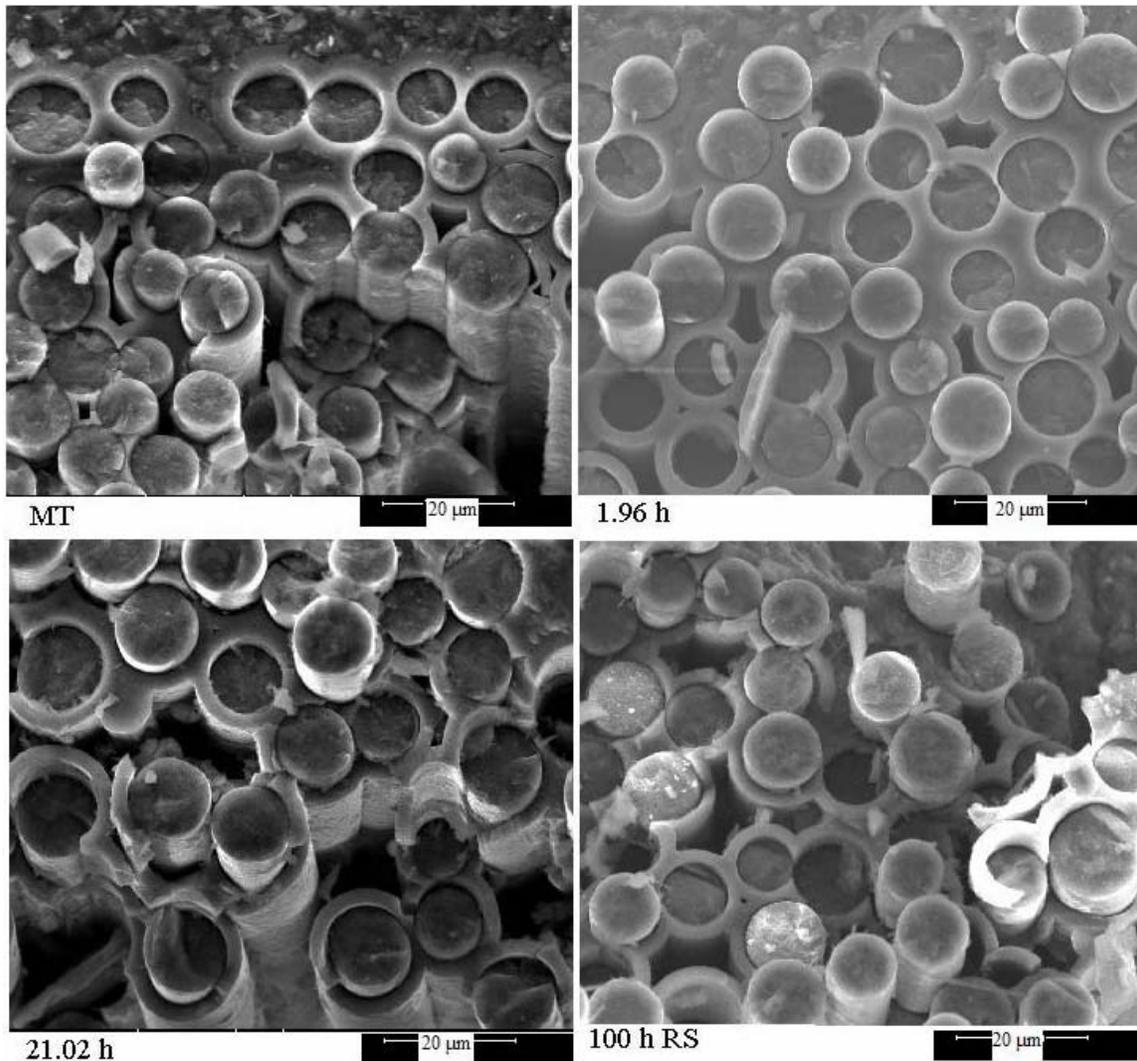
Figure 42: Stress Rupture Tests - Humid Conditions - 400°C - 3000x

Comparisons of the 3000x images in Figure 42 and Figure 43 show that at all times the BN layer is distinguishable from the fiber and the CVI SiC, that the fibers experience both interior and exterior debonding. It also shows that nearest neighbor fibers fail at different fiber locations.

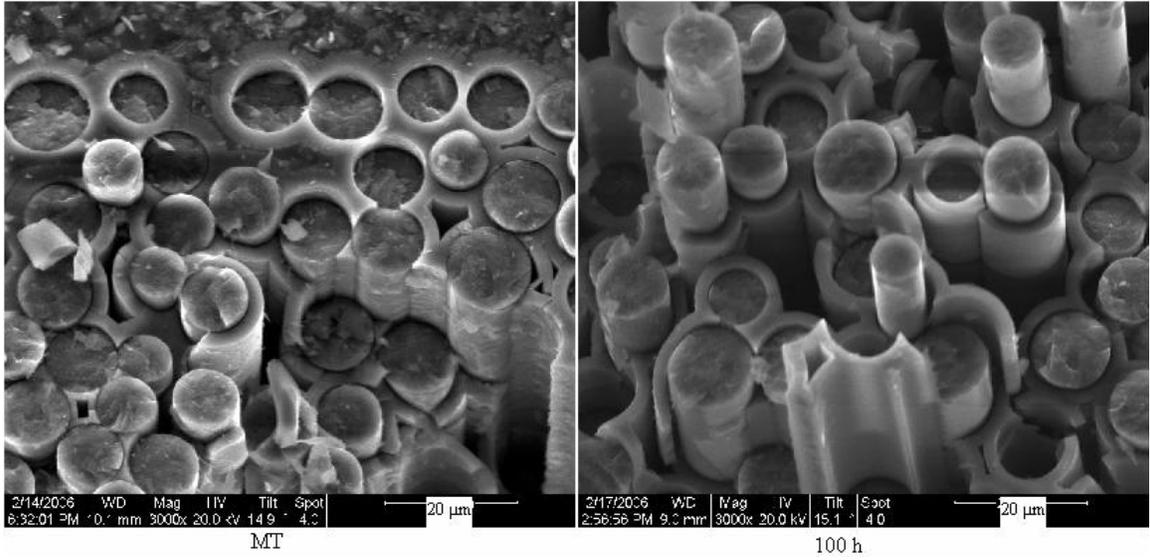
Figure 43: Stress Rupture Test - Ambient Air - 400°C - 3000x

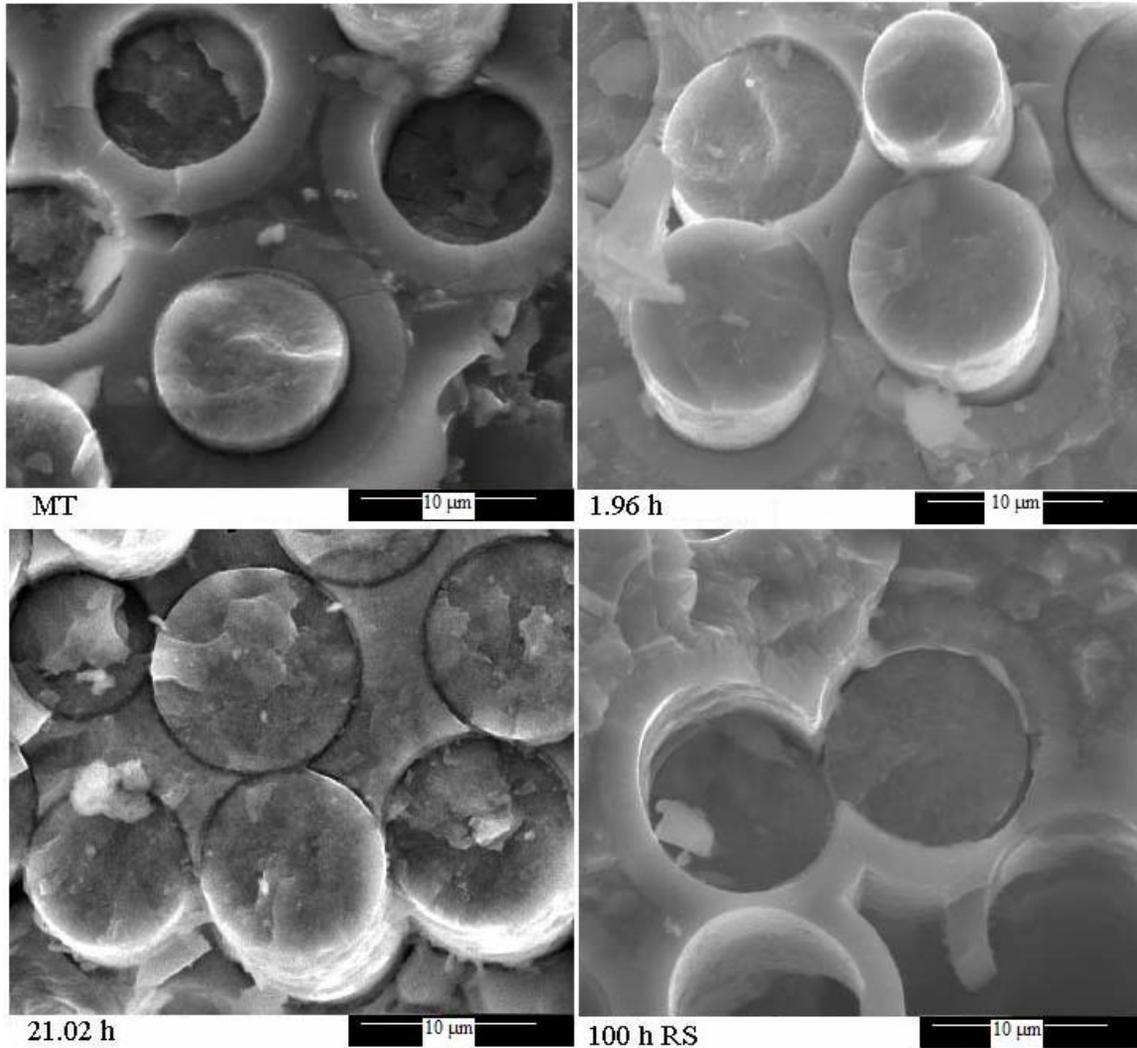
Figure 44: Stress Rupture Tests - Humid Conditions - 400°C - 8000x

Comparisons of the 8000x images in Figure 44 and Figure 45 show no distinguishable characteristics between the room temperature monotonic test and the tests run at 400°C, both humid and air. However, the brittle fracture of the matrix, fiber, and interphase is obvious.

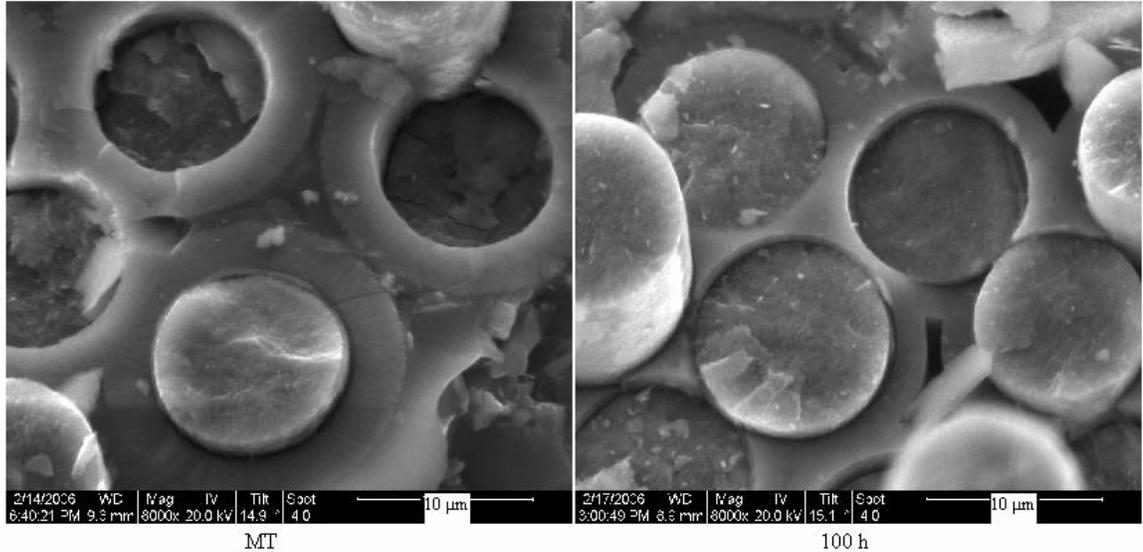
Figure 45: Stress Rupture Test - Ambient Air - 400°C - 8000x
