Characterization of Compressive Creep Behavior of Oxide/Oxide Composite with Monazite Coating at Elevated Temperature

**CHARACTERIZATION OF COMPRESSIVE CREEP BEHAVIOR OF
OXIDE/OXIDE COMPOSITE WITH MONAZITE COATING
AT ELEVATED TEMPERATURE**

THESIS

AFIT/GAE/ENY/06-M17

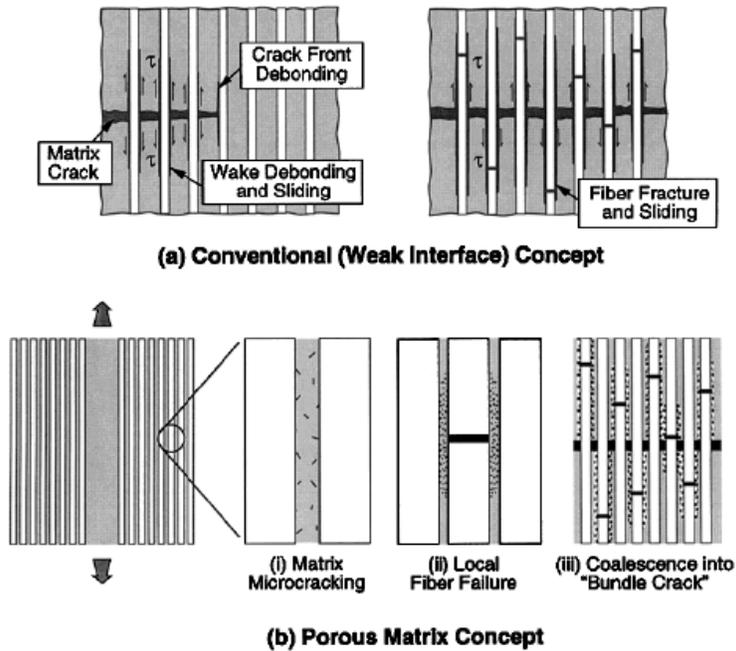
Figure 1. “Schematics of the Damage Processes that Enable Damage Tolerance in a) Conventional Dense-Matrix Weak-Interface CMC and b) Porous Matrix CMCs Without Fiber Coatings” [43:15].

Ceramic materials are known to be very brittle. Why CMCs have become so appealing is that the introduction of continuous fiber reinforcement can make ceramics behave in a less brittle manner and make them more damage tolerant [4:565]. As the density of a ceramic increases so do its mechanical properties. Unfortunately, testing has shown that in CMCs porosity in the matrix plays a vital role in crack deflection [28,43:15]. Figure 1 shows the two known crack deflection mechanisms for CMCs.

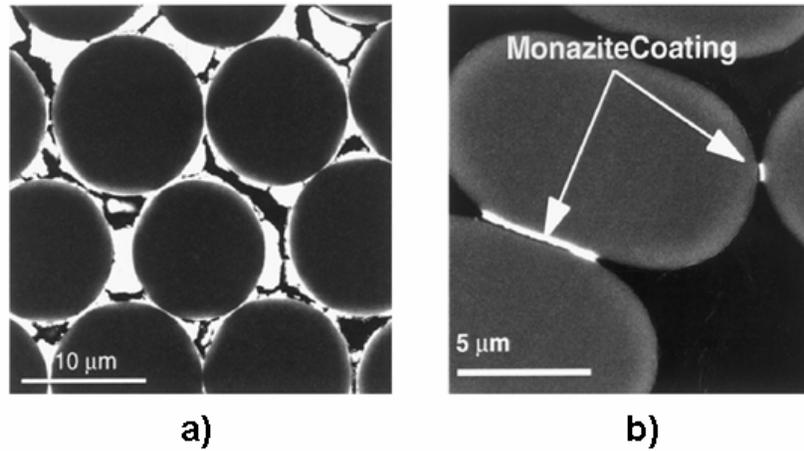
Figure 2. Monazite Coating is the Bright Areas in the Pictures. (a) Shows Fiber Bridging and (b) Shows Incomplete Fiber Coverage [14:584]

The application of fiber coatings is a difficult process and has become a large field of study. Two common problems associated with fiber coatings are fiber bridging and poor fiber coverage (see Figure 2). The former can lead to poor matrix infiltration into fiber bundles and the latter allows fiber and matrix to bond together making the composite more brittle [14:584,28:2624]. There are three gas-phase deposition techniques for applying coatings to ceramic fibers: CVD, physical vapor deposition (PVD), and combustion CVD. Of the three, the latter two unfortunately do not work well when applying coatings to filaments, because they essentially rely on line-of-sight and therefore it is difficult to apply the coating to all the fibers [28:2623-24]. Using liquid-phase processes is a cost-effective option, but very little work has been done on applying ceramic coatings to ceramic fibers [28:2624]. One technique used is the sol-gel technique, which was used in this investigation to apply the coating to the fiber. In the course of this process the fiber is passed through a tank containing a sol and wound on a wheel, where sol-gel transition occurs. Finally the gel-coated fiber is subjected to controlled heating to densify the gel [10:24,10:126]. Some of the work that has been done applied vacuum enhanced dip-coating [29]. All of the above the processes are

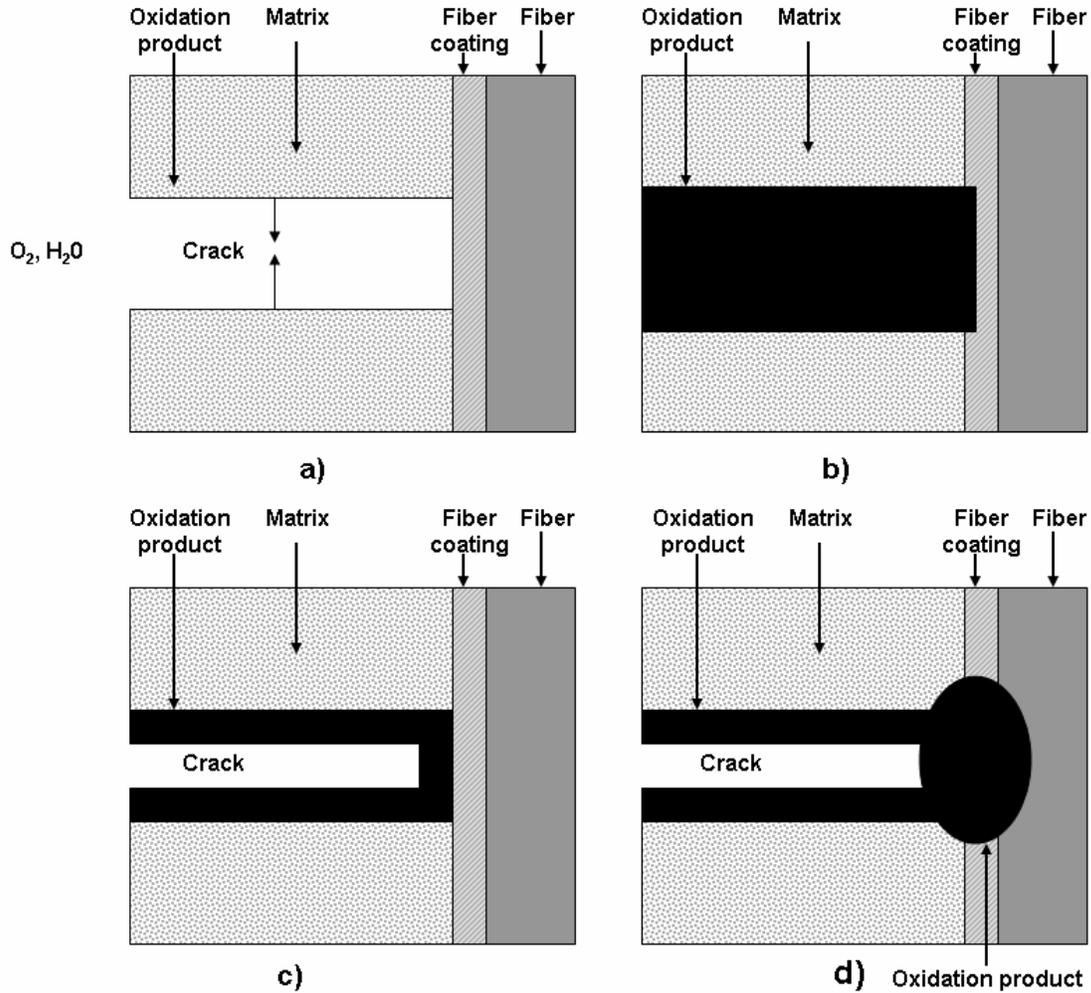
Figure 3. Schematic Representation of Oxidation Progression through Matrix Crack of CMC with Fiber Coating

As seen in Figure 3a, the oxidants enter the crack and then products of the oxidation reduce the width of the crack as seen in Figure 3c. Two things occur at this point. The products either seal the crack preventing damage to the fiber/coating/matrix interface as seen in Figure 3b or as shown in Figure 3d the crack may not seal before the oxidant seeps into the coating and through to the fiber where it oxidizes the fiber. For this exact reason, all-oxide CMCs have been developed for use in long-term, high-temperature environments.

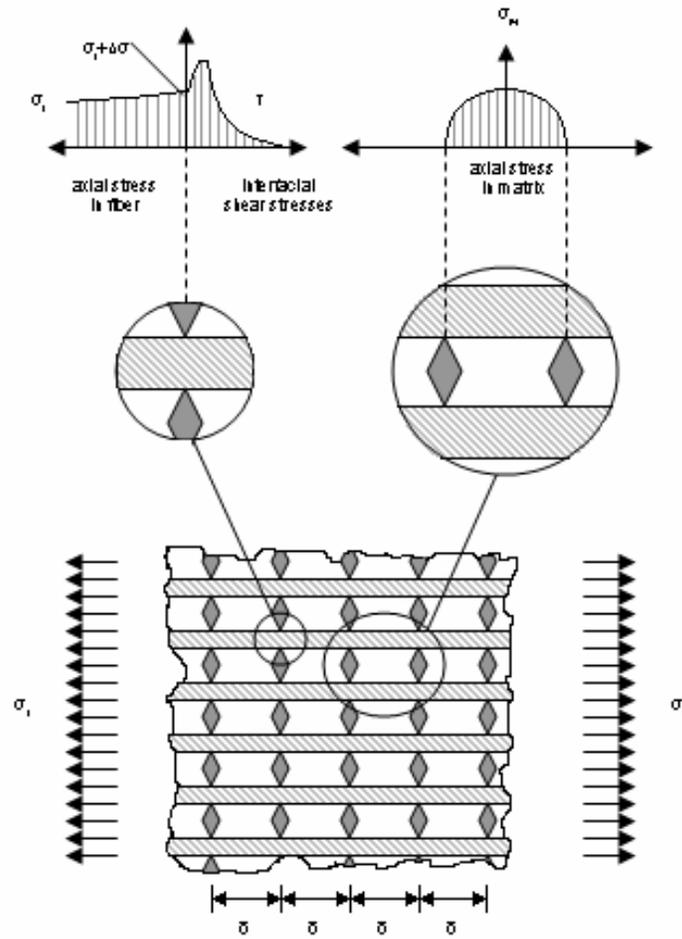
Figure 4. Schematic of Matrix Cracking and Local Stress Distributions in Composite under Longitudinal Tension

As with monolithic materials, ceramic matrix composites fail in different manners when exposed to different types of loading. Composites fail when the phase with the lower ultimate strain does and in the case of CMCs that phase is commonly the matrix. Under tension CMCs, like other brittle-matrix composites, first develop multiple matrix cracks. “These cracks create local stress distributions with high interfacial shear stresses and increased tensile stress in adjacent fibers” [12:90]. This is schematically shown in Figure 4.

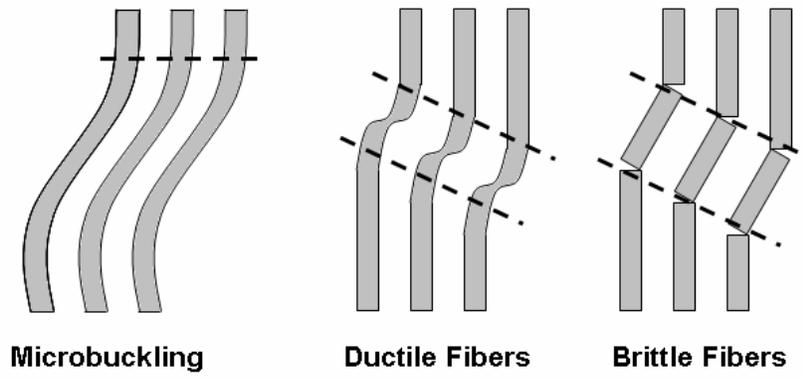
Figure 5. Schematic of Microbuckling, which Leads to Excessive Deformation in Ductile Fibers or Fracture Planes in Brittle Fibers

However, in compression a reinforced fiber composite has a much different failure mechanism. Compression introduces what is called microbuckling or kinking of the fibers within the matrix. These form kink zones, which cause fracture planes in brittle fibers. Figure 5 illustrates microbuckling and Figure 6 shows the possible shear failure mode for composites containing high fiber volume ratios. Figure 7 shows the final mode of failure that a CMC can experience in compression, which can be referred to as transverse splitting. In this mode of failure the matrix splits apart causing delamination.

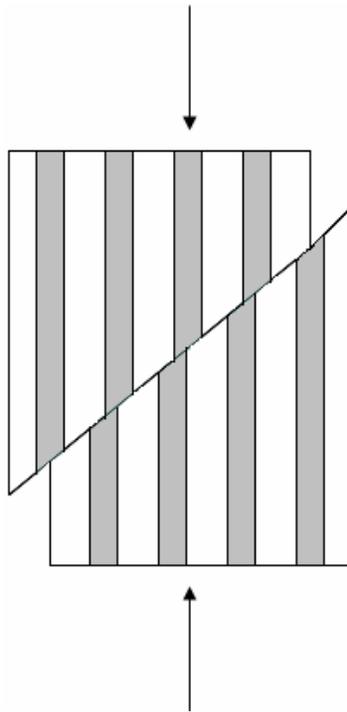
Figure 6. Schematic of Shear Failure Mode of Unidirectional Composite Under Longitudinal Compression

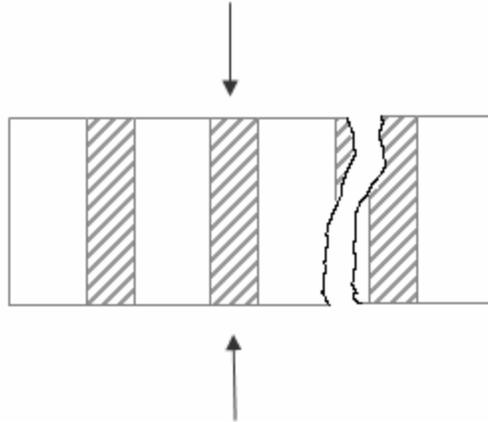
Figure 7. Schematic of Transverse of Splitting of Unidirectional Composite Under Longitudinal Compression

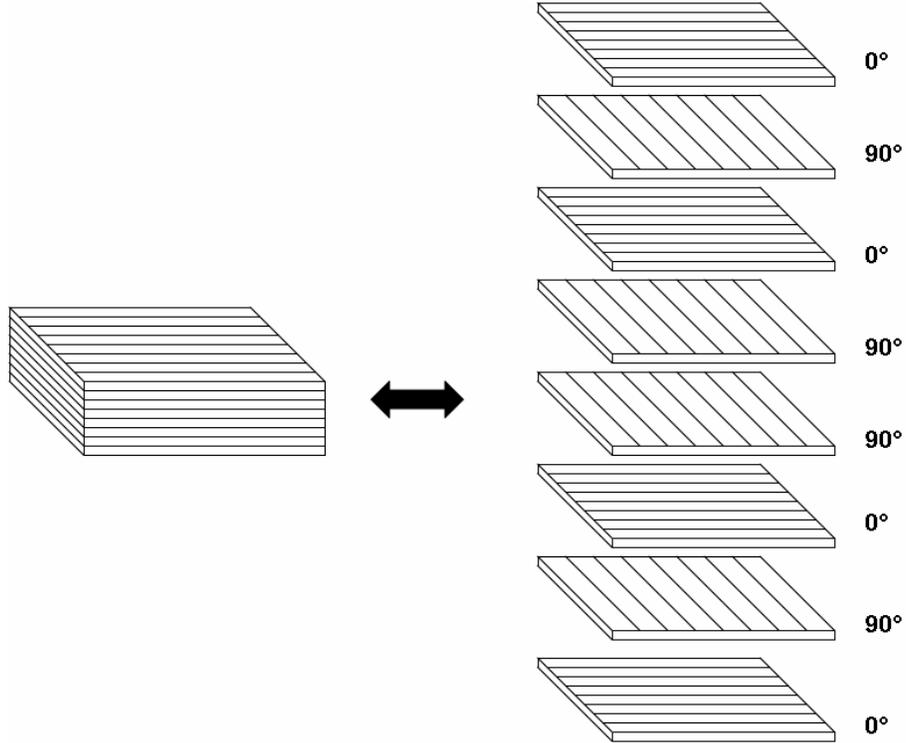
Figure 8. Schematic of $(0^\circ/90^\circ/0^\circ/90^\circ)_s$ Fiber Orientation

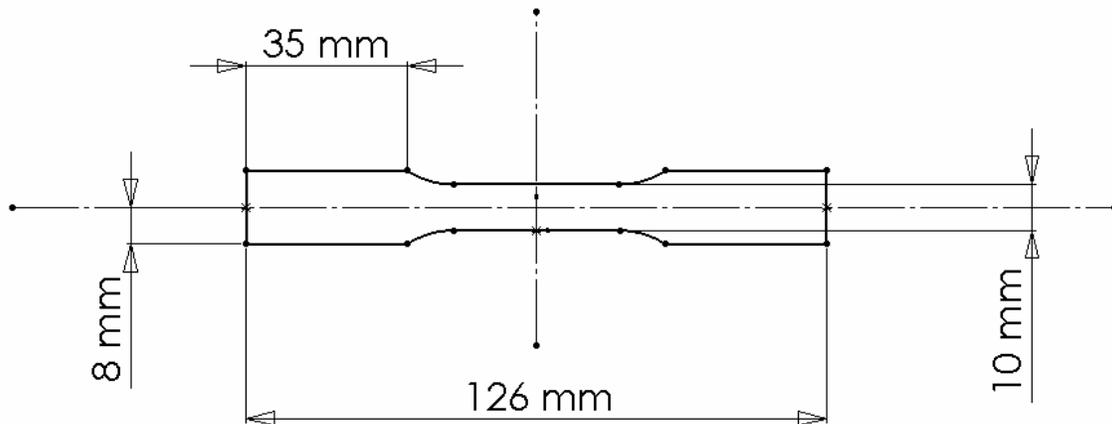
Figure 9. Tensile Specimen

When referring to the specimens it is important to specify their various fiber orientations. The specimens with $\pm 45^\circ$ fiber orientation were referred to as such or as “off-axis” specimens. It was necessary to refer to the on-axis specimens in two ways because not all were oriented along the same direction in the panel and the fiber direction of the surface layer appeared to play a direct role in the strength of the material. Therefore, the specimens that had the surface layer with 0° fiber orientation were referred to as 0° specimens and those that had the surface layer with the 90° fiber orientation were referred to as 90° specimens. Tensile specimens were cut to specifications in Figure 9. Standard dog-bone shape was used to promote failure in the gage section.

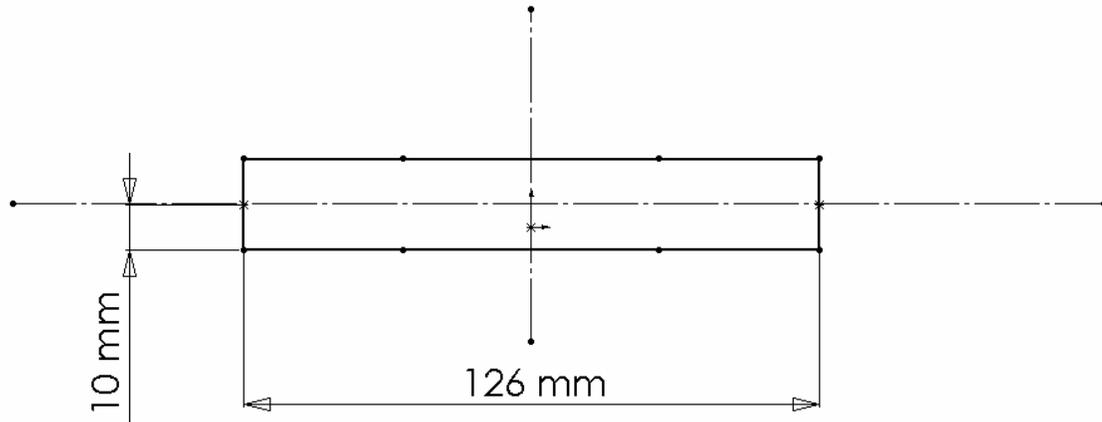
Figure 10. Compression Specimen

The specimens had to be no less than 126 mm in length to accommodate the oven for high-temperature testing. Ideally, a shorter, wider specimen is wanted for compression testing, but a shorter specimen could not be used with the testing equipment involved. A specimen width of 20 mm was chosen due to constraints imposed by the size of the oven. Figure 10 shows a compressive test specimen.

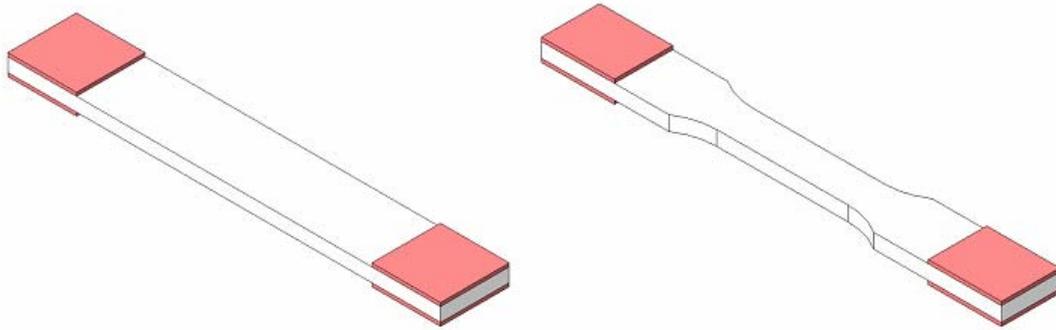
Figure 11. Tabbed Compressive and Tensile Specimens, Respectively

the tab surface. Then pressure was applied to the tab for one minute to ensure a good bond. Representations of a tabbed specimen can be seen in Figure 11.

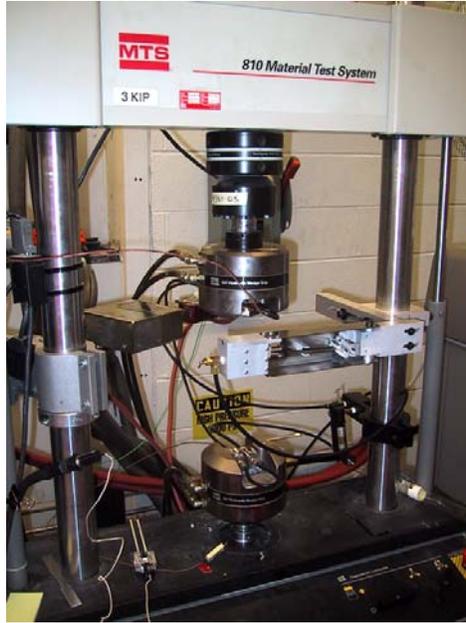
Figure 12. 25kN Servo Hydraulic Machine

Two servo hydraulic machines were used to test the material. Both were manufactured by Material Testing Systems (MTS) Corporation. The axial 810 Material Testing System with a 25 kN (5.5 kip) capacity was used to conduct the initial testing of the off-axis specimens and some of the initial compression work (see Figure 12). However, because of the piston size, the machine load capacity was limited to 13 kN (3 kip), which was not sufficient to cause failure of a compression specimen. Another 810 Material Testing System, with a 100 kN (22 kip) capacity was used for the compression tests. Both machines were equipped with hydraulic wedge grips that could apply pressures ranging from 0-20 MPa.

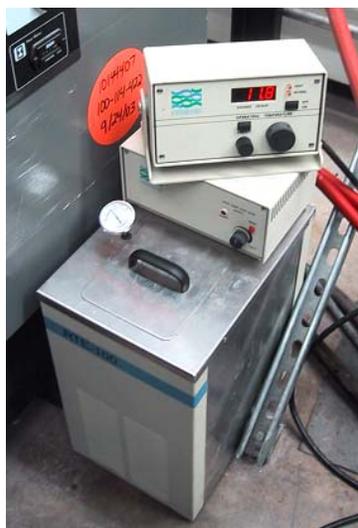
Figure 13. Chiller and Controller

The chiller was comprised of two units manufactured by NESLAB: the chiller and the controller. The chiller was used to cool water to temperatures of 9.5 °C in order to cool the grips. Figure 13 shows the chiller and the controller. The two controller units are seen resting on top of the chiller.

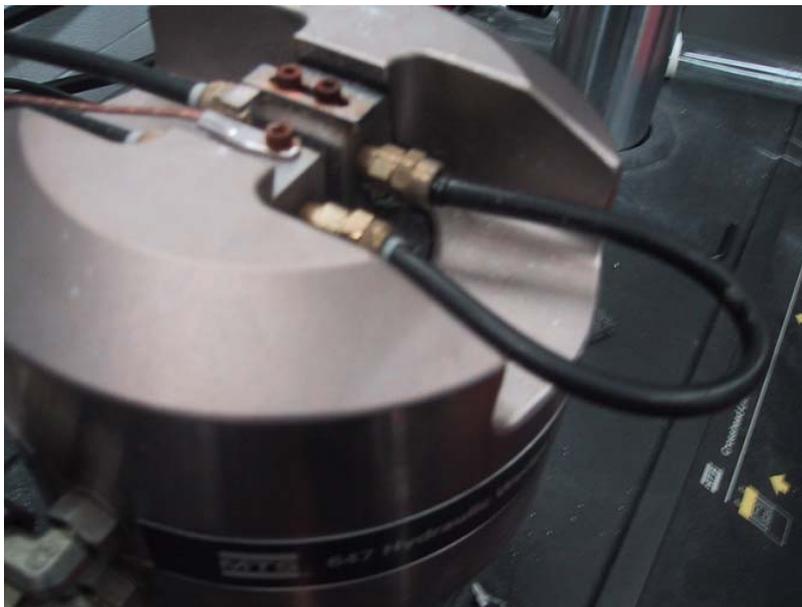
Figure 14. Tubes for Cooling Water Connected to Hydraulic Wedge Grips

The chiller system provides cooled water to the hydraulic wedges to prevent them from overheating during high-temperature testing. If the wedges overheat during testing the seals within the wedges could be destroyed, which would cause severe damage to the system. In order to avoid this, the chiller pumped water through a 6.35 mm (0.25 in) outer diameter tubing, which ran through the grips as seen in Figure 14 below. The chiller was filled with distilled water to prevent corrosion. This system was used in all high-temperature tests.

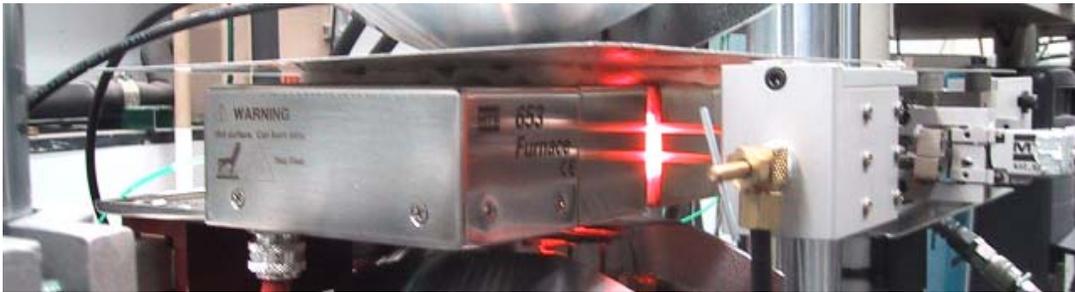
Figure 15. Oven Glows at High Temperatures

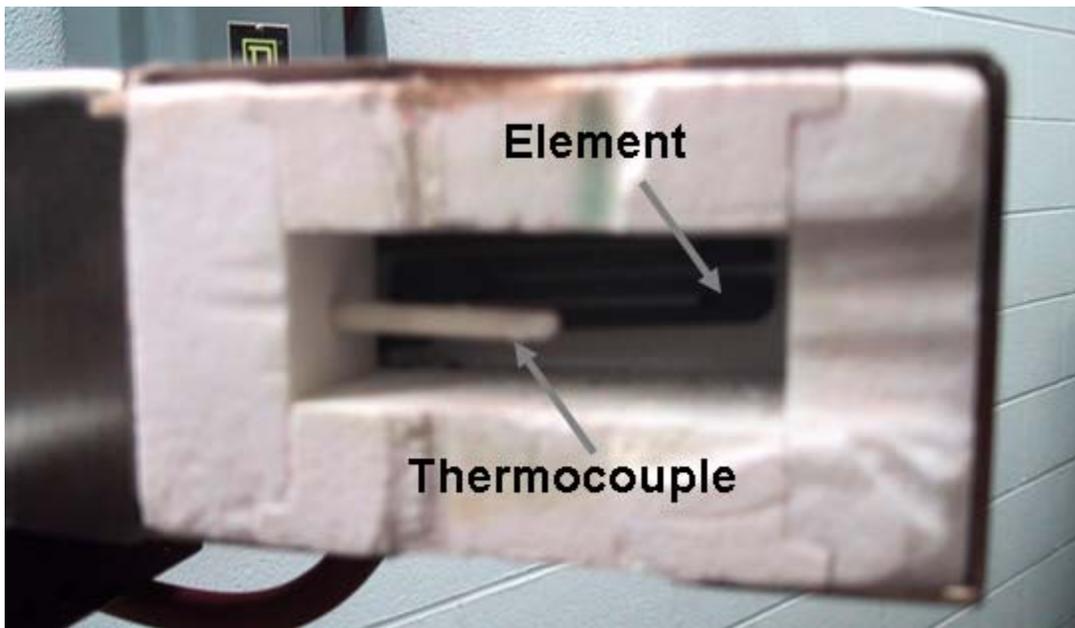
Figure 16. Interior View of Oven Half

thermocouples, which provide closed-loop feedback to the temperature controller. The oven was a single zone MTS 653 model. The max operating temperature of the oven is 1400 °C. The temperature controller was a MTS 409.83 model, shown Figure 17.

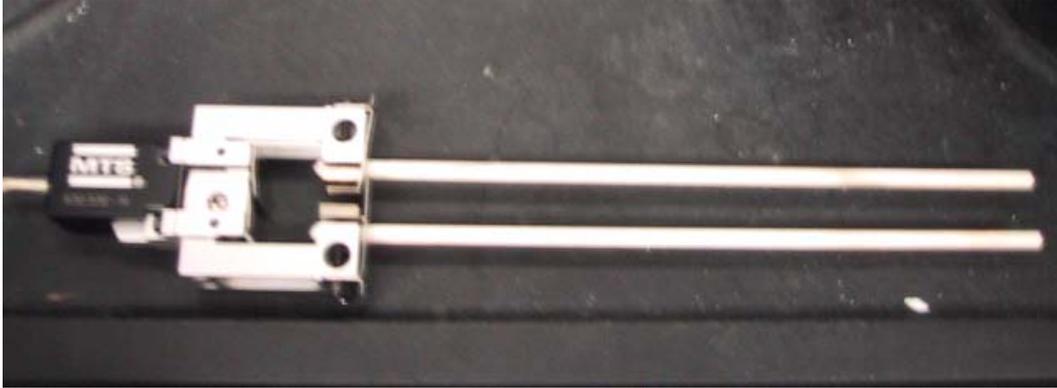
Figure 18. Extensometer Equipped with Alumina Rods

The extensometer used to gather strain data during testing was an MTS axial high-temperature extensometer, model 632.53E-14 shown in Figure 18. The gage length of the extensometer is 12.7 mm (0.5 in). The extensometer was able to handle high temperatures by using two alumina extension rods of 3.5 mm diameter and 151 mm in length. The tips of the extension rods are cone-shaped in order to ensure firm contact with the specimen during testing. During testing, the extensometer is mounted behind the heat shield seen in Figure 19.

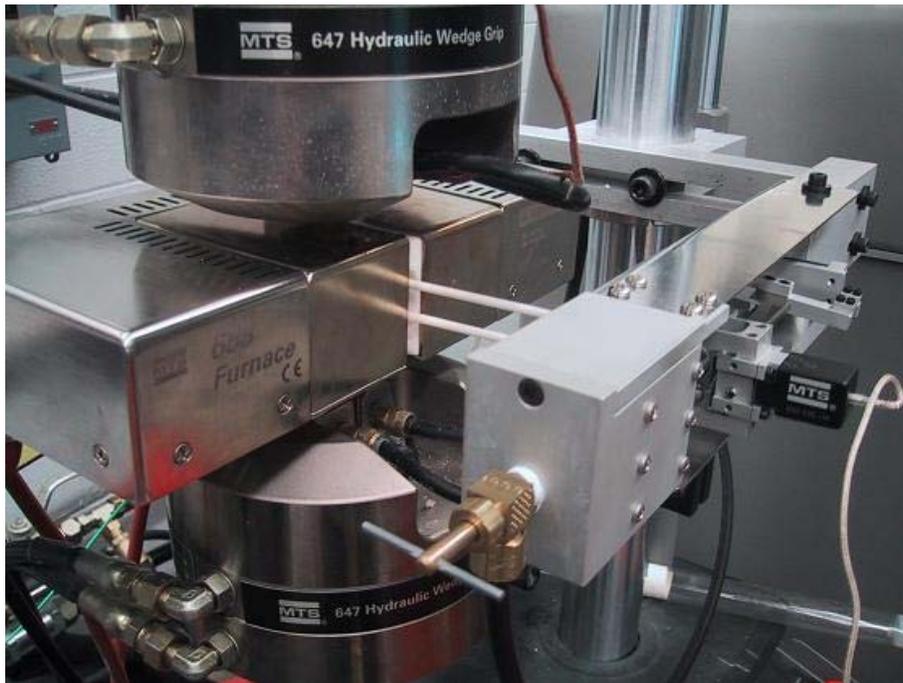
Figure 19. Extensometer Mounted Behind the Heat Shield

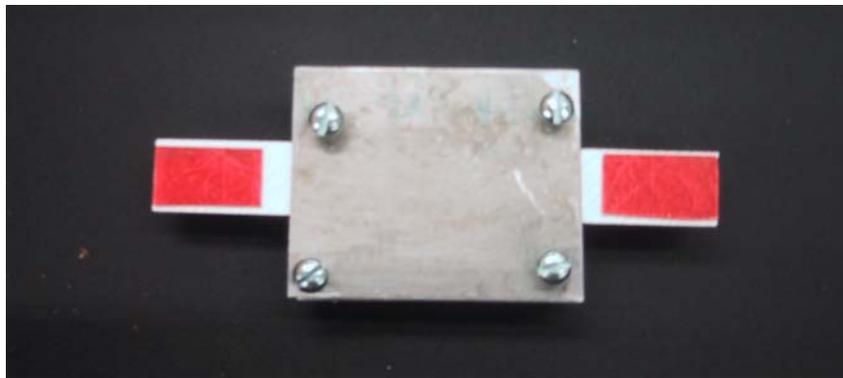
Figure 21. Specimen Equipped with Anti-Buckling Device

In order to accomplish parts of the testing the actual specimens had to be outfitted with two pieces of equipment, namely the thermocouples and the anti-buckling brackets. In order to perform the temperature calibration, two S-type thermocouples were attached to the gage section on each face of the specimen using high temperature ceramic cement and safety wire. It was extremely important to ensure good contact between the specimen surface and the tip of the thermocouple in order to obtain accurate temperature readings of the specimen surface. The thermocouples were connected to an OMEGA HH202A portable two-channel temperature sensor for read-out. The anti-buckling device, created for a use at room temperature consisted of two pieces of 7075-T6 aluminum bolted together that covered the sides of the specimen as shown in Figure 21 below.

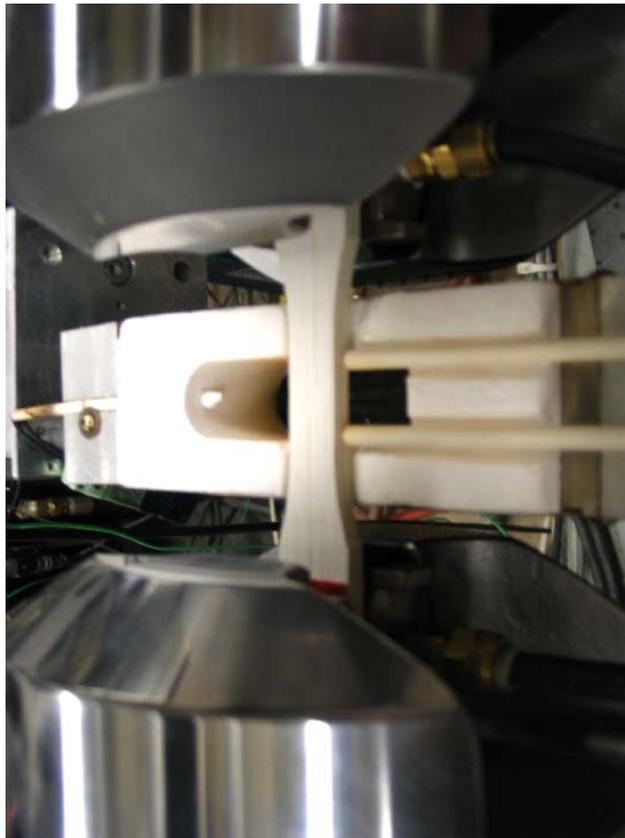
Figure 22. Tensile Specimen Secured in the Grips of the Servo-Hydraulic Machine

The monotonic tension tests were performed on the N610/alumina and N610/monazite/alumina CMCs with both $0^\circ/90^\circ$ and $\pm 45^\circ$ fiber orientations. The tests were conducted in displacement control mode at a rate of 0.05 mm/s at room temperature and at 900 °C. The specimens were placed in the 25 kN servo-hydraulic machine with a grip pressure of approximately 8 MPa (1150 psi). The following, Figure 22, shows a tensile specimen properly secured in the grips of the servo-hydraulic testing machine.

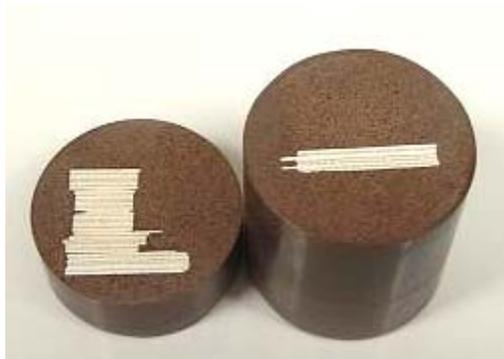
Figure 23. Pieces of Specimen Mounted in Conductive Resin

The specimens prepared to view cross-sections required polishing. To accomplish this, the specimens were mounted in a resin mold using the Simplimet 2000 manufactured by Buehler. The resin mold was conductive to allow better viewing with the SEM. The molding process was set for a total of five minutes and thirty seconds. The mount was then removed and ready for polishing. Figure 23 shows two mounts containing cross-sections of a specimen.

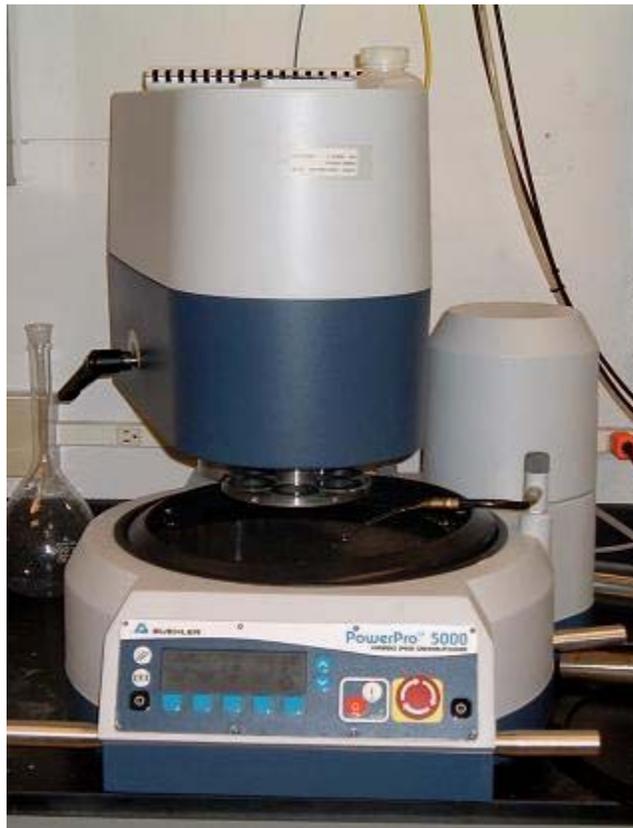
Figure 24. Polishing machine

The polishing process consisted of five steps using grits of 240 (60 μm), 400 (30 μm), and 600 (15 μm). The final polishing steps used diamond pastes of 0.10 and 0.05 μm . Between each of the grits, the specimen was placed in an ultra sonic bath in order to remove the many resin particles, which sometimes get embedded in the surfaces of the specimens. Polishing was accomplished manually using the PowerPro 5000, manufactured by Buelher (see Figure 24).

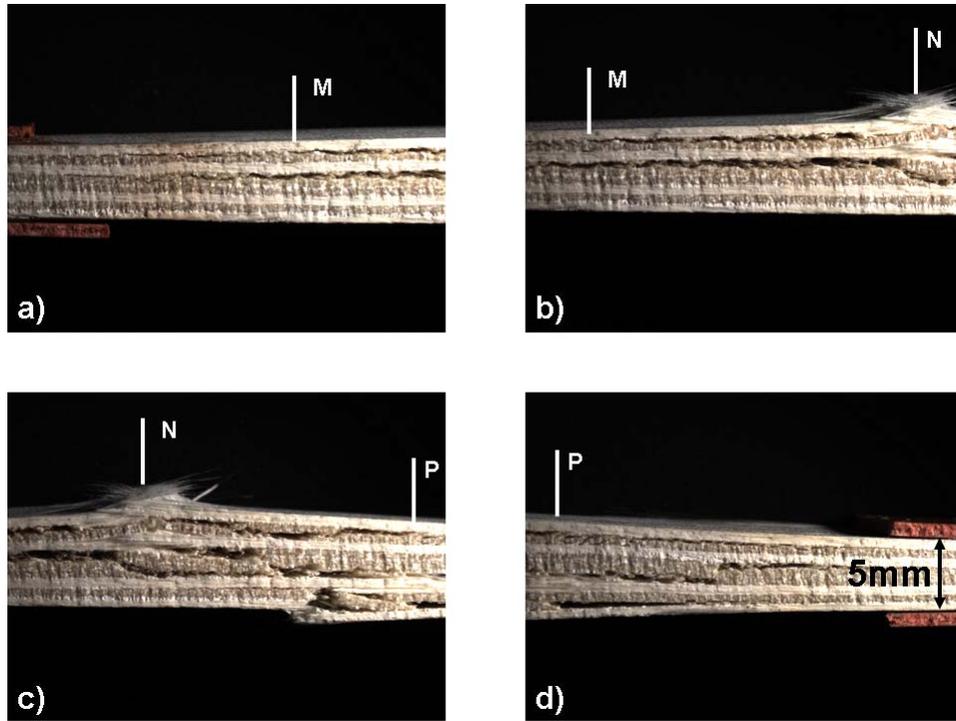
Figure 26. Side View of Specimen

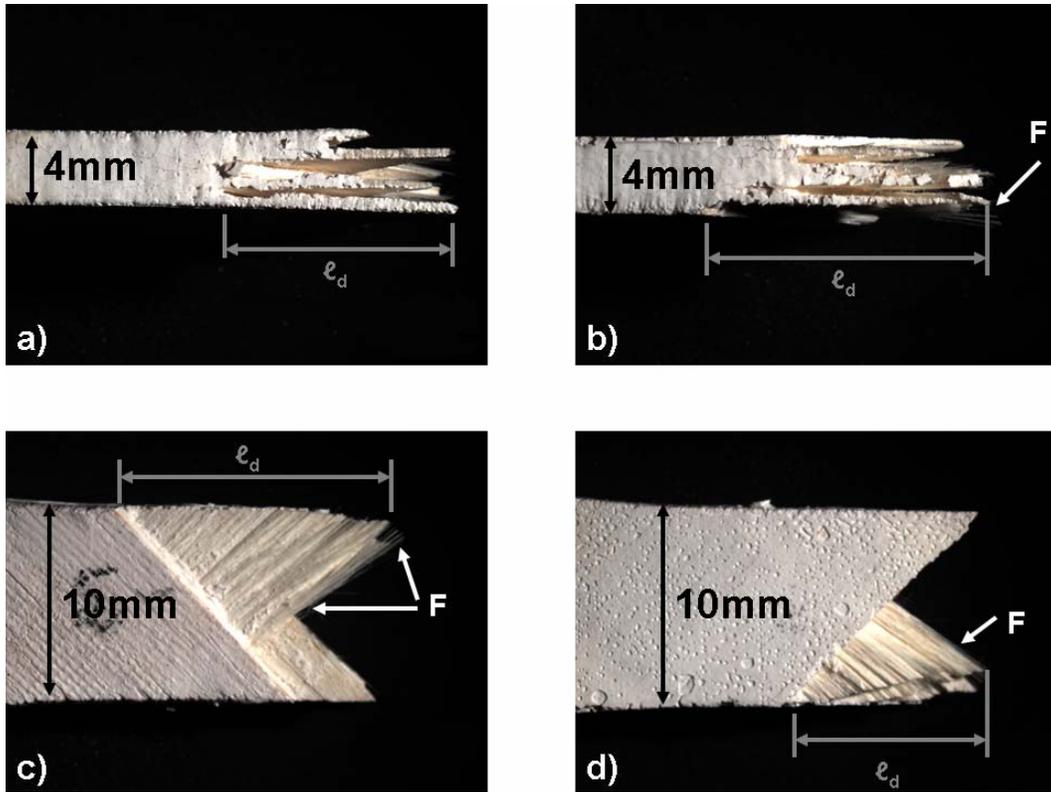
Figure 27. Surface View of Specimen

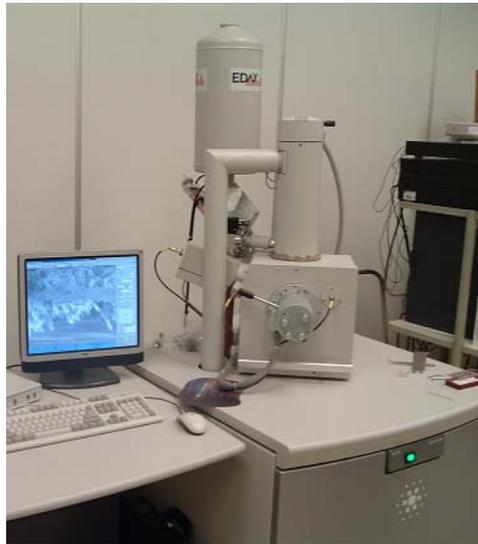
Figure 28. Scanning Electron Microscope.

A scanning electron microscope (SEM), seen in Figure 28, can produce high resolution images in three dimensions at high levels of magnification. The SEM works by emitting a beam of electrons, which are focused by two successive condenser lenses into a beam with a spot size of approximately 5 nm [3]. Resolution is dependent on the spot size. The focused primary electrons strike the surface of the sample and are scattered in a non-elastic manner. Interactions in a region created by the scattered electrons, called an interaction volume, lead to the emission of electrons and produce an image [3].

An SEM can have several different modes of operation. Normal high vacuum mode was used with conductive samples. In the case of non-conductive samples, the environmental scanning electron microscopy (ESEM) mode was employed. ESEM operates in what is called a “wet” mode making non-conductive samples conductive. If samples are non-conductive the electrons tend to charge the surface of the sample and make the image really bright and therefore hard to see. To prevent the charging of the specimen surfaces, the specimens were either viewed in ESEM mode or coated with carbon. Sometimes a piece of copper tape was secured to the sides of the specimen to further reduce charging of the specimen surface. Some SEMs are equipped with a back-scatter feature. This feature was used to capture a view of the monazite coating.

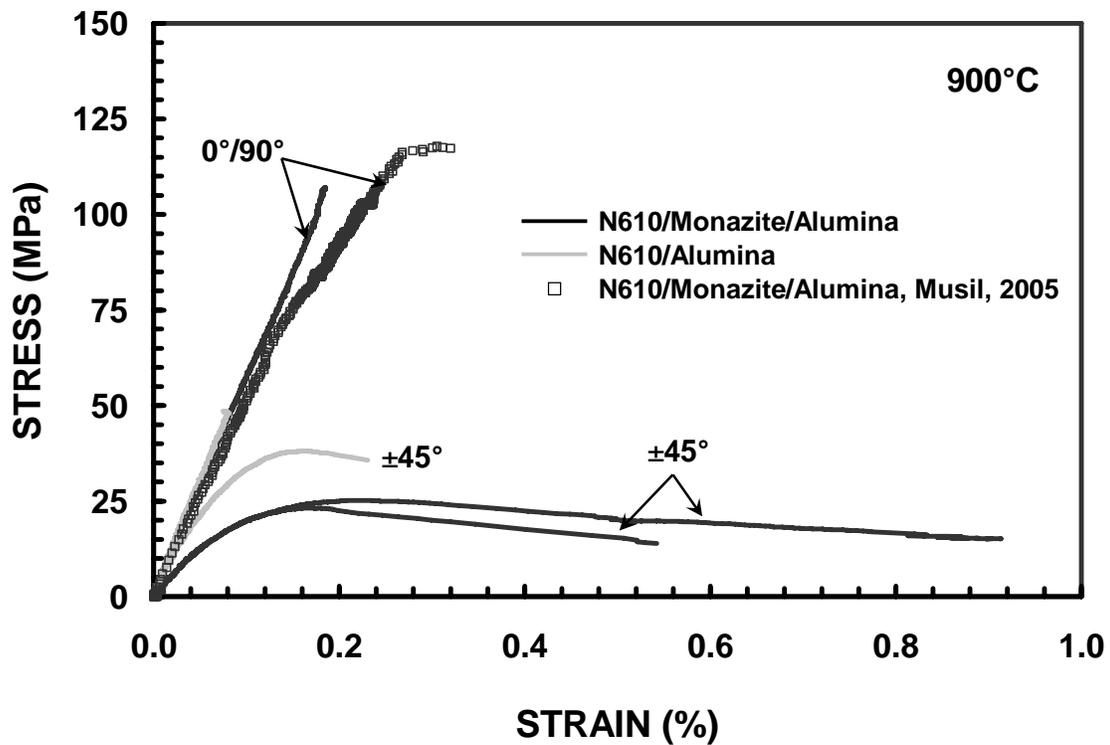
Figure 29. Tensile Stress-Strain Curves for N610/Monazite/Alumina and N610/Alumina Ceramic Composites with $0^\circ/90^\circ$ and $\pm 45^\circ$ Fiber Orientation. Data from References [34,38] are Also Shown.

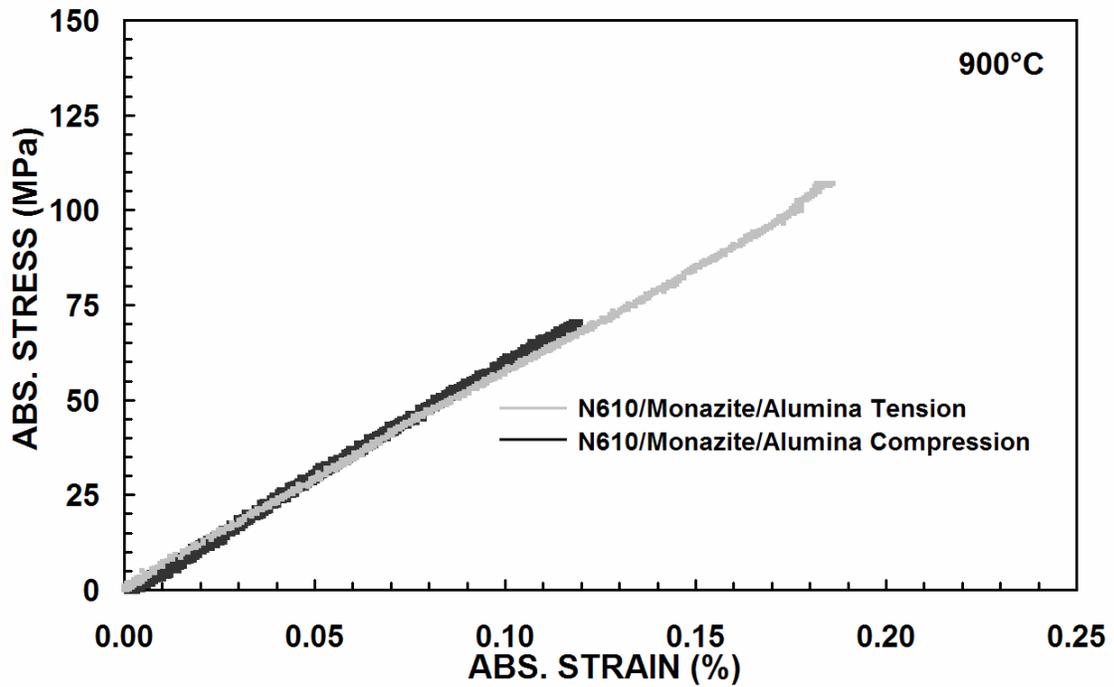
Figure 30. Monotonic Tensile/Compressive Behavior of On-Axis Dogbone-Shaped Specimens at 900 °C

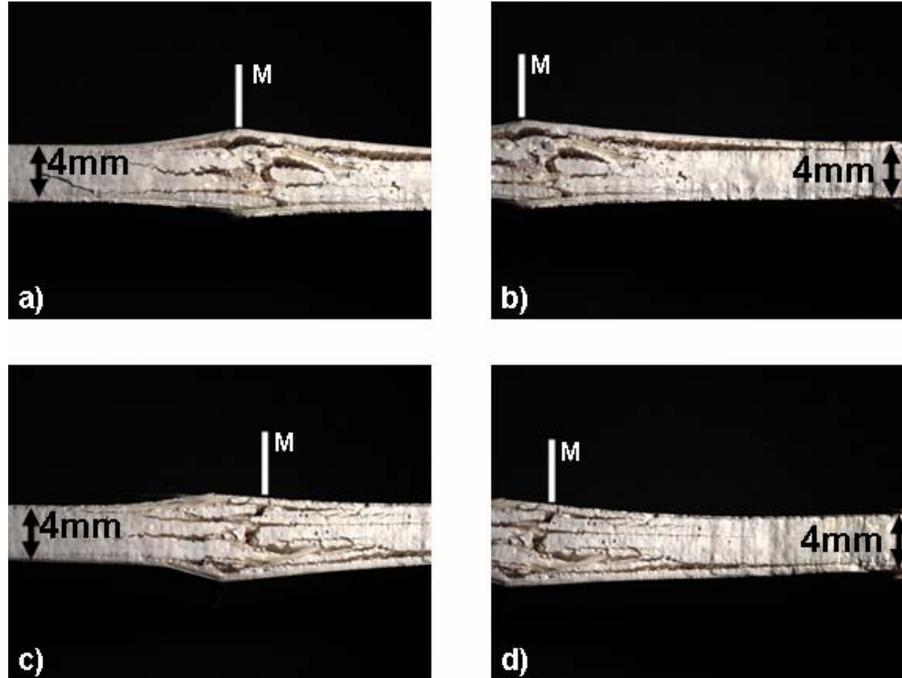
Figure 31. N610/Monazite/Alumina Specimen Tested in Compression at 900 °C Shows an Asymmetric Fracture Surface Suggesting Possible Buckling.

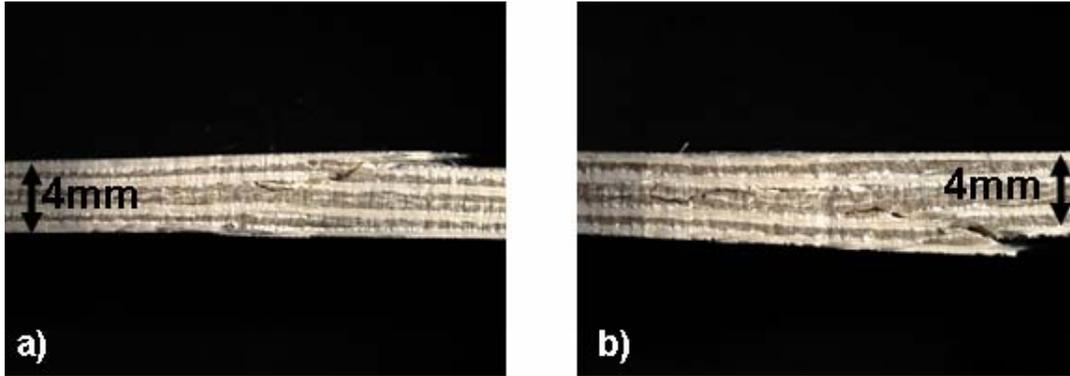
Figure 32. Specimen Tested in Compression with Anti-Buckling Device

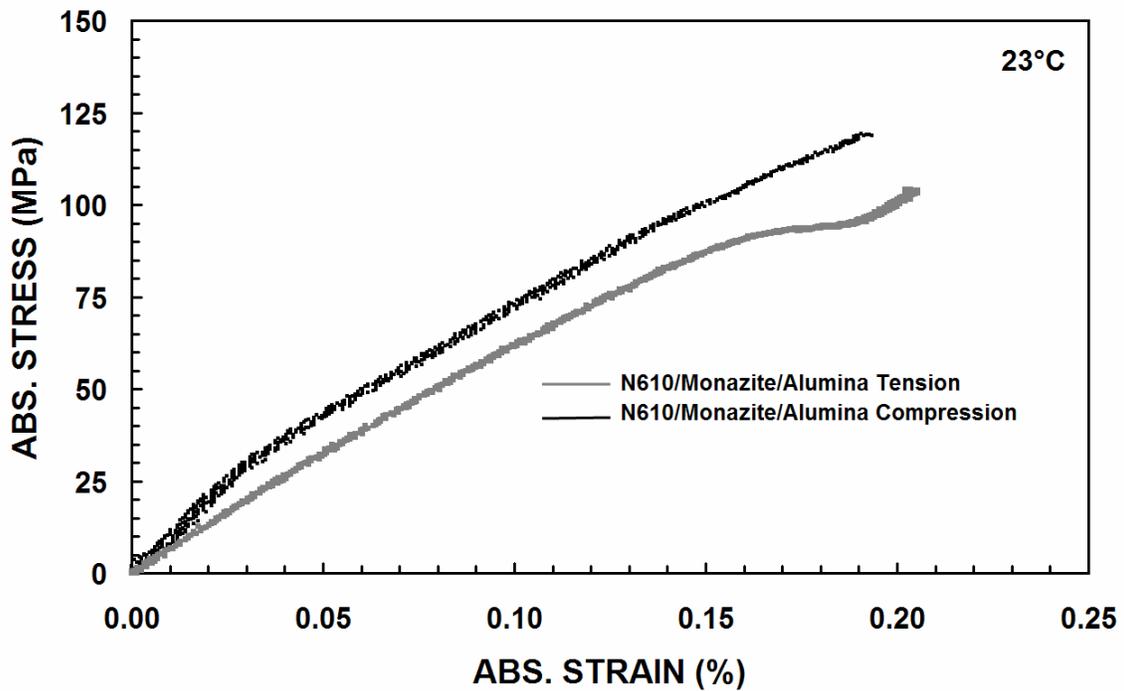
Figure 33. Tensile and Compressive Stress-Strain Curves for N610/Monazite/Alumina at 23 °C. Compression Test Employed Anti-Buckling Device.

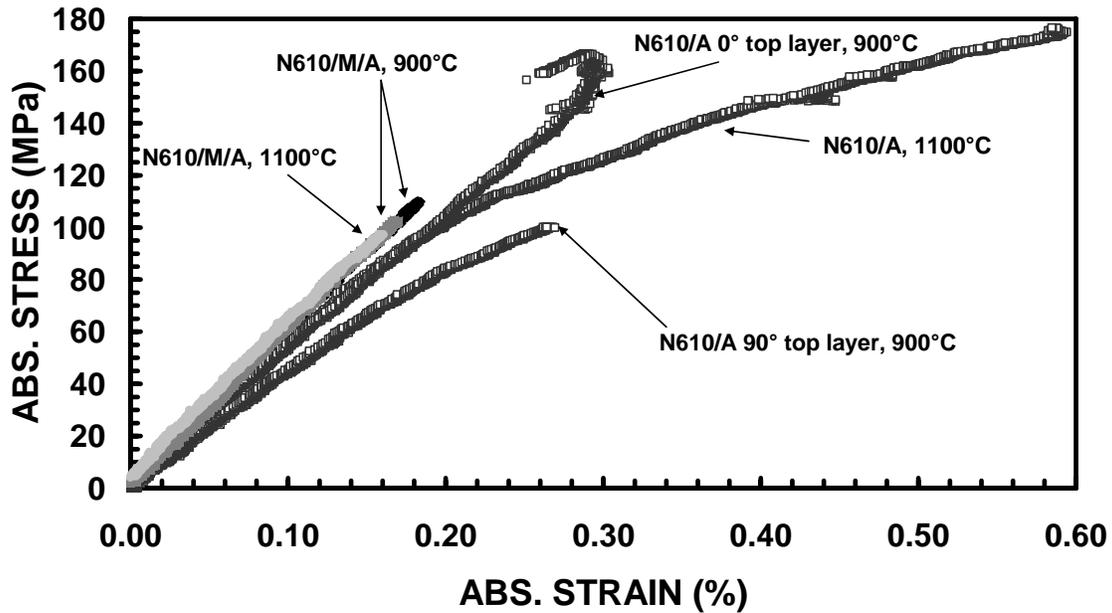
Figure 34. Compression Stress-Strain Curves for N610/Monazite/Alumina and N610/Alumina at 900 °C

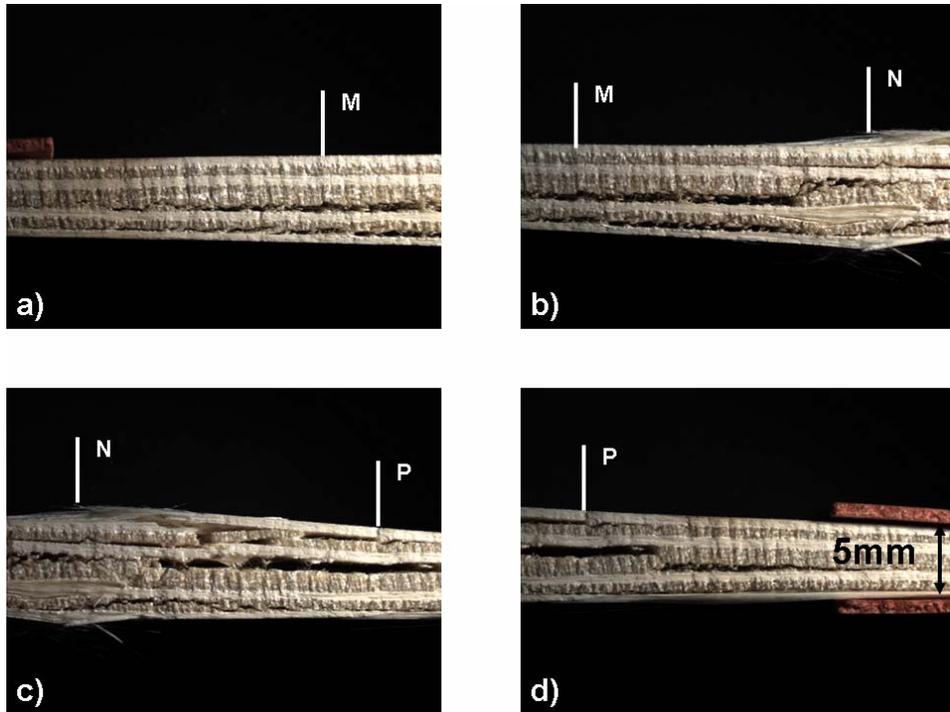
Figure 35. Side 1 of N610/Monazite/Alumina Specimen Asymmetric Fracture Suggests Buckling

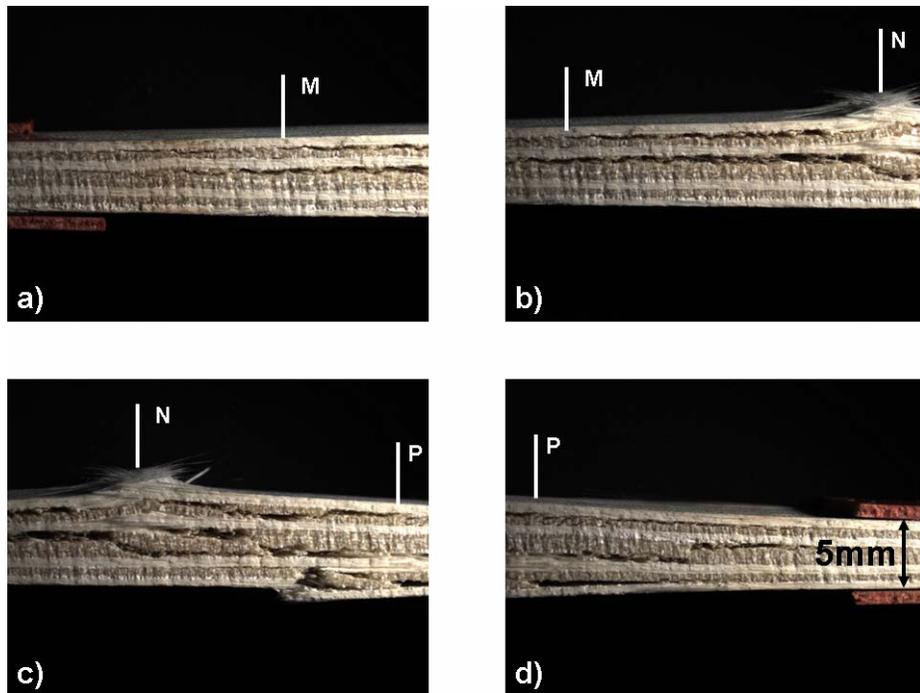
Figure 36. Side 2 of N610/Monazite/Alumina Specimen Asymmetric Fracture Suggests Buckling

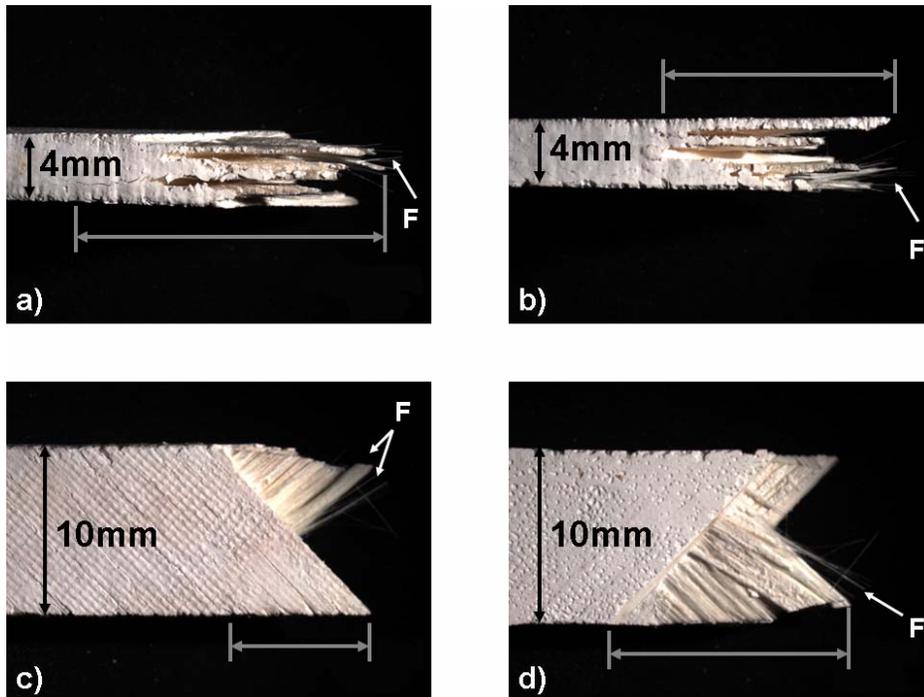
Figure 37. N610/Monazite/Alumina Specimens with $\pm 45^\circ$ Fiber Orientation Tested in Monotonic Tension at 900 °C

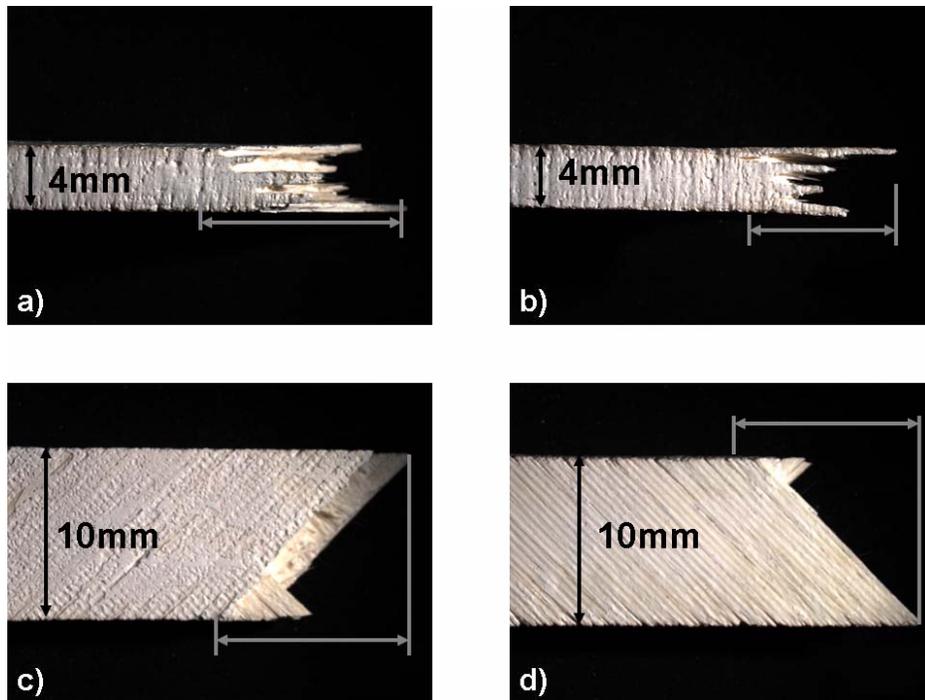
Figure 38. N610/Alumina Specimens with $\pm 45^\circ$ Fiber Orientation Tested in Monotonic Tension at 900°C

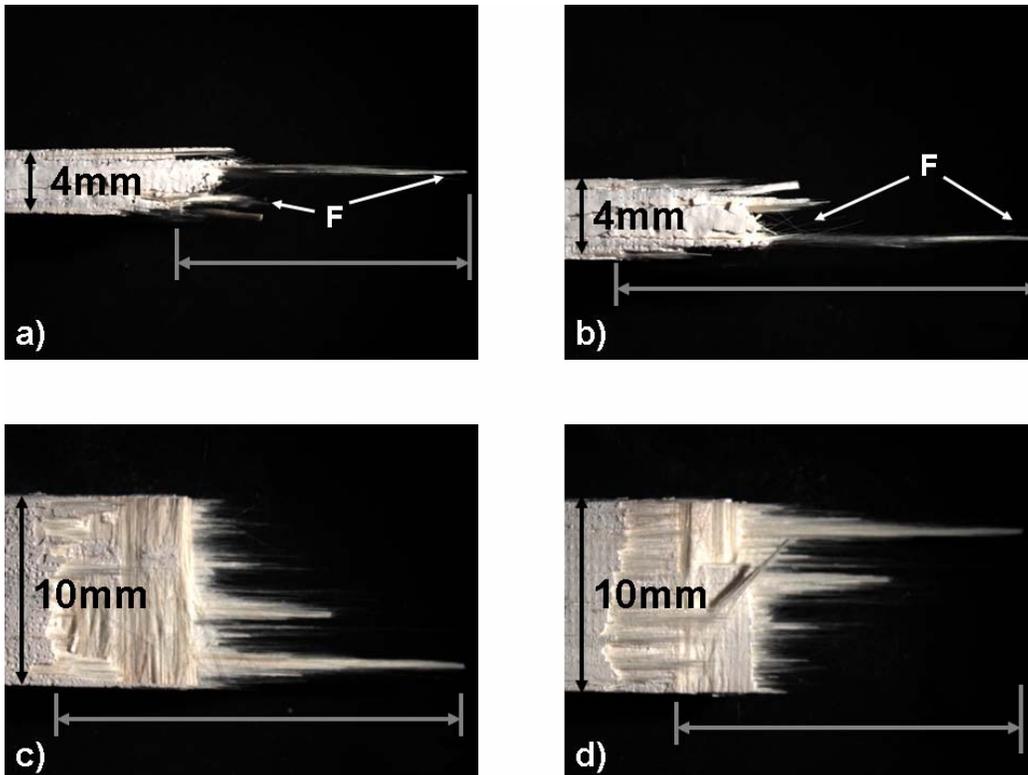
Figure 39. N610/Monazite/Alumina Specimen with $0^\circ/90^\circ$ Fiber Orientation Tested in Tension at 900°C
