Characterization of Compressive Creep Behavior of Oxide/Oxide Composite with Monazite Coating at Elevated Temperature

**CHARACTERIZATION OF COMPRESSIVE CREEP BEHAVIOR OF
OXIDE/OXIDE COMPOSITE WITH MONAZITE COATING
AT ELEVATED TEMPERATURE**

THESIS

AFIT/GAE/ENY/06-M17

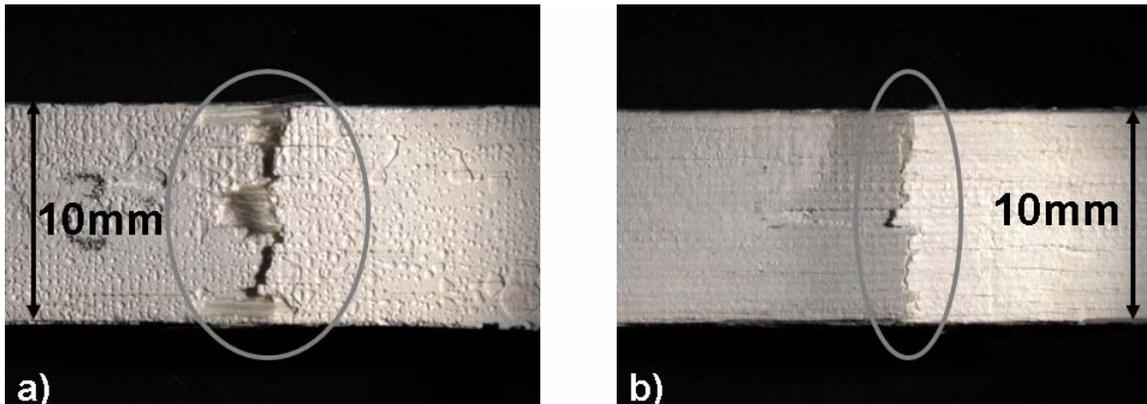
Figure 40. Dogbone-Shaped N610/Monazite/Alumina Specimen with 0°/90° Fiber Orientation Tested in Compression at 900 °C without the Anti-Buckling Device

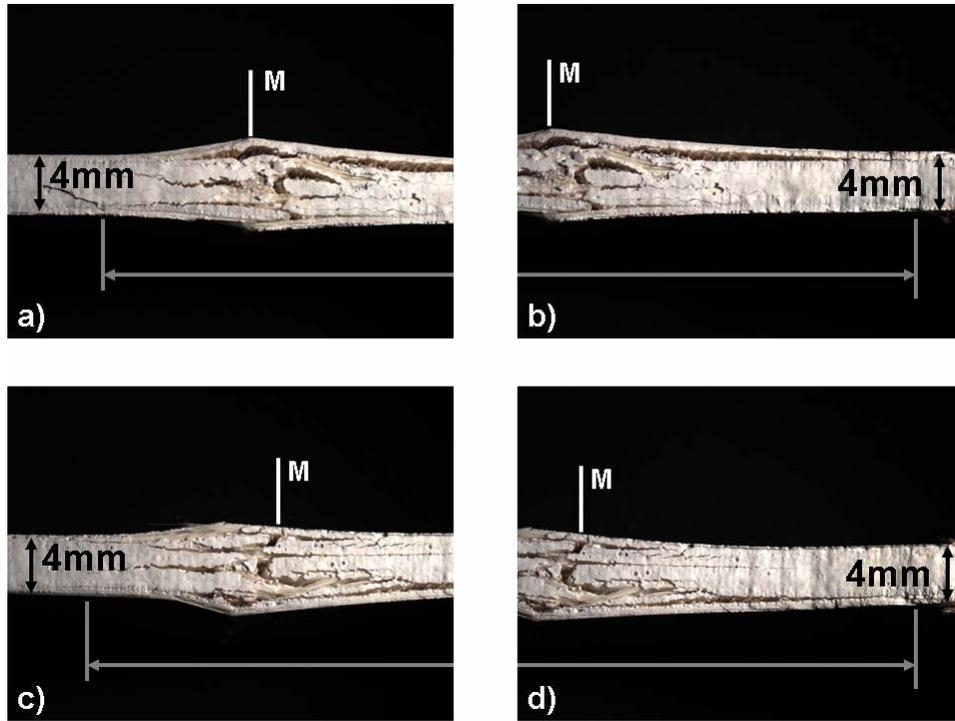
Figure 41. Dogbone-Shaped N610/Monazite/Alumina Specimen with $0^{\circ}/90^{\circ}$ Fiber Orientation Tested in Compression at 900°C without the Anti-Buckling Device

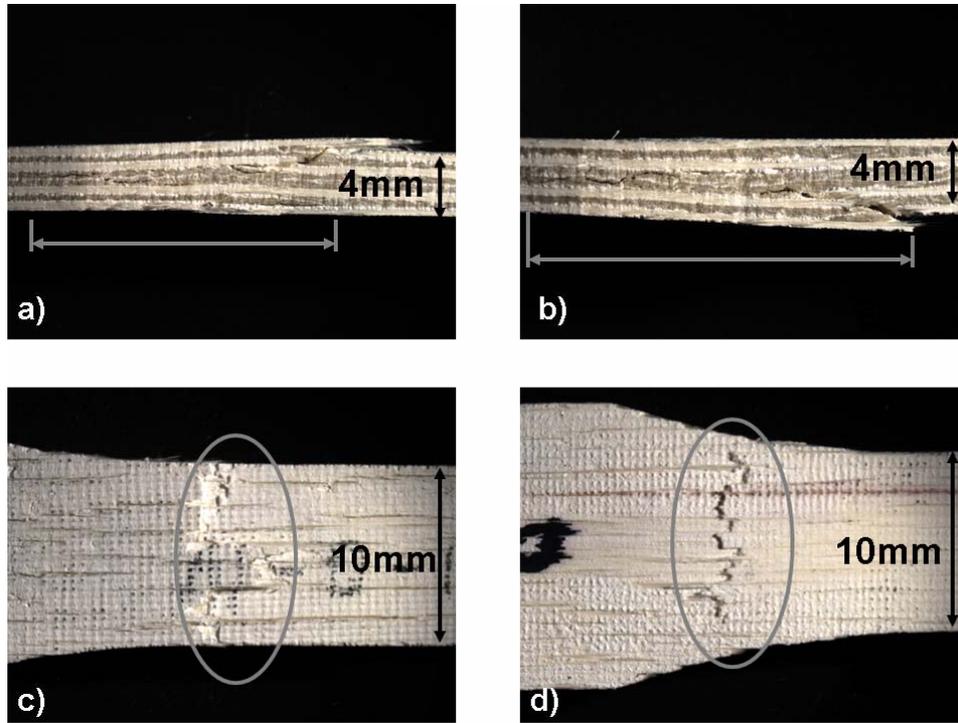
Figure 42. Dogbone-Shaped N610/Monazite/Alumina Specimen with $0^{\circ}/90^{\circ}$ Fiber Orientation Tested in Compression with the Anti-Buckling Device at 23°C .

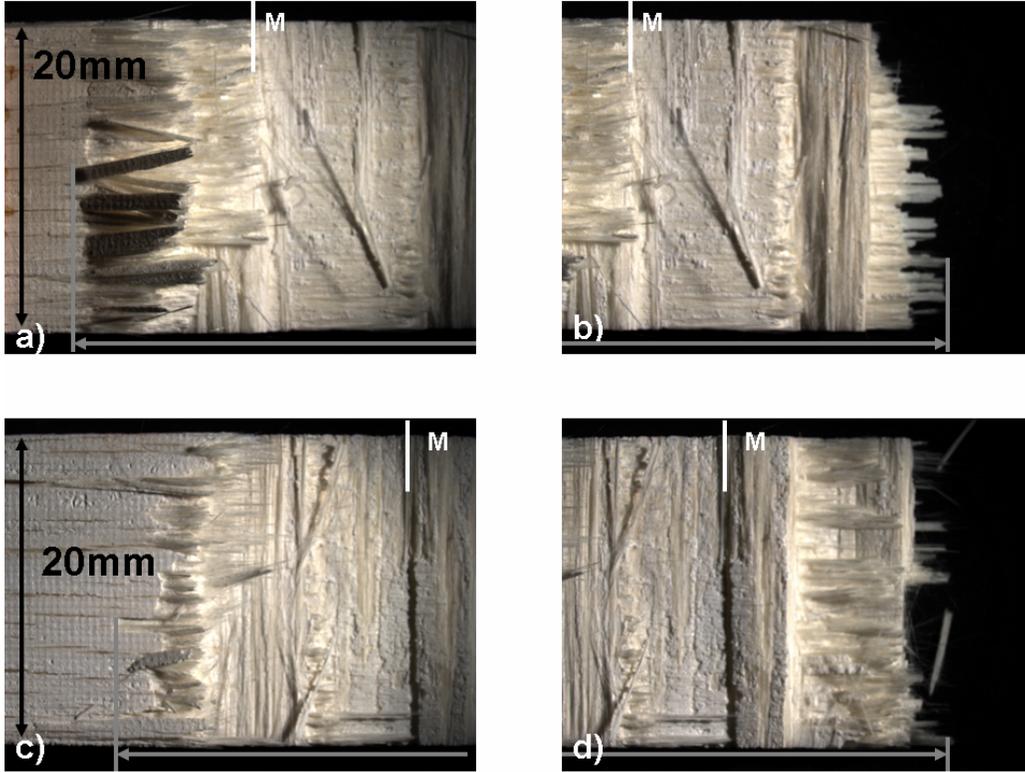
Figure 43. Straight-Sided N610/Monazite/Alumina 0°/90° Specimen Tested in Compression at 900 °C

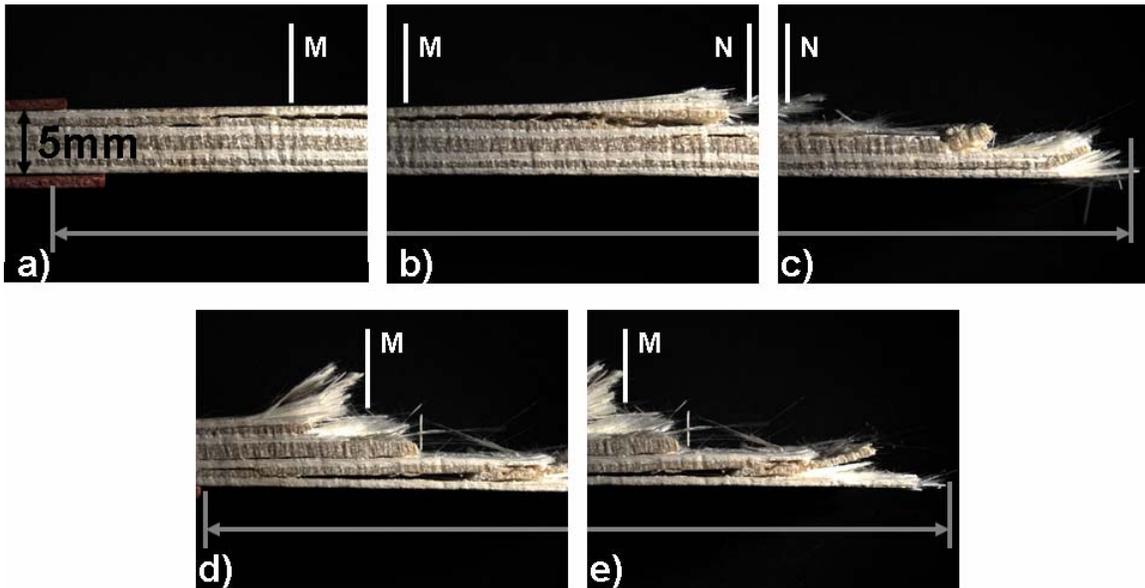
Figure 44. Side Views of a Straight-Sided N610/Monazite/Alumina 0°/90° Specimen Tested in Compression at 900 °C

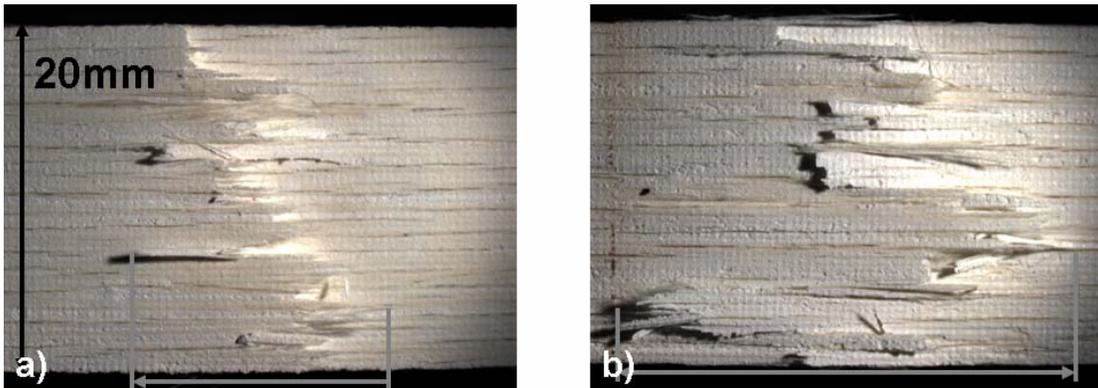
Figure 45. Straight-Sided N610/Monazite/Alumina $0^\circ/90^\circ$ Specimen Tested in Compression at 1100°C

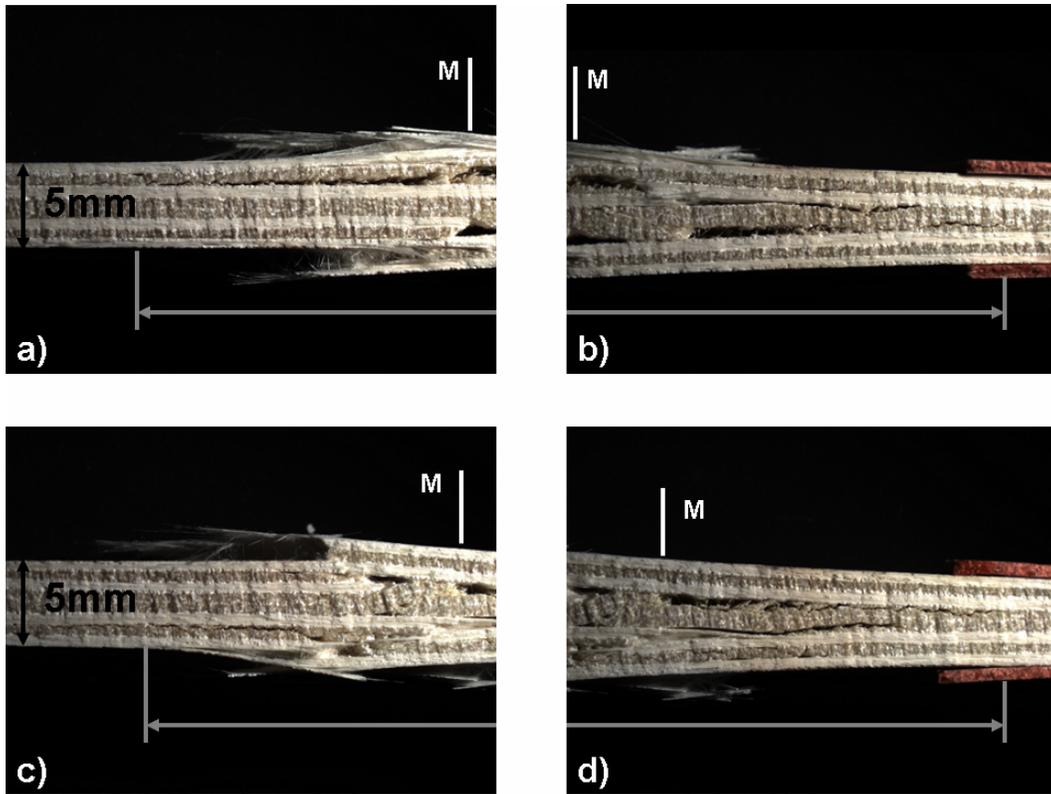
Figure 46. Side Views of the Straight-Sided N610/Monazite/Alumina 0°/90° Specimen Tested in Compression at 1100 °C

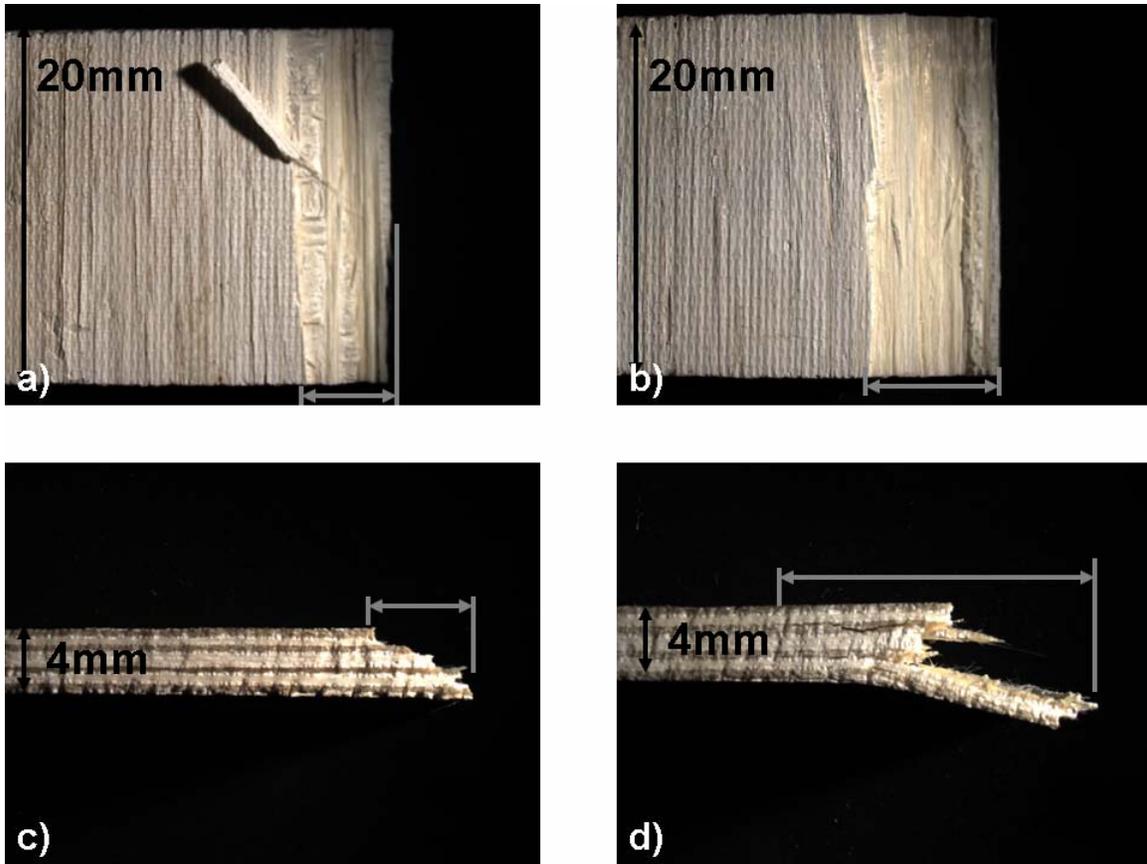
Figure 47. Straight-Sided N610/Alumina 0°/90° Specimen Tested in Compression at 900 °C

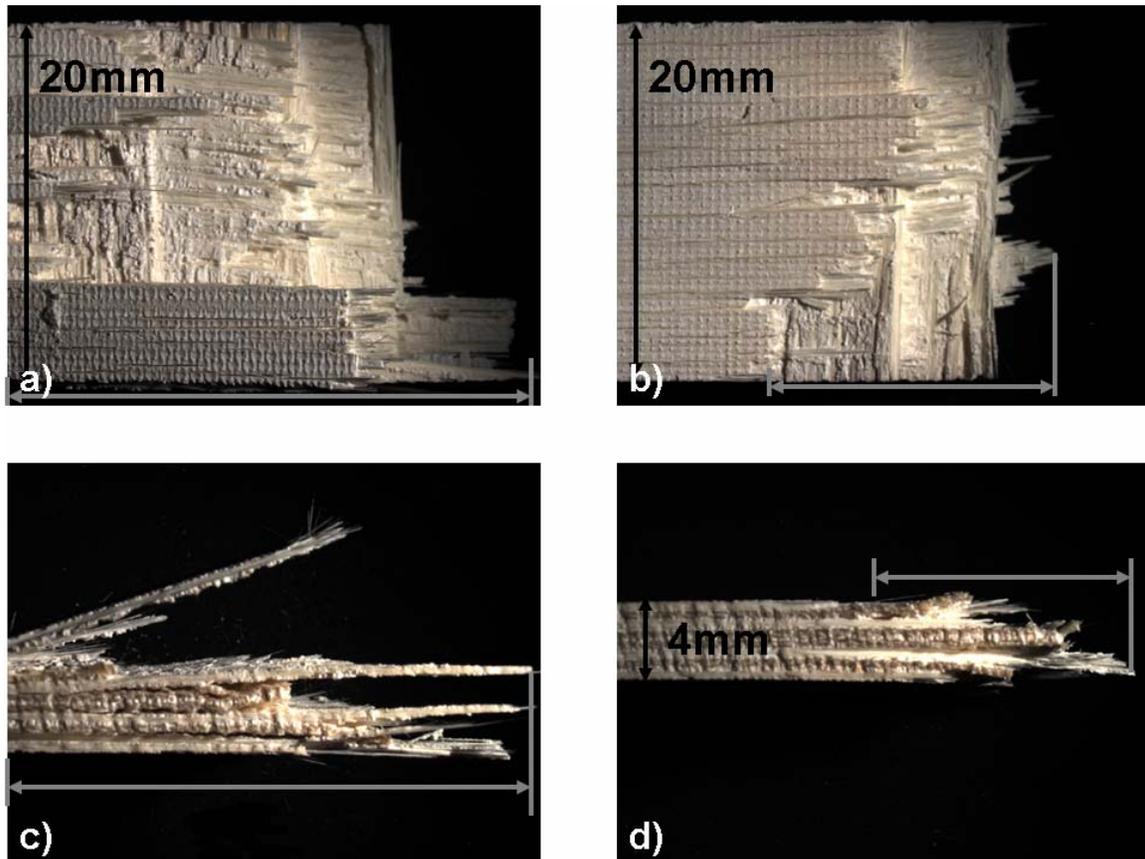
Figure 48. Straight-Sided N610/Alumina 0°/90° Specimen Tested in Compression at 1100 °C

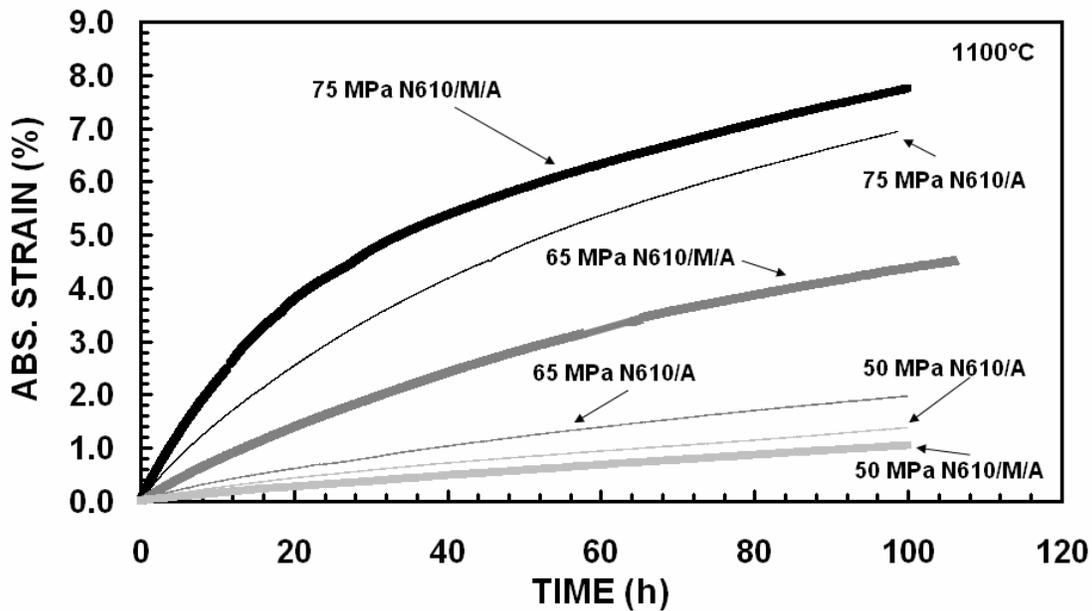
Figure 49. Compressive Creep Strain as a Function of Time for N610/Monazite/Alumina and N610/Alumina Composites at 1100 °C

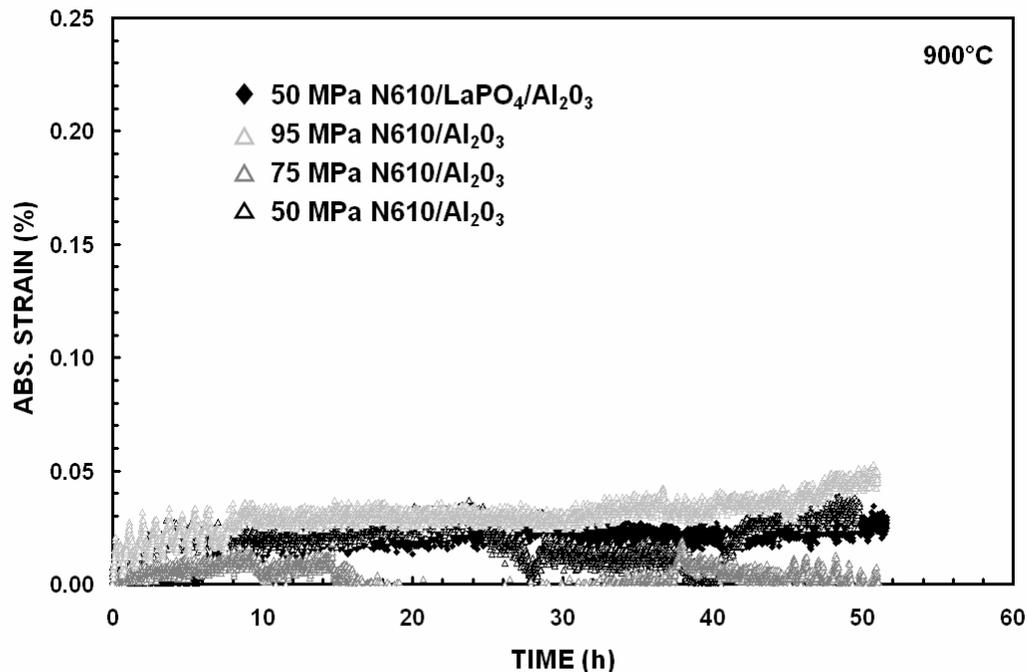
Figure 50. Compressive Creep Strain as a Function of Time for N610/Monazite/Alumina and N610/Alumina Composites at 900 °C

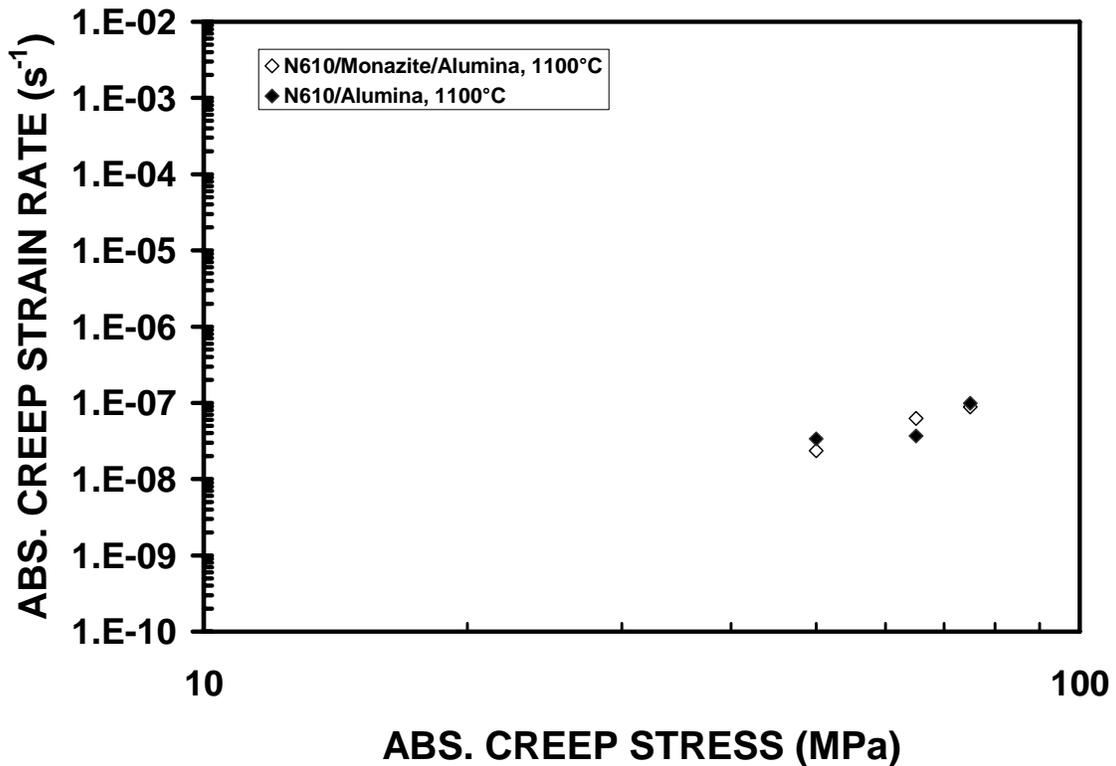
Figure 51. Compressive Creep Strain Rates as a Function of Applied Stress for N610/Monazite/Alumina and N610/Alumina Composites at 1100 °C

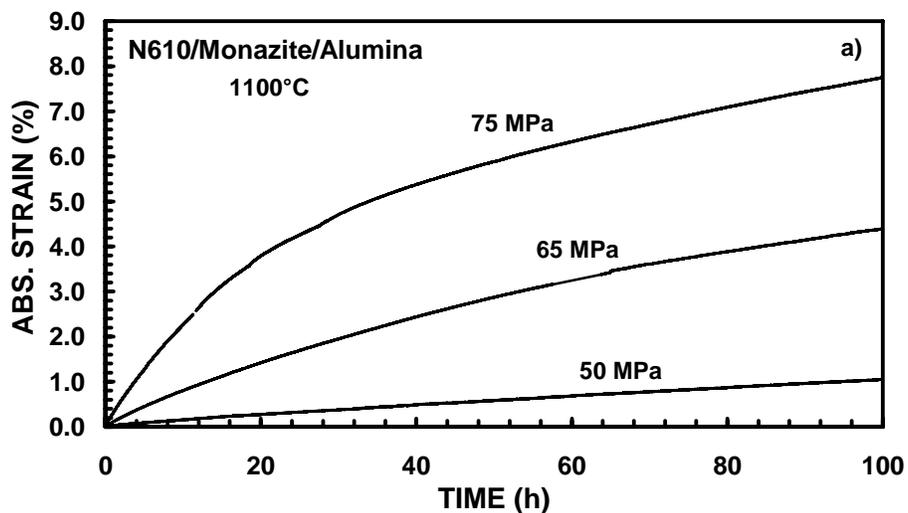
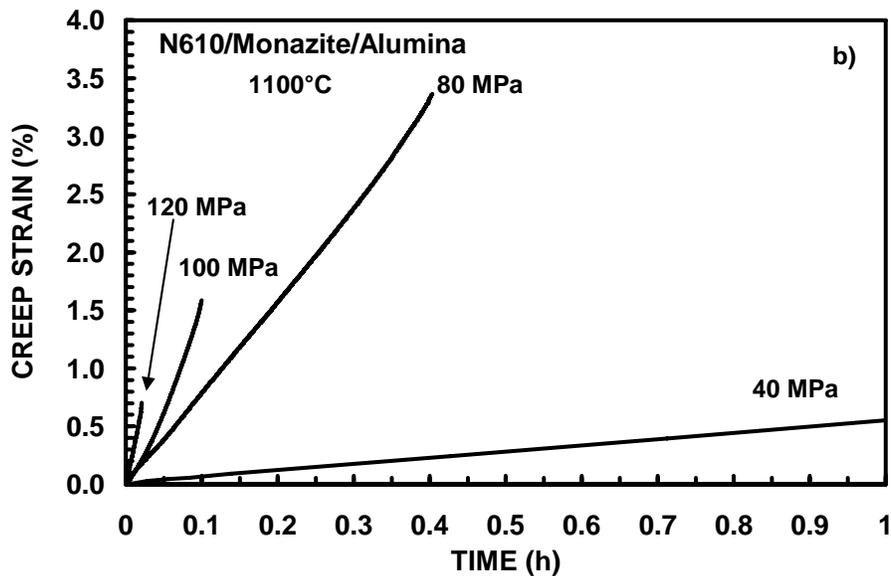
Figure 52. Creep Curves for N610/Monazite/Alumina Composite at 1100 °C: (a) Compressive Creep and (b) Tensile Creep [34,38]

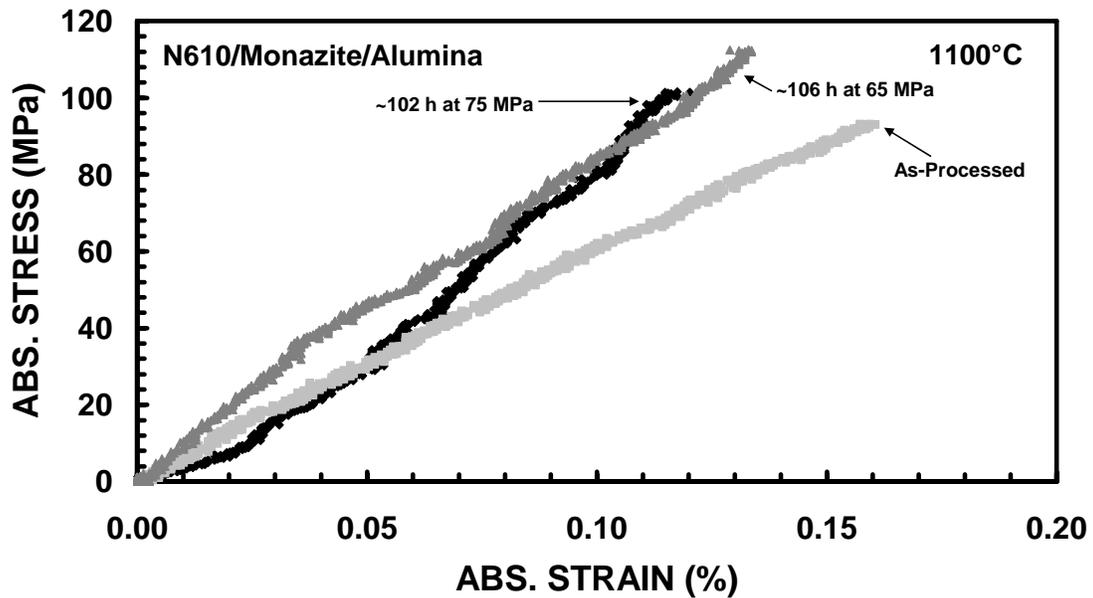
Figure 53. Effects of Prior Compressive Creep at 1100 °C on Compressive Stress-Strain Behavior of N610/Monazite/Alumina Ceramic Composite

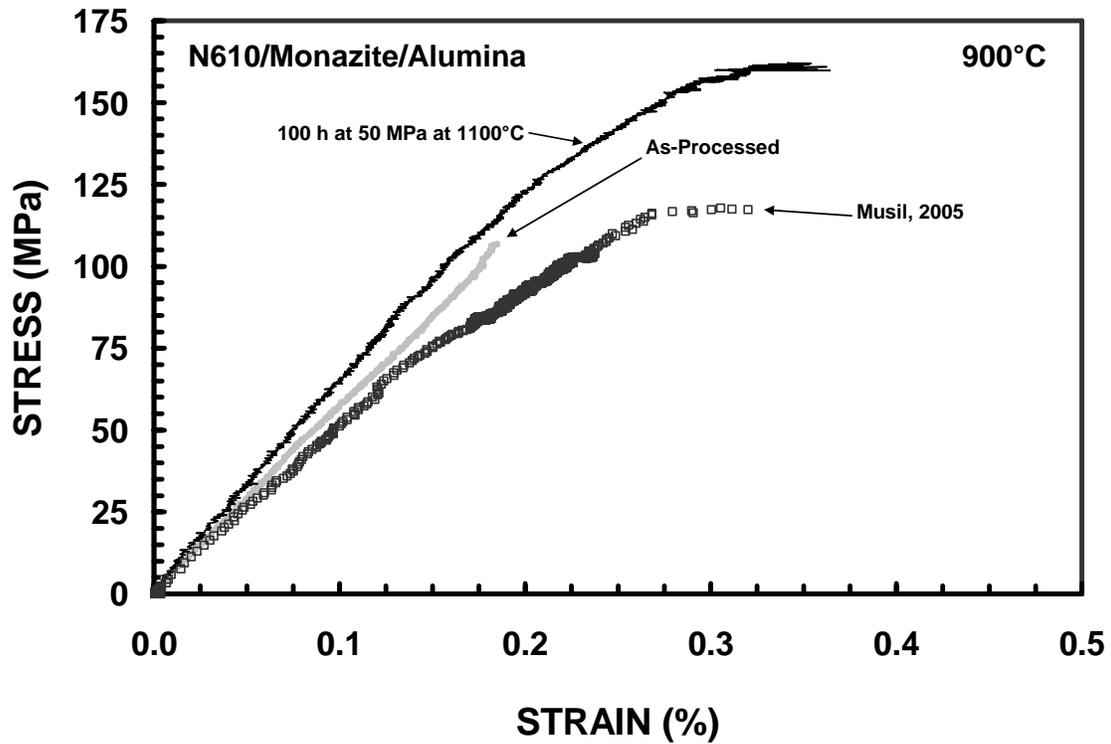
Figure 54. Effects of Prior Compressive Creep at 1100 °C on Tensile Stress-Strain Behavior of N610/Monazite/Alumina Ceramic Composite

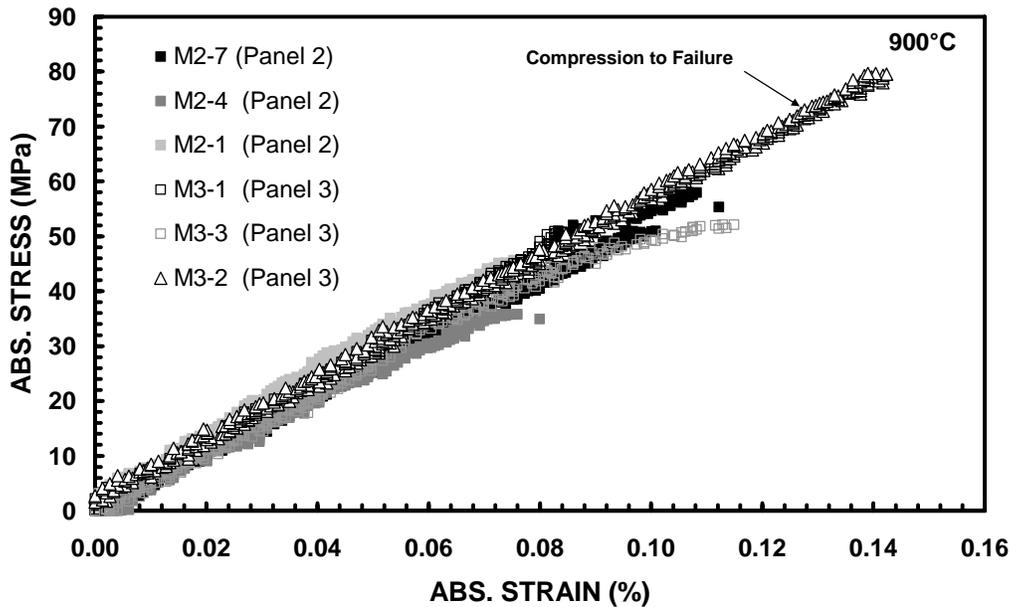
Figure 55. Compressive Stress-Strain Curves for N610/Monazite/Alumina Specimens from Panels M2 and M3 at 900 °C

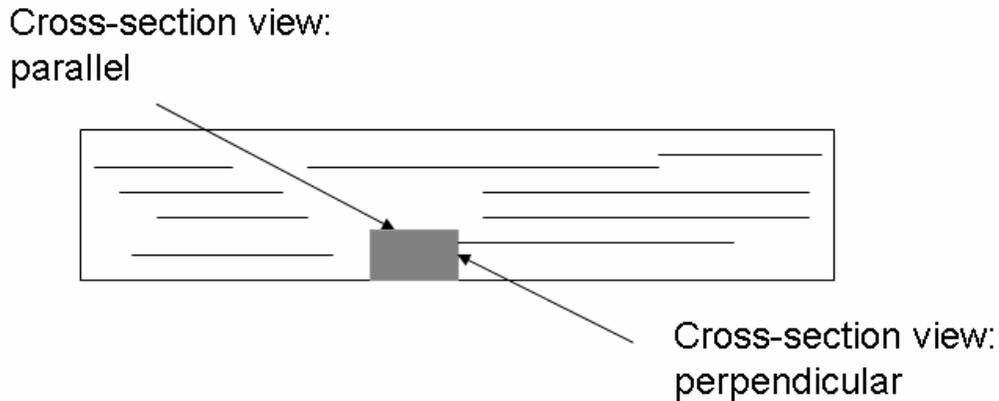
Figure 56. Schematic of Specimen Showing the Type of Cuts made to View Cross-Sections

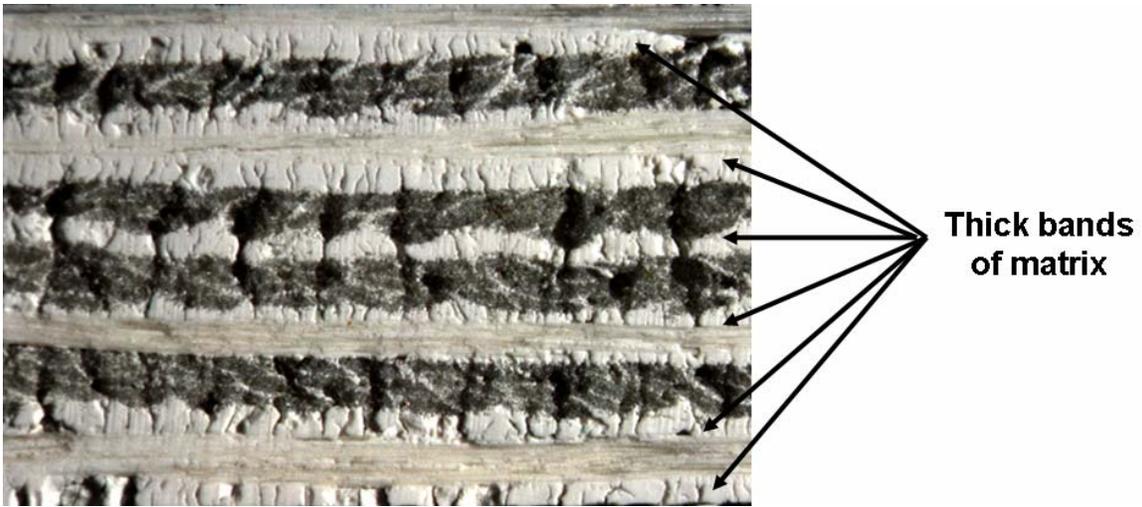
Figure 57. Parallel Cross-Sectional View of Virgin Specimen from Panel M2

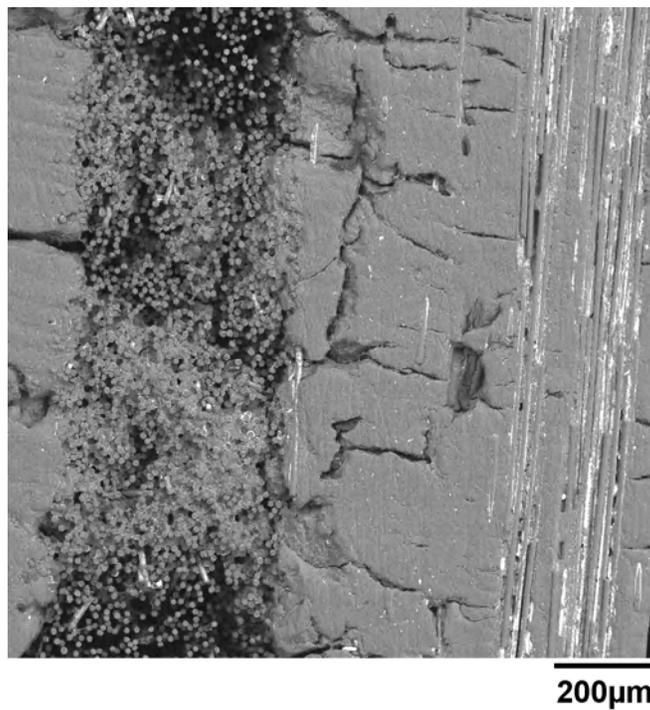
Figure 58. Backscatter SEM Image of Cross-Section of Panel M2 Showing Matrix-Rich Areas and Large Regions Void of Matrix Material in the 90° Fiber Layer. Bright White Areas on Both Fiber Layers are Monazite Coating.

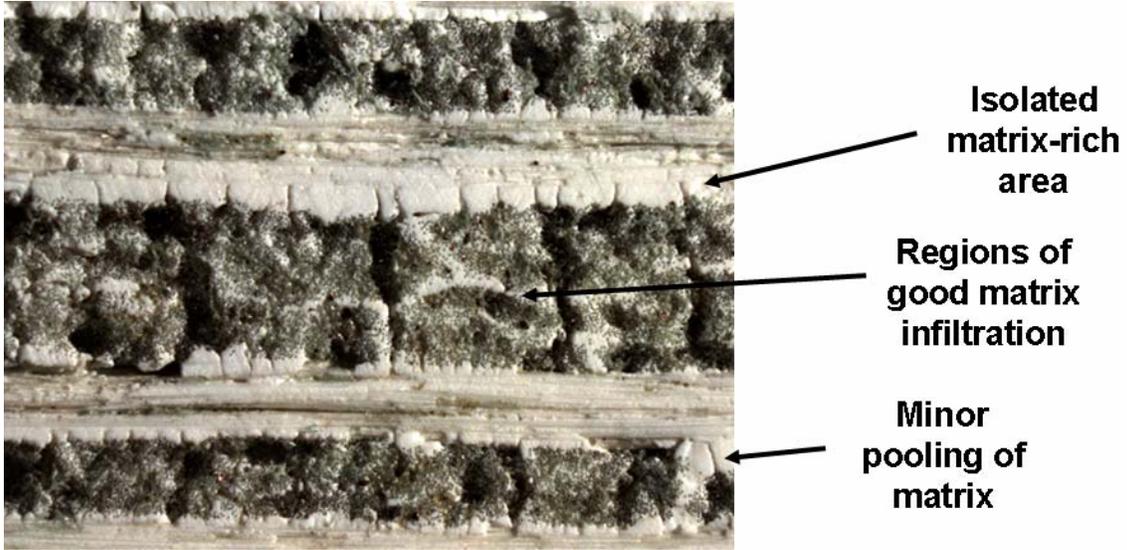
Figure 59. Parallel Cross-Sectional View of Virgin Specimen from Panel M1

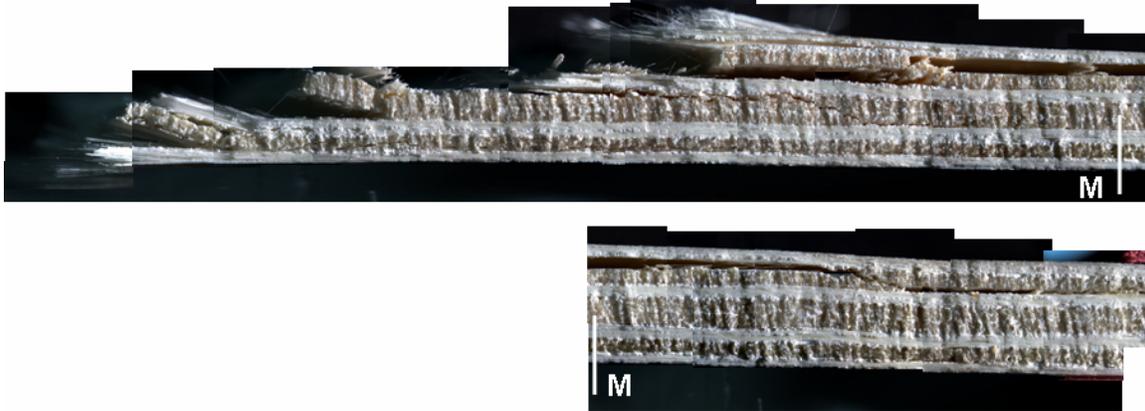
Figure 60. Propagation of Crack through a Specimen from Panel M1

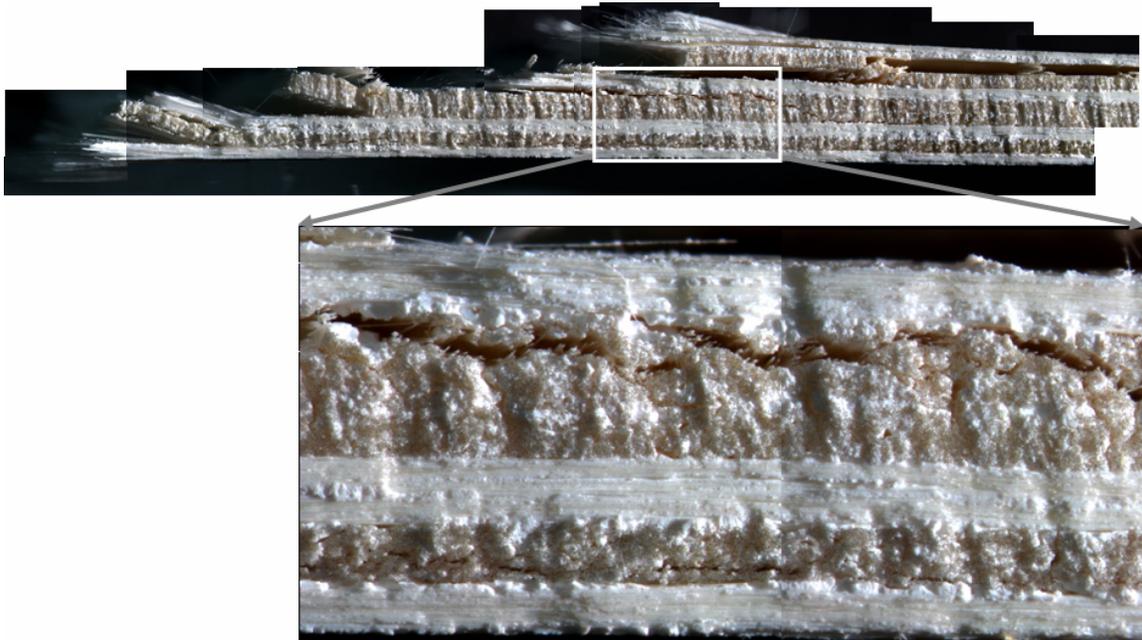
Figure 61. Magnified View of a Fracture Surface from Panel M1 Showing Cracks Initiating and Self-arresting in 90° fiber layers

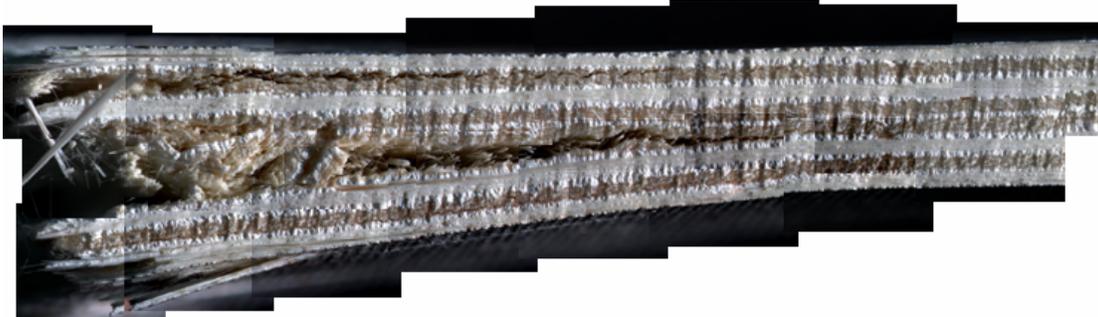
Figure 62. Crack Propagation through Fibrous 90° Layers of a Specimen from Panel M2.

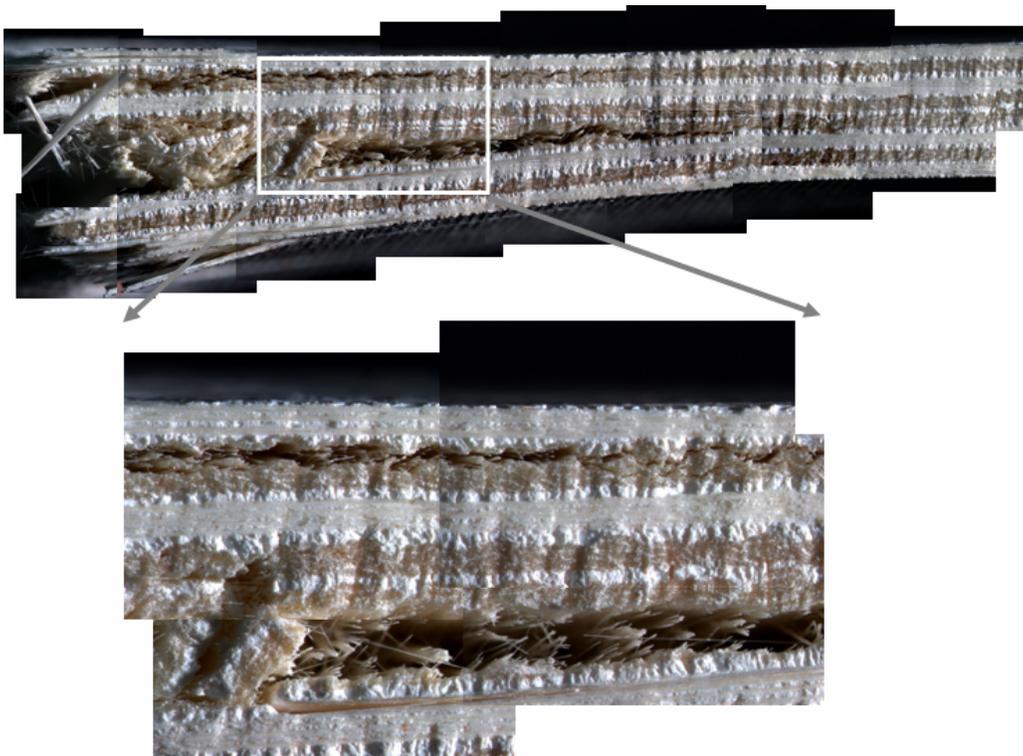
Figure 63. Magnified View of a Fracture Surface from Panel M2 Showing Cracks Propagating through 90° Fiber Layers. No Crack Deflection is Observed.

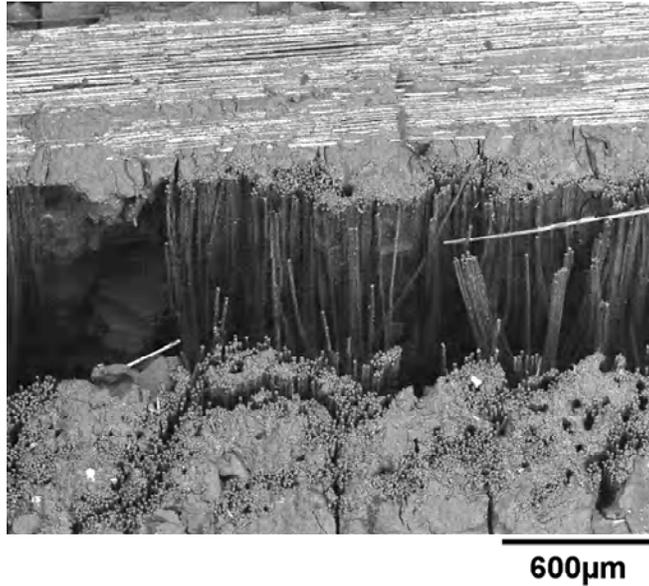
Figure 64. Backscatter SEM Image of Fracture Surface Shown in Figure 62.

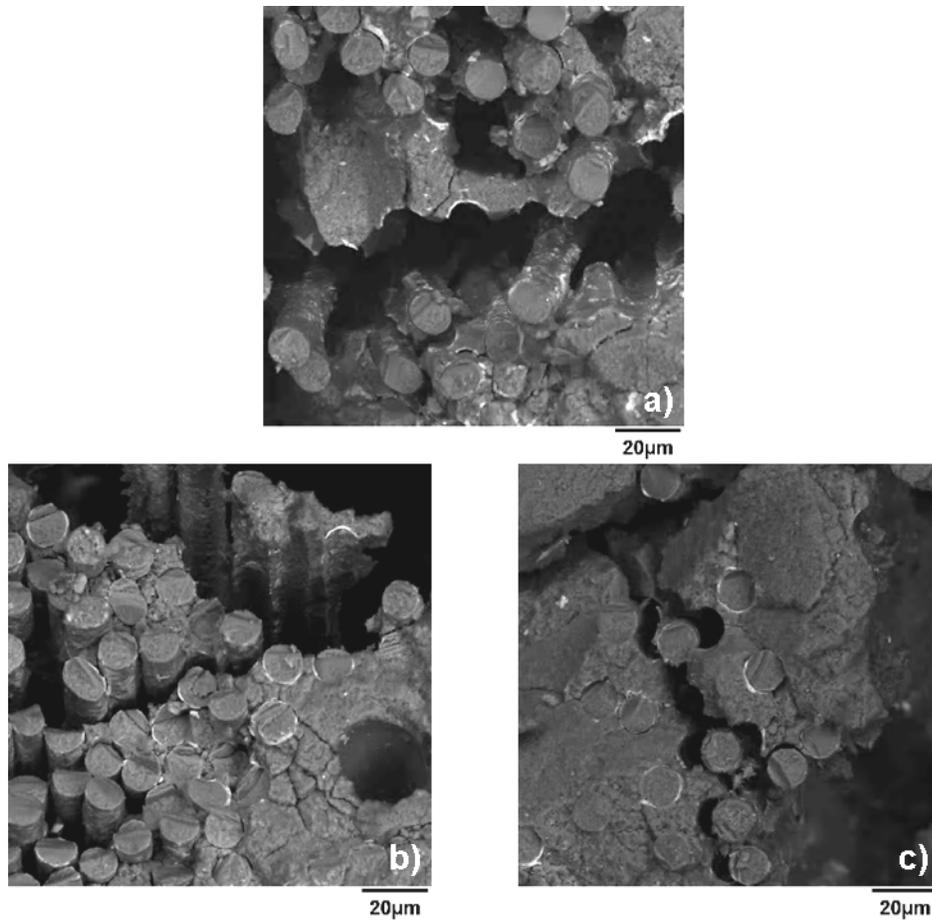
Figure 65. Backscatter SEM Images of Representative Crack Propagation in specimens from Panel M1 (a) and Panel M2 (b and c)

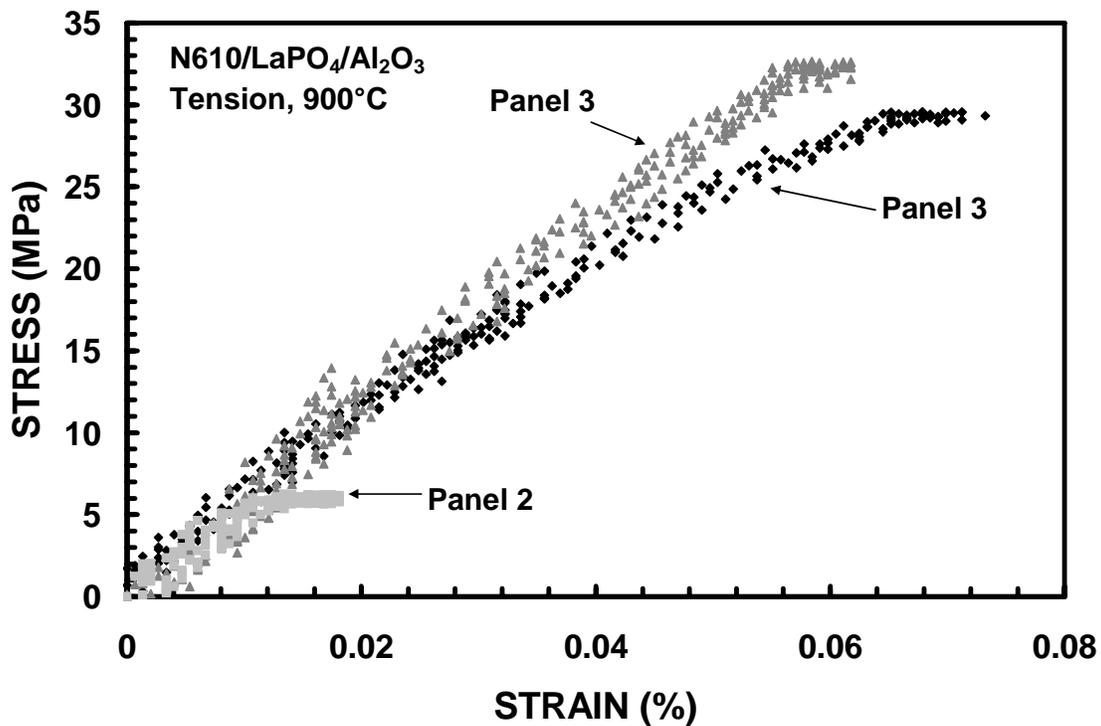
Figure 66. Tensile Stress-Strain Curves for N610/Monazite/Alumina Panels M2 and M3 at 900 °C

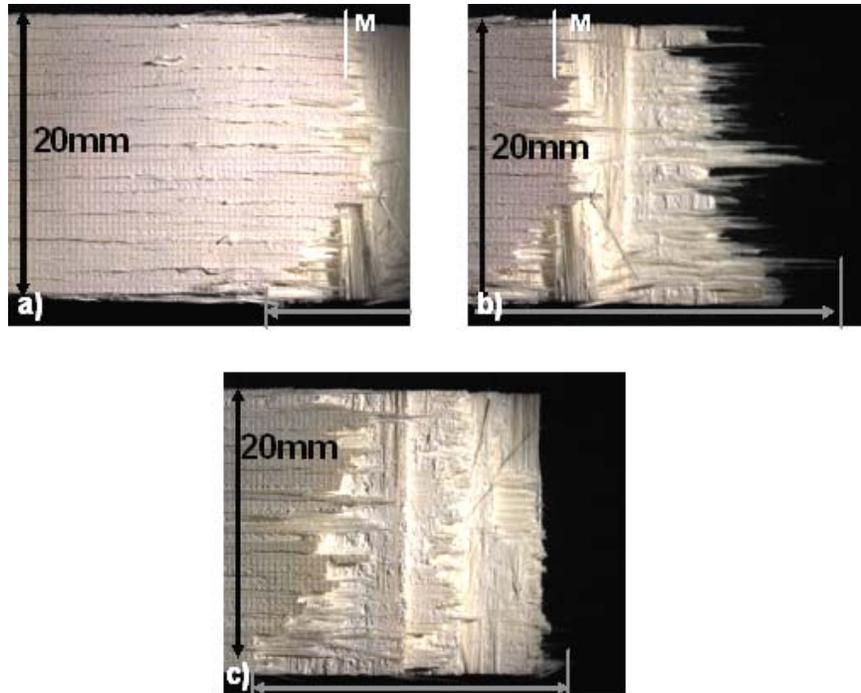
Figure 67. Fracture surfaces of N610/Monazite/Alumina Specimen Tested in Compression-to-Failure at 1100 °C after having achieved a Creep Run-Out at 75 MPa at 1100 °C

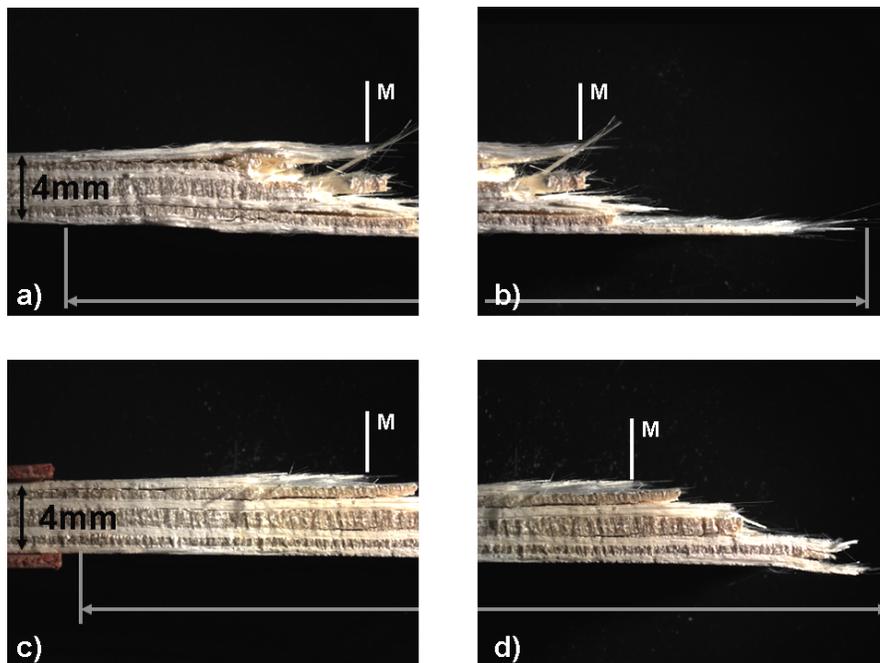
Figure 68. Side View of Fracture Surfaces of a N610/Monazite/Alumina Specimen Tested in Compression-to-Failure at 1100 °C after having achieved a Creep Run-Out at 75 MPa at 1100 °C

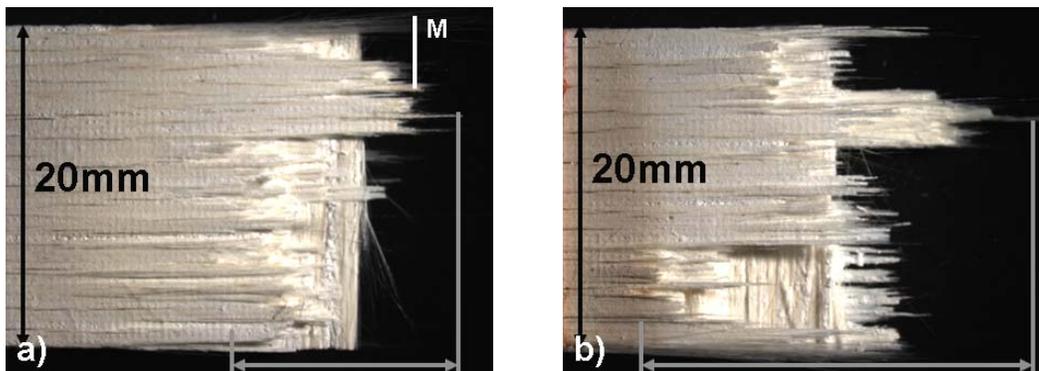
Figure 69. Fracture surfaces of N610/Monazite/Alumina Specimen Tested in Compression-t-Failure at 1100 °C after having achieved a Creep Run-Out at 65 MPa at 1100 °C

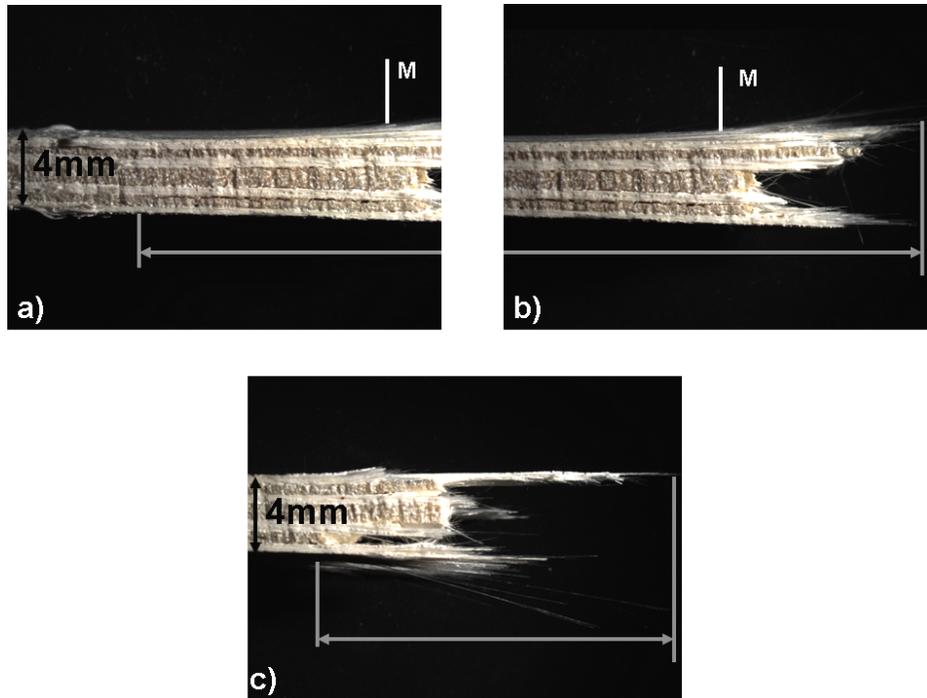
Figure 70. Side View of Fracture Surfaces of a N610/Monazite/Alumina Specimen Tested in Compression-to-Failure at 1100 °C after having achieved a Creep Run-Out at 65 MPa at 1100 °C

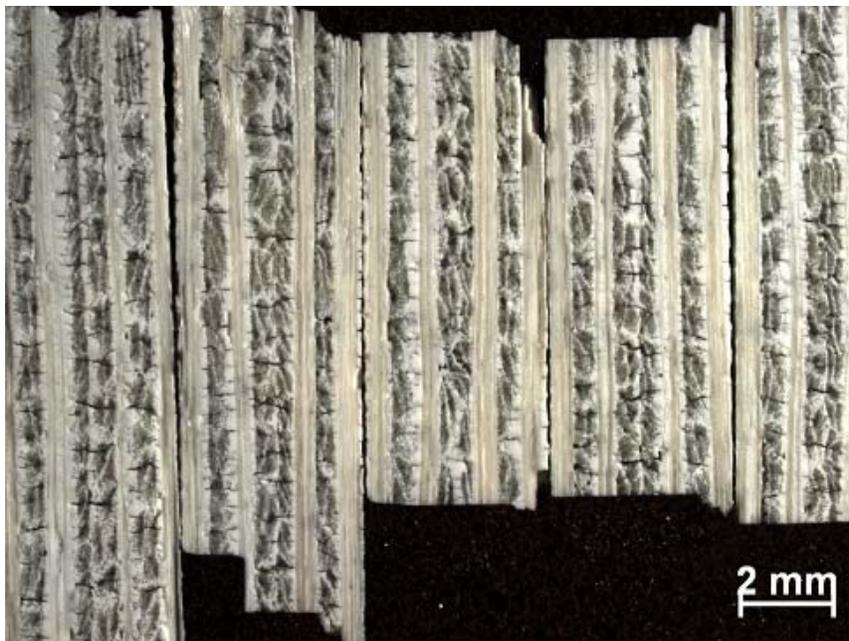
Figure 72. Micrograph of N610/Alumina Ceramic Composite. Virgin Material is on the Far Left Followed by Sections of the Specimen Tested in Compressive Creep at 1100 °C.
