Effect of Hold Times on Fatigue Behavior of Nextel 720™/Alumina Ceramic Matrix Composite at 1200°C in Air and in Steam Environment

THESIS

John M. Mehrman, Captain, USAF
AFIT/GAE/ENY/06-M23

AIR FORCE INSTITUTE OF TECHNOLOGY

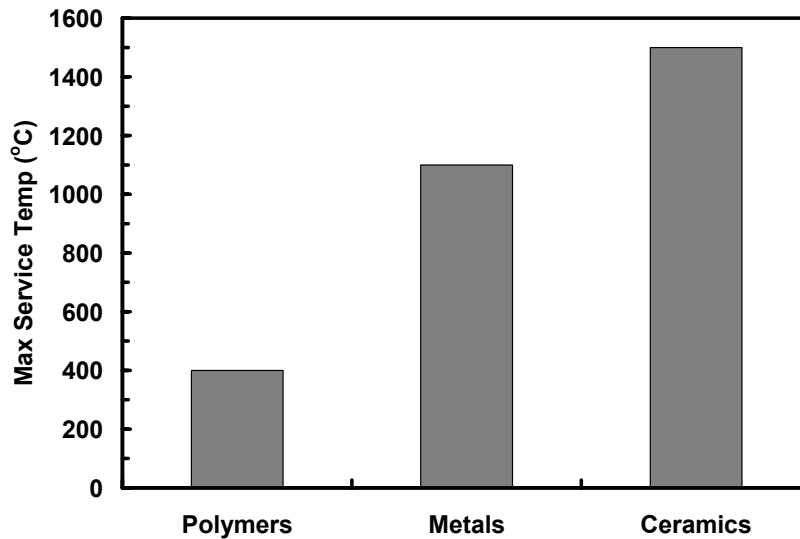
Figure 1. Maximum service temperature of polymers, metals and ceramics [7:5].

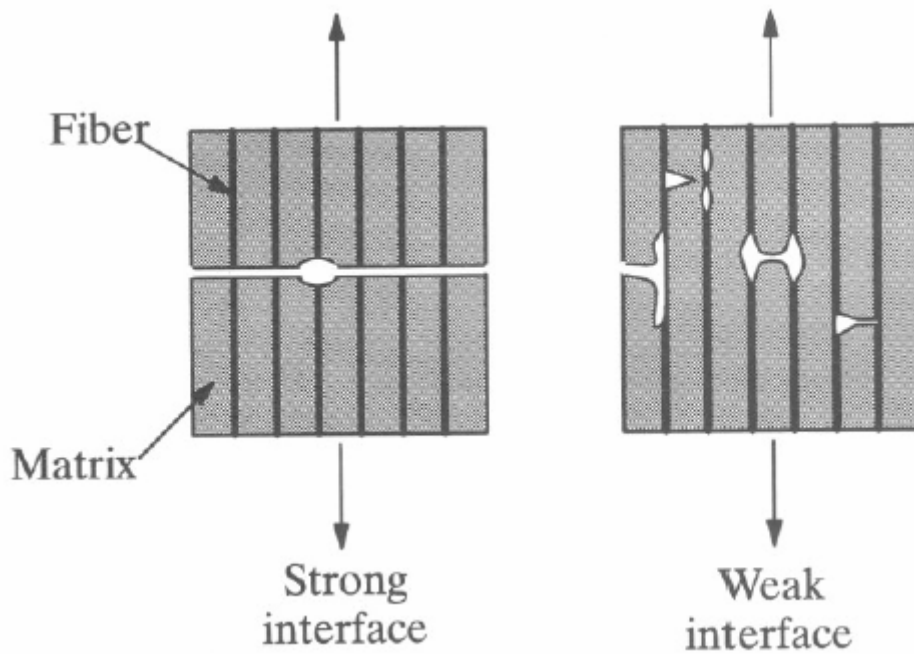
Figure 3. Failure of a CMC as a function of interfacial bond [7:170].

toward the fiber/matrix interface region. In order to maintain structural integrity of the fibers, cracks must be deflected around the fibers and not allowed to propagate through the fiber. A weak fiber/matrix interfacial bond allows debonding and crack deflection followed by crack bridging, fiber fracture and finally fiber pullout [7:169]. Crack deflection is the energy dissipating event that provides for a delayed failure and higher toughness in CMCs. Figure 3 shows a schematic of the failure of a CMC as a function of the interfacial bond. The interface between fiber and matrix is recognized as being the critical element that achieves the flaw tolerance that distinguishes CMCs from monolithic ceramics [36].

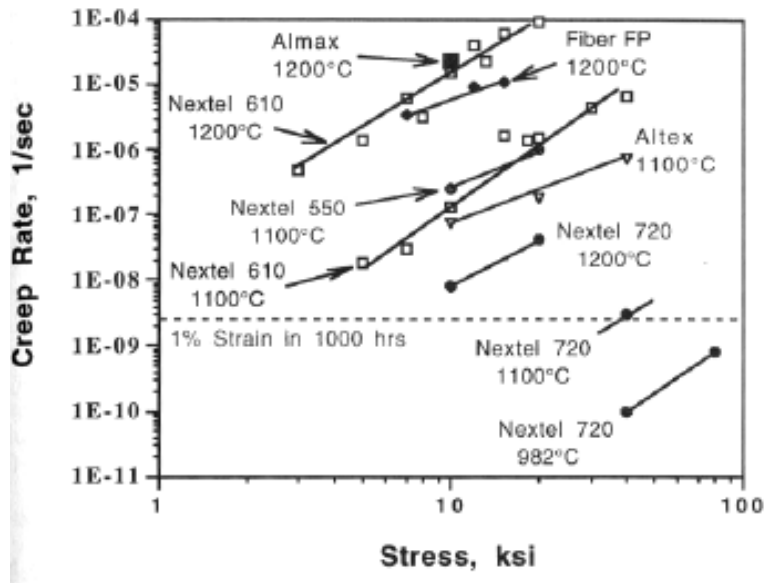
Figure 6. Comparison of creep rates for N720 and other commercially available polycrystalline oxide fibers (10 ksi = 69 MPa) [40].

crystals of mullite and α - Al_2O_3 with grain sizes up to $0.5\mu\text{m}$ are present [40]. The absence of non-crystalline phases in the fiber leads to better creep performance [41]. In fact, the N720 fiber had demonstrated better creep performance than any other commercially available polycrystalline oxide fiber (see Figure 6 [40]).

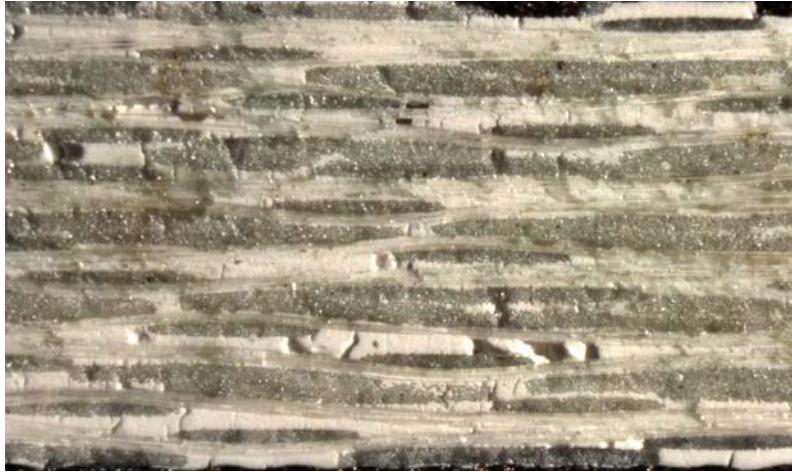
Figure 7. Optical micrograph of polished as-received N720/A material.

Figure 7 shows an optical micrograph of the as-received N720/A material. The micrograph shows good matrix infiltration as well as matrix microcracks. Matrix cracks are formed during the sintering of the material due to a difference in the coefficient of

thermal expansion of the matrix and fiber. These microcracks, however, do not affect the strength of the material because of the porous nature of the matrix [44].

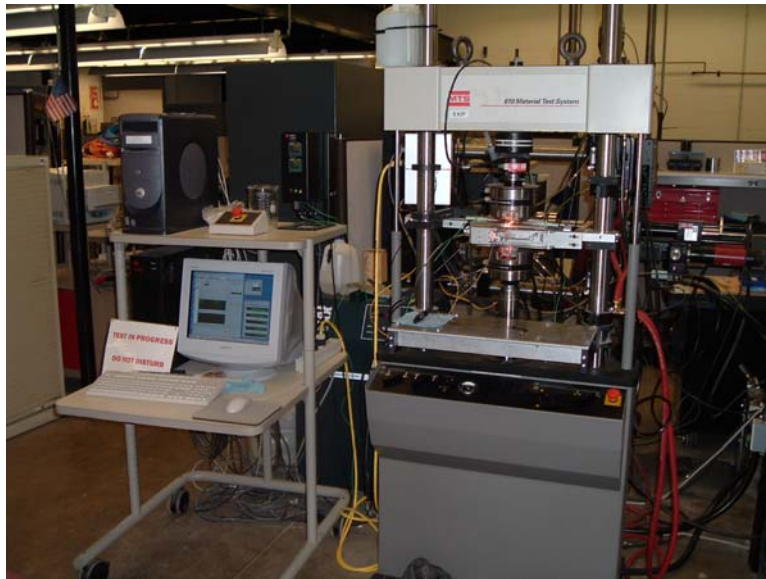
Figure 10. Mechanical testing station.

Figure 10 show the overall mechanical testing station set-up

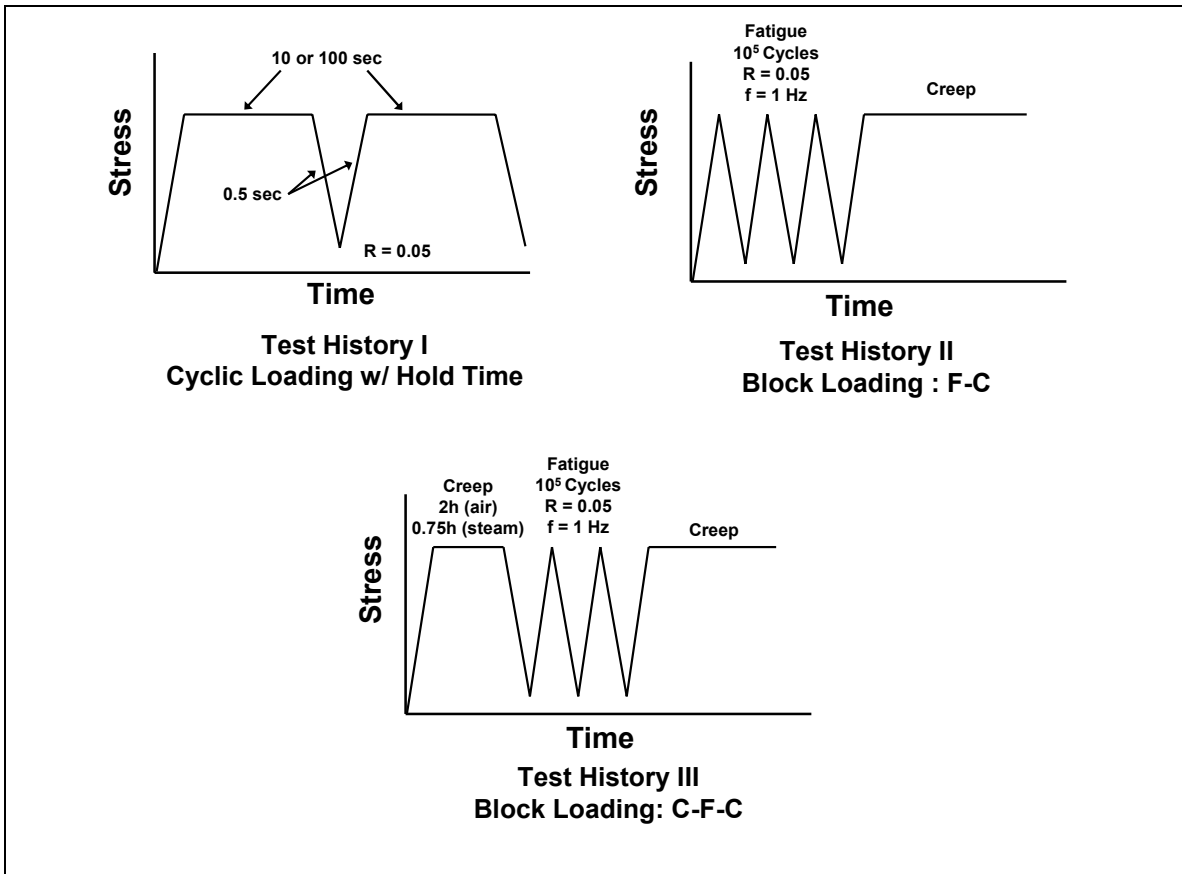
Figure 15. Combined creep/fatigue test histories.

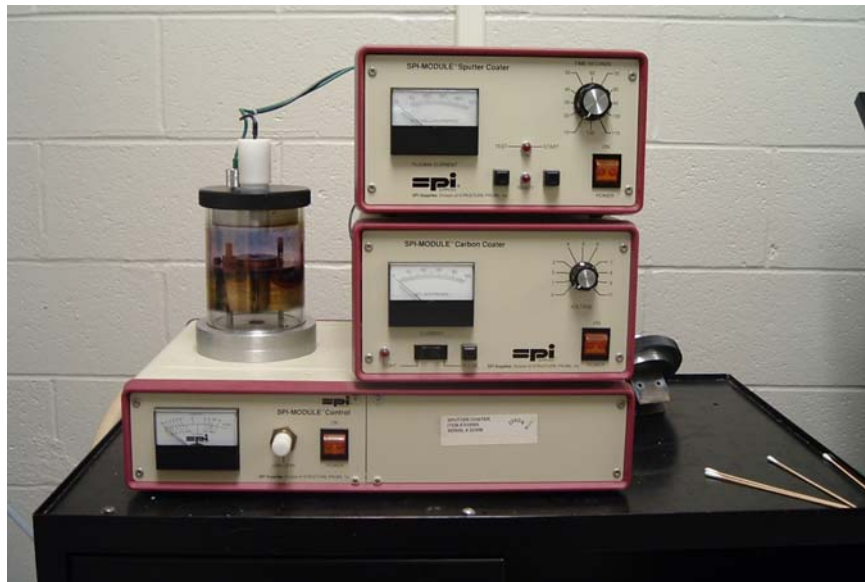
Figure 16. SPI-Module Controller and Carbon Coater.

Non-conductive materials like the alumina and mullite found in the Nextel 720/A CMC tend to build up a charge when bombarded by the electron beam of the SEM. This leads to distortion of the image and, if severe enough, can lead to damage of the specimen. To combat this problem, two different methods were used. The first was to coat a specimen with a thin layer of a conductive material. For this research, both carbon and gold coatings were tried out. Carbon coating was chosen based on image quality, and more importantly, because gold would have been detrimental to the spectroscopy characterization discussed later. A SPI Supplies SPI-Module Control and Carbon Coater, shown in Figure 16, were used to coat the specimens.

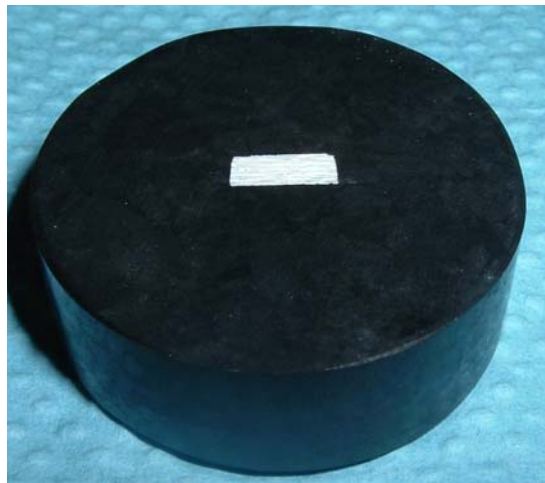
Figure 18. Mounted and polished N720/A specimen.

Untested N720/A CMC was mounted in a carbon resin fill and polished for viewing with the optical microscope as well as the SEM. A Buehler Simplimet 2000 automatic mounting press was used to mount the specimen in a Buehler Konductomet conductive filled phenolic mounting compound. The specimen was then polished with a Buehler PowerPro 5000 variable speed grinder and polisher. The specimen was first ground with 240(60 μm), 400(30 μm), and then 600(15 μm) grit sandpapers. Then it was polished with 6 μm , 1 μm , 0.1 μm , and lastly 0.05 μm Buehler Metadi diamond suspension paste. Lastly, it was carbon coated using the SPI Supplies SPI-Module Control and Carbon Coater mentioned above. Figure 18 shows a picture of the mounted and polished specimen prior to carbon coating.

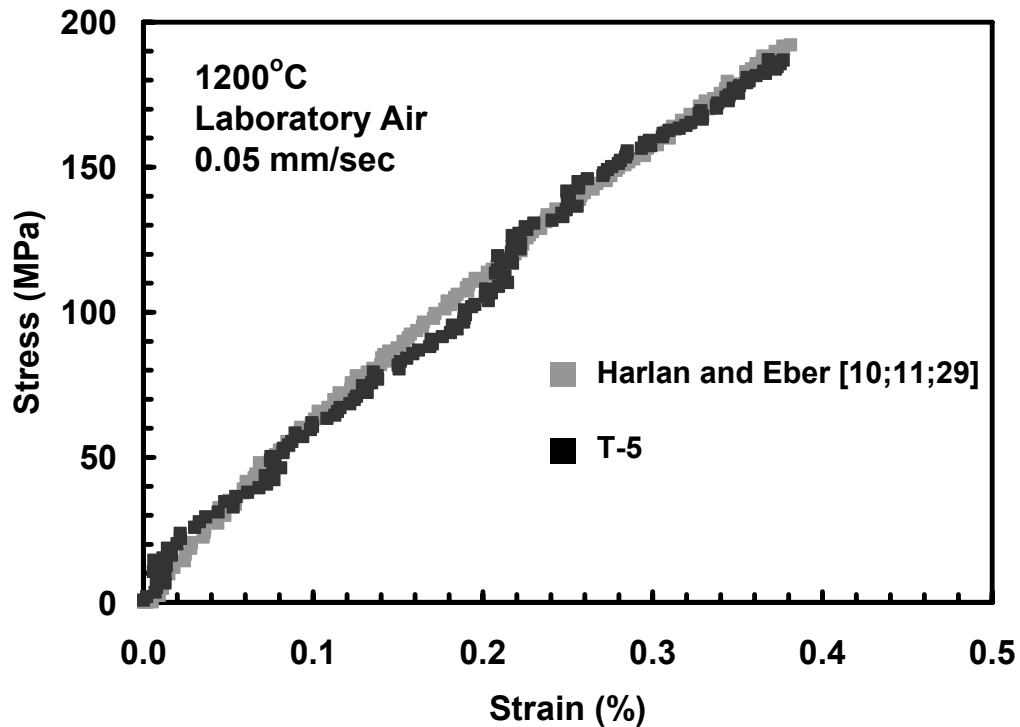
Figure 19. Tensile stress-strain curves for N720/A at 1200°C in laboratory air.

The stress-strain curve obtained in this test is shown in Figure 19 together with the stress-strain curve reported in ref [10;11;29]. It is seen that the results are consistent with those reported previously. Note the linearity of the stress strain curve, which is consistent for a CMC with a porous matrix. In this case the fibers carry most of the load, the stress-strain behavior of the composite is fiber-dominated [12].

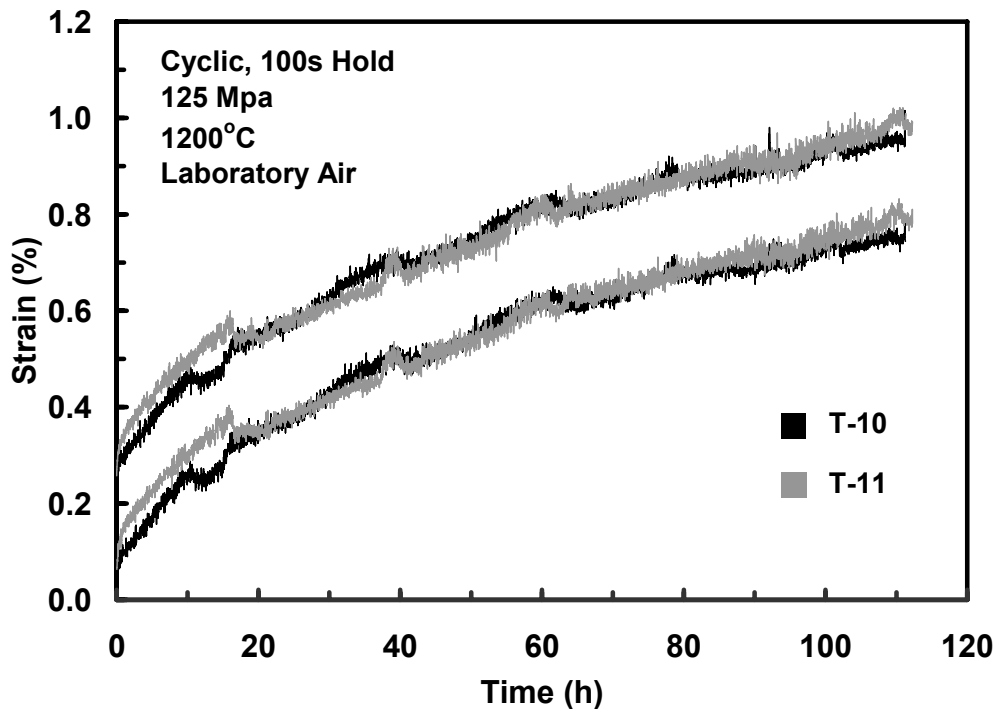
Figure 21. Maximum and minimum strain vs time for N720/A composite tested with cyclic, 100s hold condition at 125MPa and 1200°C in laboratory air.

restarted after the furnace was repaired. The test was repeated to remove any doubt about the validity of the initial test results. Figure 21 shows the variation with time of maximum and minimum strain and it is seen that the results of both tests were consistent. Ratcheting was observed in all tests which is consistent with results reported by Eber [10;29]. Further figures in this report will focus on maximum strain and no longer show the strains at minimum stress.

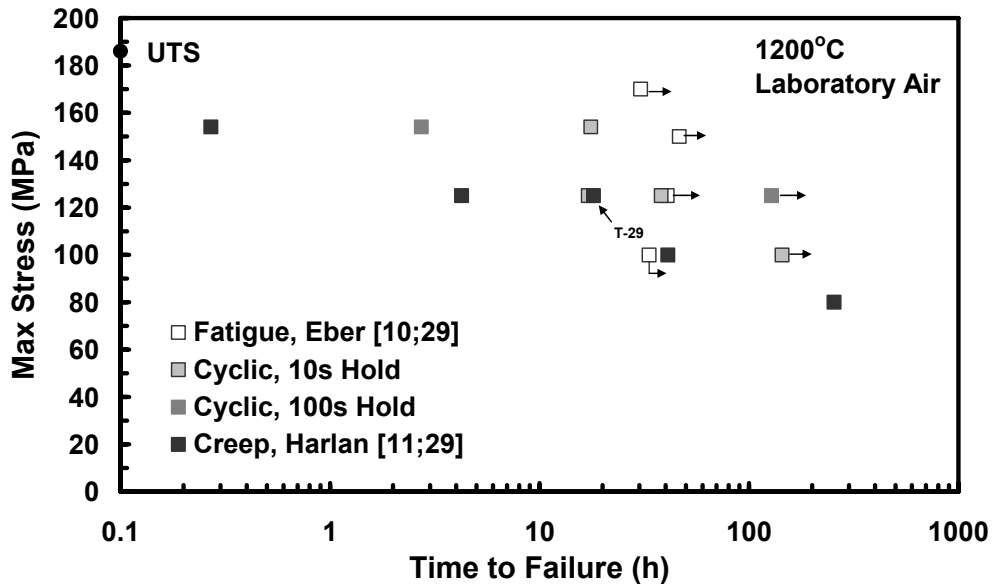
Figure 22. Maximum stress vs time to failure for N720/A at 1200°C in laboratory air. Creep[11;29] and fatigue[10;29] are also shown.

10 s hold time test showed an order of magnitude improvement over the 100 s hold time test, which exhibited an order of magnitude improvement compared to the pure creep test.

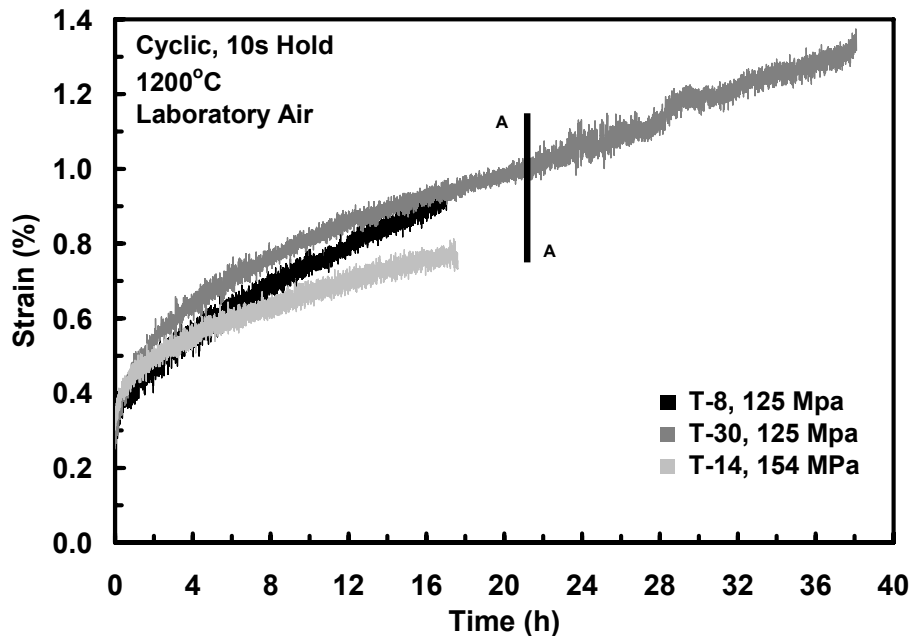
Figure 23. Maximum strain as a function of time at 1200°C in laboratory air.

10 s hold time was resumed and continued until failure. The total test duration from start to failure was 38.1 h. It is not known how the additional creep time at 125 MPa affected the time to failure of this specimen. However, two points should be noted: (1) after the interruption and restart, the strain returned to the same, pre-interruption level, and continued at the same strain rate to failure, and (2) the strain accumulated by T-30 is nearly the same as that accumulated by T-8, and significantly greater than the strain accumulated by T-14 tested at a higher stress level of 154 MPa.

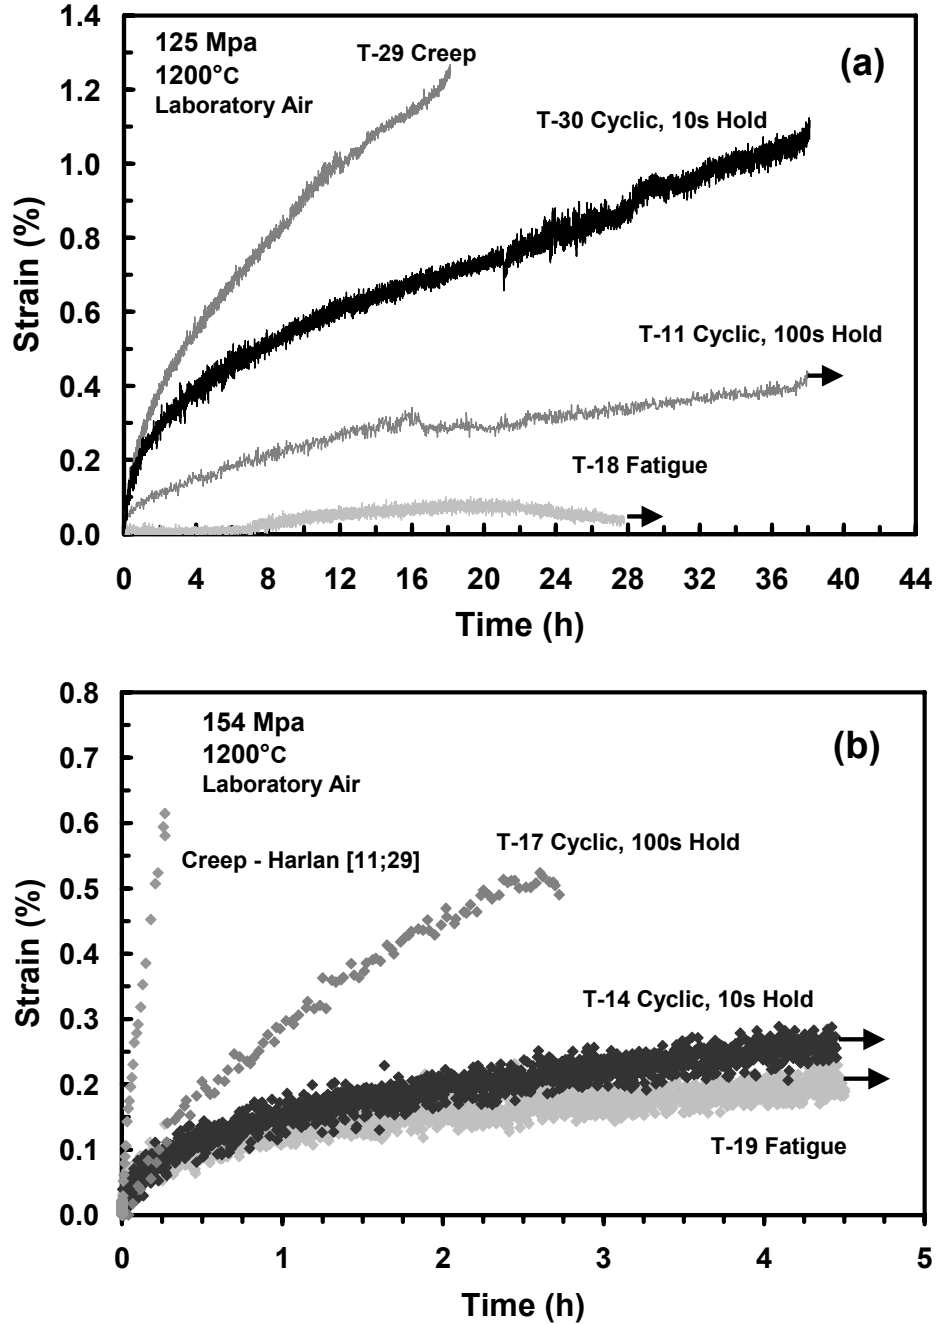
Figure 24. Maximum strain as a function of time at 1200°C in laboratory air for maximum stress of (a) 125 MPa and (b) 154 MPa. Creep data from ref [11;29] included.

measurement was taken at the maximum stress level and does not include the thermal or elastic strains, thus all of the strains start at zero.

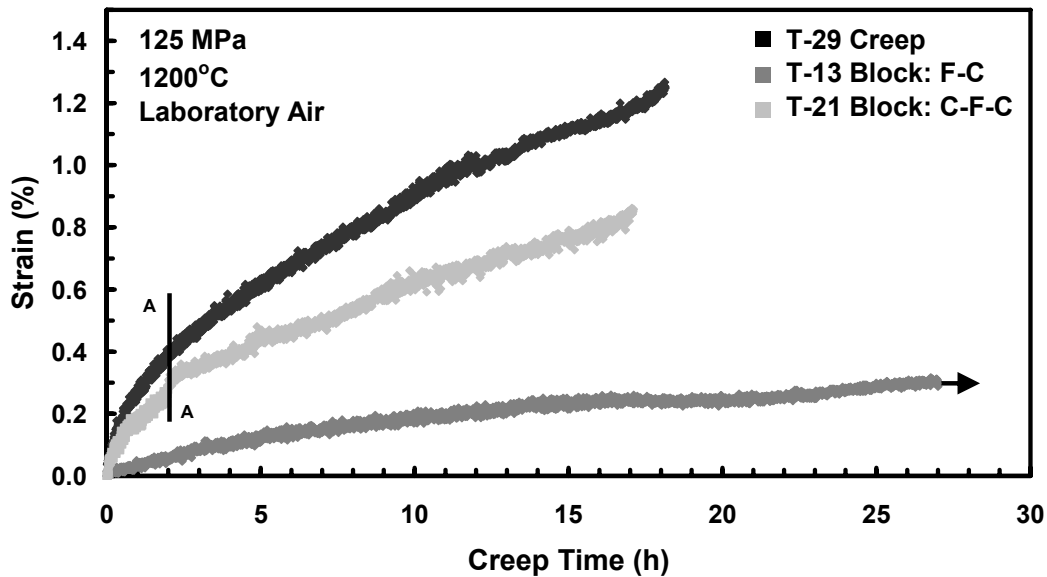
Figure 29. Creep strain as a function of time of N720/A at 125 MPa and 1200°C in laboratory air.

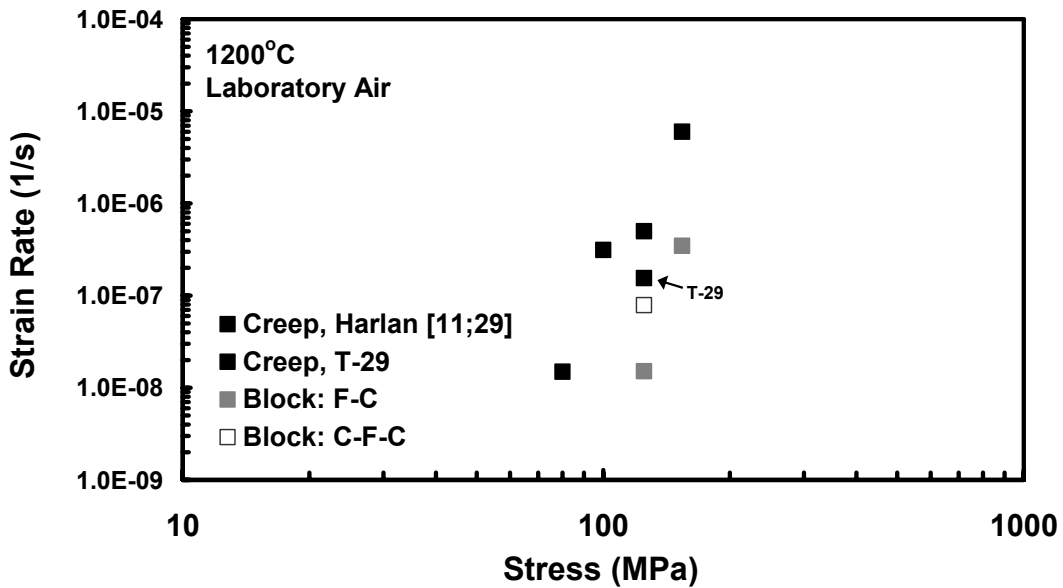
Figure 30. Creep rate vs creep stress for N720/A at 1200°C in laboratory air. Effect of prior fatigue is evident. Pure creep data from Harlan[11;29].

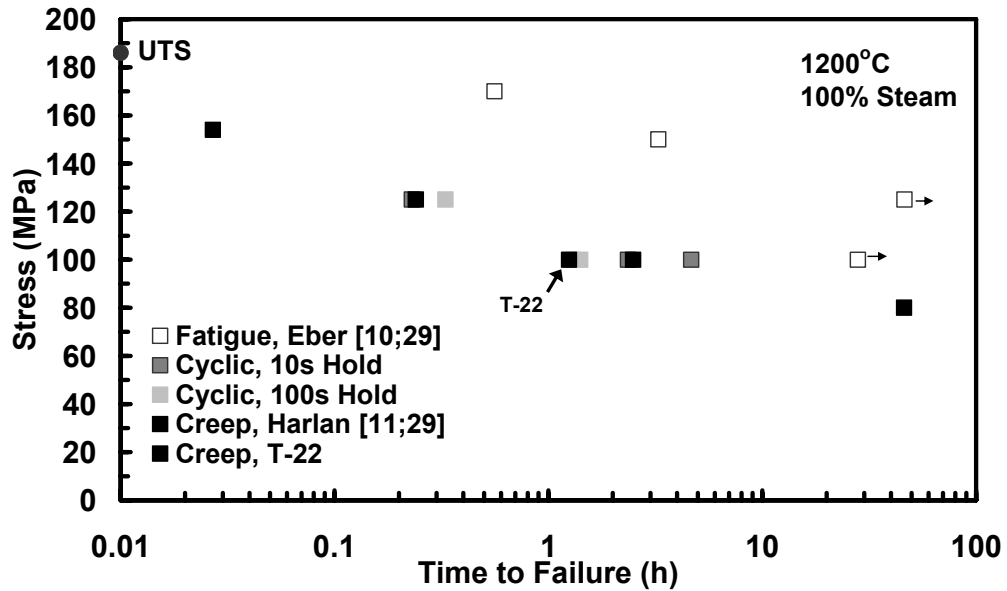
Figure 31. Maximum stress vs time to failure at 1200°C in steam environment. Fatigue results from Ref [10;29] and creep results for Ref [11;29] are also included.

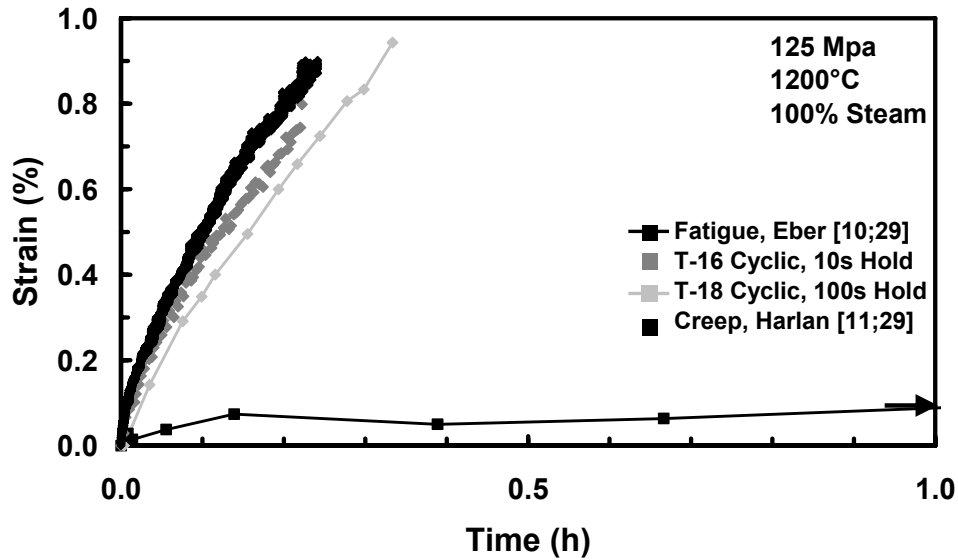
Figure 33. Maximum strain as a function of time at 1200°C in steam environment at maximum stress of 125MPa. Fatigue results from ref [10;29] and creep results from ref [11;29] are also included.

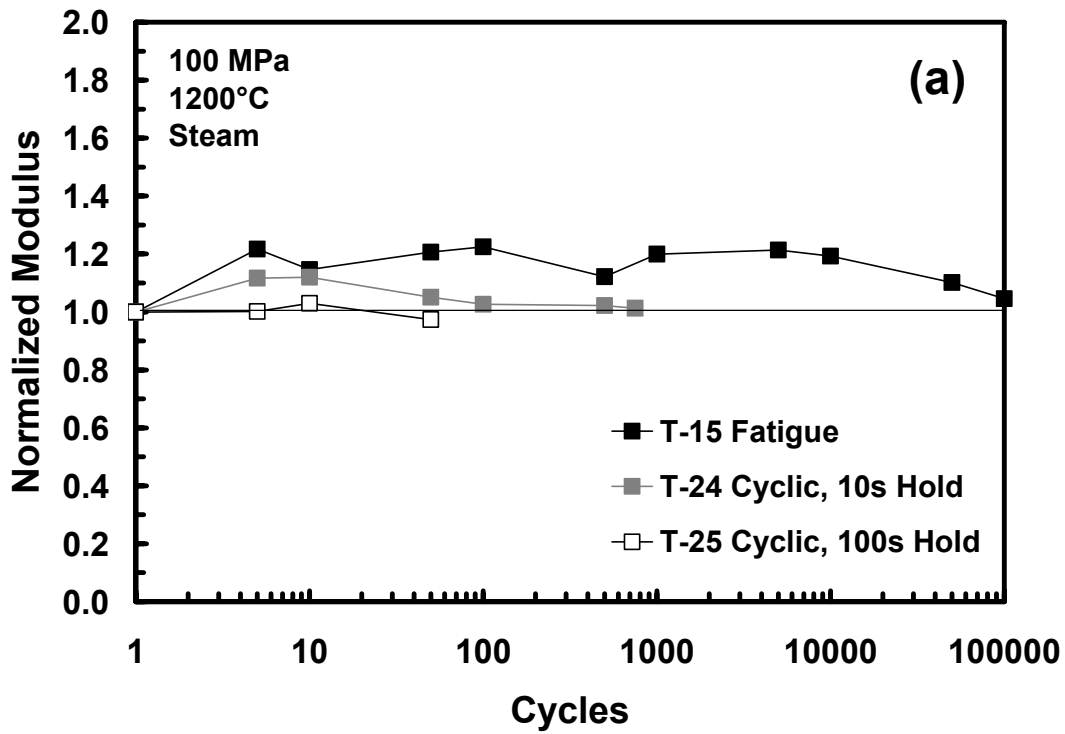
Figure 35. Normalized modulus vs cycles at 1200°C in steam environment for maximum applied stress of (a) 100 MPa and (b) 125 MPa.

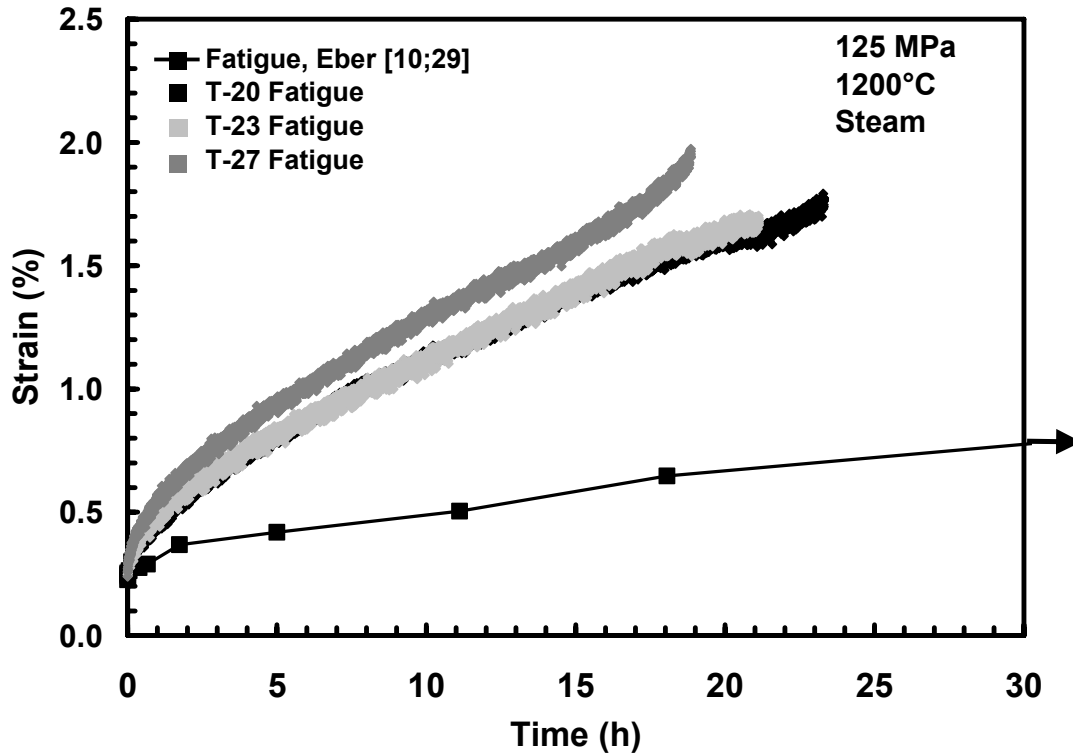
Figure 36. Maximum strain as a function of time at 1200°C in steam environment. Results reported by Eber [10;29] are also included.

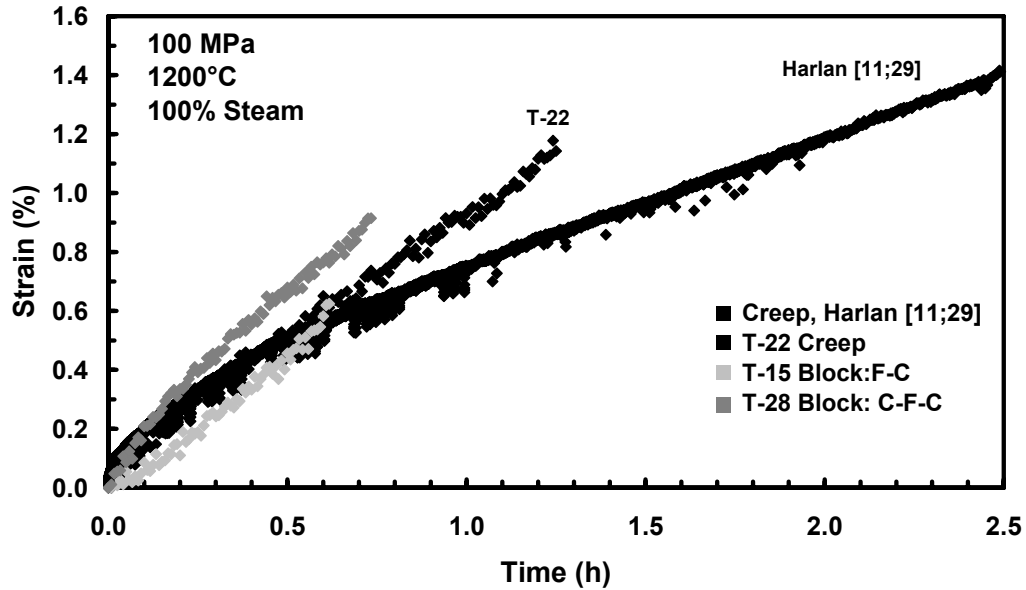
Figure 37. Creep strain vs time at applied stress of 100 MPa at 1200°C in steam environment. Creep data from ref [11;29] also included.

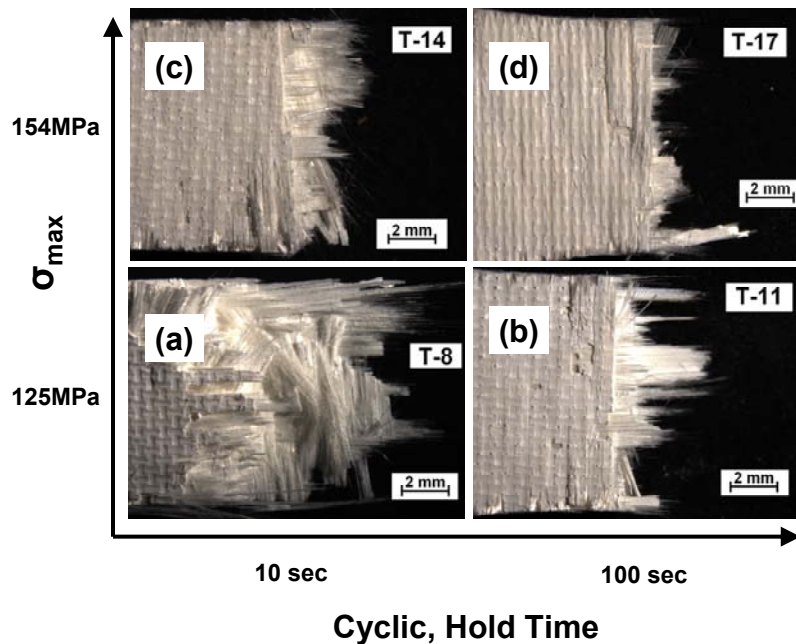
Figure 42. Fracture surfaces of N720/A specimens subjected to cyclic loading with hold times at 1200°C in laboratory air: (a) maximum stress = 125MPa, hold time = 10s; (b) maximum stress = 125MPa, hold time = 100s; (c) maximum stress = 154MPa, hold time = 10s; (d) maximum stress = 154MPa, hold time = 100s.

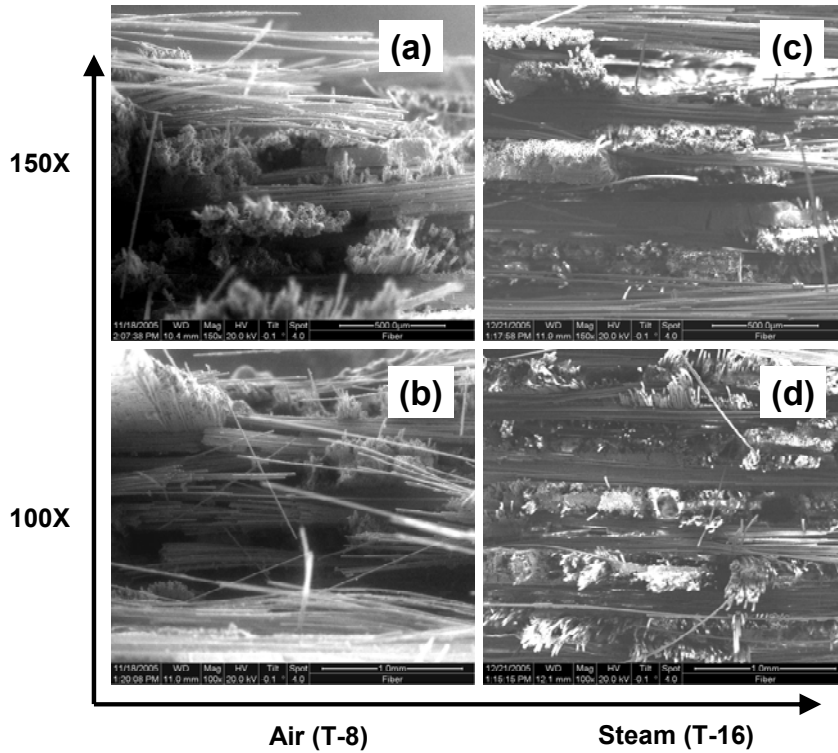
Figure 51. SEM micrographs of N720/A subjected to cyclic loading with 10 s hold time at 125MPa and 1200°C in: (a) air; (b) air; (c) steam; (d) steam.

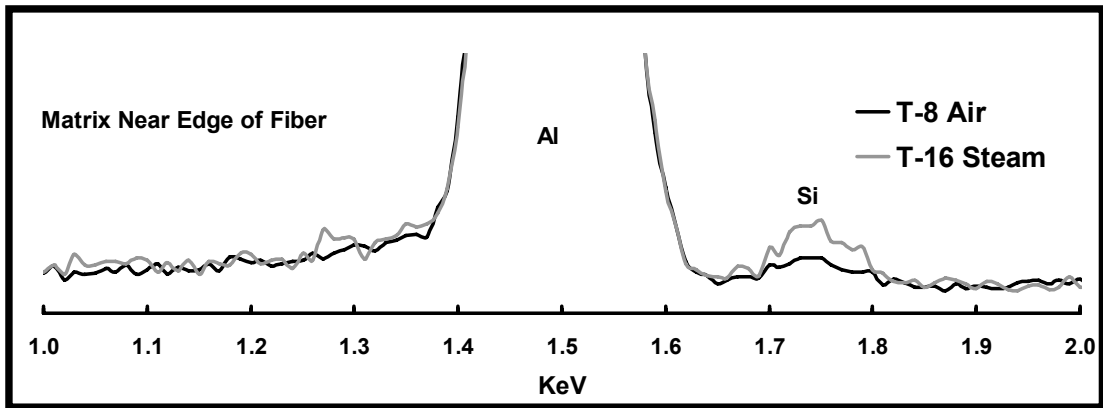
Figure 57. EDS spectrum of the matrix near the fiber edge of N720/A specimens tested in air compared with spectrum of matrix near the fiber edge of specimen tested in steam environment.
