Fatigue Behavior of a Functionally-Graded Titanium Matrix Composite

**FATIGUE BEHAVIOR OF A FUNCTIONALLY-GRADED TITANIUM MATRIX
COMPOSITE**

THESIS

AFIT/GAE/ENY/05-M06

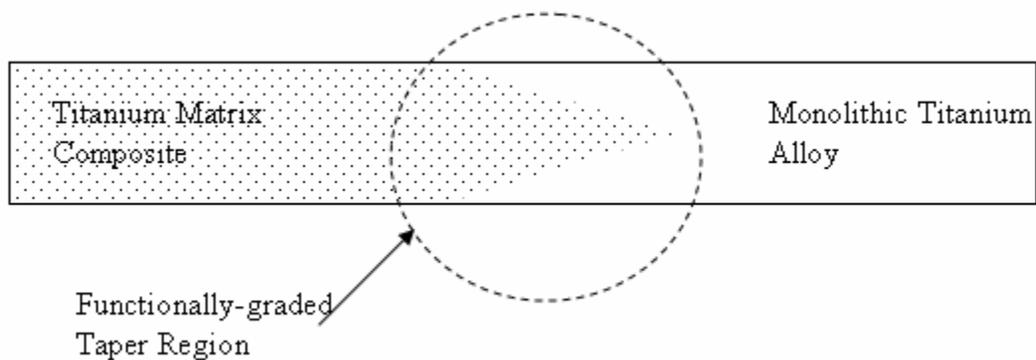
Figure 1: Functionally-graded, double scarf joint

This research investigates the mechanical behavior of a functionally-graded titanium matrix composite. The material is composed of a titanium matrix composite and a monolithic titanium alloy functionally-graded through the thickness (see Figure 1).

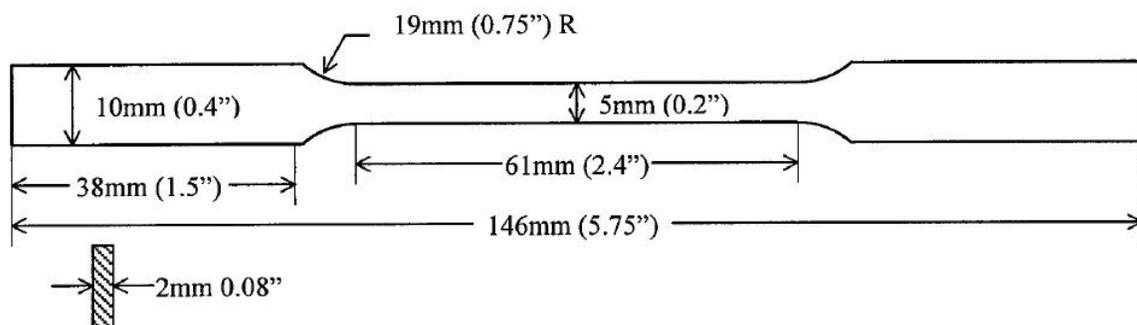
Figure 5: Dogbone specimen geometry

specimen was needed to ensure failure in the gage section during fatigue loading. By reducing the gage section's cross-sectional area, the localized stress is increased. However, in order to minimize stress raisers on the specimen edge, the shoulder radius must be as large as possible. This design loop resulted in the chosen geometry (see Figure 5). All specimens were cut from the plates by technicians of the AFIT Model Shop using Electrical-Discharge Machining (EDM) techniques.

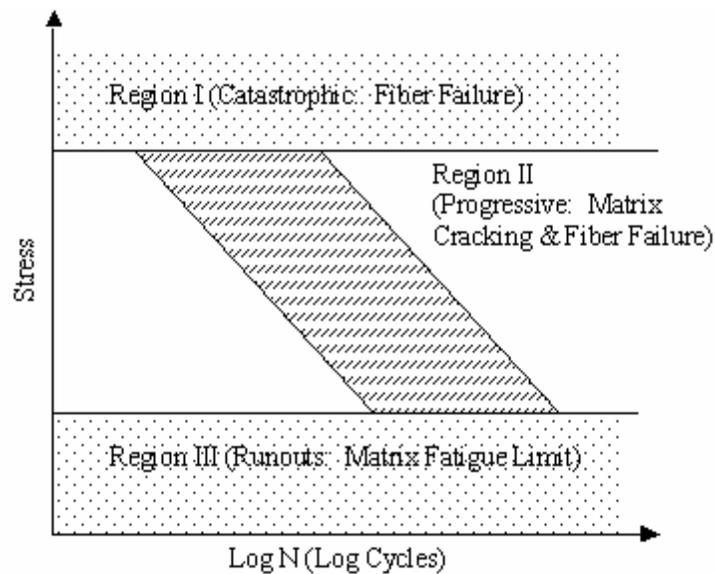
Figure 13: Typical S-N diagram

Many researchers have attempted to show the fatigue life diagram as three distinct regimes (Regime I, II and III) where each regime represents an area where certain failure mechanisms play dominant roles. Using Talreja's approach [21] for unidirectional composites, Region I failures correspond to overloading of the fibers resulting in fiber breakage and interfacial debonding. Damage in this region is characterized as catastrophic or non-progressive. Region II failures correspond to matrix, fiber and fiber/matrix interface cracking. Damage in this region is characterized as progressive. Region III corresponds to matrix cracking and the matrix fatigue limit. Damage in this region, if it occurs at all, is characterized as non-propagating or referred to as runout. A typical S-N diagram showing these regions is shown in Figure 13.

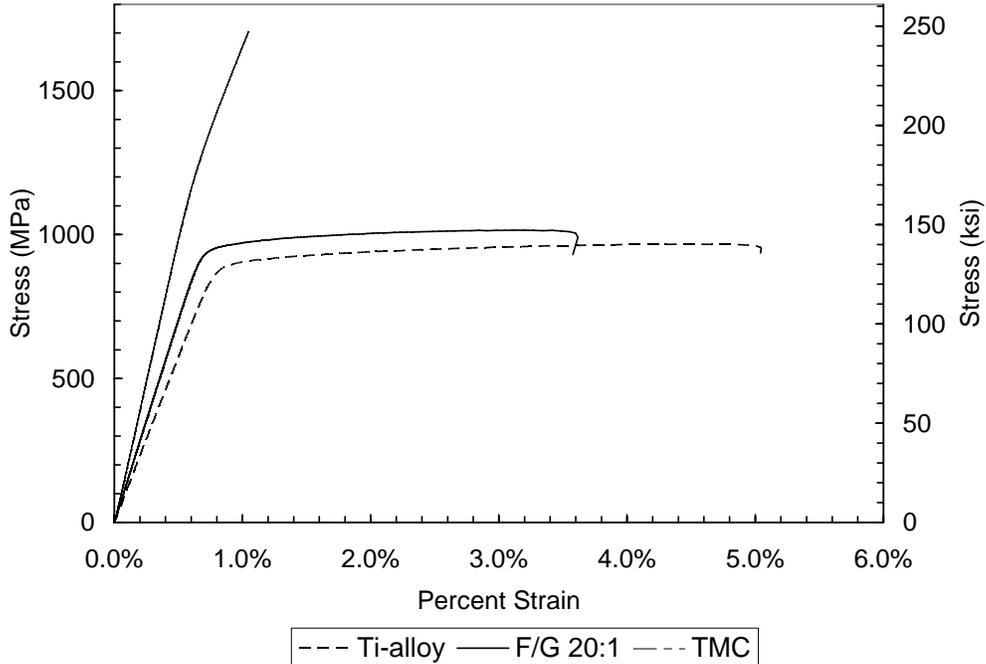
Figure 15: Tensile test results

The other measurement taken is the ultimate strength of the material. Just as its name implies, it is the highest stress value reached before failure occurs. The results from the extensometer and load measurements for the three materials are shown in Figure 15 and summarized in Table 1.

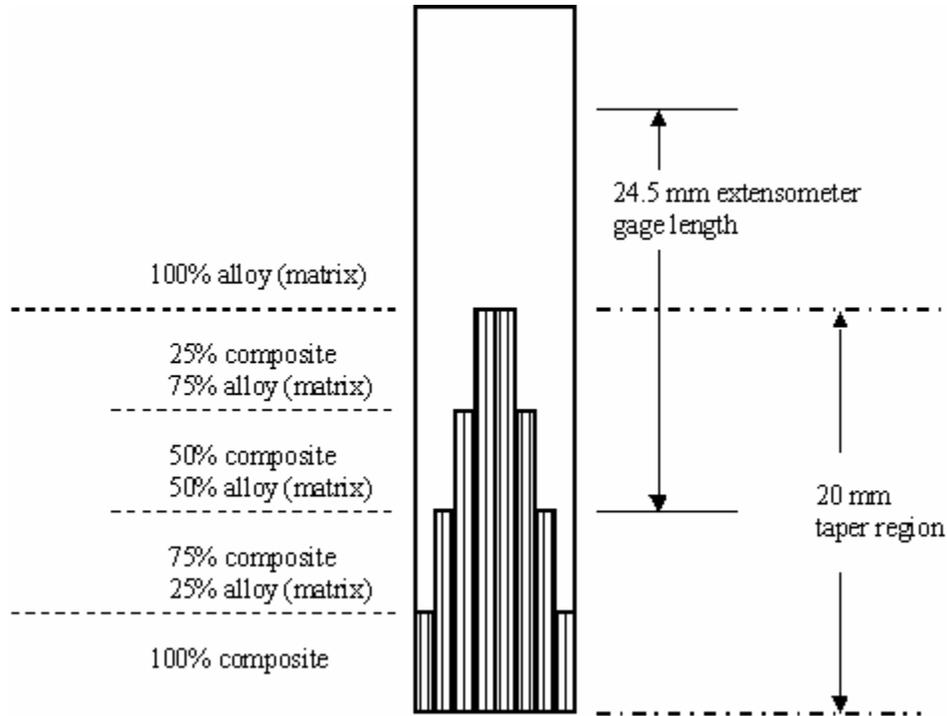
Figure 19: Taper section

19) where each step encompasses a different region with differing volume fractions of composite.

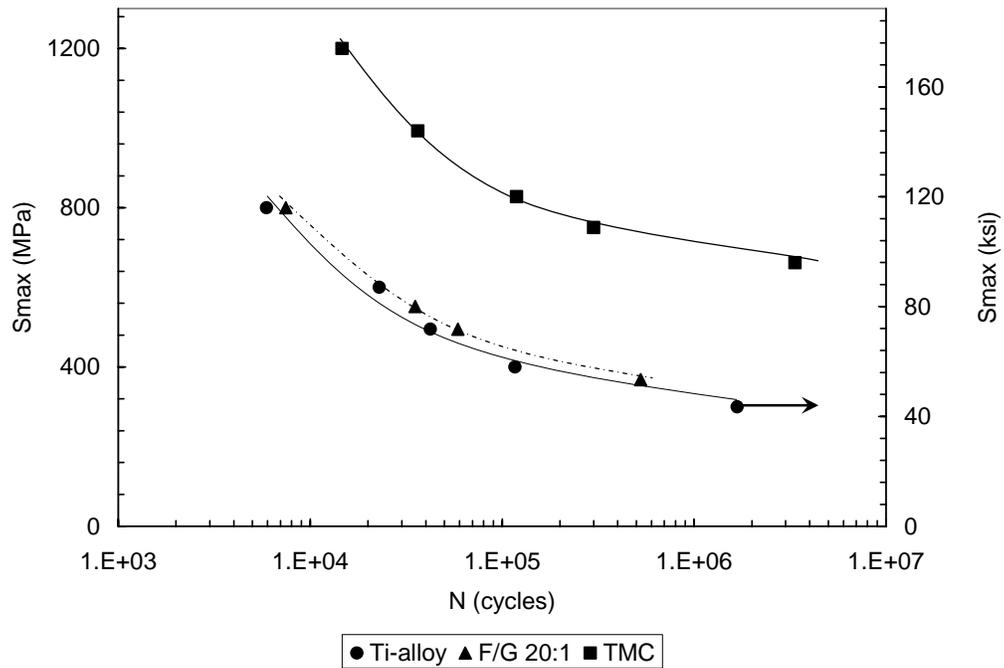
Figure 20: Tension-tension S-N curves

Spec. #	Max Stress (MPa)	Stress Range (MPa)	Cycles to Failure
F/G-02	368.00	331.20	526182
F/G-01	495.00	445.50	58872
F/G-03	552.00	496.80	35242
F/G-10	800.00	720.00	7470
Ti-02	300.00	270.00	>1677668
Ti-04	400.00	360.00	116659
Ti-01	495.00	445.50	42278
Ti-03	600.00	540.00	22917
Ti-10	800.00	720.00	5917
TMC-02	662.00	595.80	3355745
TMC-11	750.00	675.00	299873
TMC-01	827.50	744.75	118853
TMC-03	993.00	893.70	36354
TMC-10	1200.00	1080.00	14646

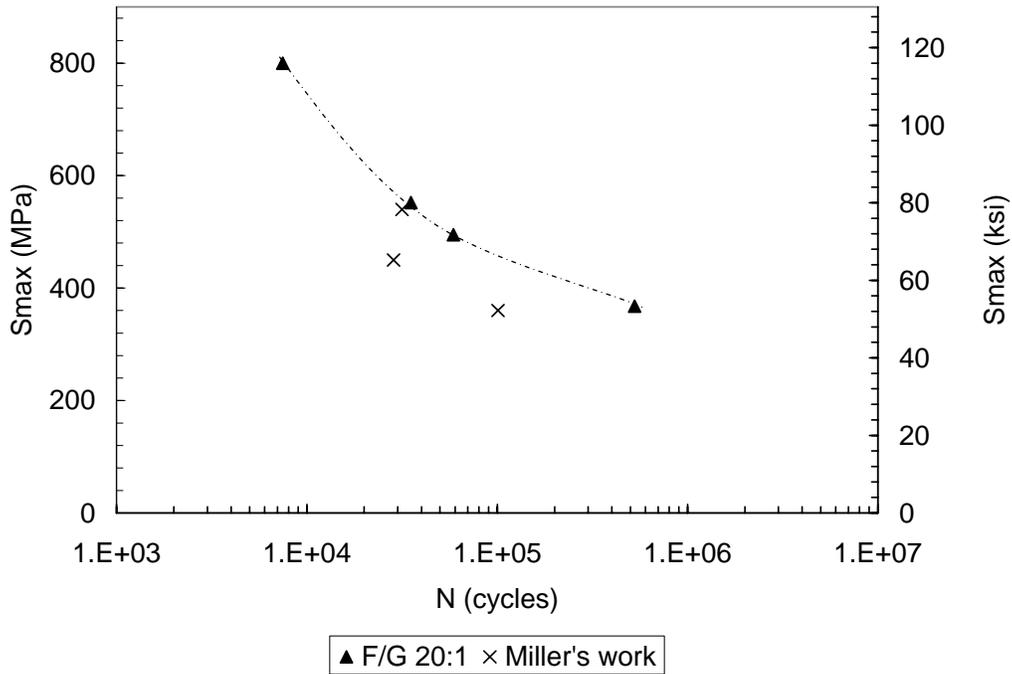
Figure 23: F/G TMC (20:1) comparison of tension-tension fatigue results

The results for the functionally-graded material under tension-tension fatigue showed higher fatigue lives when compared with Miller's data [15]. It should be noted that Miller also performed tests on a F/G TMC with a taper ratio of 4:1, however the present work is focused on the 20:1 taper ratio. A plot comparing Miller's results with the present work is shown in Figure 23.

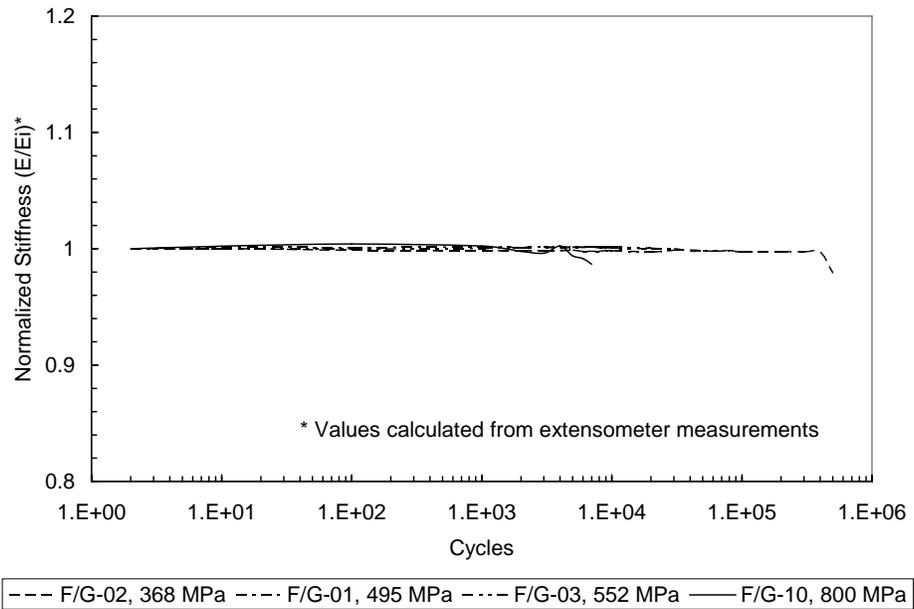
Figure 24: Tension-tension: normalized stiffness vs. fatigue cycles

material. Figure 24 and Figure 25 show plots of the normalized stiffness versus cycle number and normalized fatigue life, while Figure 26 and Figure 27 show plots of the percent strains versus cycle number and normalized fatigue life.

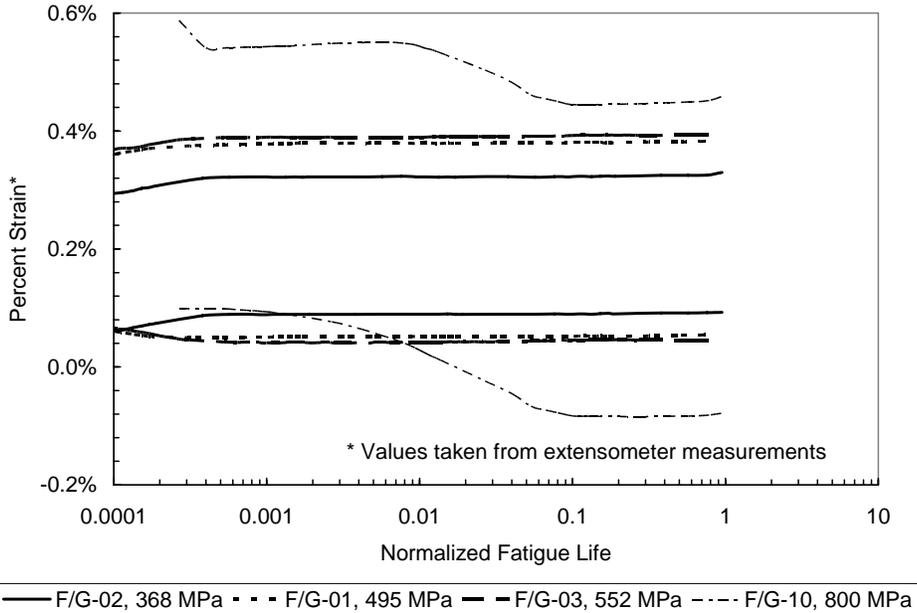
Figure 27: Tension-tension: max & min percent strain vs. normalized fatigue life

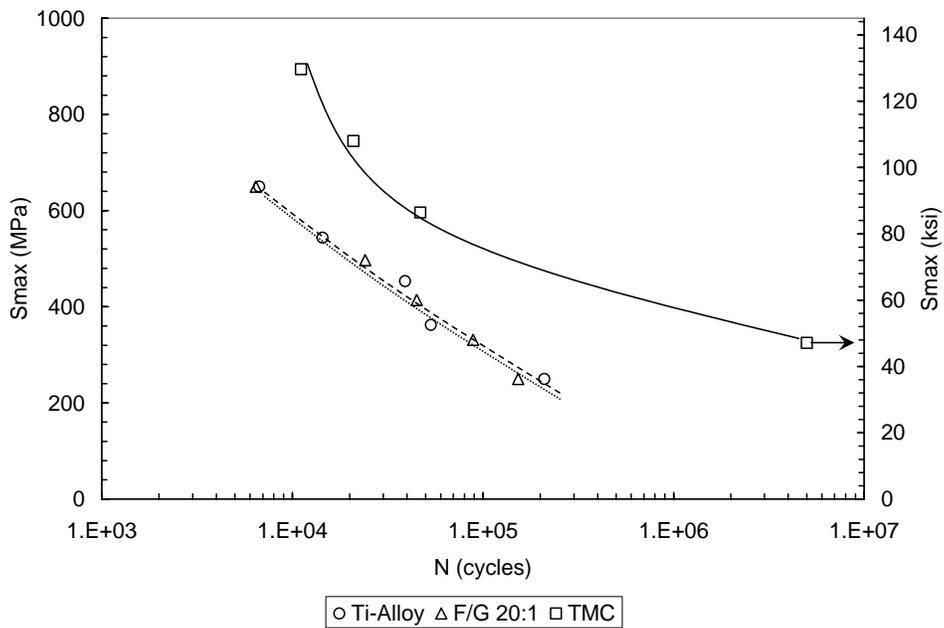
Figure 28: Tension-compression S-N curves

Spec. #	Max Stress (MPa)	Stress Range (MPa)	Cycles to Failure
F/G-08	250.00	500.00	153054
F/G-05	331.17	662.34	88922
F/G-04	414.00	828.00	44946
F/G-06	496.83	993.66	24101
F/G-09	650.00	1300.00	6442
Ti-08	250.00	500.00	209926
Ti-06	362.48	724.97	53341
Ti-05	453.10	906.21	39035
Ti-07	543.72	1087.45	14424
Ti-09	650.00	1300.00	6709
TMC-08	325.00	650.00	>5000000
TMC-05	595.79	1191.59	46934
TMC-04	744.76	1489.52	20955
TMC-06	893.72	1787.45	11117

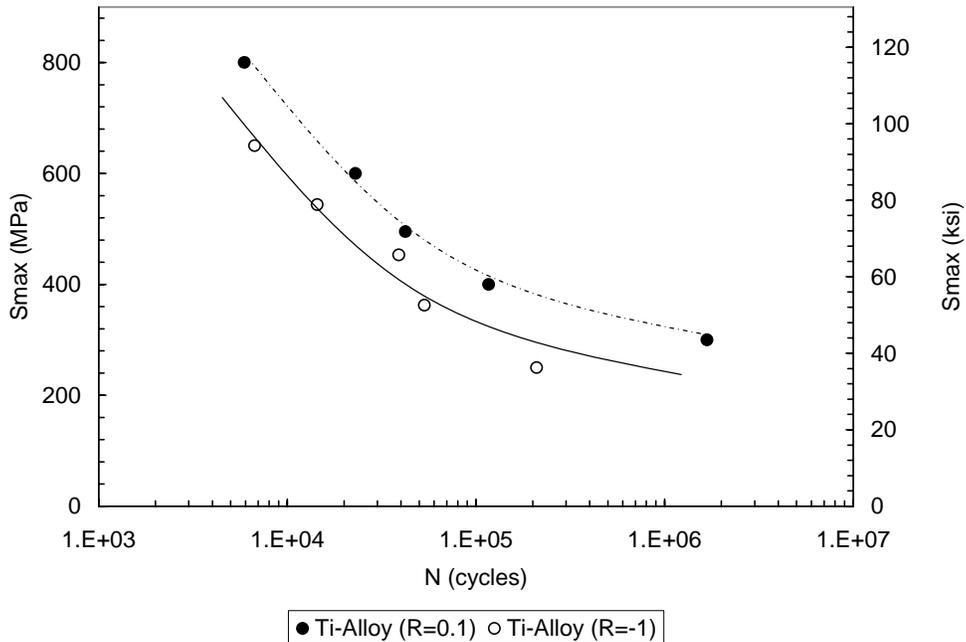
Figure 29: Titanium alloy TT and TC fatigue results (maximum stress comparison)

The fatigue life curve for the titanium alloy under tension-compression fatigue is shown in Figure 29. These results form the lower bound for the functionally-graded material under fully-reversed fatigue loading. As expected, when plotted on a maximum stress basis, the results show a shift in the fatigue life curve down and to the left when compared with the tension-tension results.

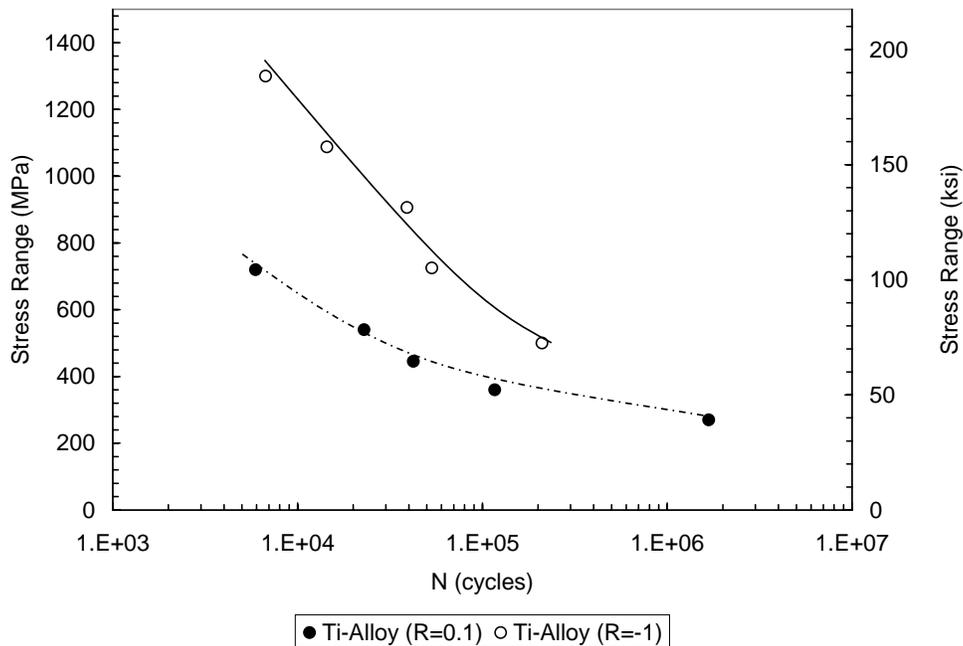
Figure 30: Titanium Alloy TT and TC fatigue results (stress range comparison)

However, when plotted on a stress range basis, a different phenomenon occurs (see Figure 30). The tension-compression fatigue lives are much longer than the tension-tension fatigue lives when plotted on a stress range basis. This would conclude that, while additional damage does occur during the compressive loading portion (representing half of the load range in the tension-compression case), it is not as detrimental to the fatigue life as a load range made up of tensile loads equal to twice the compressive range value.

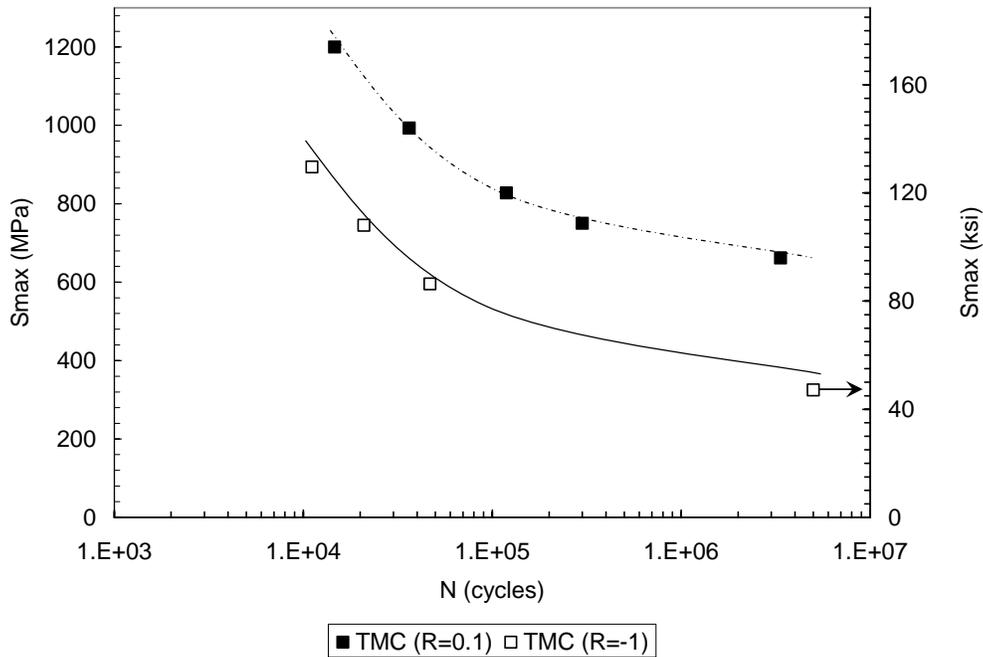
Figure 31: TMC TT and TC fatigue results (maximum stress comparison)

The fatigue life curve for the composite under tension-compression fatigue is compared to the results from the tension-tension case on a maximum stress basis in Figure 31. This data forms the upper bound for the functionally-graded material under fully-reversed fatigue loading.

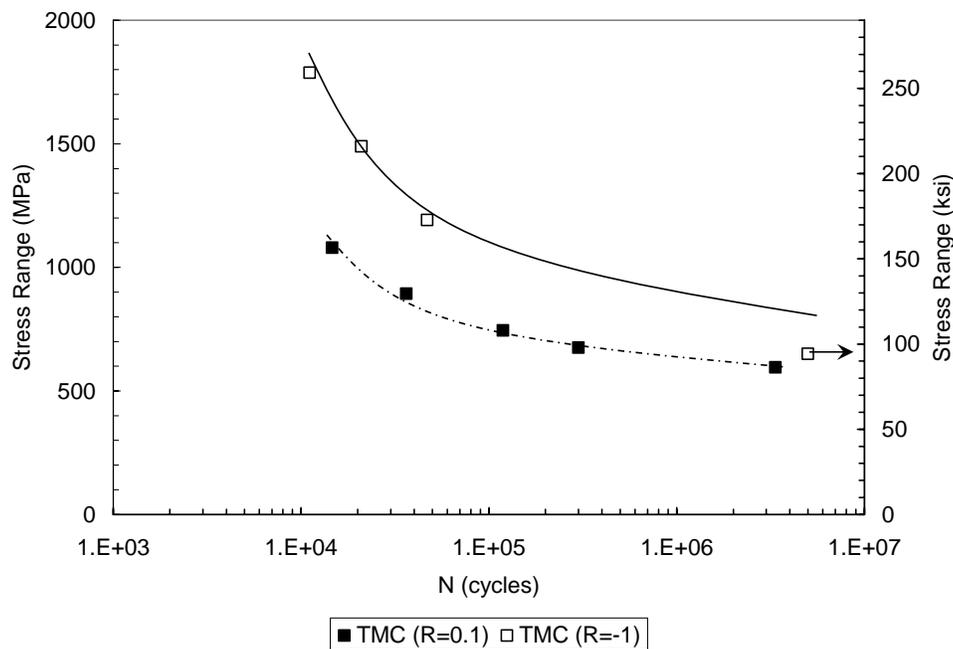
Figure 32: TMC TT and TC fatigue results (stress range comparison)

The fatigue lives for the tension-compression fatigue case are plotted on a stress range basis in Figure 32. As before, the tension-compression fatigue lives are much longer than the fatigue lives of the tension-tension case.

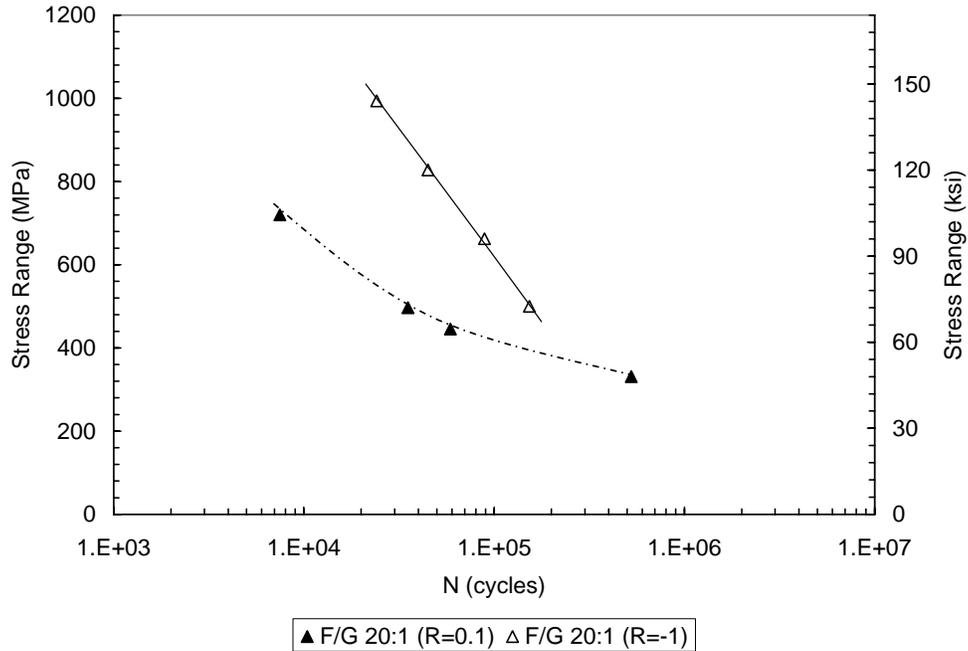
Figure 34: F/G TMC (20:1) TT and TC fatigue results (stress range comparison)

The results are plotted on a stress range basis in Figure 34. Again, the fatigue lives for the tension-compression case are longer than the fatigue lives for the tension-tension case. These results support the observation that the tensile mean stresses present in tension-tension fatigue are detrimental to the fatigue life of the material, while the compressive loading portion is actually beneficial.

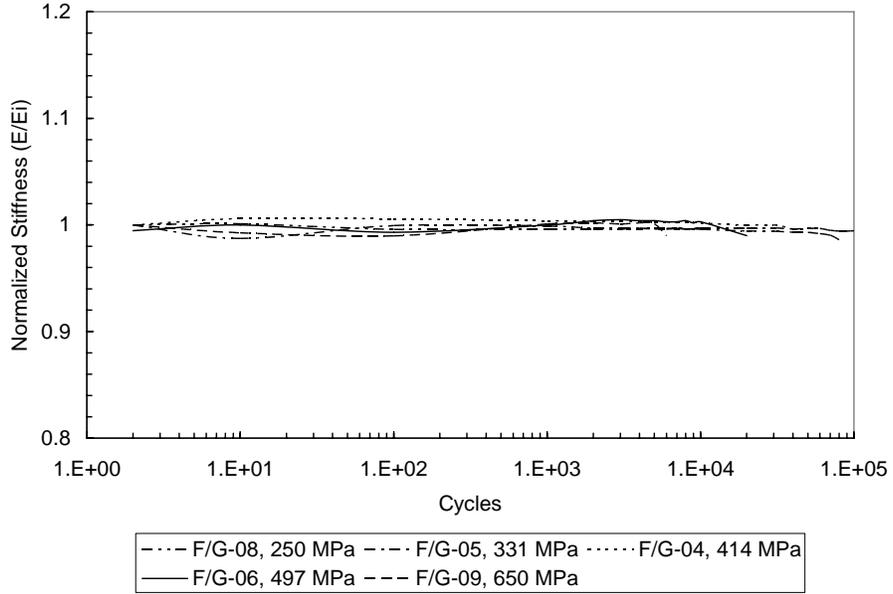
Figure 35: Tension-compression: normalized stiffness vs. fatigue cycles

Again, normalized stiffness and percent strain histories are plotted below for the functionally-graded material. Figure 35 and Figure 36 show plots of the normalized stiffness versus cycle number and normalized fatigue life, while Figure 37 and Figure 38 show plots of the percent strains versus cycle number and normalized fatigue life.

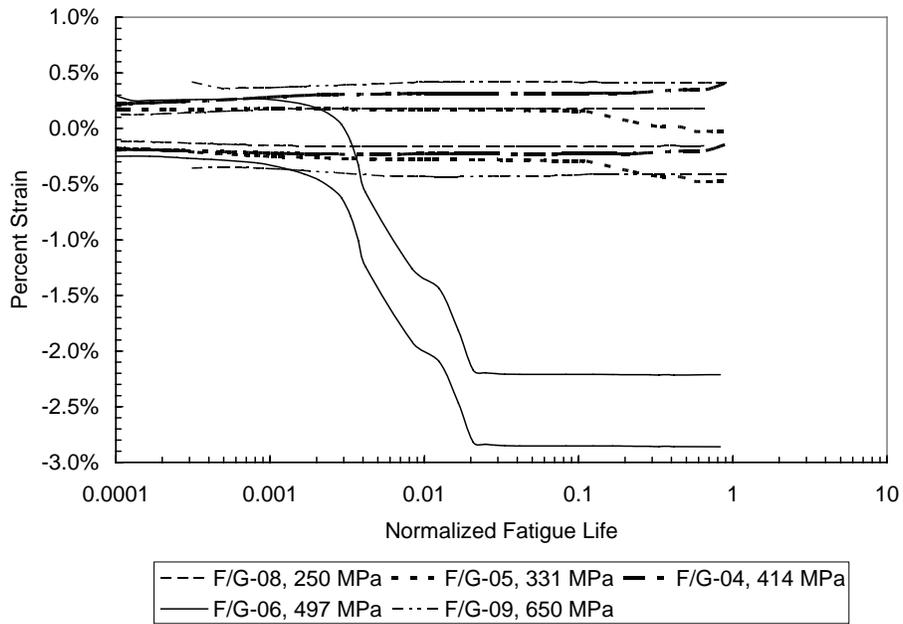
Figure 38: Tension-compression: percent strain vs. normalized fatigue life

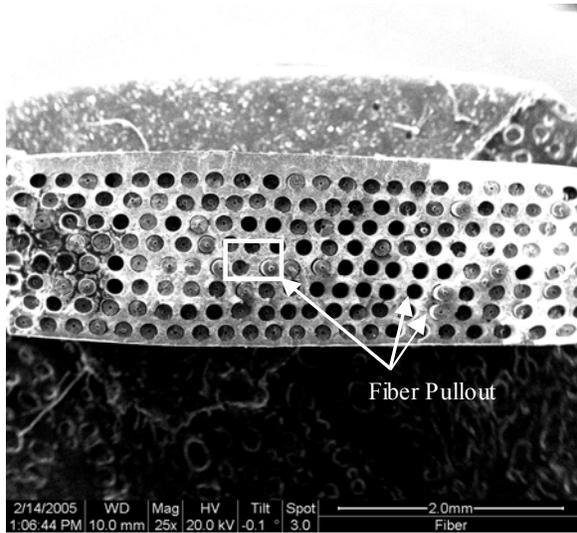
Figure 41: Specimen TMC-001, fracture surface from tensile test

The fracture surface for the composite showed evidence of fiber fracture and fiber pullout (see Figure 41). In order for failure to occur in a unidirectional composite where loading is in a direction parallel to the fibers, all fibers across the cross section must fracture [4:293-305]. The relative contributions of plasticity and damage can be seen in Figure 42. As discussed earlier, pores in the matrix material are prone to form voids representative of a plasticity failure mechanism. As the matrix fails, the load is then transferred to the fibers that ultimately fail either by fiber cracking, debonding or pullout, all of which are representative of damage.

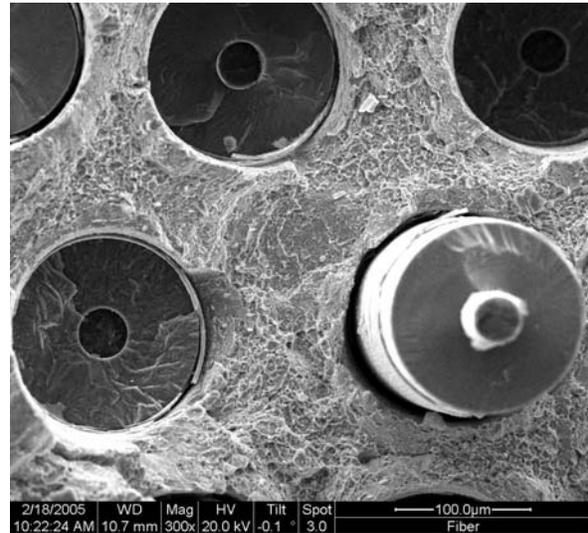
Figure 42: Specimen TMC-001, close-up showing fiber pullout & matrix ductility

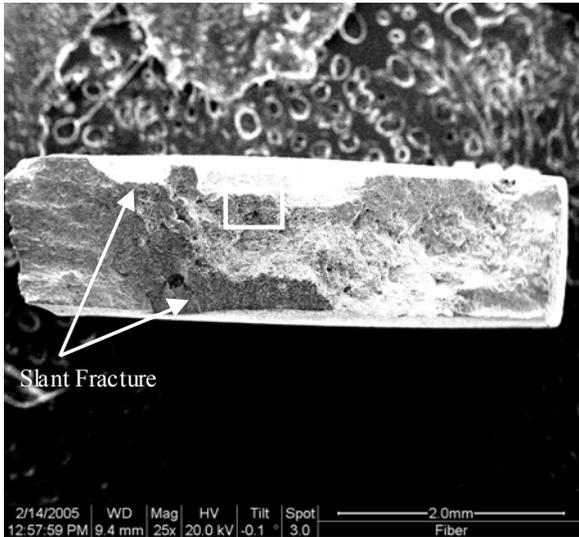
Figure 43: Specimen F/G-001, fracture surface from tensile test

The fracture surface of the functionally-graded material is shown in Figure 43. Since failure occurred in the alloy section, the mechanisms associated with the failure are similar to those discussed for the pure alloy specimen. This time the slant fracture can be seen on both sides of the specimen, indicating initial failure near the center. Again, the rough dimpled surface representative of ductile failure can be seen (see Figure 44).

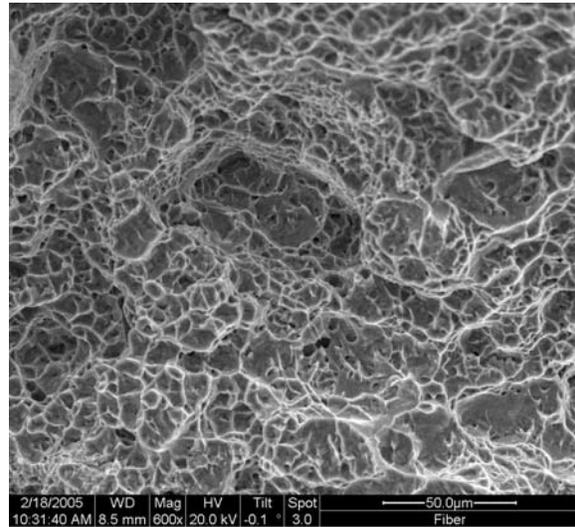
Figure 44: Specimen F/G-001, ductile void coalescence

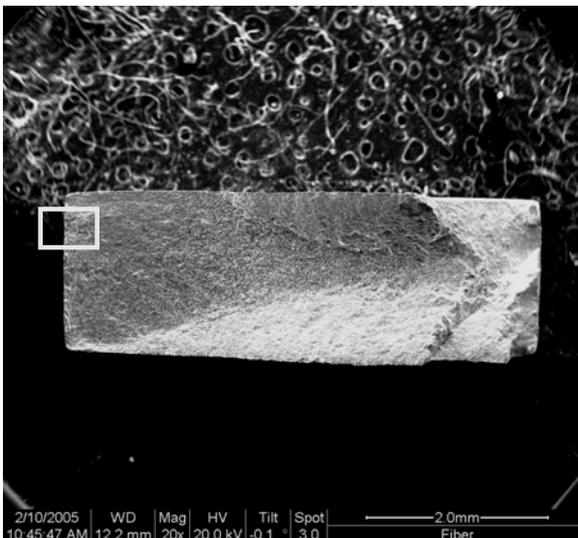
Figure 46: Specimen Ti-03, overall view of fracture surface

Regardless of this fact, the alloy specimens all had similar failure characteristics. From the overall view of the fracture surface, the transition from the fatigue crack propagation region and the final overload region could be distinguished and the point of crack initiation could be narrowed down to the flat, brittle crack face away from the more ductile, overload region (see Figure 46). Upon closer examination of this area, the crack initiation site seemed to be the edge of the specimen where stress raisers are present (see Figure 47).

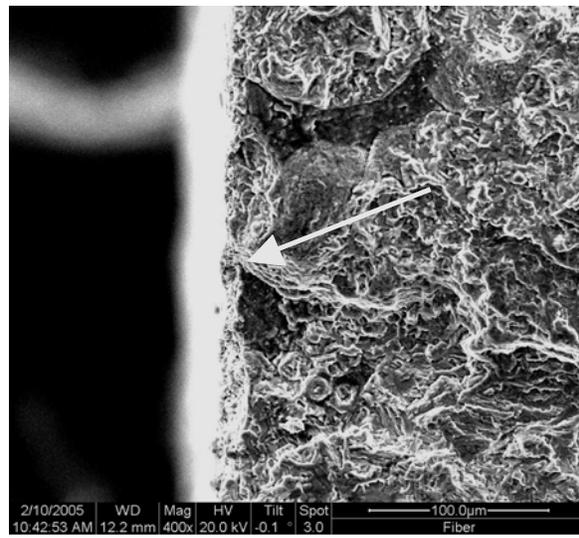
Figure 47: Specimen Ti-03, close-up of crack initiation site

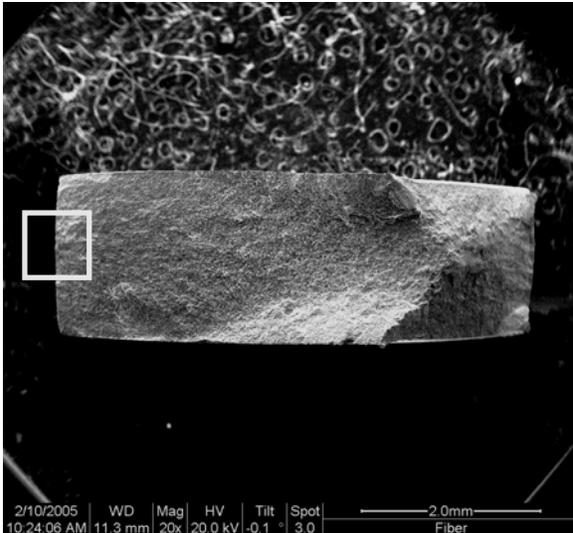
Figure 48: Specimen Ti-01, overall view of fracture surface

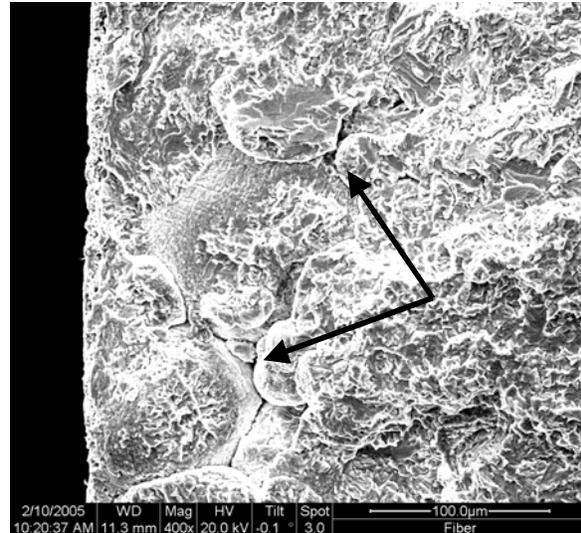
Figure 49: Specimen Ti-01, close-up view of residual pores

examination of the crack center revealed the residual pores in the material (see Figure 49). As mentioned before, all of the alloy specimens that failed under tension-tension fatigue loading exhibited similar characteristics in the failure region. More examples of these types of failures can be found in the appendix.

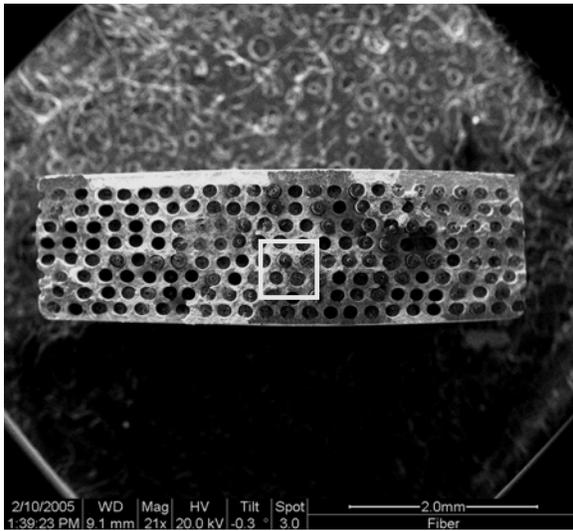
Figure 51: Specimen TMC-10, overall view of fracture surface

When looking at the fracture surface, fiber failure and pullout appear to dominate as damage mechanisms (see Figure 51). At this high stress level, the transition from Region II to Region I on the S-N curve becomes apparent. Upon closer examination of the fracture surface, evidence of ductile void coalescence and necking is observed (see Figure 52).

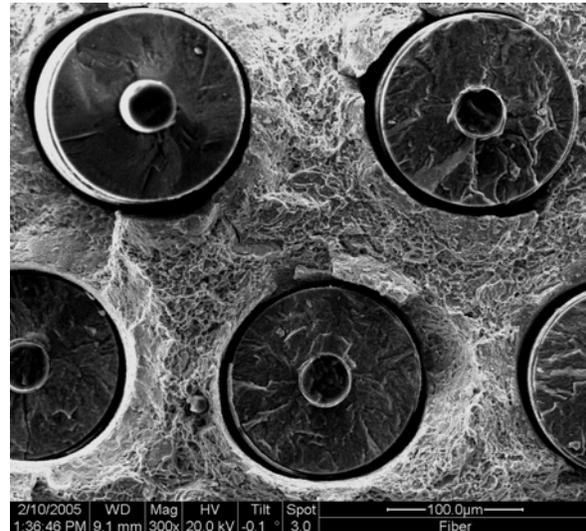
Figure 52: Specimen TMC-10, ductile void coalescence and necking

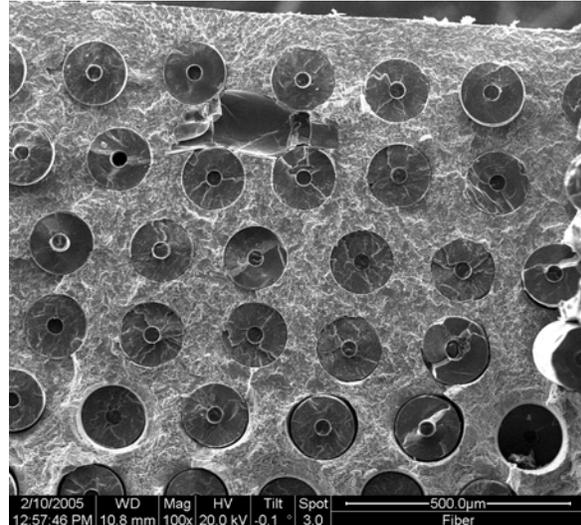
Figure 54: Specimen TMC-03, close-up view of fracture surface

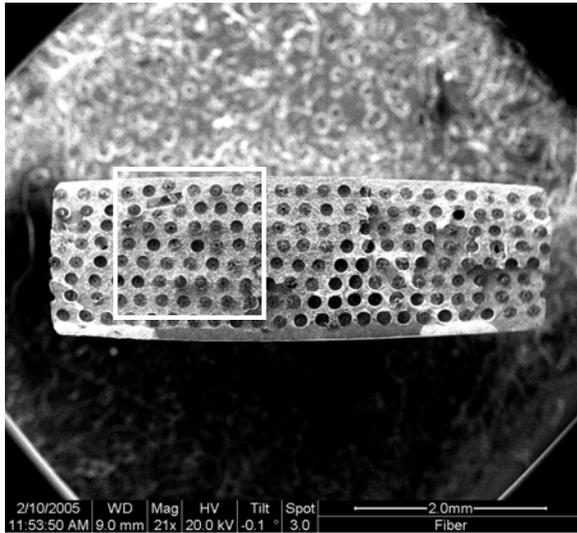
Figure 55: Specimen TMC-01, overall view of fracture surface

As the stress level lowers, less fiber failure and more matrix cracking can be seen (see Figure 55). Upon closer examination of the fracture surface, another fiber shard is observed (see Figure 56). The fiber shard can act as a crack initiator and is usually a sign of poor manufacturing processes. Nevertheless, the results found for this specimen place it also in Region II of the S-N curve.

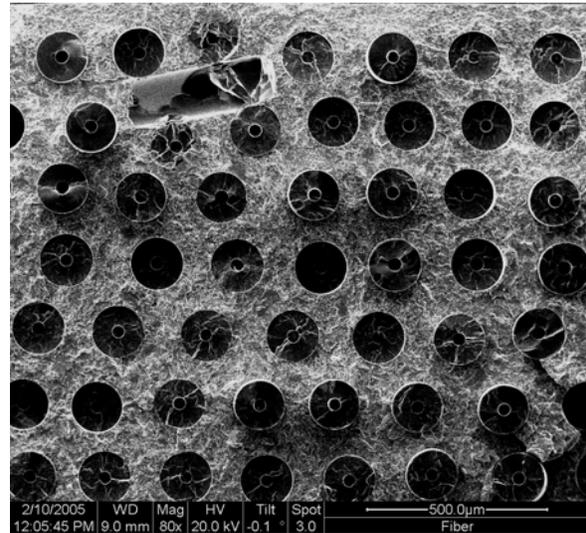
Figure 56: Specimen TMC-01, close-up view of fracture surface

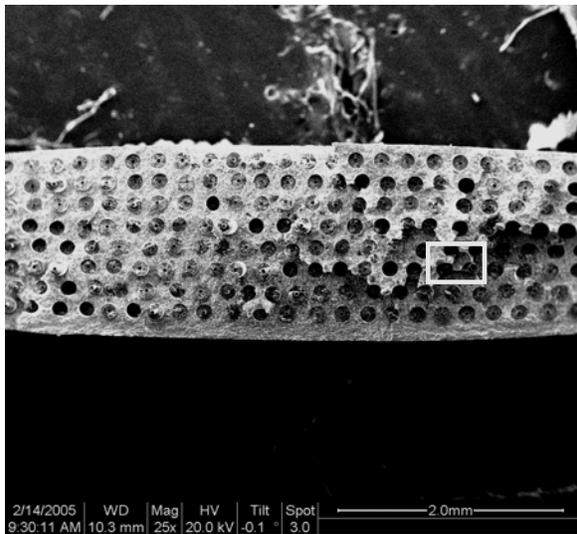
Figure 57: Specimen TMC-11, overall view of fracture surface

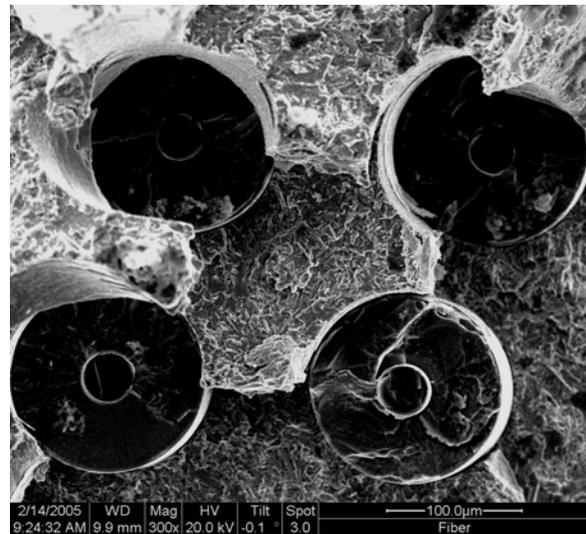
Figure 58: Specimen TMC-11, multiple crack fronts

Again, matrix plasticity as well as some fiber failure can be seen (see Figure 58).

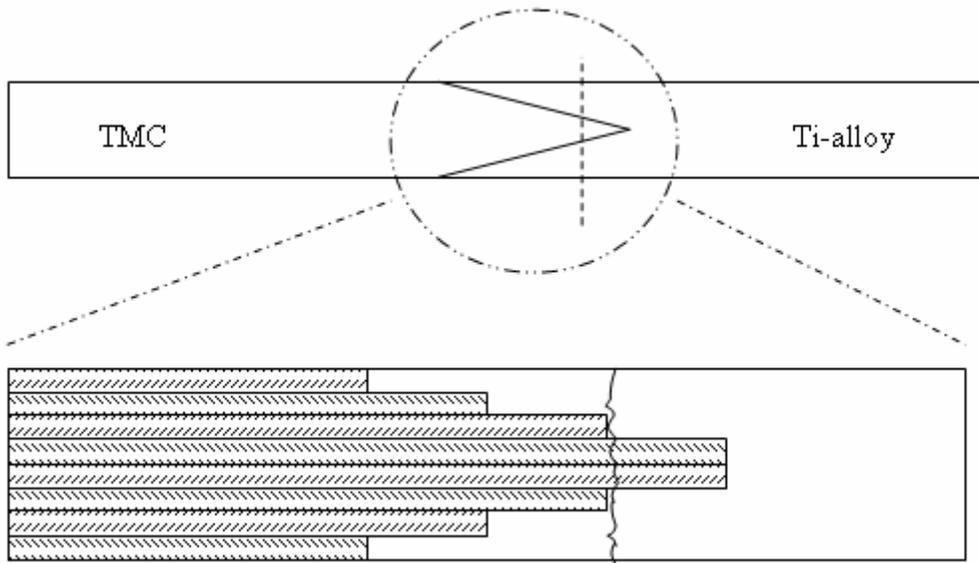
Figure 60: Schematic of failure locations in F/G taper region

While the two specimens that failed in the alloy region simply showed similar microscopic results as the pure alloy specimens mentioned above, the failures in the taper region showed more interesting results as they both failed in the same region of the taper (see Figure 60). A brief discussion of each failure is provided below.

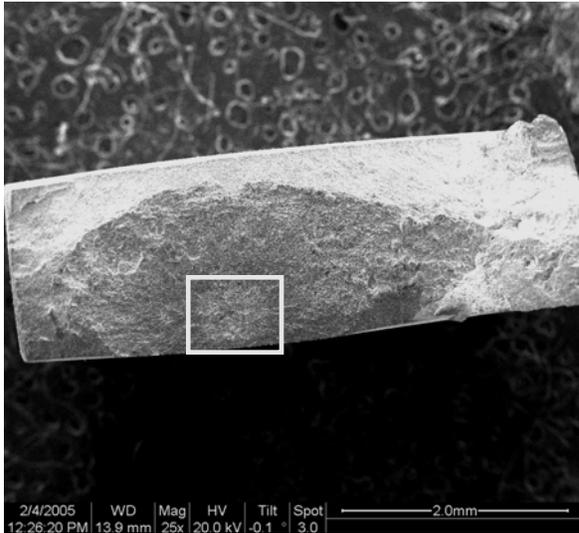
Figure 61: Specimen F/G-10, overall view of fracture surface

Specimen F/G-10: 800 MPa. This highest stress level test failed after only 7,470 cycles and failed in the alloy section of the specimen. Examination of the sectioned specimen revealed similar findings as the pure alloy specimens. The final overload fracture associated with stage III crack propagation is clearly seen (see Figure 61). Following away from this area, the striations associated with stage II crack propagation lead to the point of crack initiation (see Figure 62). The matrix flaw at the crack initiation site is similar to those found in the pure alloy specimens. This is as expected since failure in the alloy region only serves to provide information about the alloy section itself.

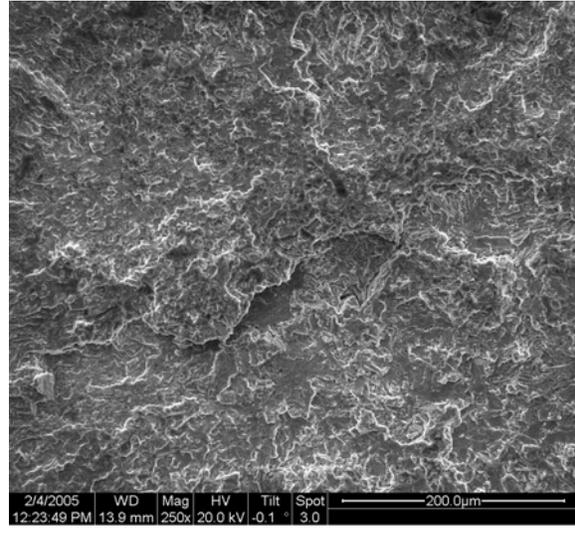
Figure 62: Specimen F/G-10, close-up view of matrix flow

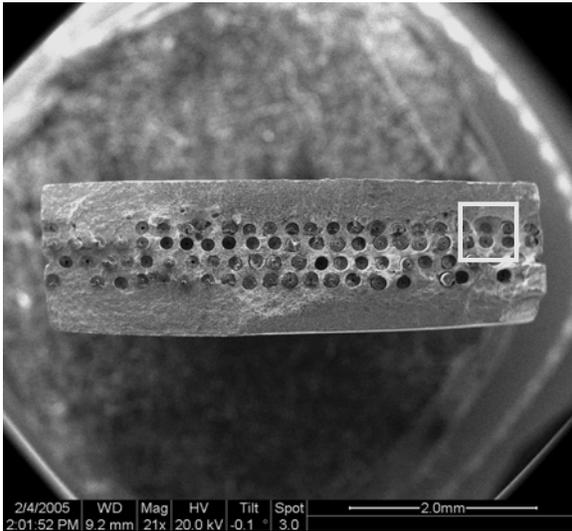
Figure 64: Specimen F/G-03, fracture surface (looking toward composite side)

to the next step. The existence of four plies is readily seen (see Figure 64). Looking toward the pure composite end of the specimen, it is apparent that the areas of “missing fibers” along the upper and lower plies represent the higher “peaks” of the fracture surface. Upon closer examination, it was determined that the fiber ends were the points of crack initiation as deposits of the matrix material still existed on some of the fibers (see Figure 65). In this figure, the upper two fibers both show smooth textures characteristic of a fiber end, while the lower two fibers both show signs of fracture by their rough textures.

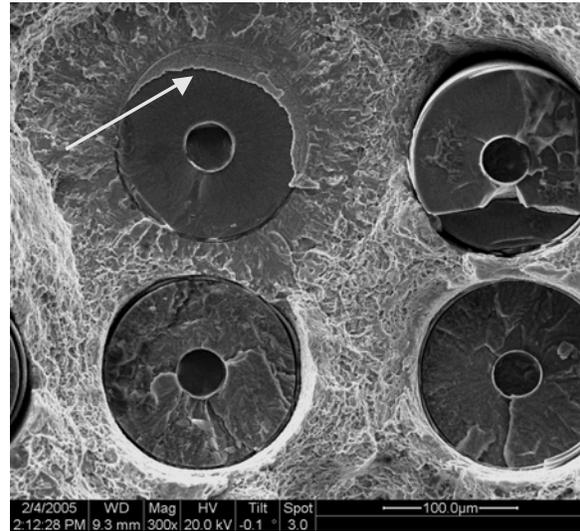
Figure 65: Specimen F/G-03, matrix material on smooth fiber end

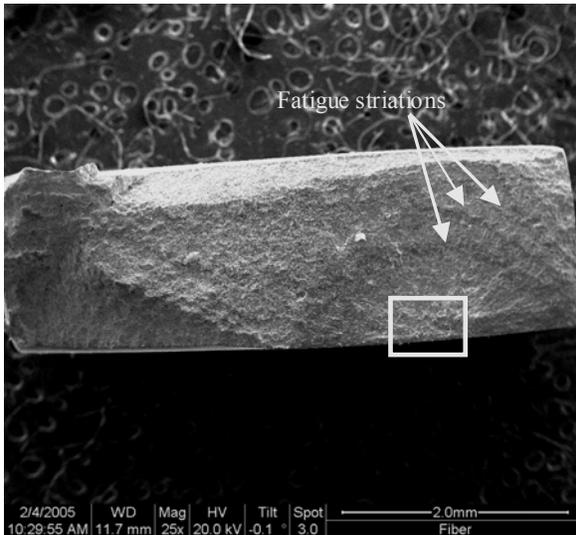
Figure 66: Specimen F/G-01, overall view of fracture surface

Specimen F/G-01: 495 MPa. This specimen failed after 58,872 cycles and failure occurred in the alloy region. Examination of the sectioned specimen revealed residual pores as the cause of crack initiation (see Figure 66 and Figure 67). Just as in the pure alloy specimens, the residual pores become centers for crack initiation. Again, failures in the alloy region will exhibit characteristics similar to the pure alloy specimens.

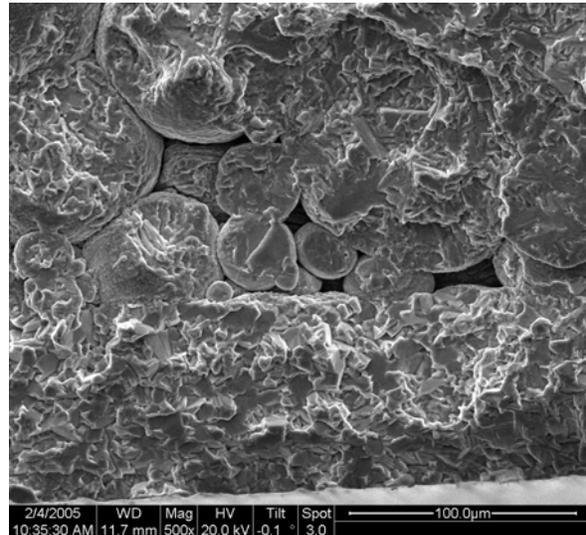
Figure 67: Specimen F/G-01, close-up view of residual pores

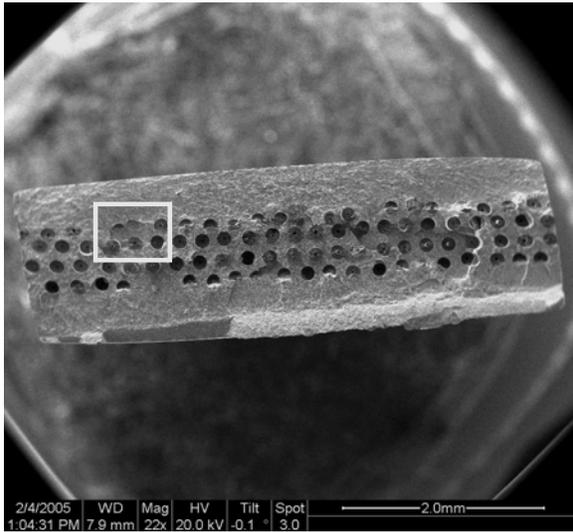
Figure 69: Specimen F/G-02, fracture surface (looking toward composite side)

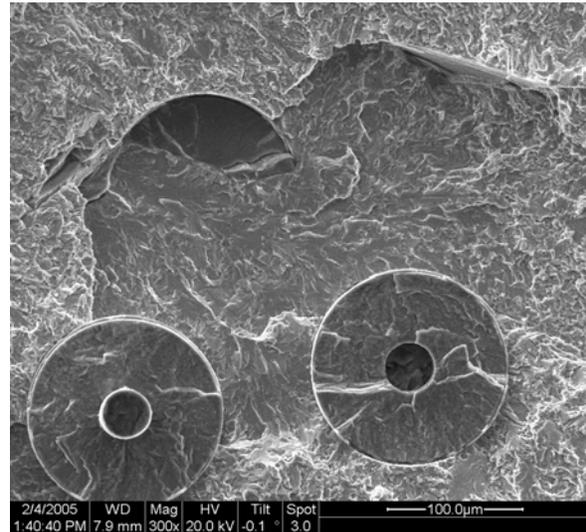
Figure 70: Specimen F/G-02, matrix material on fiber end

these areas showed deposits of the matrix material on some of the fibers (see Figure 70). The lower two fractured fibers can again be distinguished by their rough appearance, while over half of the upper fiber is covered by matrix material.

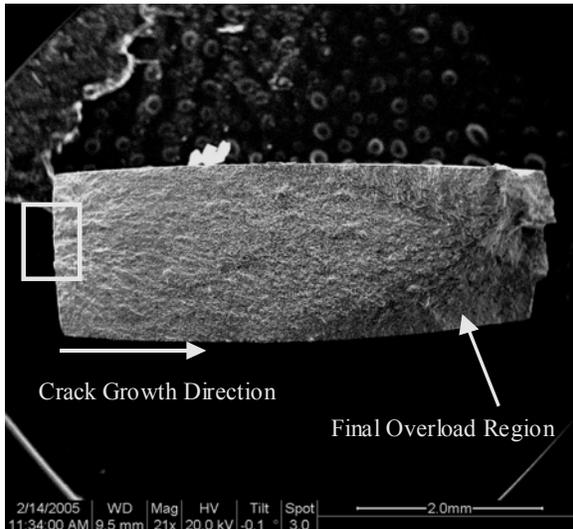
Figure 72: Specimen Ti-08, overall view of fracture surface

As before in the tension-tension case, the alloy specimens all had similar failure characteristics. The transition from the fatigue crack propagation region and the final overload region could again be distinguished from the overall view and the point of crack initiation could be found (see Figure 72). Just as in the tension-tension case, the crack initiation site seemed to be the edge of the specimen where stress raisers are present (see Figure 73).

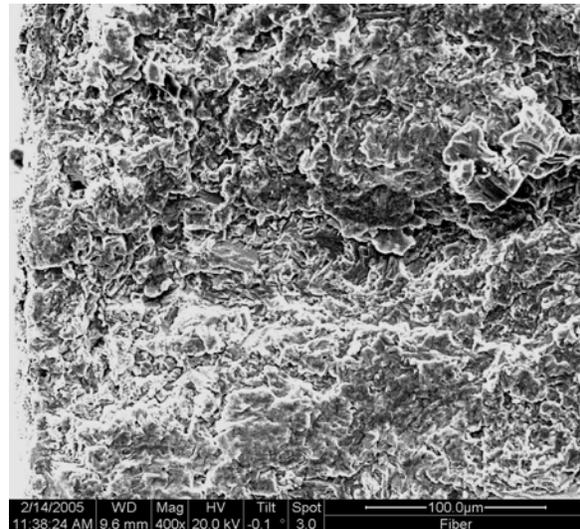
Figure 73: Specimen Ti-08, close-up of crack initiation site

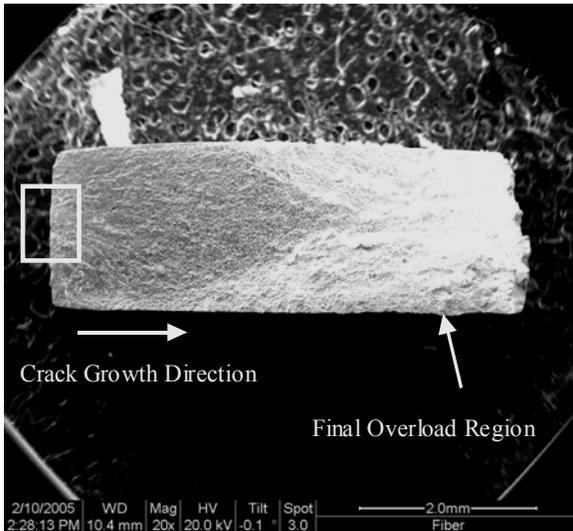
Figure 74: Specimen Ti-06, overall view of fracture surface

Notice also the shortening of the fatigue crack propagation region and the respective lengthening of the final overload region when the stress level is increased. Even with this relatively small increase in stress level, the difference is clearly seen. Although residual pores can be observed as crack initiators, none of the specimens tested in tension-compression showed this phenomenon. Instead, all failures seemed to occur at stress raisers at the edge of the specimens. More examples of these types of failures can be viewed in the appendix.

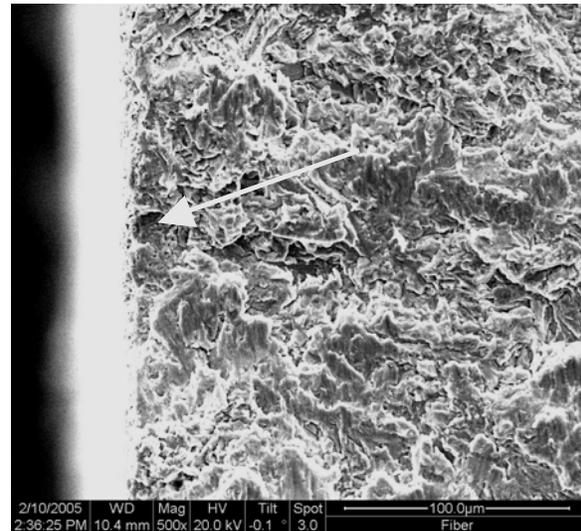
Figure 75: Specimen Ti-06, close-up view of crack initiation site
