Fatigue Behavior of a Functionally-Graded Titanium Matrix Composite

**FATIGUE BEHAVIOR OF A FUNCTIONALLY-GRADED TITANIUM MATRIX
COMPOSITE**

THESIS

AFIT/GAE/ENY/05-M06

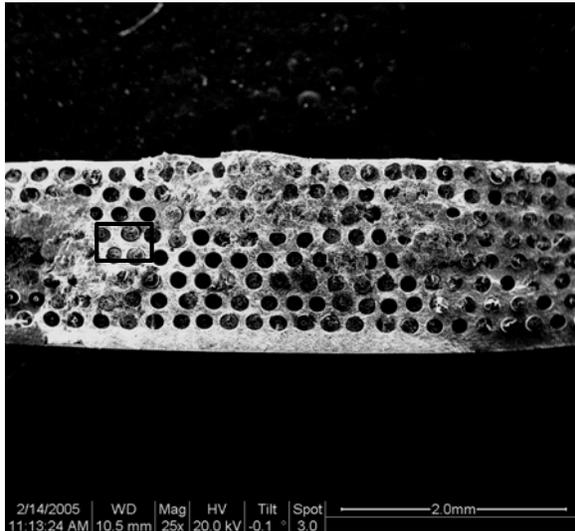
Figure 77: Specimen TMC-06, overall view of fracture surface

At this highest stress level, it is no surprise that fiber failure was the dominating mechanism (see Figure 77). Upon closer investigation of the fracture surface, evidence of ductile void coalescence and necking were observed (see Figure 77).

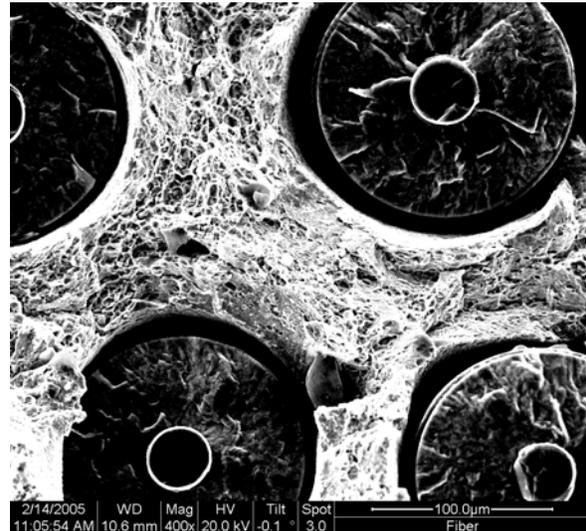
Figure 78: Specimen TMC-06, ductile void coalescence and necking

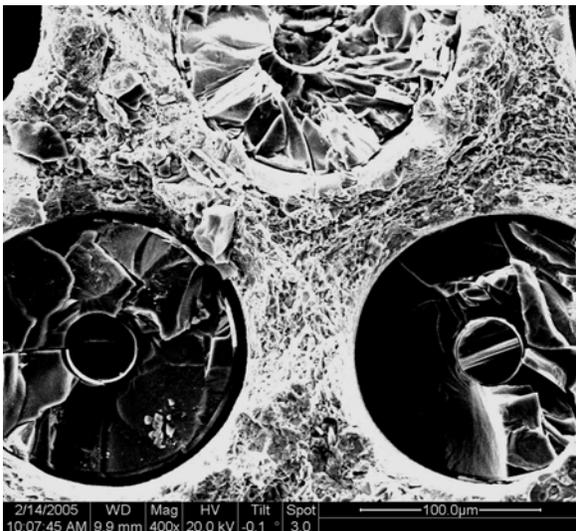
Figure 80: Specimen TMC-04, 1: catastrophic fiber failure

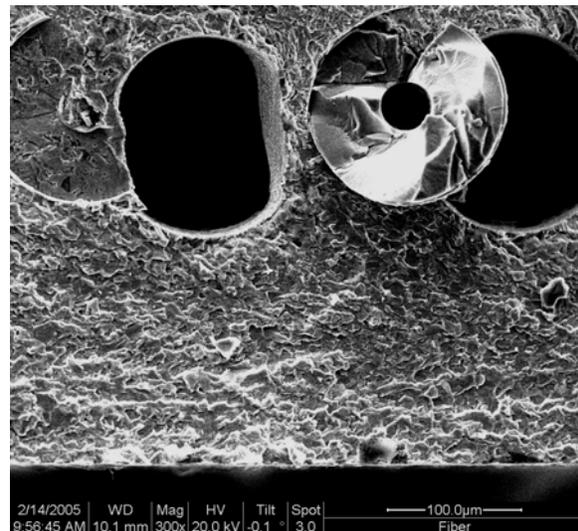
Figure 81: Specimen TMC-04, 2: fiber failure and compression damage

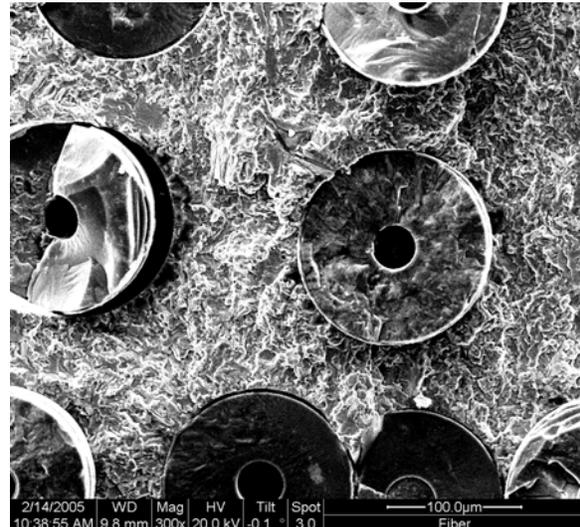
Figure 83: Specimen TMC-05, mixed mode failure

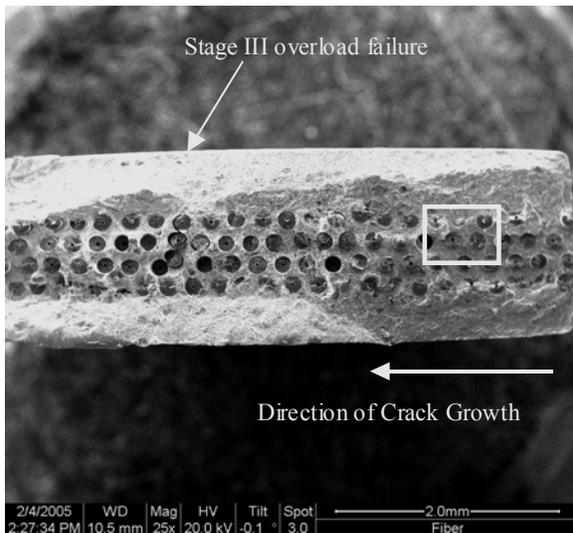
Figure 86: Specimen F/G-09, fracture surface (looking toward composite side)

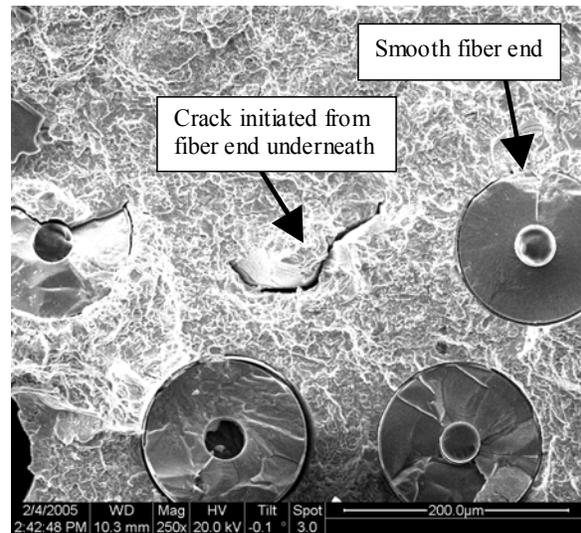
Figure 87: Specimen F/G-09, close-up showing crack originating from fiber end

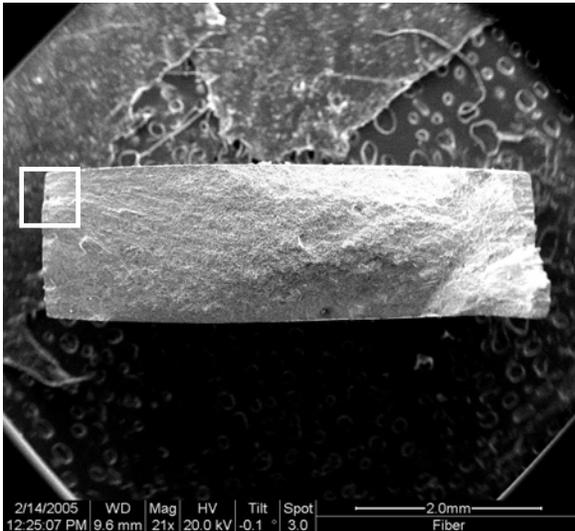
Figure 92: Specimen F/G-04, overall view of fracture surface

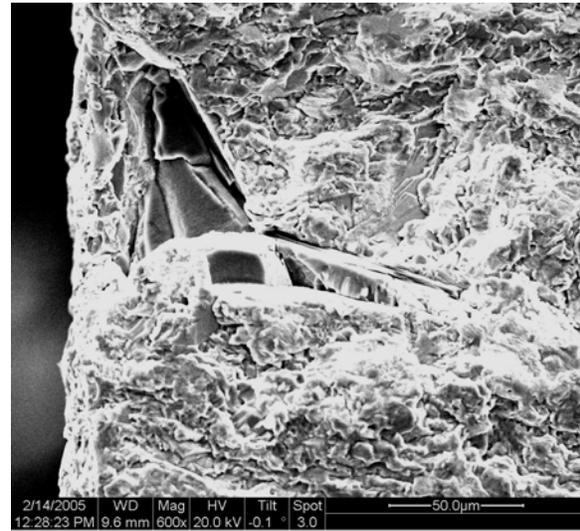
Figure 93: Specimen F/G-04, close-up showing matrix flaw

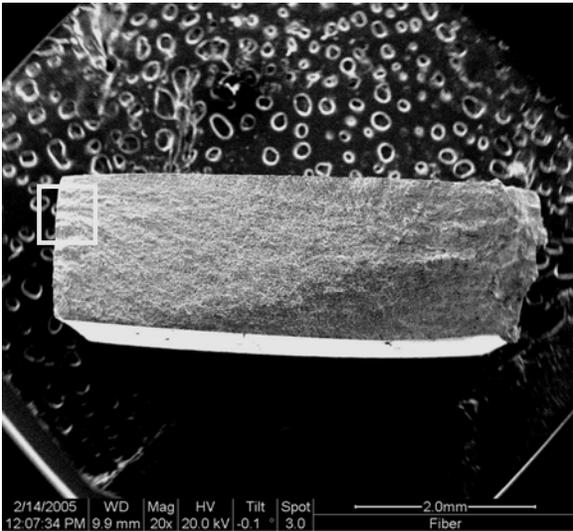
Figure 94: Specimen F/G-05, overall view of fracture surface

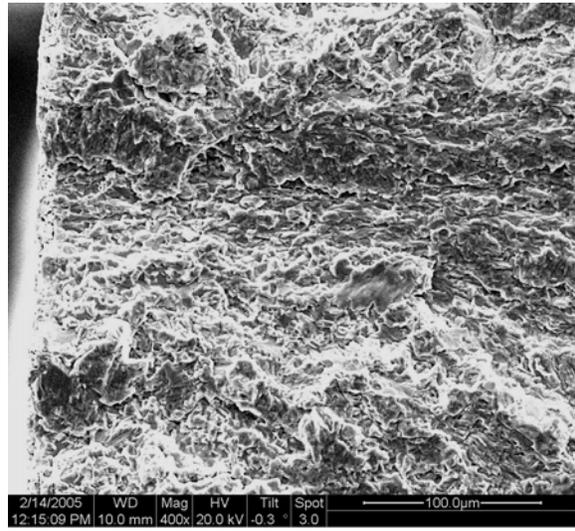
Figure 95: Specimen F/G-05, closeup of crack initiation site

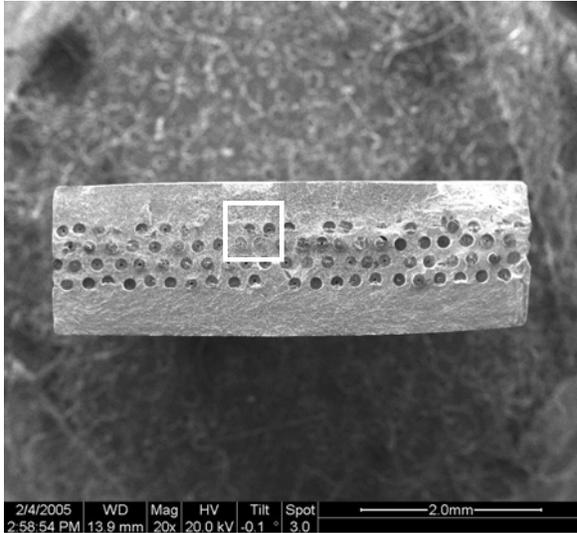
Figure 97: Specimen F/G-08, fracture surface (looking toward alloy side)

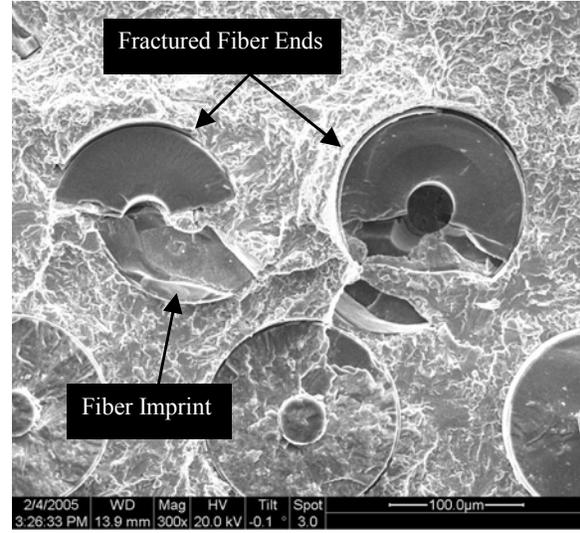
Figure 98: Specimen F/G-08, fractured fiber ends

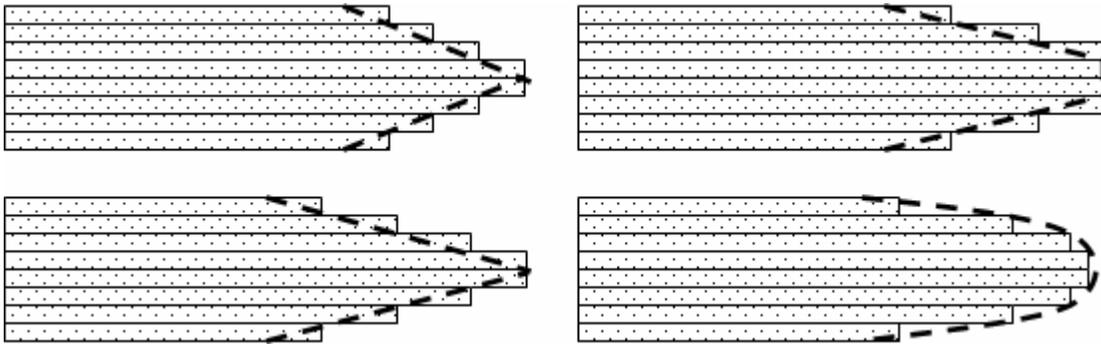
Figure 99: Sample ply lay-ups for taper region

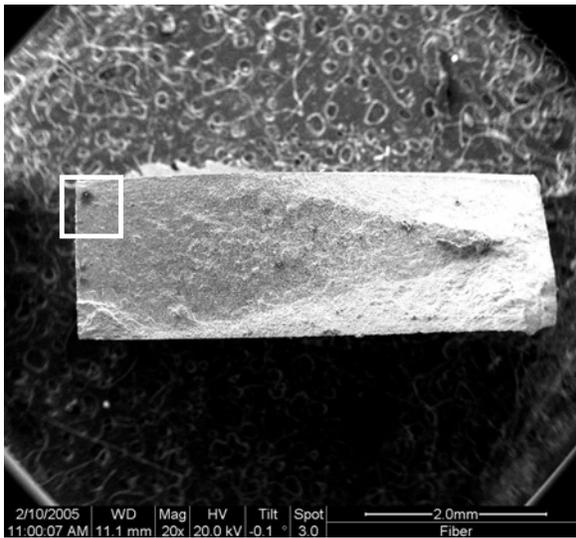
Figure 105: Specimen Ti-04, overall view of fracture surface

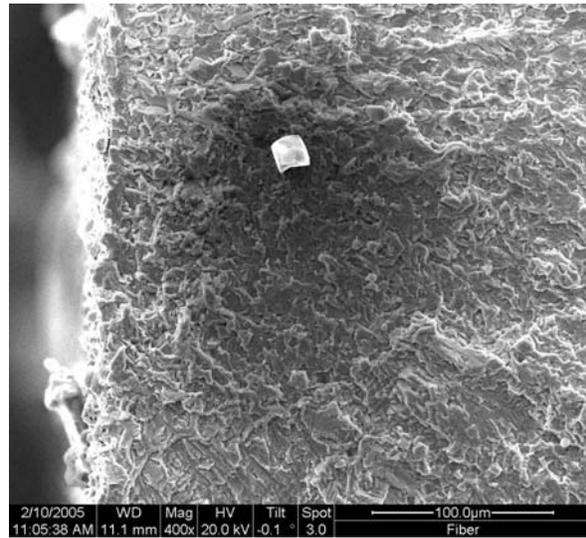
Figure 106: Specimen Ti-04, close-up view of void

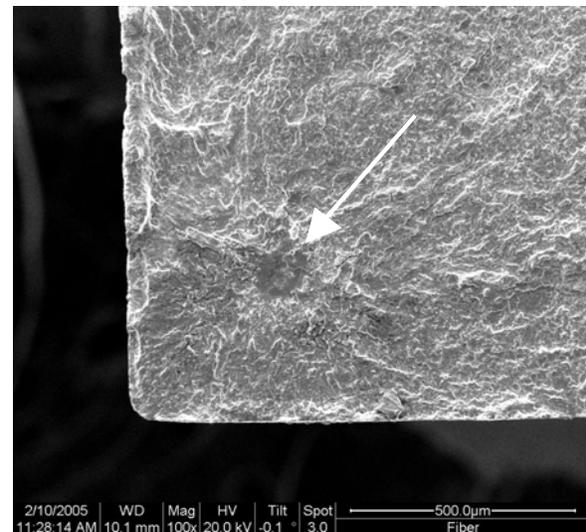
Figure 108: Specimen Ti-10, close-up of crack initiation site

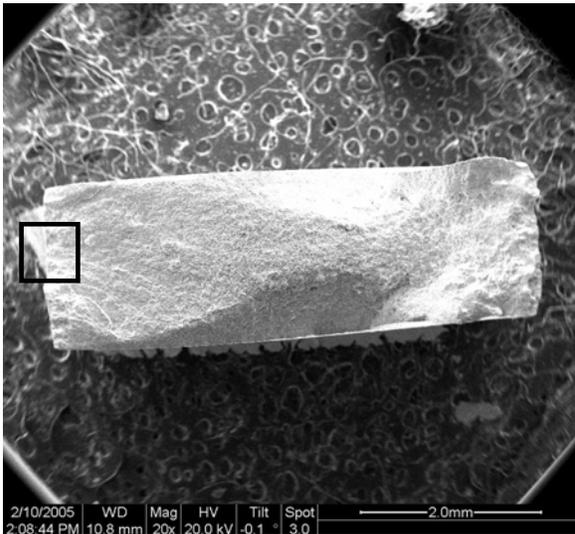
Figure 109: Specimen Ti-05, overall view of fracture surface

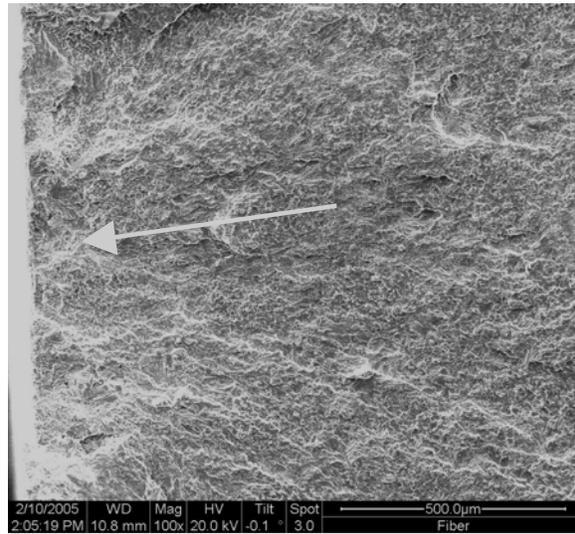
Figure 110: Specimen Ti-05, close-up view of crack initiation site

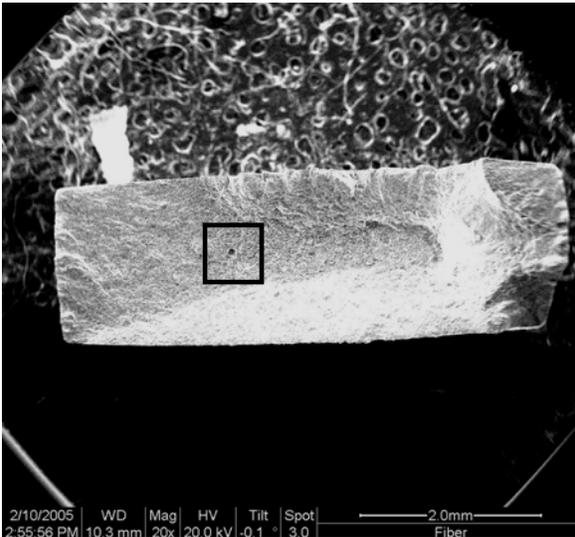
Figure 111: Specimen Ti-07, overall view of fracture surface

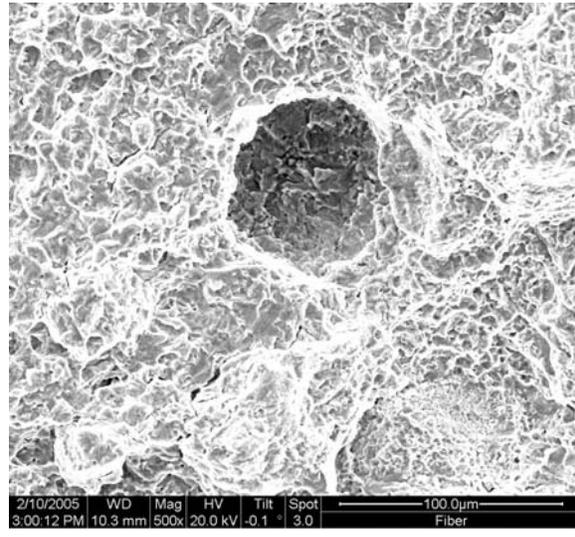
Figure 112: Specimen Ti-07, close-up of void in crack path

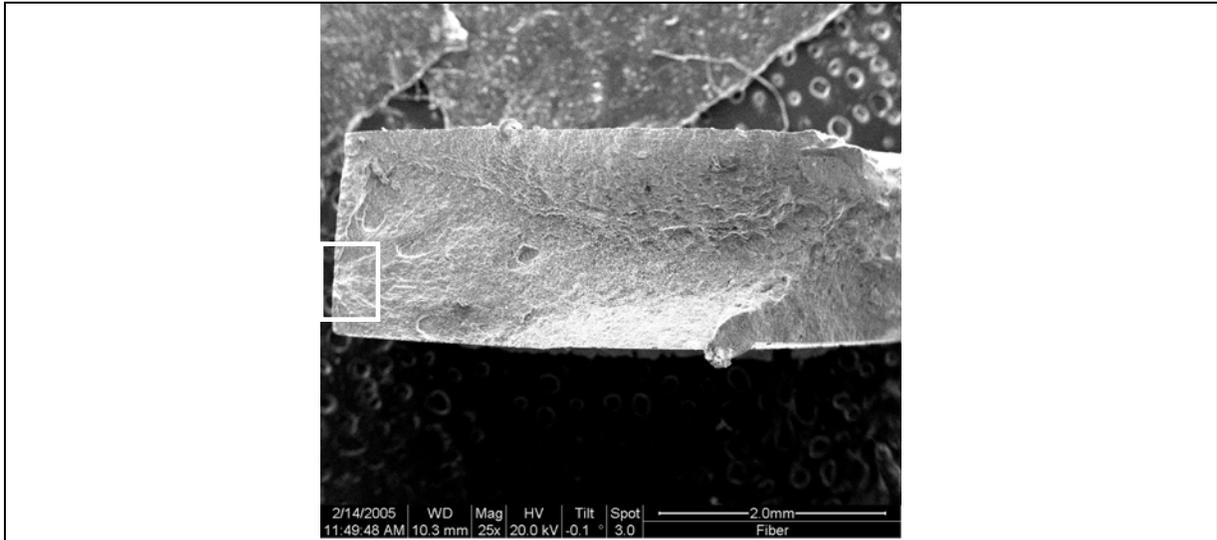
Figure 113: Specimen Ti-09, overall view of fracture surface

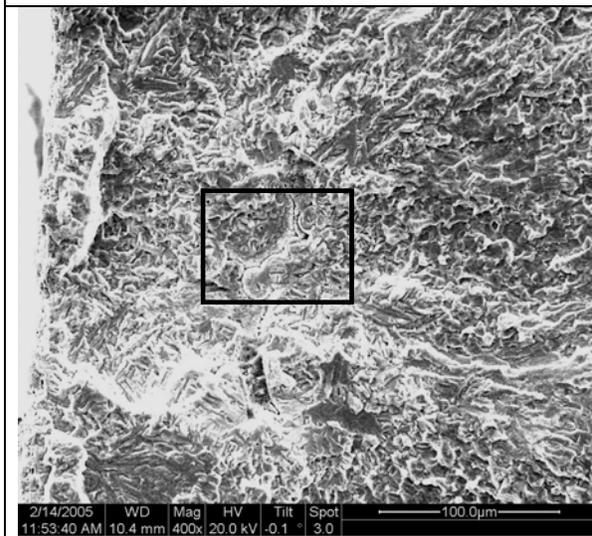
Figure 114: Specimen Ti-09, close-up of crack initiation site

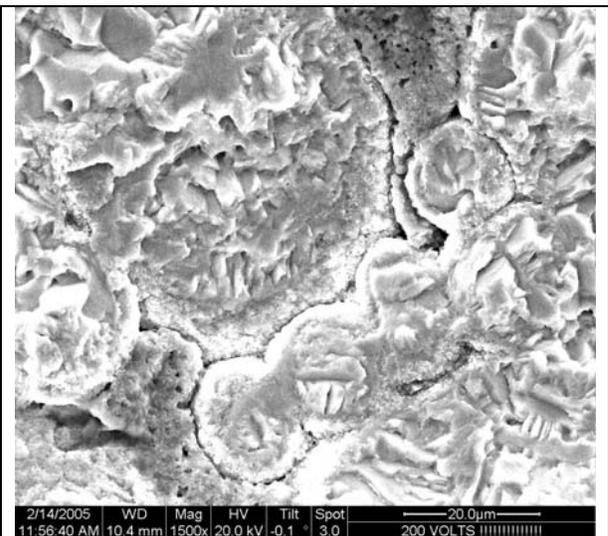
Figure 115: Specimen Ti-09, slip plane
