Tension-tension Fatigue Behavior of Nextel™ 720/Alumina-mullite Ceramic Composite at 1200°C in Air and in Steam

THESIS

AFIT-ENY-MS-20-J-078

AIR FORCE INSTITUTE OF TECHNOLOGY

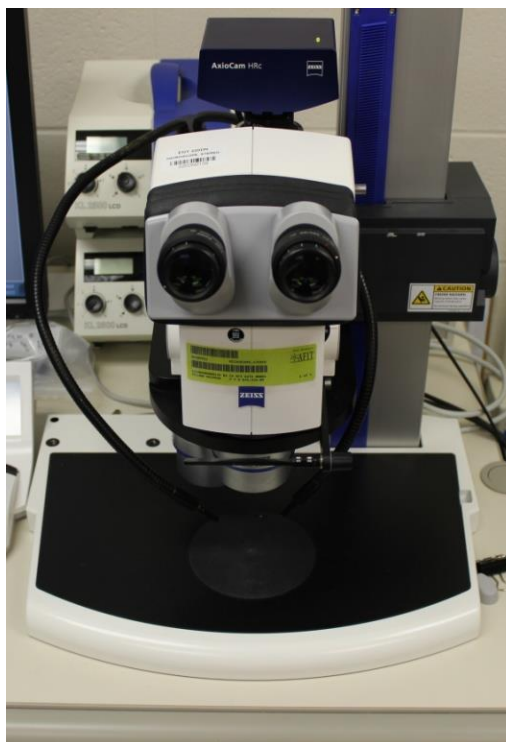
Figure 15. Zeiss Discovery V12 optical microscope equipped with an AxioCam HRc digital camera
