Air Force Institute of Technology

AFIT Scholar

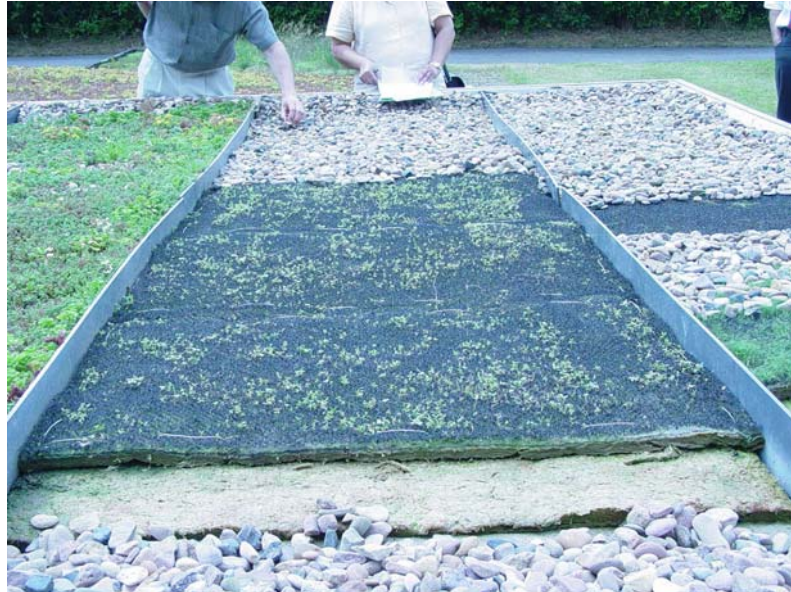
Figure 2.6 Soil-less plants. Xeroflor's seed-impregnated mats. Plastic mesh covers seed impregnated mats; pebbles cover others; pre-grown mats grow without soil as well.

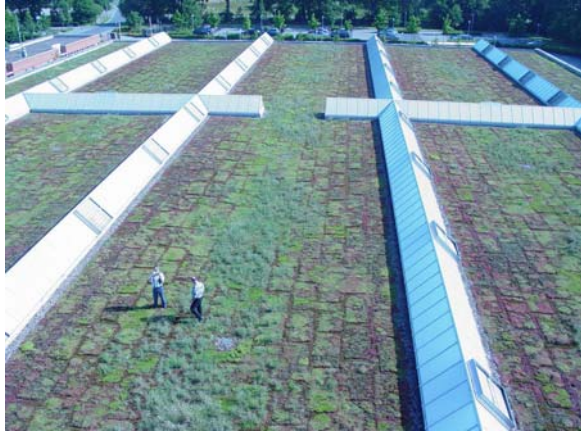
Figure 4.9 Oldenburg Bus Station. Atypical roof. Vegetated mats made with coconut fibers that later shrunk leaving gaps between the mats. Gaps filled in with mosses.

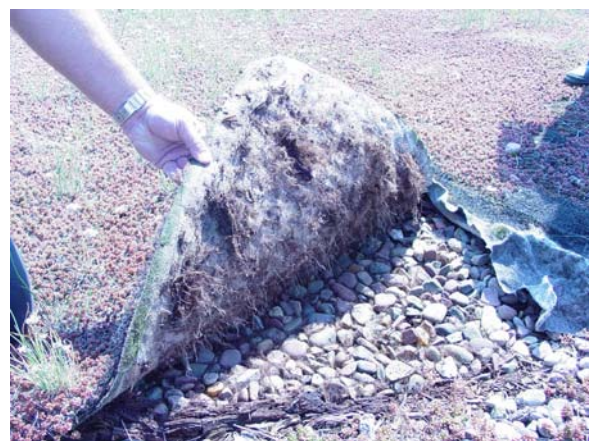
Figure 4.20 Building 3. Only sedums remain on the portions of the roof with only gravel and no soil.

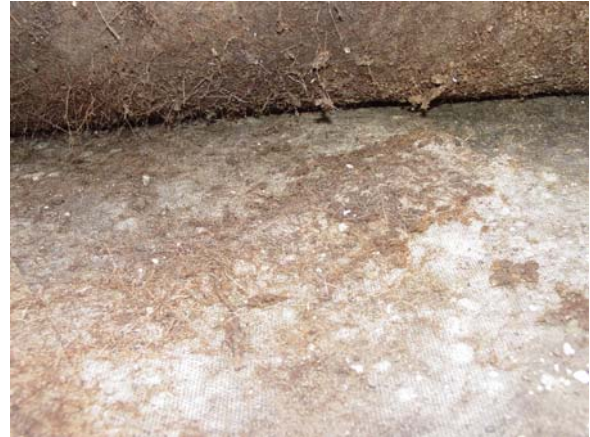
Figure 4.28 WIRO GmbH Roof. Slender sedum roots can be seen on the bottom of the vegetated mats and broken off on the Famogreen Ret membrane underneath the mats. Roots grow through the white fabric to reach the water retaining gel crystals below.

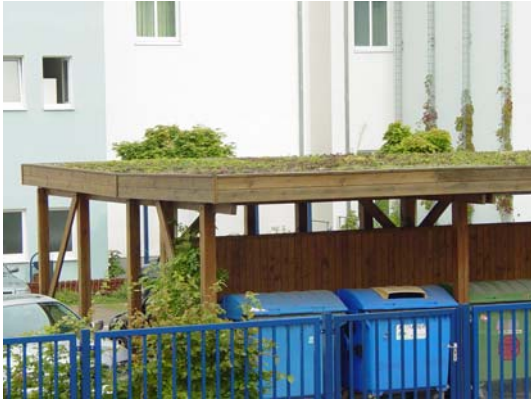
Figure 4.29 Green Roof Shed. Green roofs are installed on refuse sheds in Rostock, Germany to retain rainwater and reduce the “rain tax” Germans pay for storm water runoff. This roof is located a short distance from the WIRO roof.

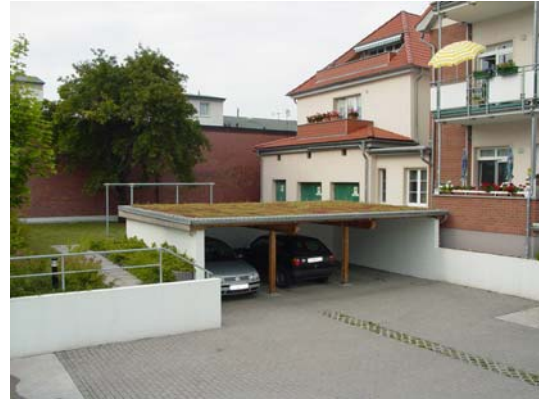
Figure 4.30 Green Roof Carport. Green roof over a carport – reducing storm water runoff.
