## Monotonic and Fatigue Loading Behavior of an Oxide/Oxide Ceramic Matrix Composite

THESIS

Steven G. Steel, Captain, USAF

AFIT/GMS/ENY/00M-02

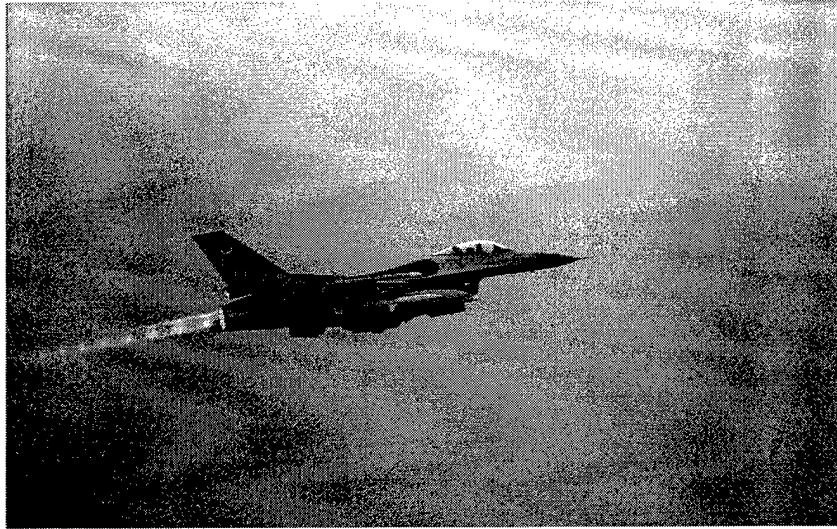
**Figure 2-3 F-16 with afterburner lit (28)**

The F110 afterburner consists of two main parts; the forward augmenter section and the trailing variable exhaust nozzle. The nozzle consists of 12 divergent flaps and 12 divergent seals, which actuate in unison to change the size of the exhaust opening. During extended afterburner lights, temperatures of the exhaust nozzle components can exceed 1000°C (29:2). Current nozzle flaps and seals are made of Rene' 41, a nickel based superalloy. The combination of high temperature and thermal cycling leads to creep deformation, which eventually results in warping and cracking. "At present a high percentage of the flaps and seals must be removed or repaired after only 1/3 of their

Zawada and Staehler of the Air Force Research Laboratory (AFRL) ground tested four different CMCs in an F110 engine at General Electric Aircraft Engines in Evandale, OH. The composite flaps accumulated up to 117 hours of engine time or 10% of design life (29:4). Two of the four CMCs showed no degradation while two showed evidence of cracks and wear. The two CMCs that performed best were selected for flight testing. Four flaps were mounted on an F-16 at Hill AFB, Utah and are currently accumulating flight hours.

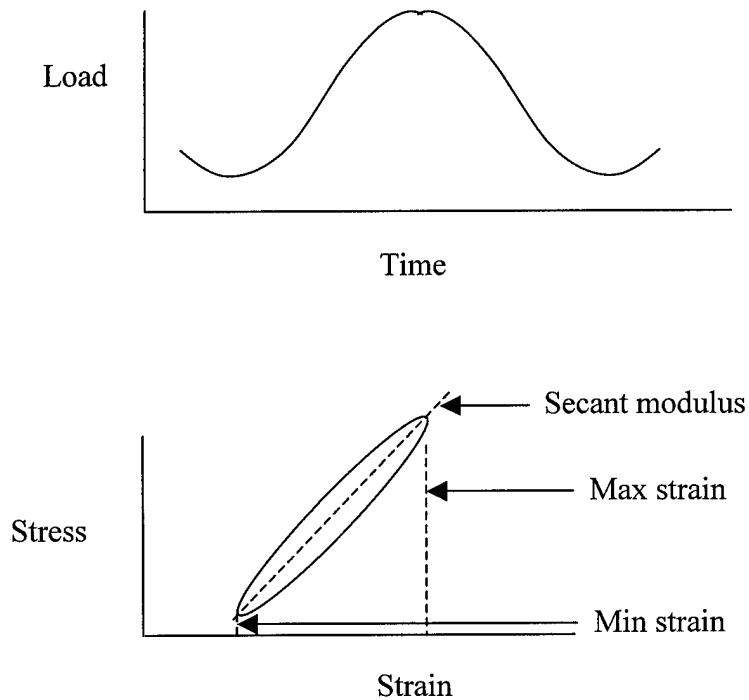
Cyclic tension tests were done at room temperature and 1200°C. The tests were done in load control with a load ratio of 0.05 ( $R = \sigma_{\max} / \sigma_{\min}$ ). The applied load had a sine wave form as shown in Figure 3-5 and a frequency of one hertz (one cycle per second).

Figure 3-5 Applied fatigue load and associated stress-strain loop

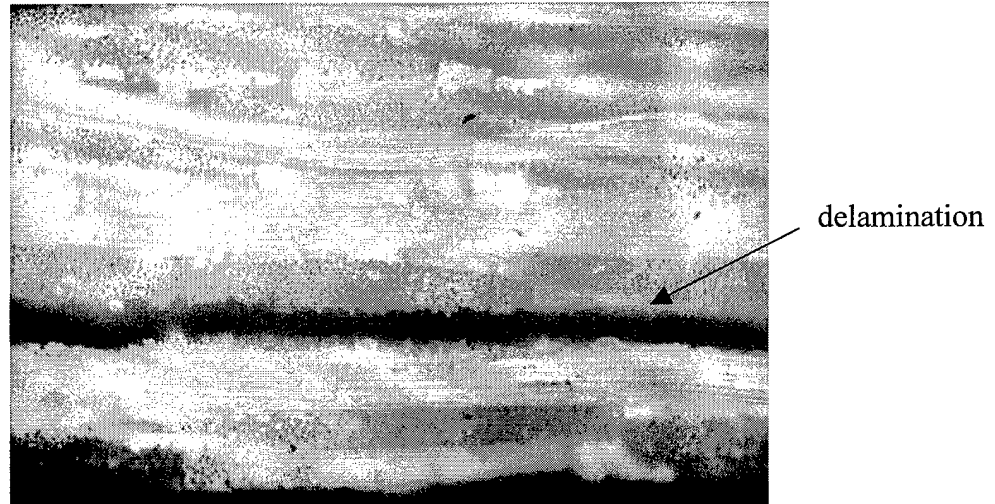
Figure 4-4 shows a delamination, or separation of plies, present at the grip section of a specimen. Such delaminations were present on several specimens. In general, the quality of the composite suffered near the edges of specimens.

**Figure 4-4 Delamination of plies in grip region, 50X**

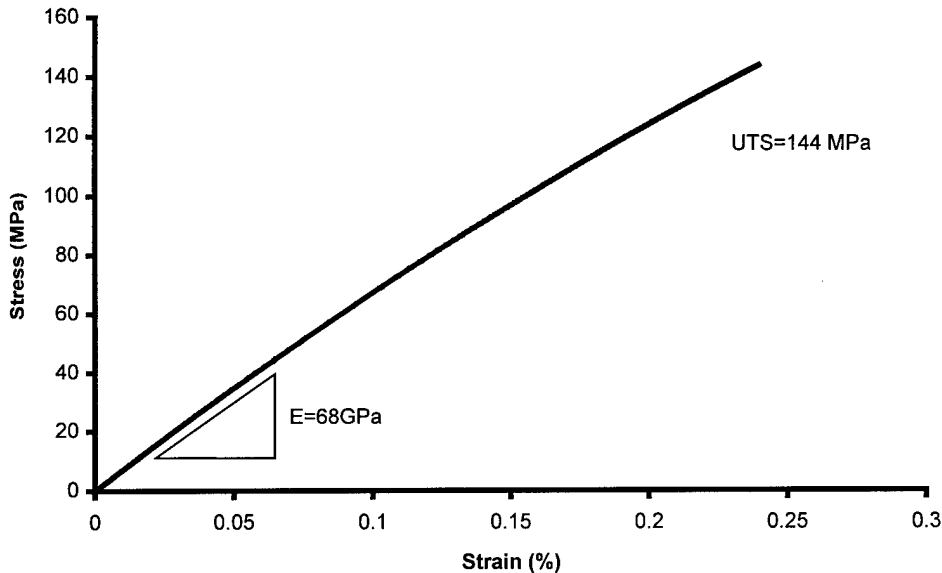
Figure 4-5 shows the stress-strain curve for specimen 2. It is typical of the three monotonic tests. A second-degree polynomial curve fit the data very nicely. The stress-strain response is nearly linear at first and then becomes slightly non-linear.

Figure 4-5 Typical room temperature stress-strain curve for N720/A

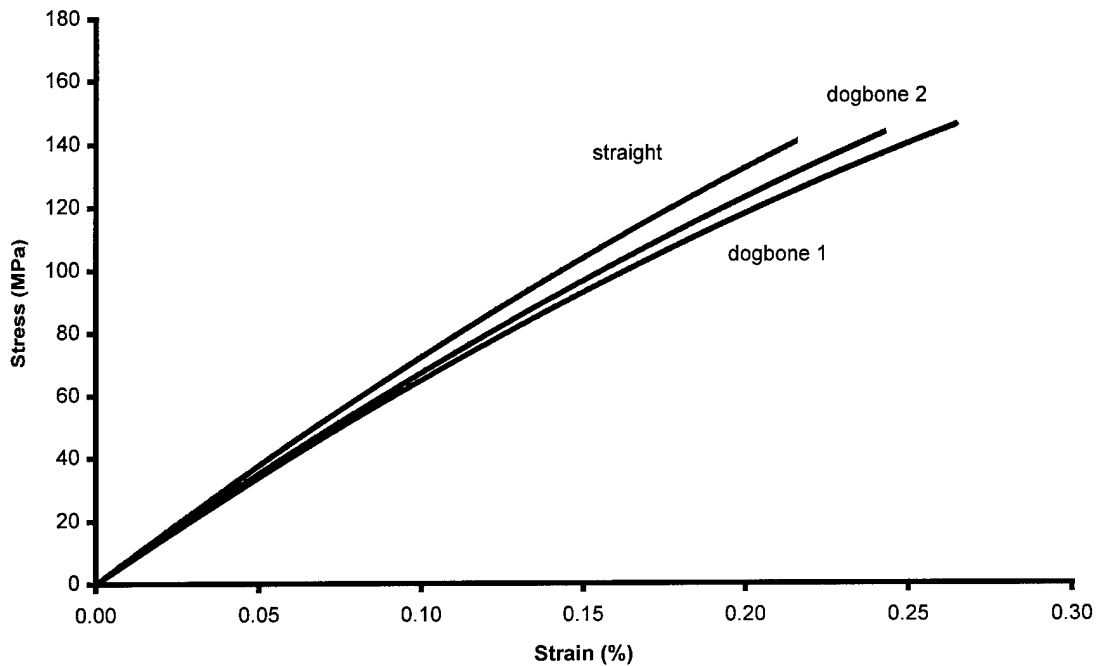
All three monotonic tests are plotted on the same graph in Figure 4-7.

**Figure 4-7 Comparison of three room temperature stress-strain curves**

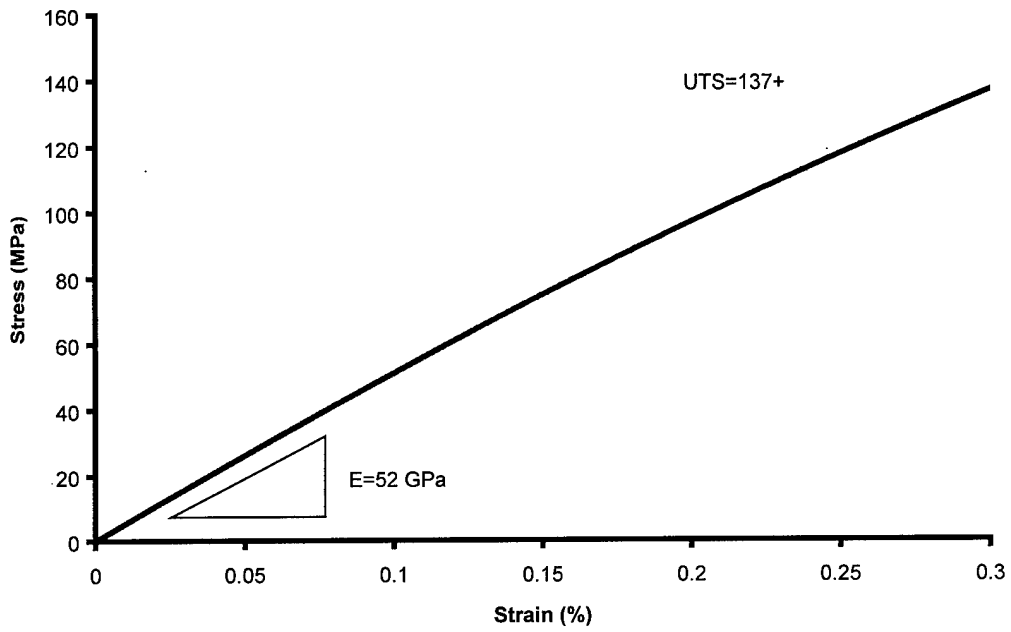
Overall, this material has very good monotonic tensile properties at 1200°C. Figure 4-12 shows a typical stress-strain curve obtained at 1200°C (specimen #5). It has the same characteristics as the room temperature tests, linear at low stress and then slightly non-linear at higher stress as the matrix cracks. Figure 4-13 shows a comparison of stress-strain curves at the two different temperatures. The difference in modulus and strain to failure is evident.

Figure 4-12 Typical stress-strain behavior at high temperature

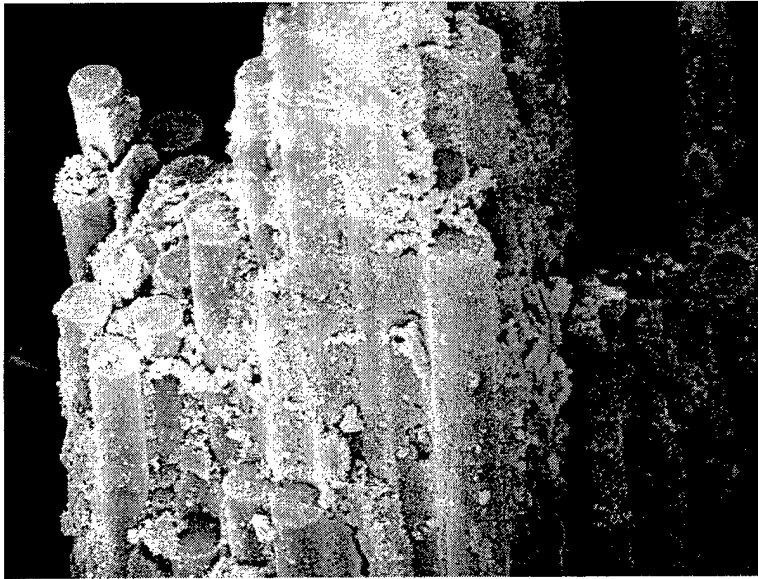
**Figure 4-15 Fracture surface of 1200°C monotonic specimen,  
700X**

Figure 4-17 shows how the matrix has sintered to the fibers and consequently the crack travels directly from the matrix through the fiber with no deflection. This is in contrast with the irregular fracture surface shown in Figure 4-15.

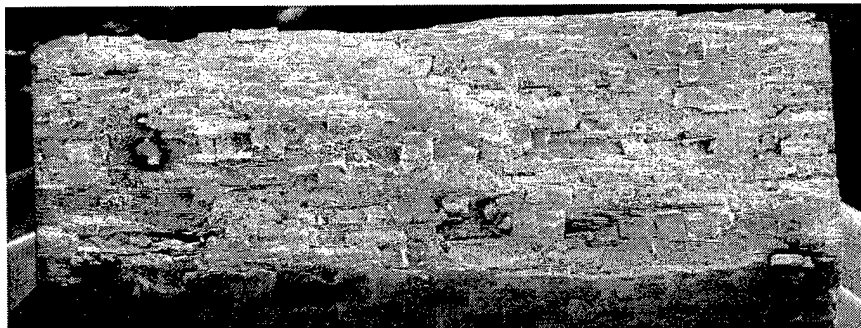
this role it was subjected to temperatures of 1200°C for several hours total. It was then accidentally dropped on the floor and it suffered a brittle fracture. The following figures illustrate the improvement in high temperature performance of N720/Alumina over GEN IV (N610/Aluminosilicate).

**Figure 4-16 Fracture surface of GEN IV after 1200°C exposure, 20X**

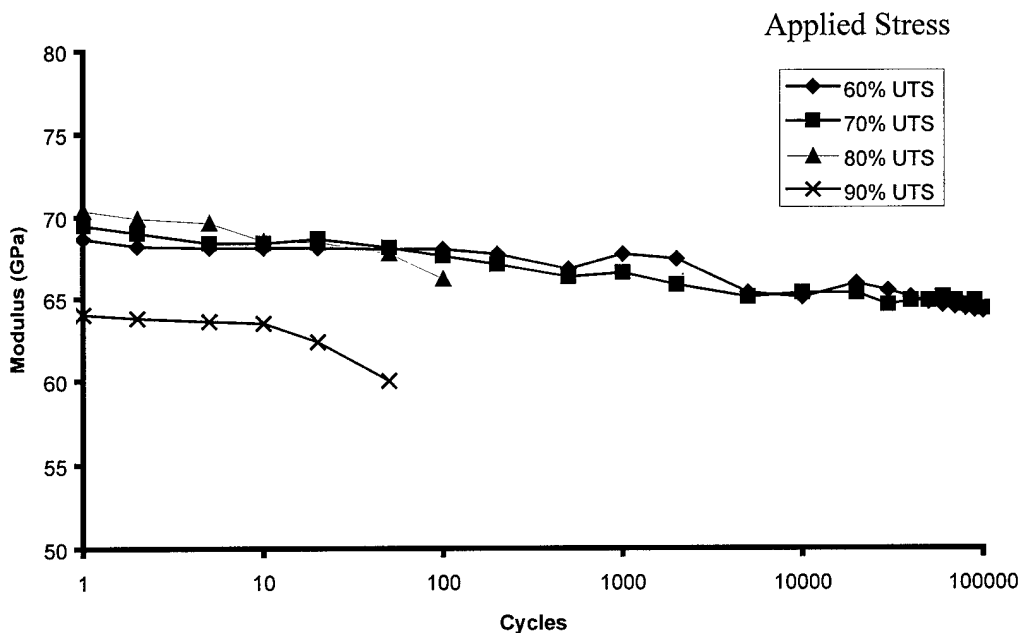
Figure 4-20 shows the modulus behavior for the four room temperature fatigue tests. For convenience the modulus used here is the secant modulus. Because the stress-strain behavior is close to linear, there is very little difference between the secant modulus and the tangent modulus calculated in the monotonic tests. As Figure 4-20 shows, there is a definite decreasing trend in the modulus behavior with cycling.

Figure 4-20 Modulus degradation during room temperature fatigue

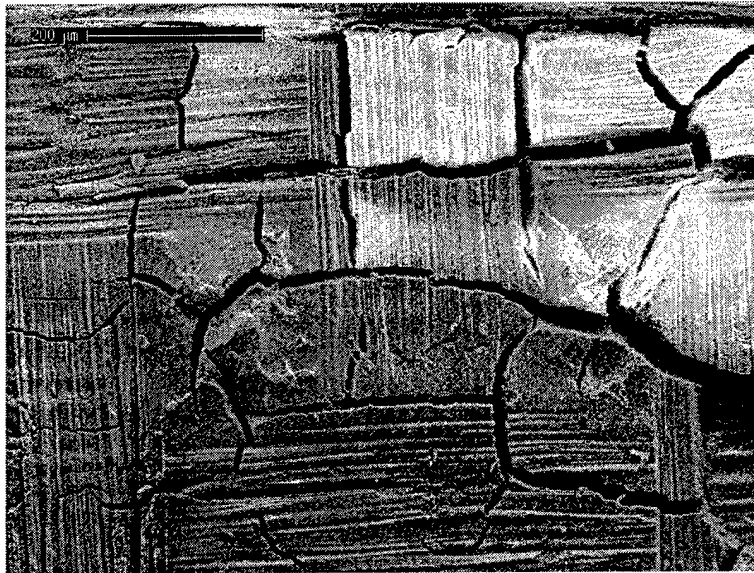
Figure 4-29 shows the cracked condition of the matrix on the specimen surface. The matrix is so cracked in the as received condition that it is impossible to tell which of these cracks if any occurred during fatigue. But the data in this section shows the composite is damaged slightly during fatigue and a likely source of this damage is cracking of the matrix beyond the original cracked condition.

**Figure 4-29 Surface of room temperature fatigue specimen after retained strength test, 140X**

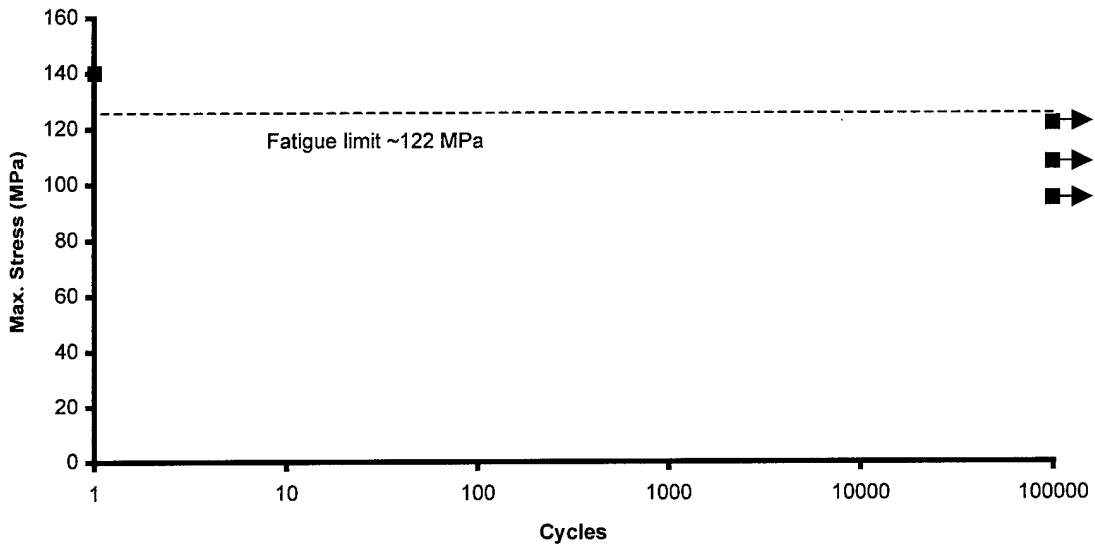
Figure 4-30 1200°C S-N curve for N720/A

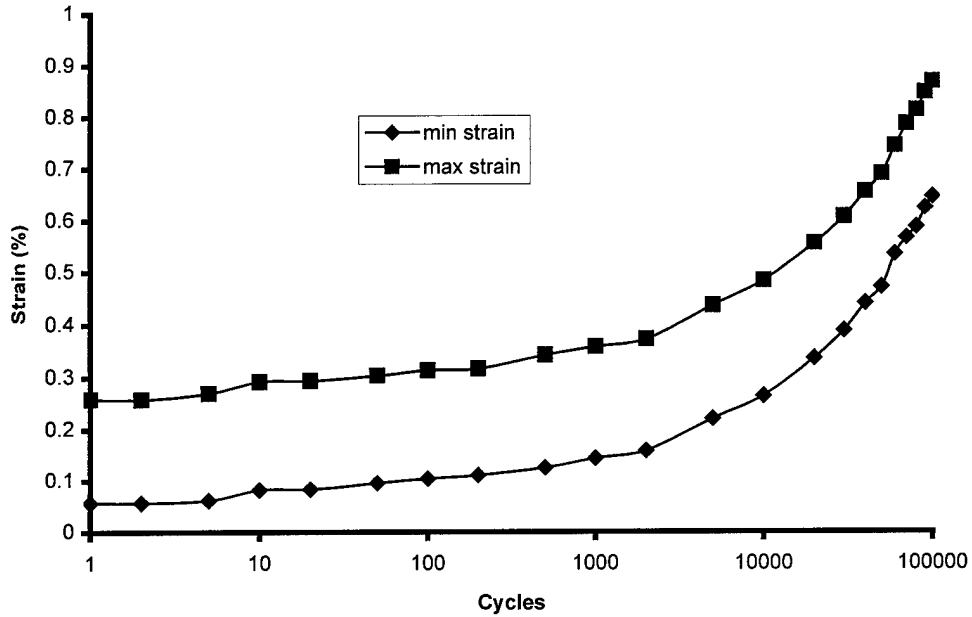
Figure 4-36 Strain accumulation during 90% stress level fatigue test at 1200°C

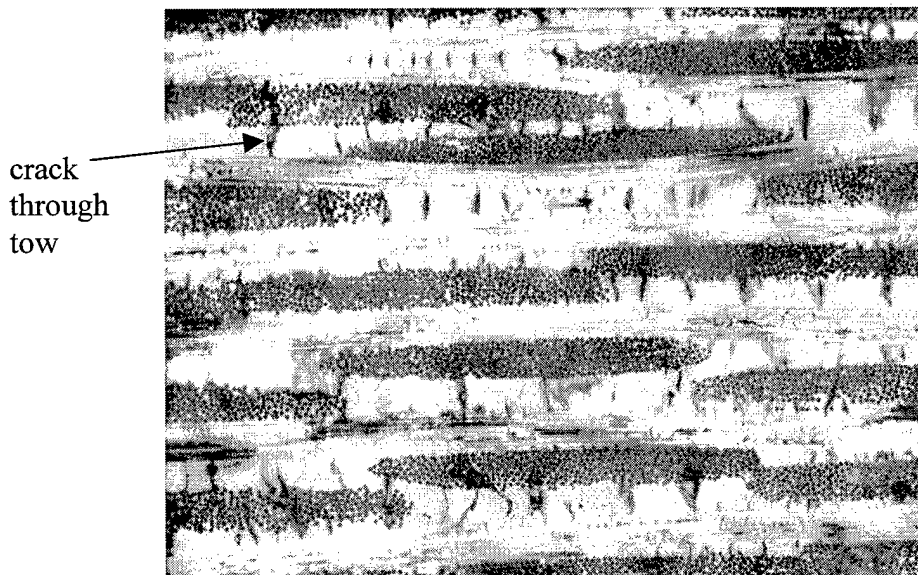
Figure 4-41 Possible fatigue damage, 50X

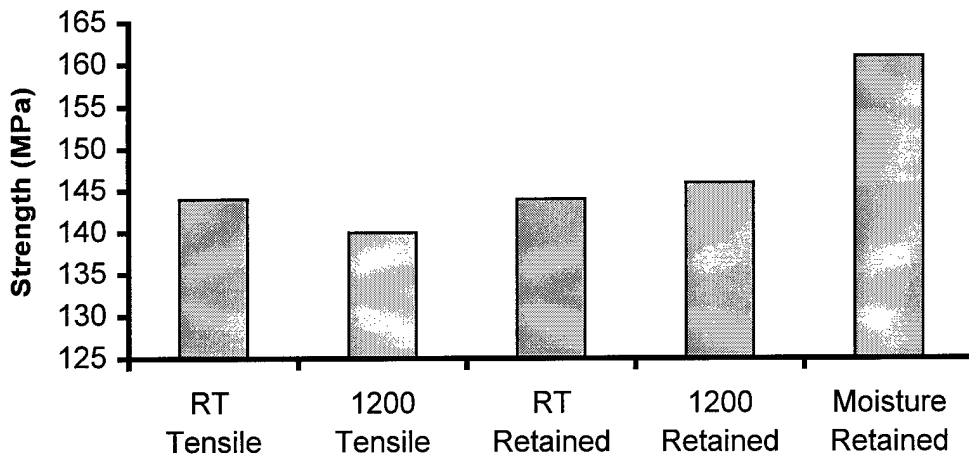
Figure 4-49 Retained strength compared to original strength
