Hazard Mapping for Infrastructure Planning in the Arctic

THESIS

AFIT-ENV-MS-21-M-201

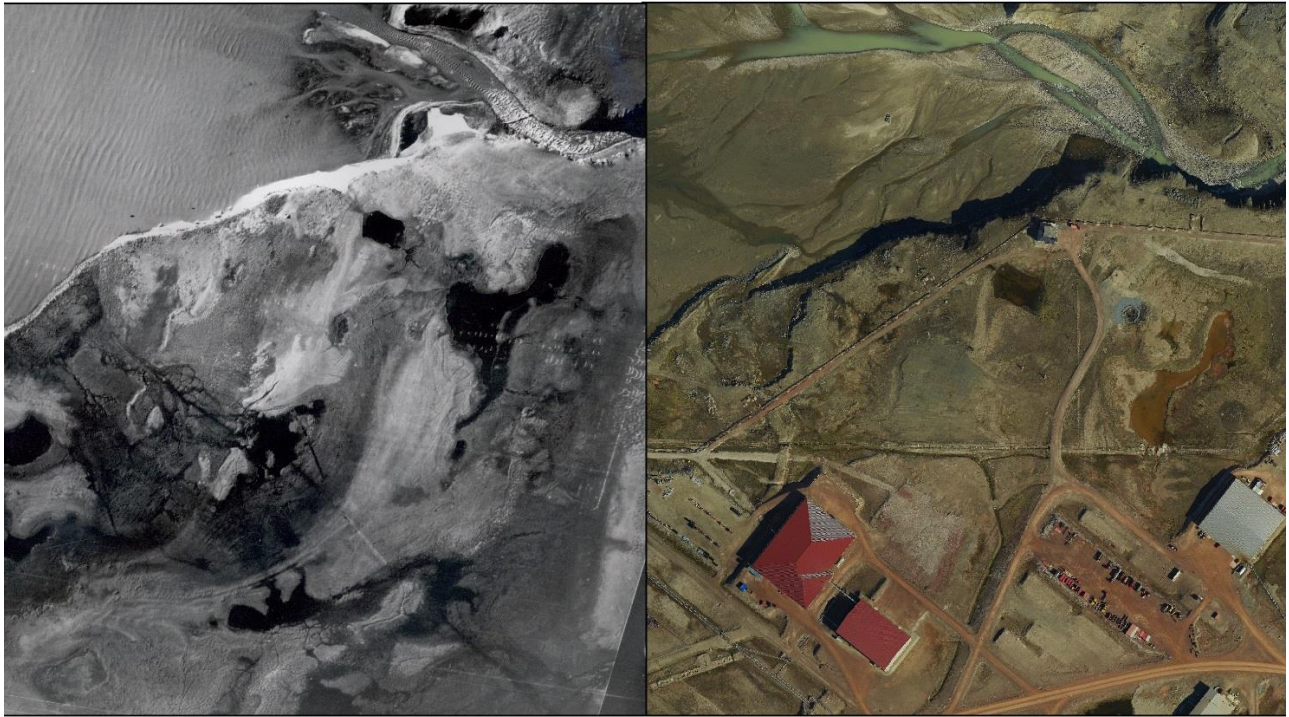
Figure 2. Juxtaposition of aerial photos from 1952 and 2018 (citation)

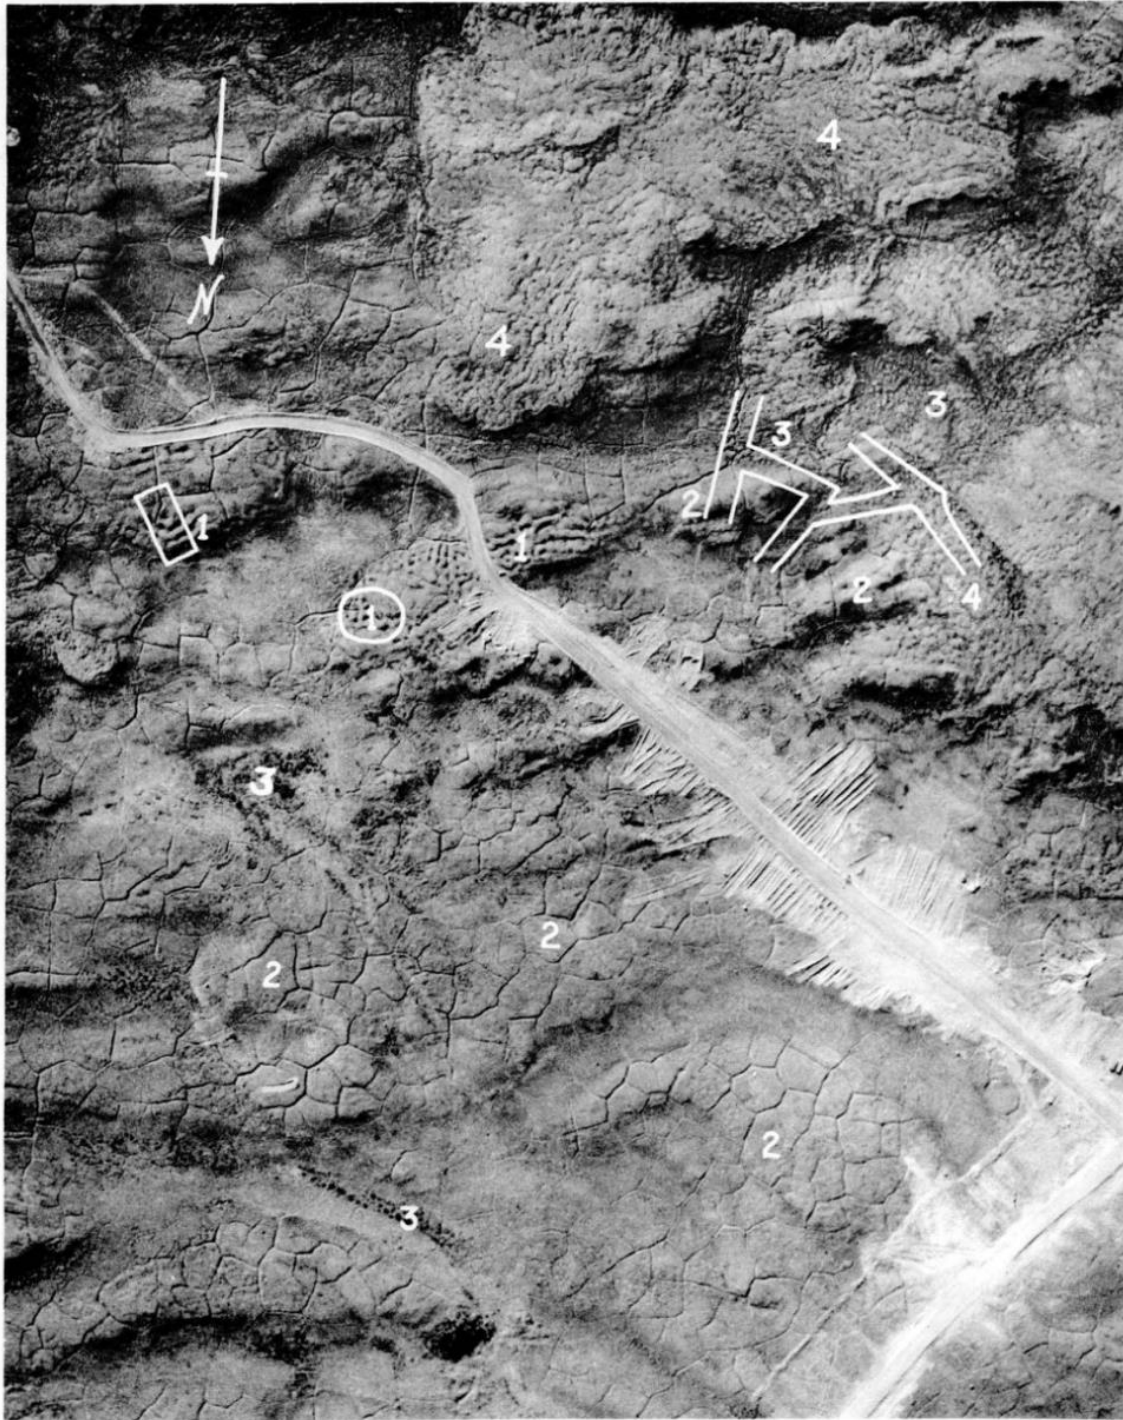
Figure 11. Aerial Photograph of a Study Near Thule Air Base (Corte, 1962)

Permafrost features can be identified through photogrammetry, which is the interpretation of photography for information. Using descriptions from permafrost experts and texts, the researcher scanned the available images for features matching the descriptions of common visible landscape features of permafrost terrain. The visual identification of features was based on Davis (2001) and Corte (1962). These resources provide examples of the identifiable features in permafrost regions (Davis, 2001) and Thule Air Base itself (Corte, 1962). Corte (1962) identifies the four major patterns shown in Table 3. The descriptions of surface cues and subsurface explorations were used to identify each feature and validate that it poses a hazard. The proximity of the study area in Corte (1962) to the focus of this research, shown in Figure 10, increases the likelihood that the features he described may be similar to the ones identified in the current study. Figure 11 shows an aerial photo from Corte (1962) that was used as a point of comparison to the features described in his study and to the features identified in the current study.

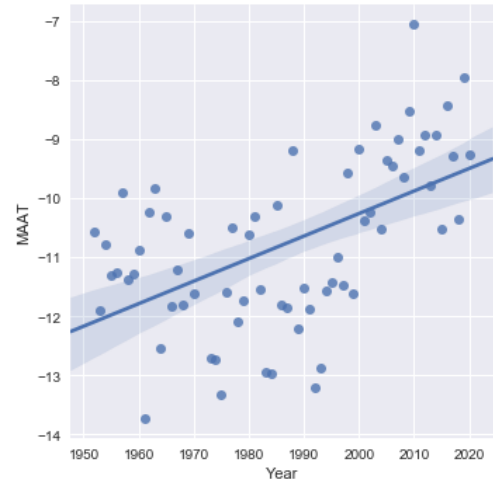
Figure 15. Model Outputs and Line of Best Fit for MAAT

The results of the Ordinary Least Squares (OLS) regression indicate an average increase of between 0.025 and 0.05 degrees Celsius per year for the last 68 years, with an R-squared of 0.295 and a 95% confidence level. The model shown in Figure 15 is statistically significant with a p-value less than 0.05, which suggests a moderate positive correlation between the MAAT and the year. These results support the conclusion that there is an increased risk of changes to the thermal balance of the terrain based on increasing air temperatures and that weather-related design parameters must be updated to improve the lifespan of facilities. This also indicates an increased risk to current and future infrastructure if maintenance and community planning efforts are not undertaken. The 10-year moving average, seen as the red line in Figure 14 additionally supports the interpretation of a more drastic warming over the past two decades in particular. This observation is supported by similar observations that coastal permafrost began degrading significantly in the early 2000s as a result of increased air temperatures and decreased sea ice (Thoman et al., 2020).

DV	MAAT
IV	Year
Observations	67
R-Squared	0.295
Model	Ordinary Least Squares
Model P-Value	0.00000205
Equation	$MAAT = 0.0382 * (Year) - 86.6$
Coefficient P-Value	0
Intercept P-Value	0

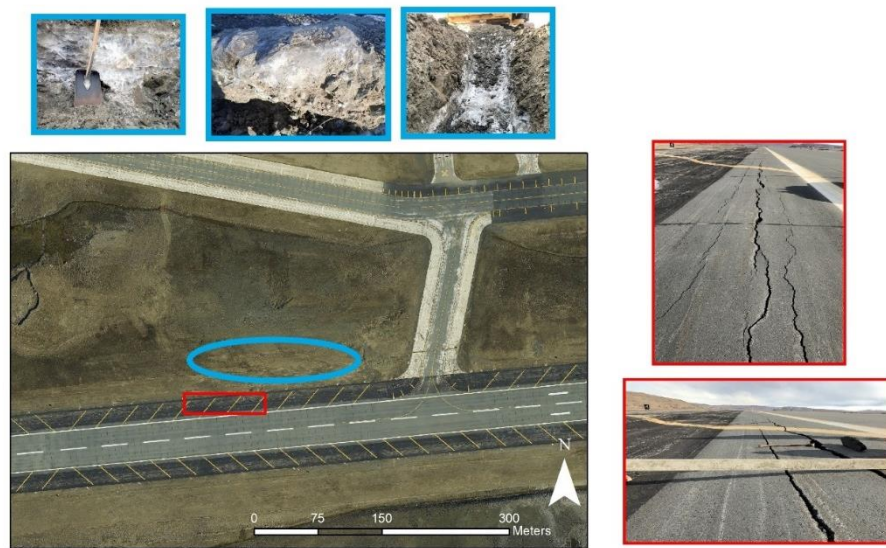
Figure 28. Severe Airfield Damage and Nearby Massive Ice

The results of this study naturally lend themselves to follow-on case studies. During the completion of this research, a four-day rain event caused severe damage on the airfield, as shown in Figure 28. Severe depressions appeared in the shoulder almost overnight which posed serious risks to the runway from loss of lateral confinement. Although cracks were sealed and fill was placed in the larger fissures before the freeze in September, this continues to pose a serious risk as the shoulders remain uninsulated and pockets of massive ice have been found in the area. With historical aerial photographs to identify visible permafrost features, a relationship can be established between the excavated massive ice and segregated ice, shown at the top of Figure 28,

and the surface morphology to predict high risk areas of the shoulder or runway. A study of pavements around the base, including the runway, using available PAVER data inspection reports and field work could follow a similar methodology to the study of foundations. Additional studies should also be completed on critical facilities in proximity to hazards such as the radar and satellite communication equipment.
