Fatigue of two oxide/oxide ceramic matrix
composites at 1200°C in air and in steam. Effect
of diamond-drilled effusion holes.

THESIS

AIR FORCE INSTITUTE OF TECHNOLOGY

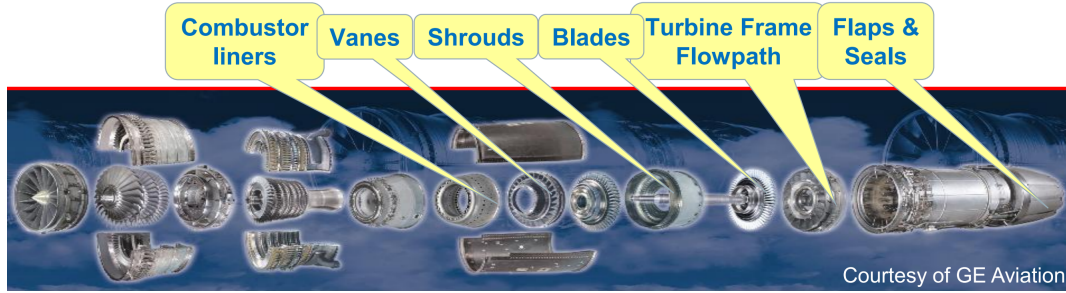
Figure 1. Potential CMC applications within a Turbine Engine [11]

Ceramic matrix composites (CMCs) are known for their ability to maintain strength properties at high temperatures. Advanced aerospace structures such as hypersonic vehicles, space re-entry thermal protection systems, aircraft engines, and various land based turbines are several areas that can benefit from CMC application [2]. In comparison to the metallic alloys and superalloys conventionally used for aircraft parts, CMCs are lower density materials which can be used in higher-temperature environments. If used within jet engines, their weight and strength properties would allow engines to operate more efficiently at higher operating temperatures and at a lesser weight, translating to cleaner and cheaper air transportation. Figure 1 highlights potential areas for CMCs within an aviation turbine engine [11].

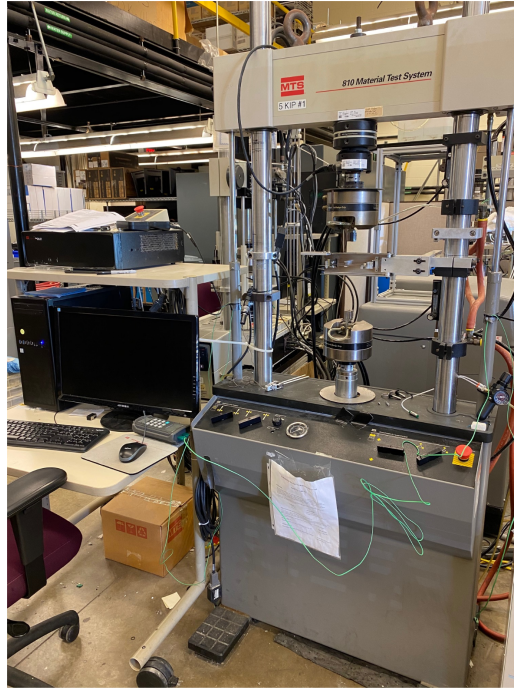
Figure 11. 5-Kip 810 Material Test System

Mechanical testing of N720/A specimens in tension-tension fatigue as well as tension testing of N720/A specimens containing a brazed joint was conducted using a 5-kip 810 Material Test System (MTS) machine. This is a servo-hydraulic testing machine equipped with water-cooled hydraulic wedge grips. This machine is capable of applying a 5-kip tensile load. For all tests on this load frame, the grip pressure was set to 8 MPa. The grips were cooled during testing using a Thermo Scientific Accel 250 Liquid Cooling system with deionized chilled water at 18°C.

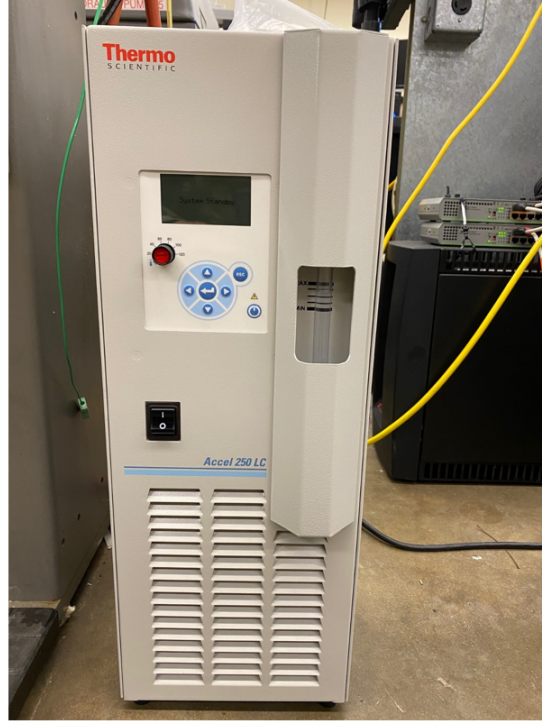
Figure 12. Thermo Scientific Accel 250 LC, Chiller used to regulate grip temperature

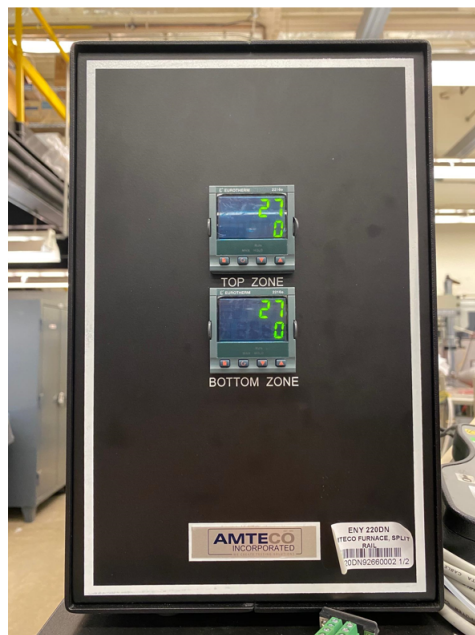
Figure 14. AMTECO Two-Zone temperature controller

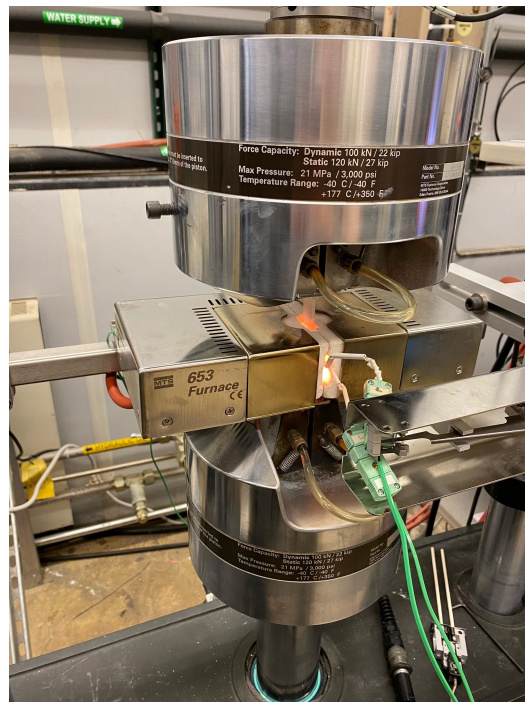
Figure 20. MTS 653 Furnace

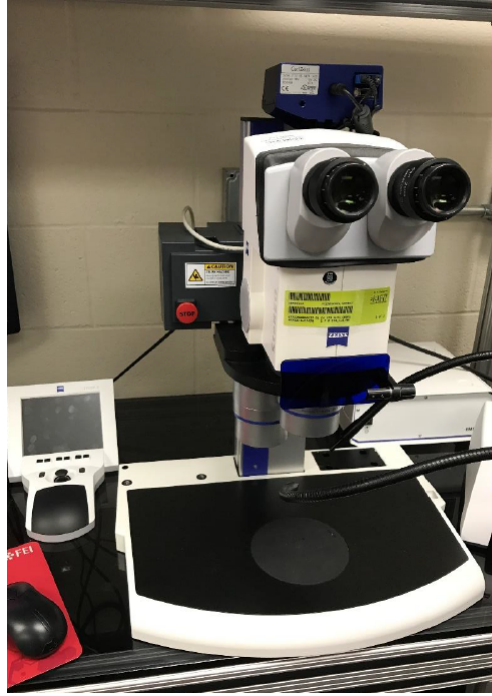
Figure 21. ZEISS Optical Microscope

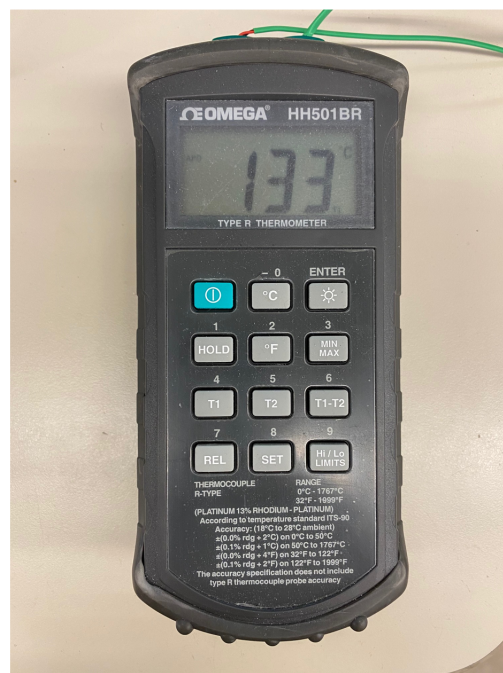
Figure 29. Omega HH501BR Thermometer used in AMTECO furnace temperature calibration

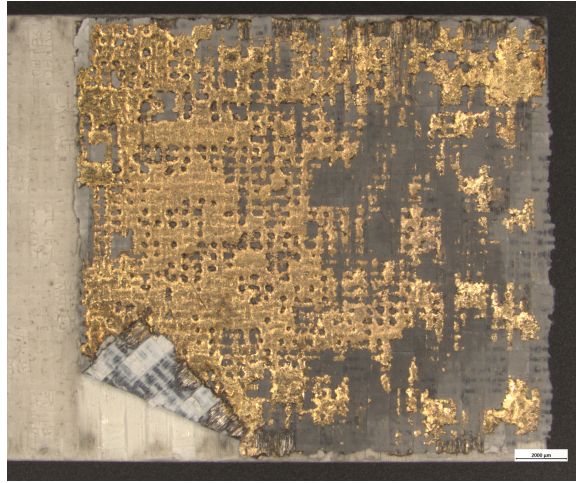
Figure 45. Top section of brazed joint

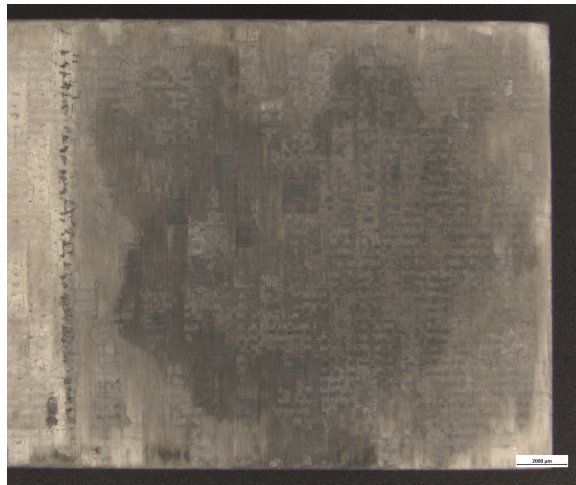
Figure 46. Bottom section of brazed joint

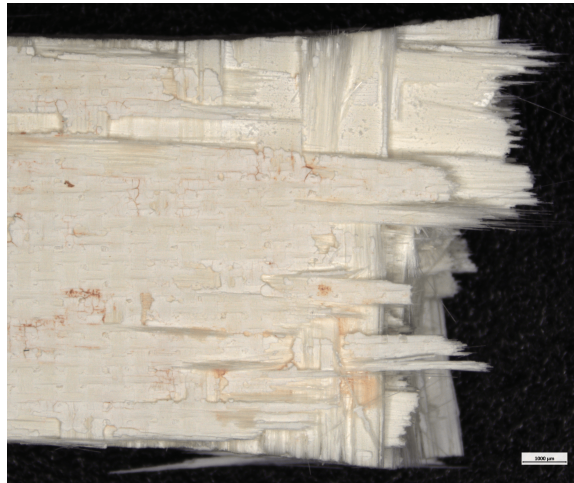
Figure 57. Optical micrograph of a N720/AM specimen fracture surface tested in tension-tension fatigue at 1200°C in air. $\sigma_{\max} = 130$ MPa, $N_f > 100,000$

Figure 58. Optical micrograph of a N720/AM specimen fracture surface tested in tension-tension fatigue at 1200°C in air. $\sigma_{\max} = 130$ MPa, $N_f > 100,000$

Figure 59. Optical micrograph of a N720/AM specimen fracture surface tested in tension-tension fatigue at 1200°C in air. $\sigma_{\max} = 130$ MPa, $N_f > 100,000$

Figure 60. Optical micrograph of a N720/AM specimen fracture surface tested in tension-tension fatigue at 1200°C in air. $\sigma_{\max} = 130$ MPa, $N_f > 100,000$

Figure 61. Optical micrograph of a N720/AM specimen fracture surface tested in tension-tension fatigue at 1200°C in air. $\sigma_{\max} = 130$ MPa, $N_f > 100,000$

Figure 62. Optical micrograph of a N720/AM specimen fracture surface tested in tension-tension fatigue at 1200°C in air. $\sigma_{\max} = 130$ MPa, $N_f > 100,000$

Figure 63. Optical micrograph of a N720/AM specimen fracture surface tested in tension-tension fatigue at 1200°C in air. $\sigma_{\max} = 130$ MPa, $N_f > 100,000$

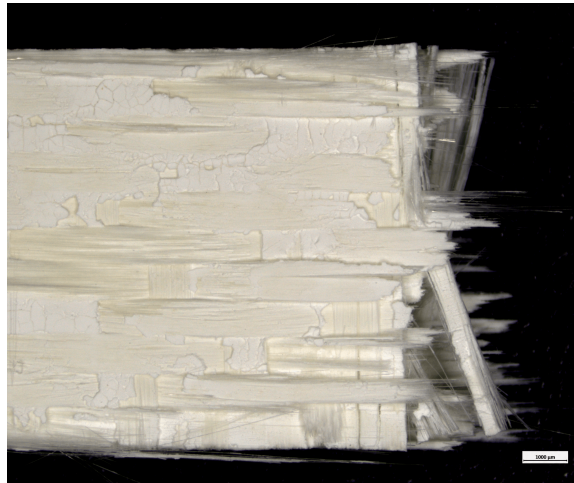
Figure 65. Optical micrograph of a N720/AM specimen fracture surface tested in tension-tension fatigue at 1200°C in air. $\sigma_{\max} = 140$ MPa, $N_f > 100,000$

Figure 67. Optical micrograph of a N720/AM specimen fracture surface tested in tension-tension fatigue at 1200°C in air. $\sigma_{\max} = 140$ MPa, $N_f > 100,000$

Figure 69. Optical micrograph of a N720/AM specimen fracture surface tested in tension-tension fatigue at 1200°C in air. $\sigma_{\max} = 140$ MPa, $N_f > 100,000$

Figure 70. Optical micrograph of a N720/AM specimen fracture surface tested in tension-tension fatigue at 1200°C in air. $\sigma_{\max} = 140$ MPa, $N_f > 100,000$

Figure 71. Optical micrograph of a N720/AM specimen fracture surface tested in tension-tension fatigue at 1200°C in air. $\sigma_{\max} = 140$ MPa, $N_f > 100,000$
