## Fatigue Behavior of a Quasi-Isotropic Graphite/Epoxy Laminate Embedded with a Piezoelectric Sensor

**Fatigue Behavior of a Quasi-Isotropic  
Graphite/Epoxy Laminate Embedded with a  
Piezoelectric Sensor**

**Thesis**

**Jon M. Coleman B.S.M.E., M.B.A.  
Captain, USAF**

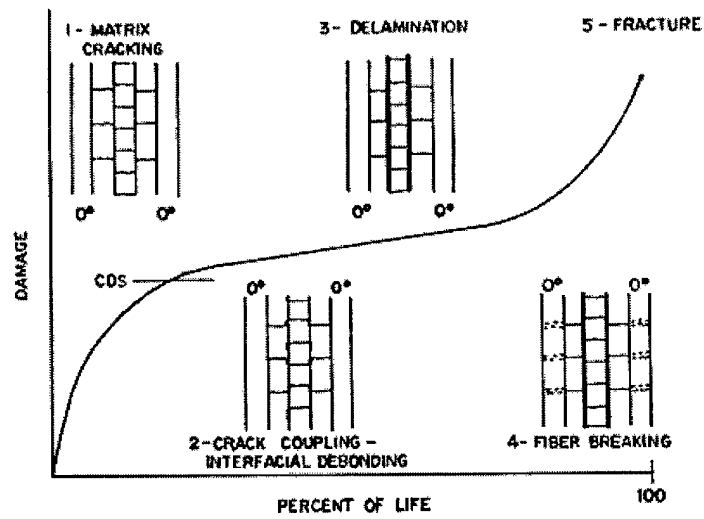
Figure 1. Damage Sequence During Fatigue Loading [21]

Other reports generally agree with the damage sequence discussed by Kim [11, 15, 20]. Stinchcomb gives a graphical representations of the cumulative damage sequence and interlaminar stresses resulting from transverse cracking [21]. Figure 1 shows the progressive damage to failure of the laminate. Figure 2 shows the interlaminar shear and normal stresses which result from the cracking of the  $90^\circ$  plies of a quasi-isotropic  $[0|\pm 45|90]_S$  laminate. Results of Stinchcomb's testing of notched carbon-epoxy specimens under complete reversed loading are shown in Figures 3 and 4. The higher loaded specimen's stiffness drops faster and fails in less cycles, but the relative damage during the life is approximately the same as shown in the Figure 4.

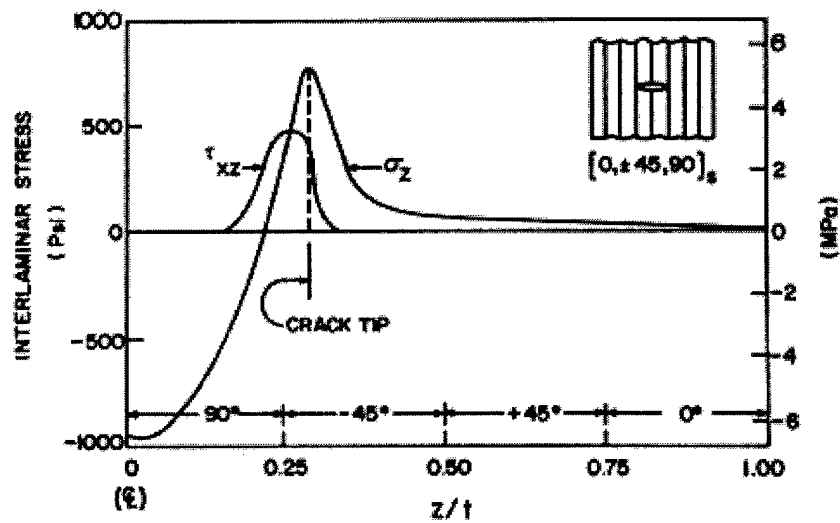
Figure 2. Interlaminar Stresses Near the Crack Tip [21]

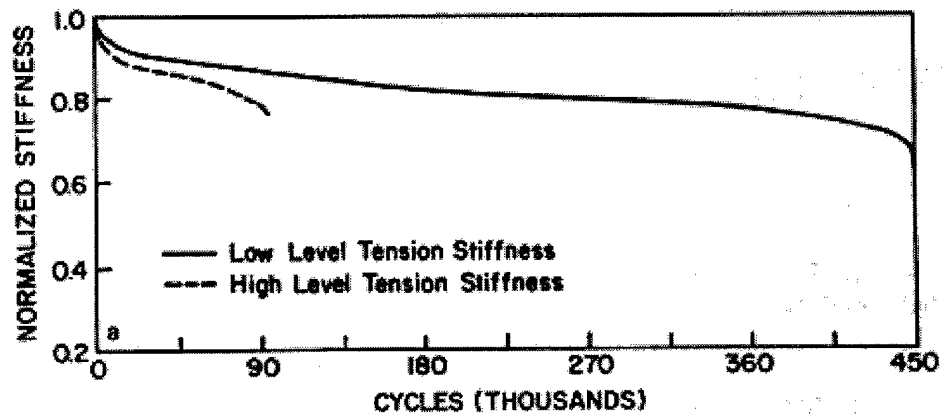
Figure 3. Normalized Stiffness vs Cycles [21]

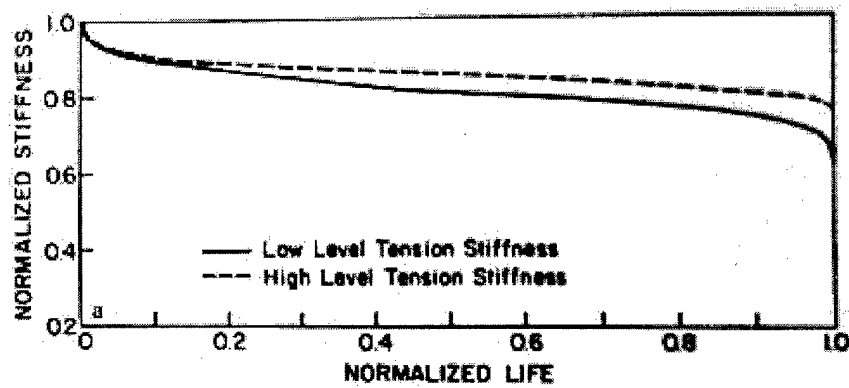
Figure 4. Normalized Stiffness vs Normalized Cycles [21]

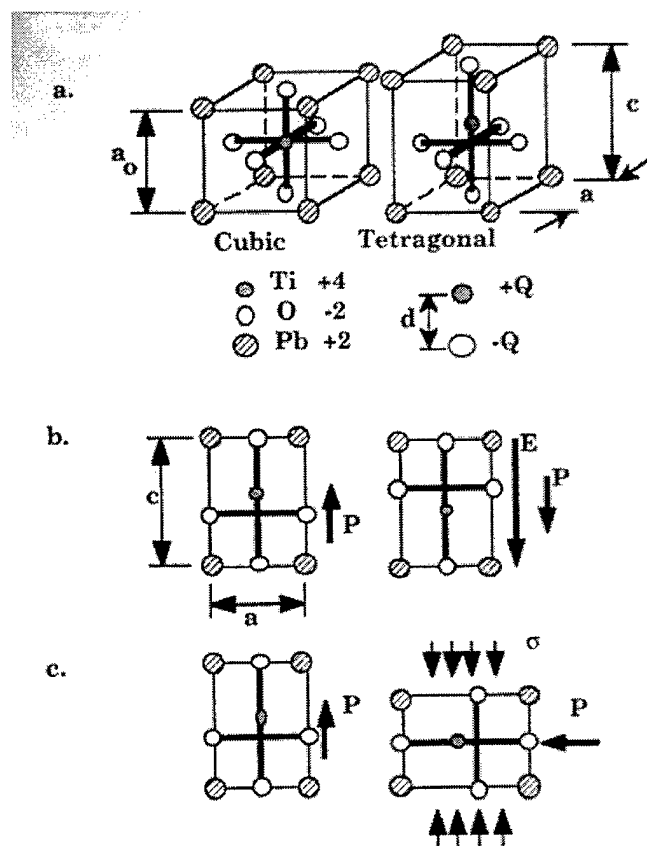
Figure 5. Switching of Polarity Due to Applied Stress and Electric Field [13]

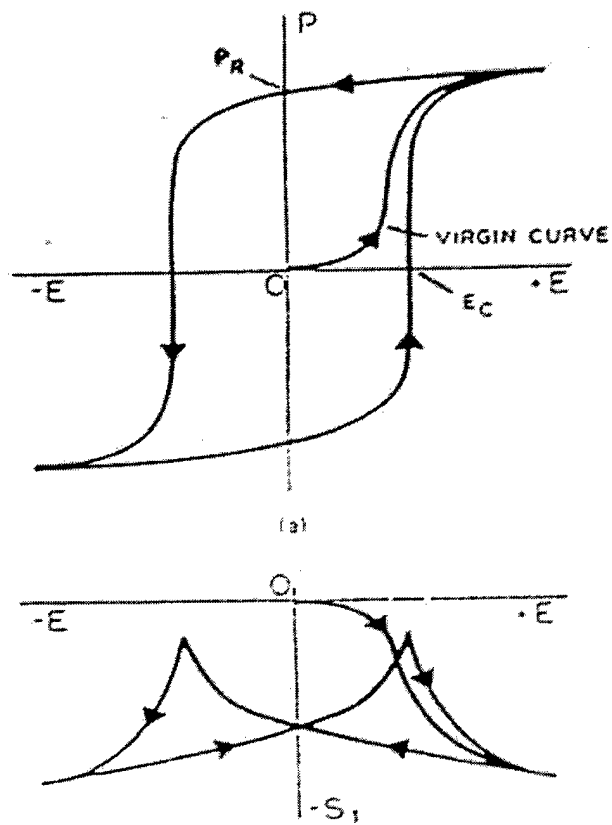
Figure 6. Polarization vs Electric Field Hysteresis Loop [3]

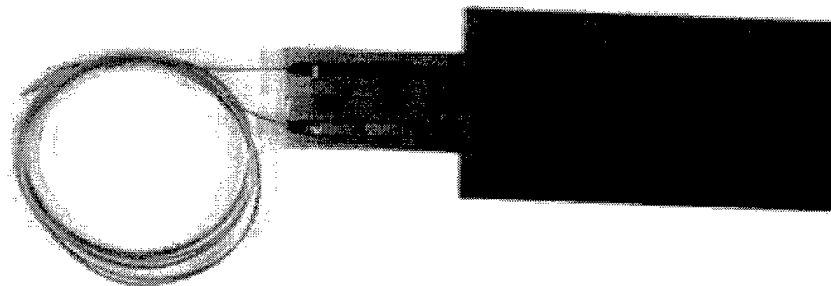
Figure 7. Active Control eXperts (ACX) QP15N PZT

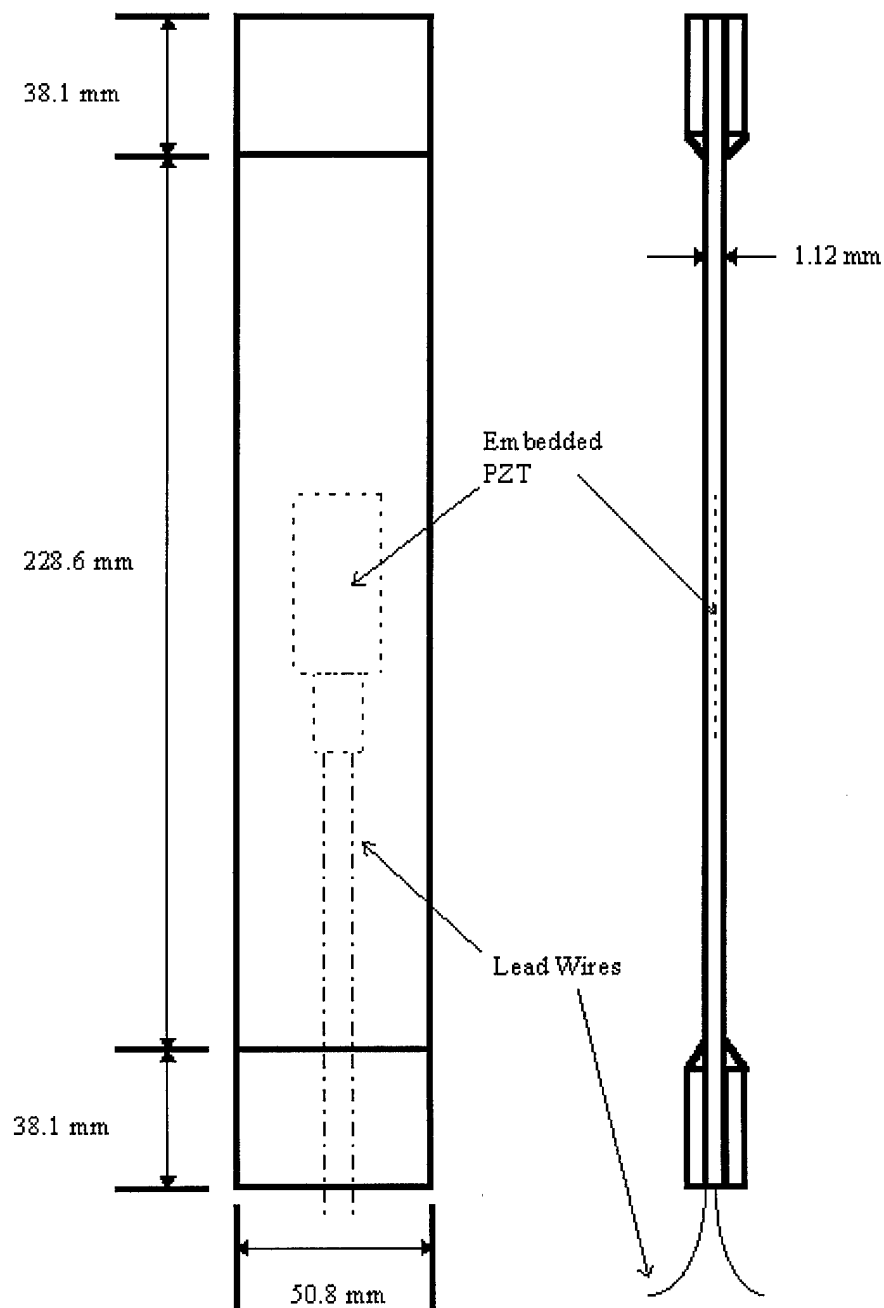
Figure 8. Diagram of Specimen with Embedded PZT

Two types of specimens were constructed, one with the sensor embedded and one without the sensor embedded. The dimensions of these two specimens were approximately the same, with the exception of some 25.4 mm wide specimens made to study the width effects. The size of the 305 mm  $\times$  50.8 mm specimens was primarily based upon the size of the embedded PZTs. In order to embed the 50.8 mm  $\times$  25.4 mm sensor, a 2:1 width and 6:1 length ratio were designed to limit edge and large inclusion effects. The actuators were normally centered in the middle of the specimens, except in one case where the PZT was placed at the edge of the specimen. This particular specimen was constructed to study the bonding interface of the PZT with the surrounding plies at the edge. This study basically involved the comparison of these two types of specimens when subjected to cyclic loading. Figure 8 is a diagram of a specimen with an embedded sensor.

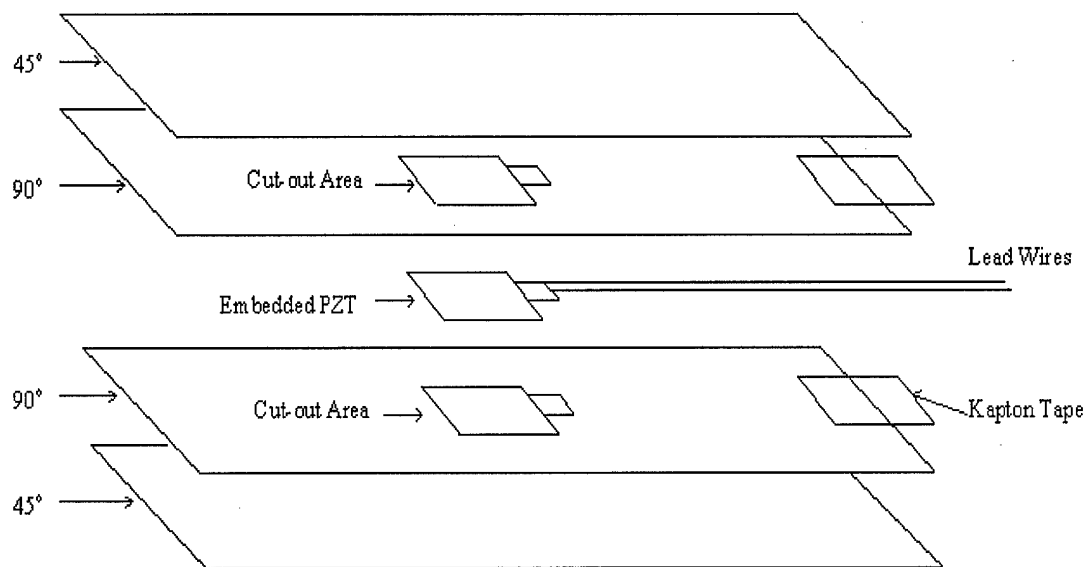
Figure 9. Diagram of Cut-out Plies and Inserted PZT in  $[0 | \pm 45 | 90]_S$  Laminate

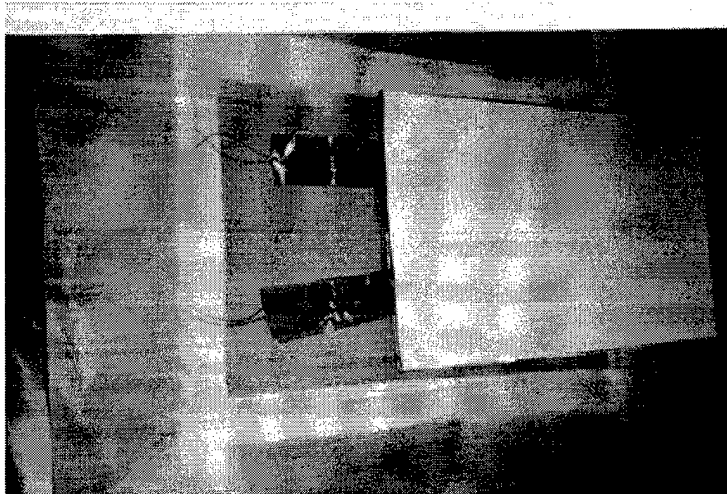
Figure 10. Kapton Tape Applied at the Ends to Protect Lead Wires

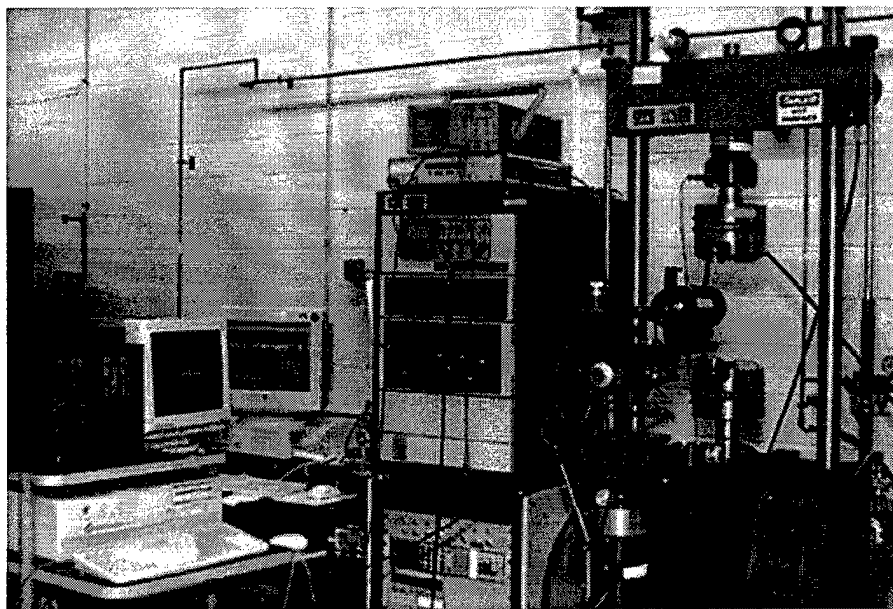
Figure 12. QRMS-II Optics, 810 MTS Test System, 486 Pentium Computers and Monitors

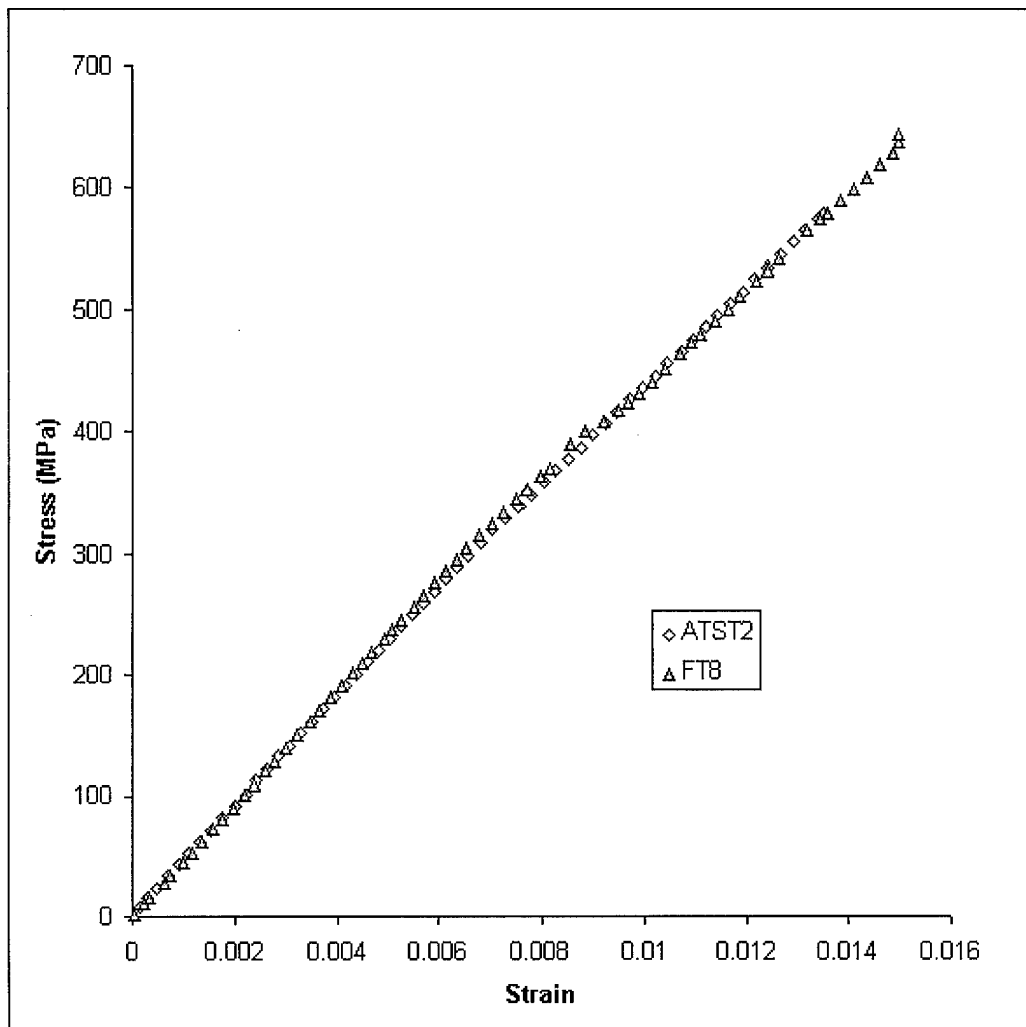
Figure 13. Stress-Strain Curve for Specimens FT8 and ATST2

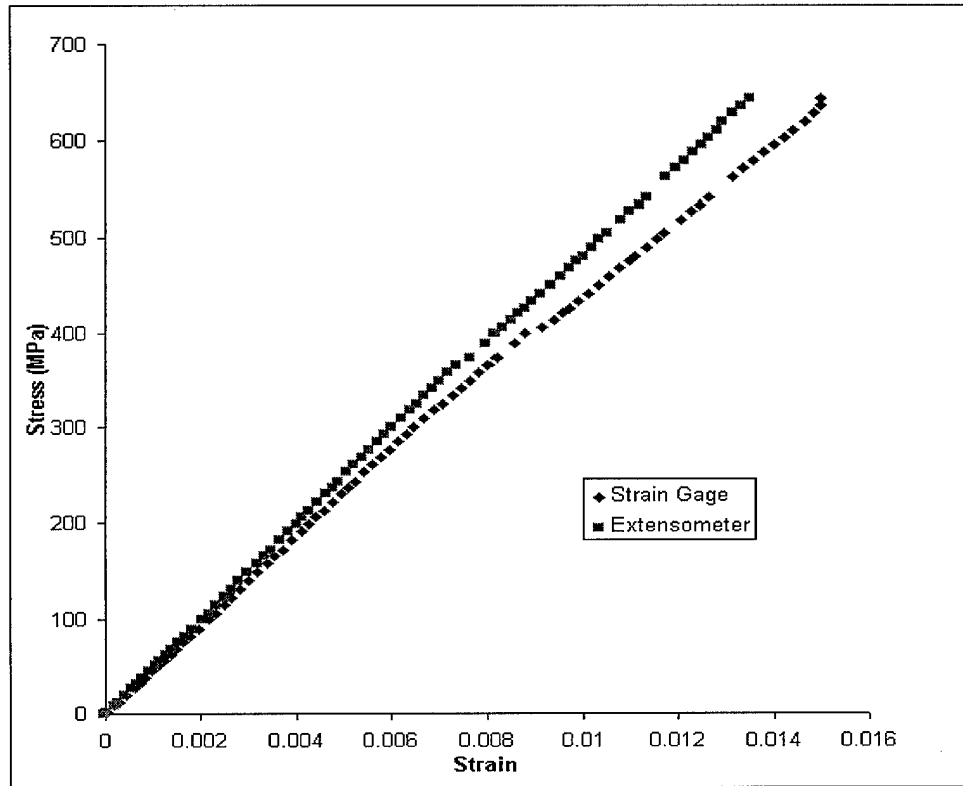
Figure 14. Extensometer vs Strain Gage Data - Specimen FT8

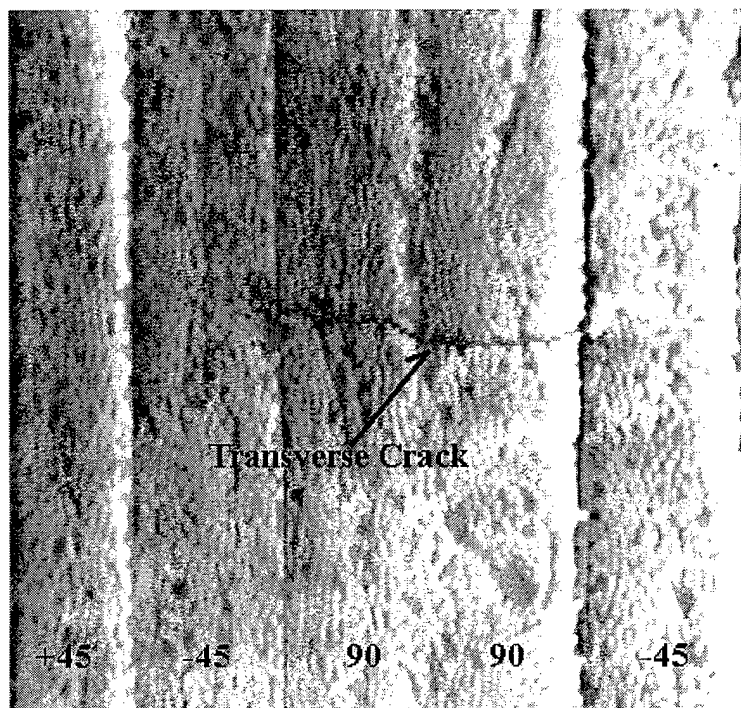
Figure 18. Transverse Cracking of 90° Plies - Specimen ATST1

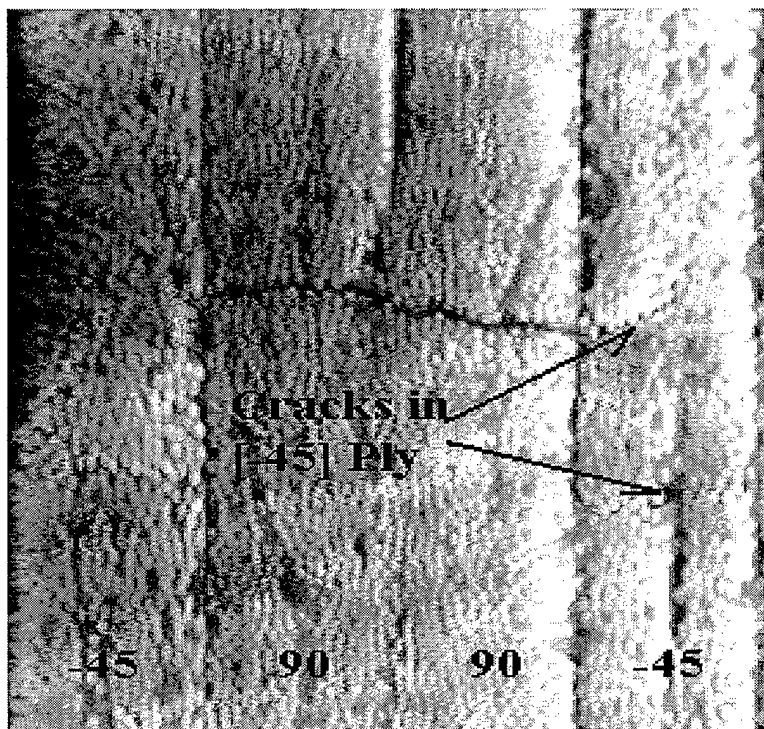
Figure 19. Crack in -45° Ply - Specimen ATST1

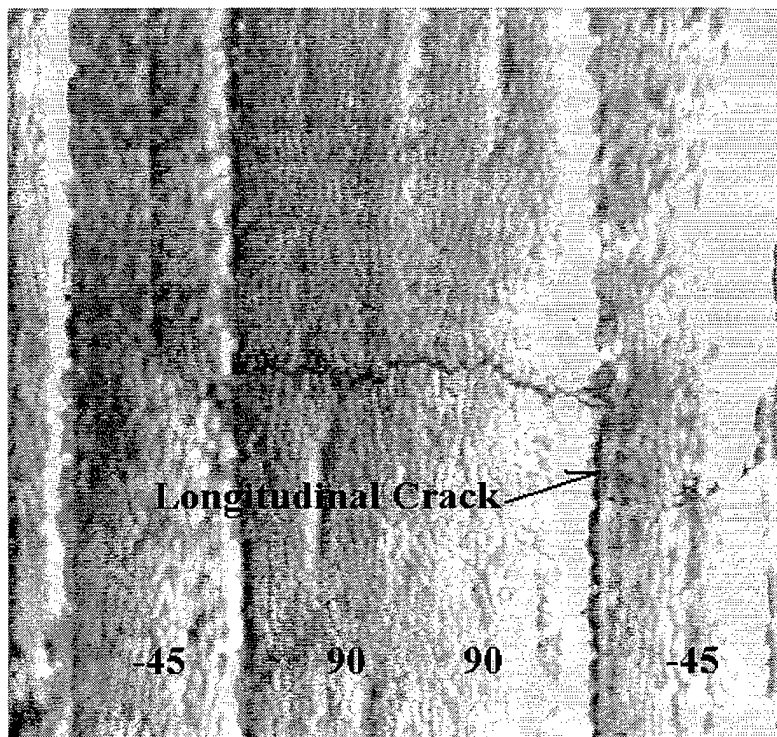
Figure 20. Longitudinal Cracking Between 90° and -45° Plies (FT7)

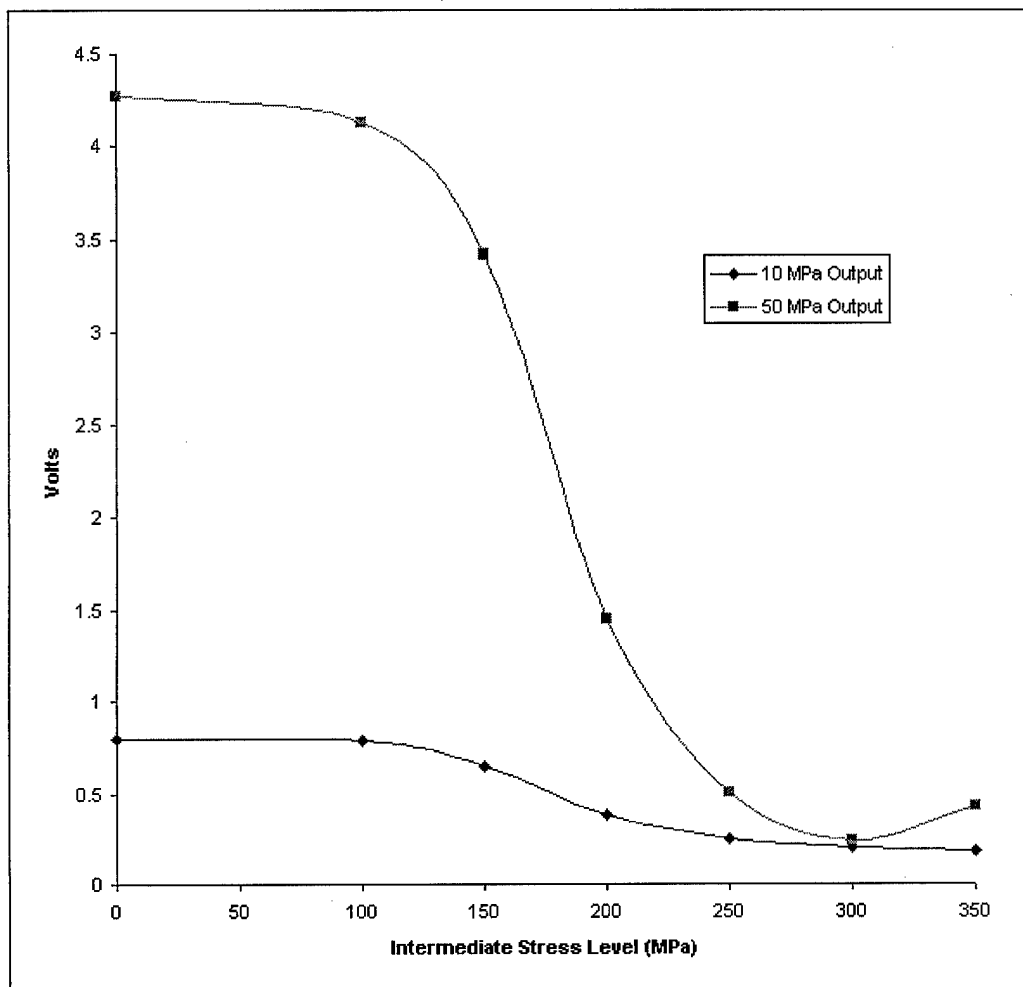
Figure 21. Degradation of PZT Output after Intermediate Static Loads (ATST1)

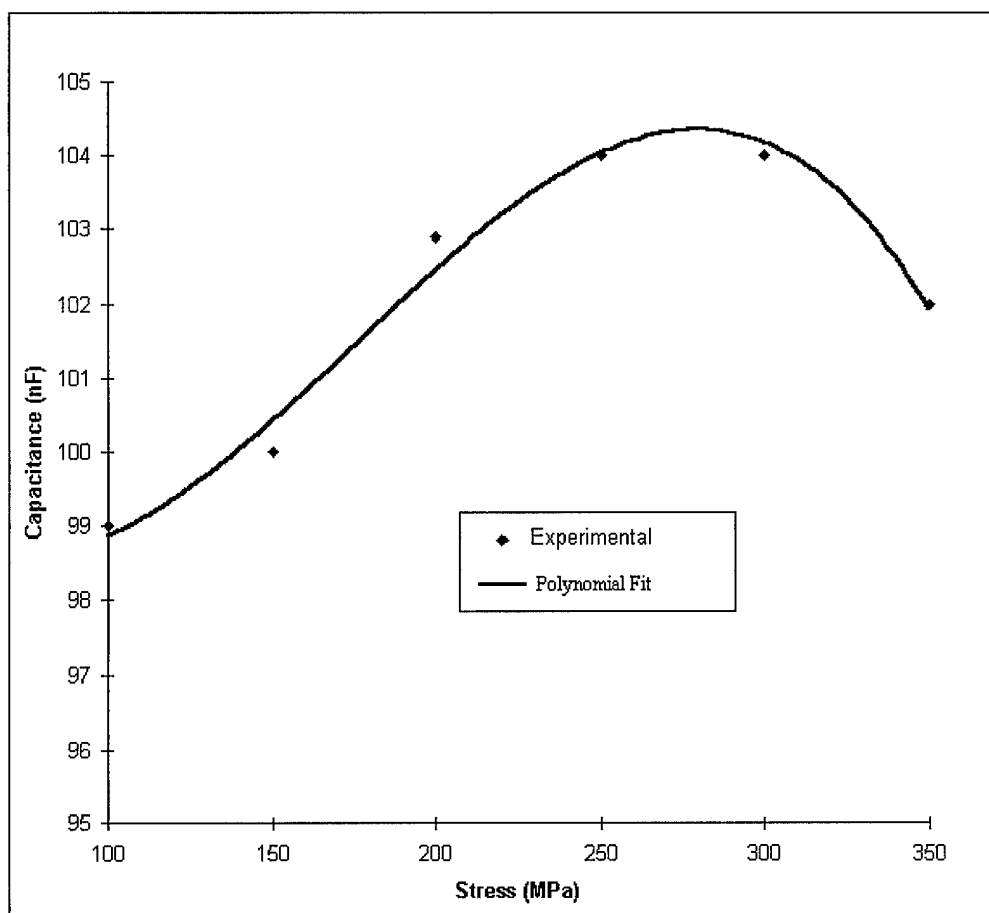
Figure 22. Capacitance vs Applied Stress - Specimen ATST1

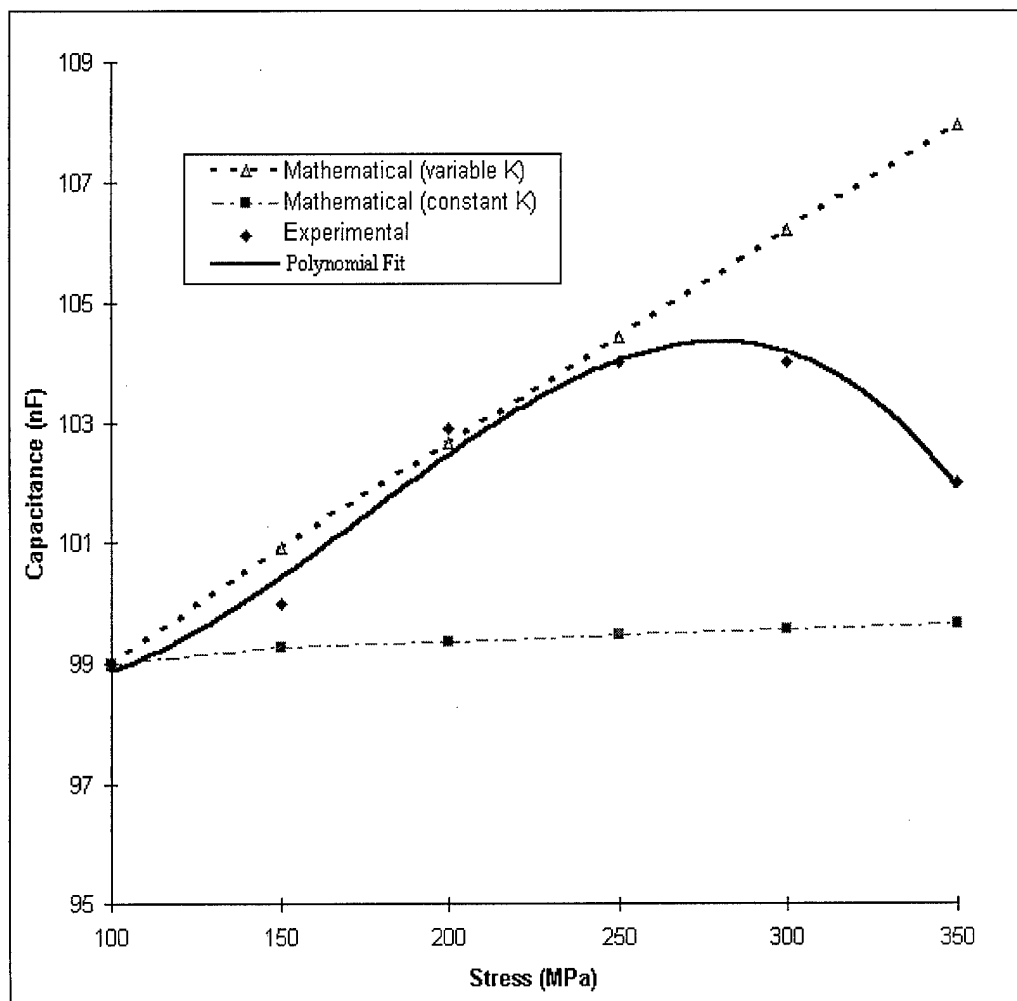
Figure 23. Mathematical vs Experimental Changes in Capacitance

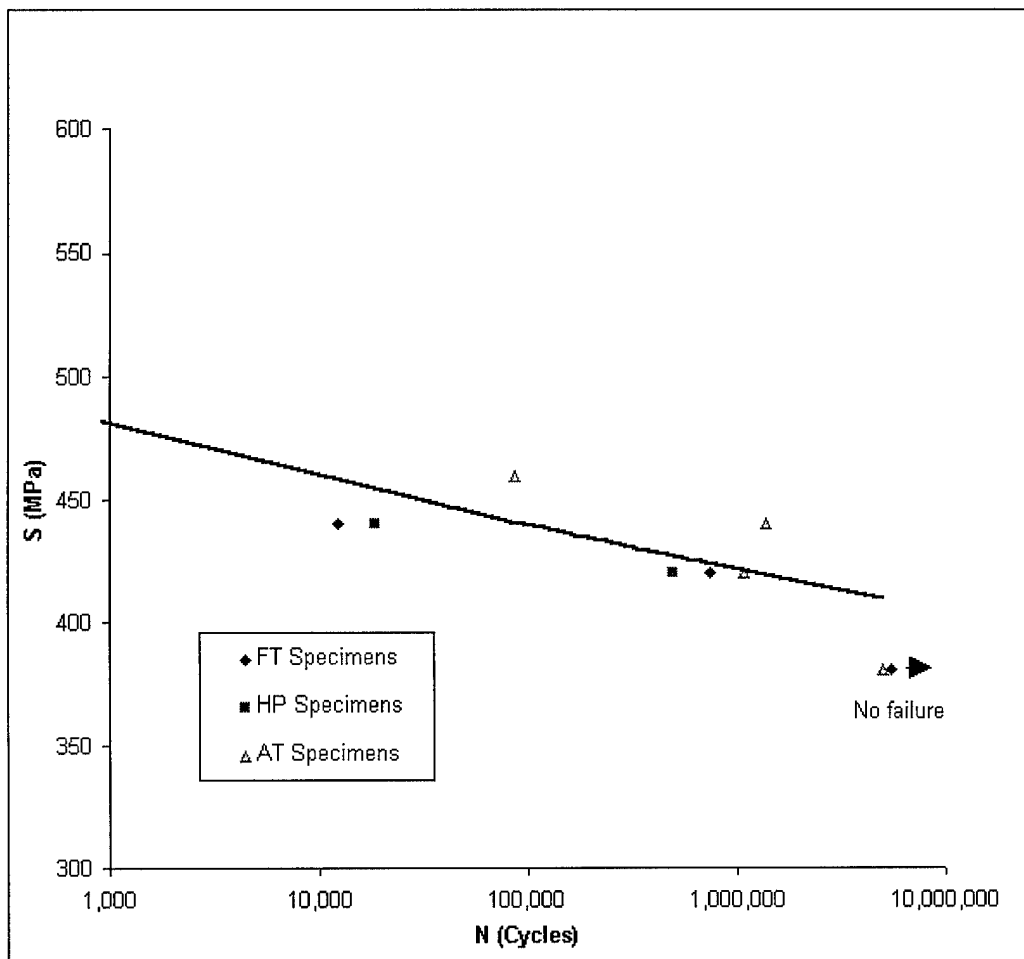
Figure 24. S-N Curve

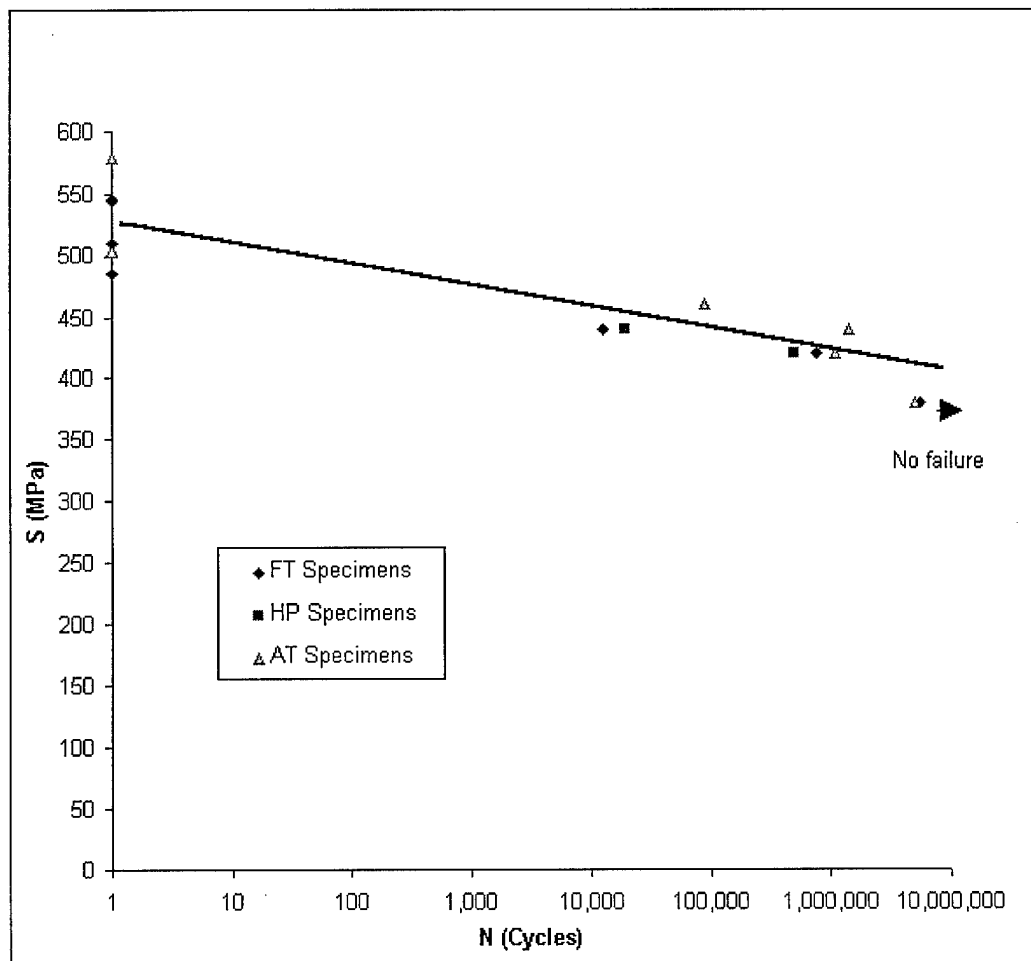
Figure 25. S-N Curve on Larger Scale

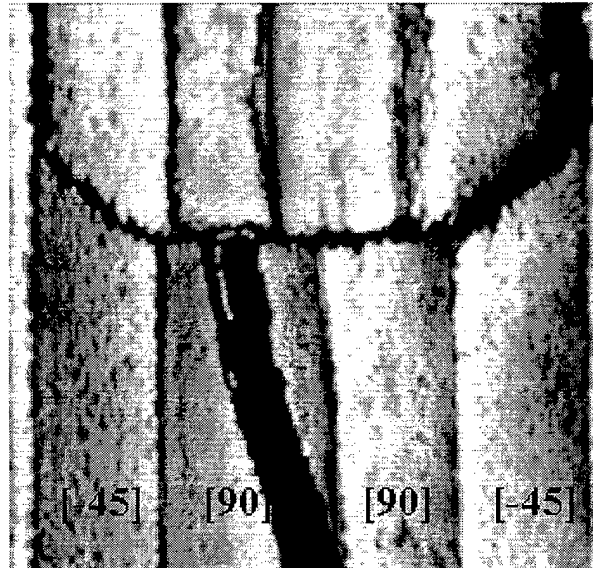
Figure 27. Delamination at Cycle 1k - Specimen AT2

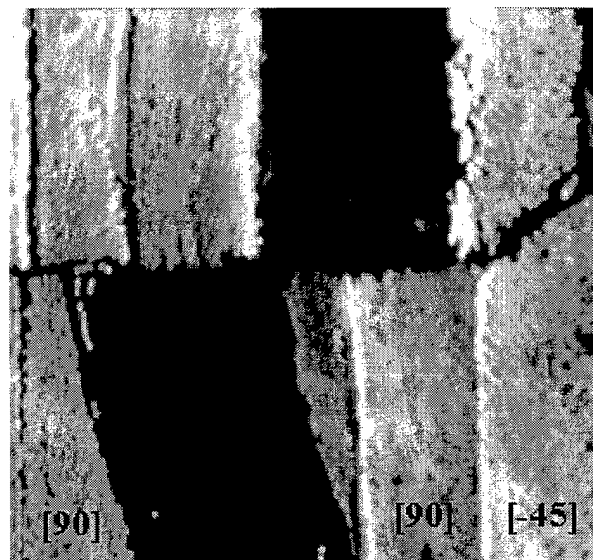
Figure 28. Delamination at Cycle 10k - Specimen AT2

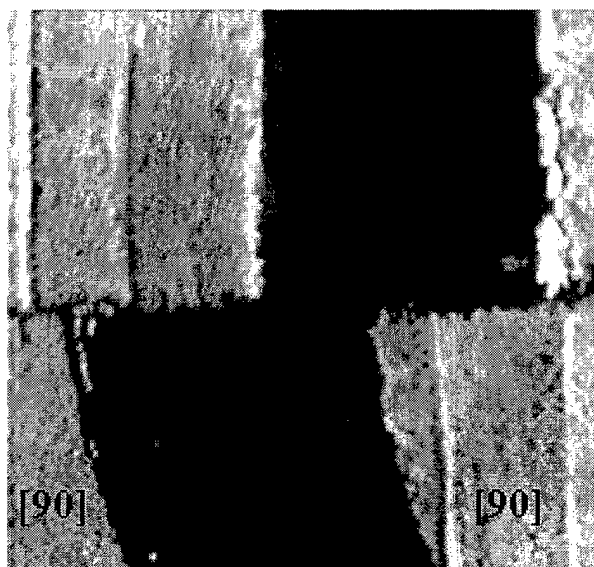
Figure 29. Delamination at Cycle 50k - Specimen AT2

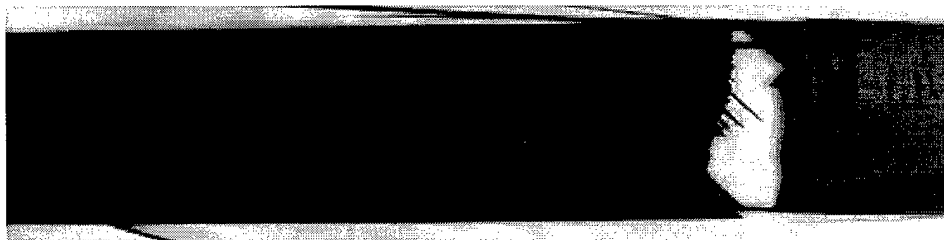
Figure 30. Failed Specimen FT4

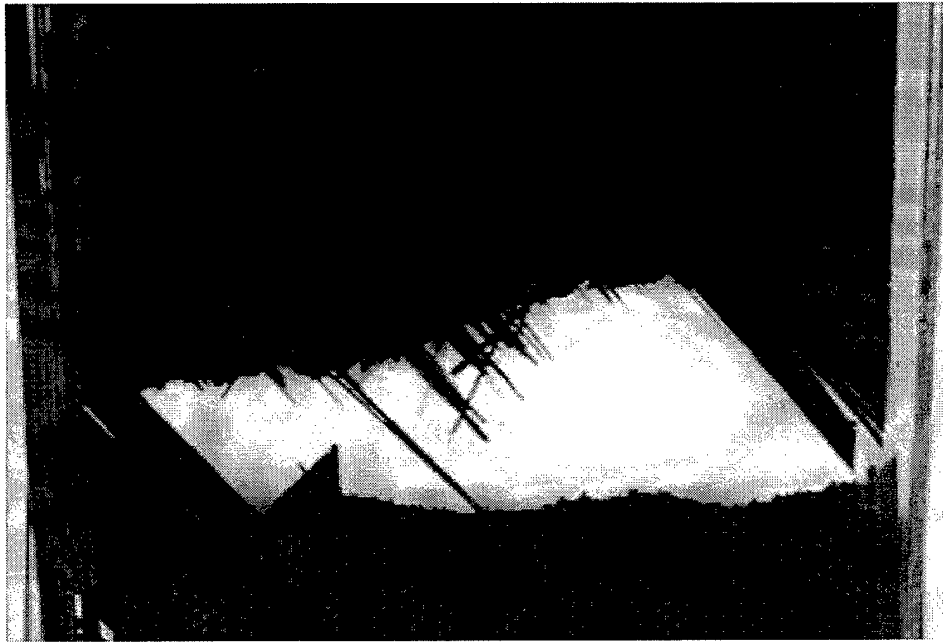
Figure 31. "Jagged" Failure Area - Specimen FT4

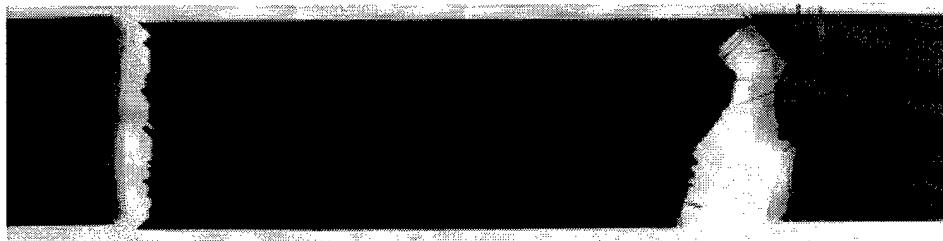
Figure 34. Failed Specimen FT5

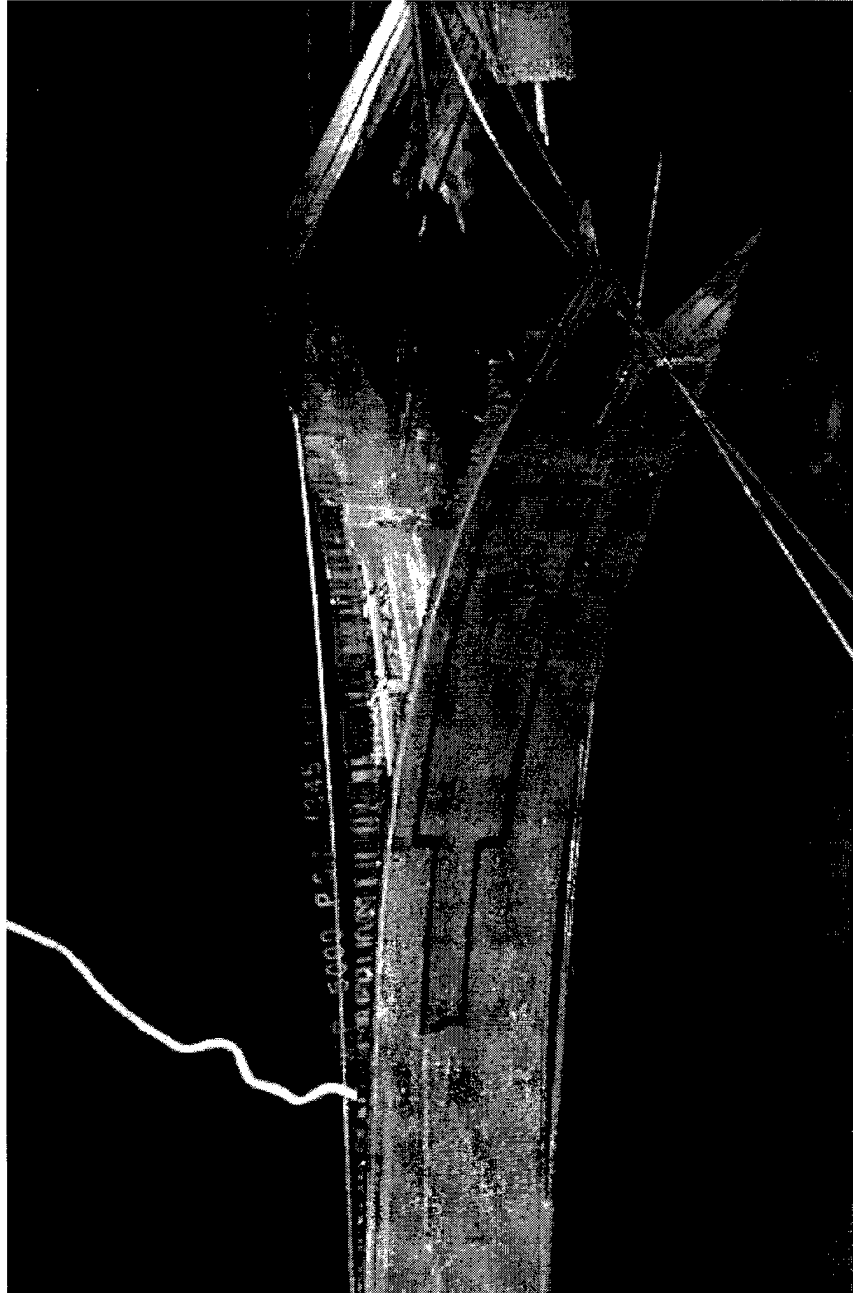
Figure 35. Failed Specimen AT2

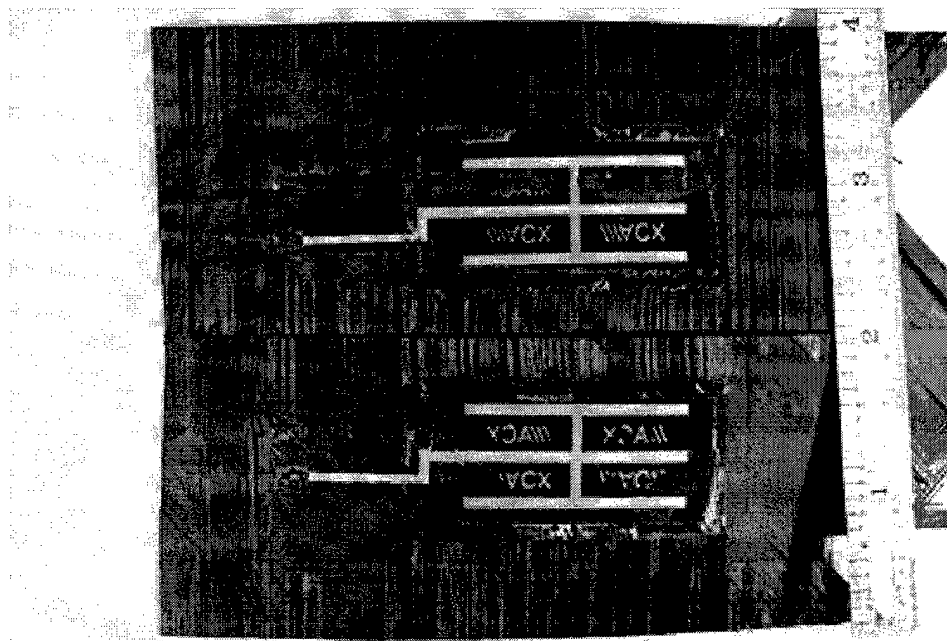
Figure 36. Split PZT of Specimen AT2

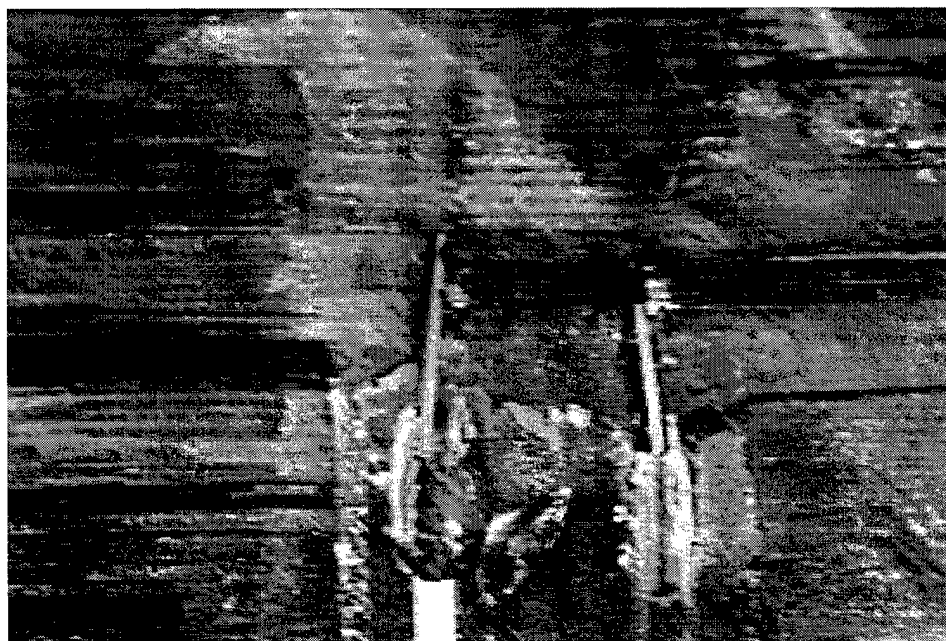
Figure 37. Lead Wires of Specimen AT2

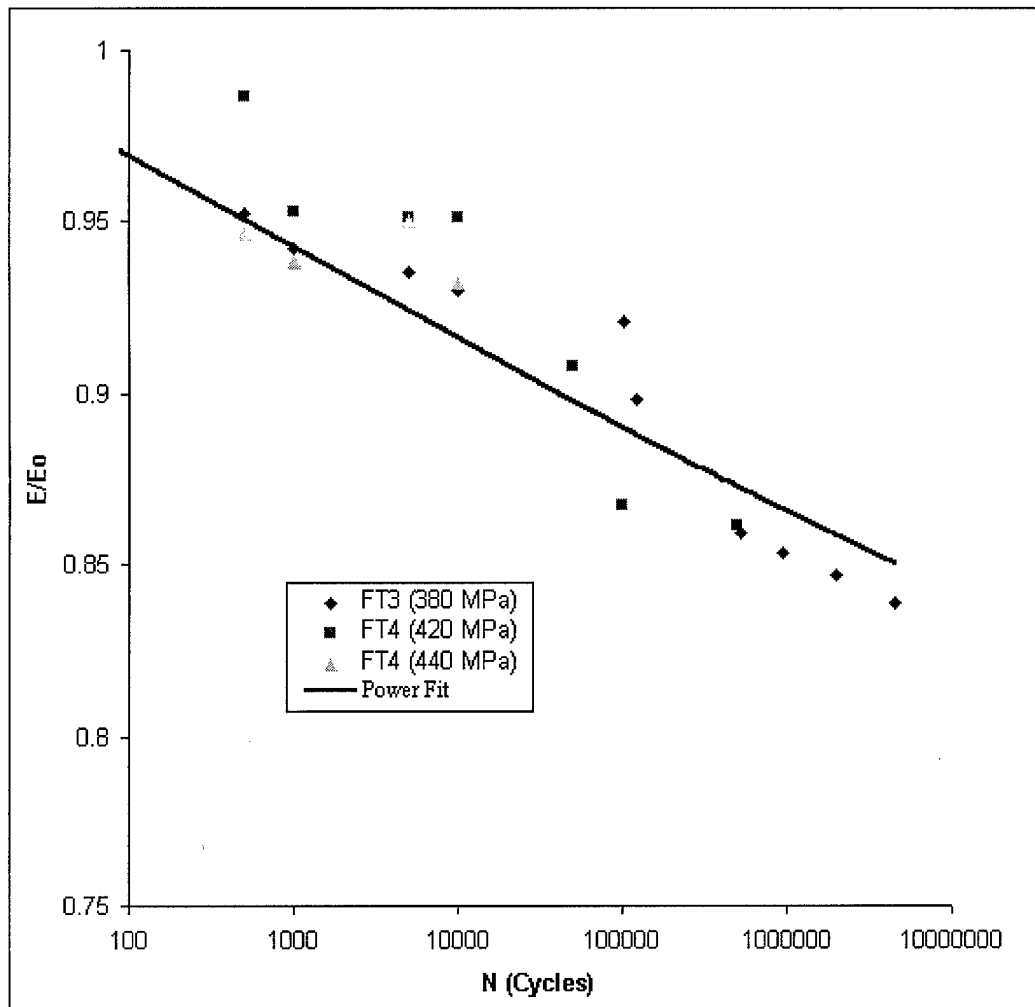
Figure 38. Normalized Modulus vs Cycles - FT Specimens

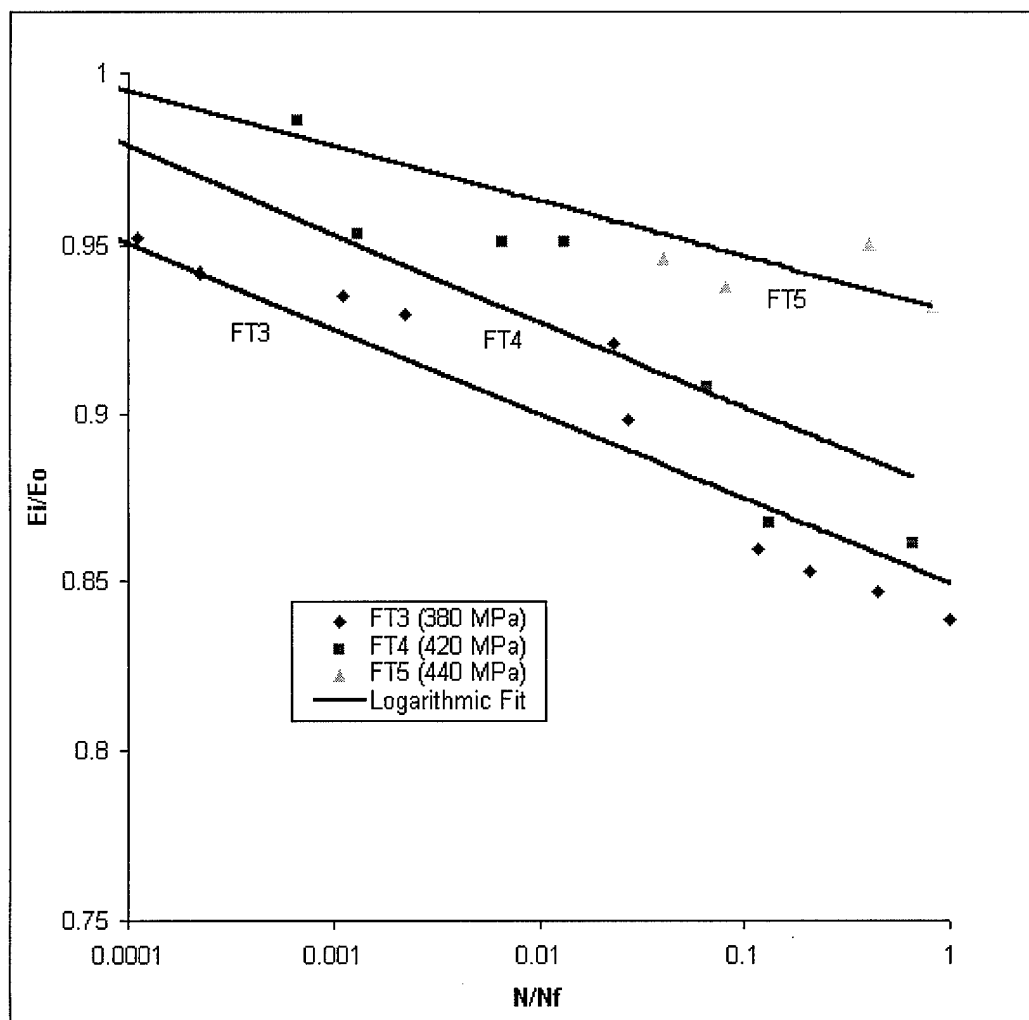
Figure 39. Normalized Modulus vs Normalized Cycles - FT Specimens

When the normalized modulus is compared with the normalized cycles to failure, stiffness reduction trends are more noticeable. Figure 39 clearly shows the different extent of stiffness reduction for each specimen. Specimen FT5 was tested at the highest load and failed after only 12,000 cycles. Obviously, there was no substantial fatigue damage before the ultimate strength of the laminate was reached. FT4's curve was slightly above FT3's curve, which indicates less fatigue damage for higher loads again. The higher stress level was sufficient to fail the specimen at an earlier point in fatigue cycling.

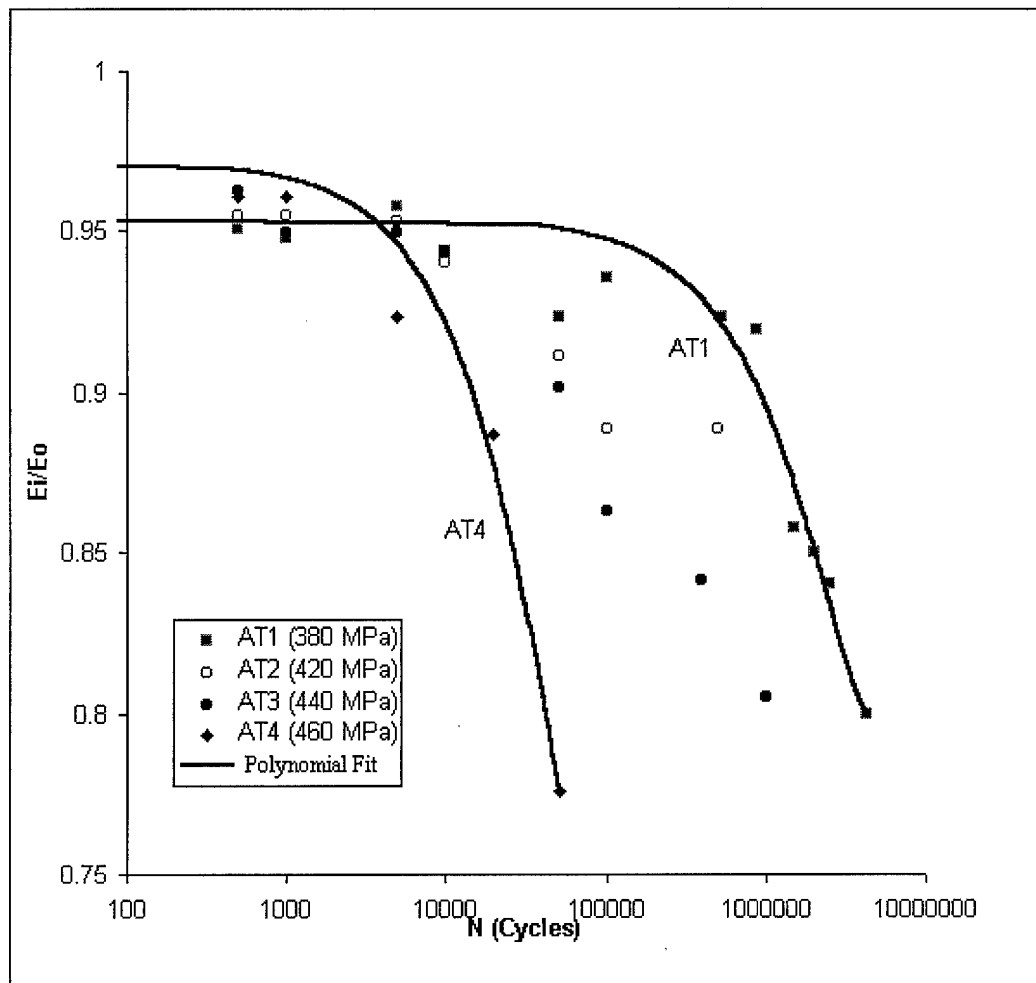
Figure 40. AT Specimens Normalized Modulus vs Cycles
