## Fatigue Behavior of a Quasi-Isotropic Graphite/Epoxy Laminate Embedded with a Piezoelectric Sensor

**Fatigue Behavior of a Quasi-Isotropic  
Graphite/Epoxy Laminate Embedded with a  
Piezoelectric Sensor**

**Thesis**

**Jon M. Coleman B.S.M.E., M.B.A.  
Captain, USAF**

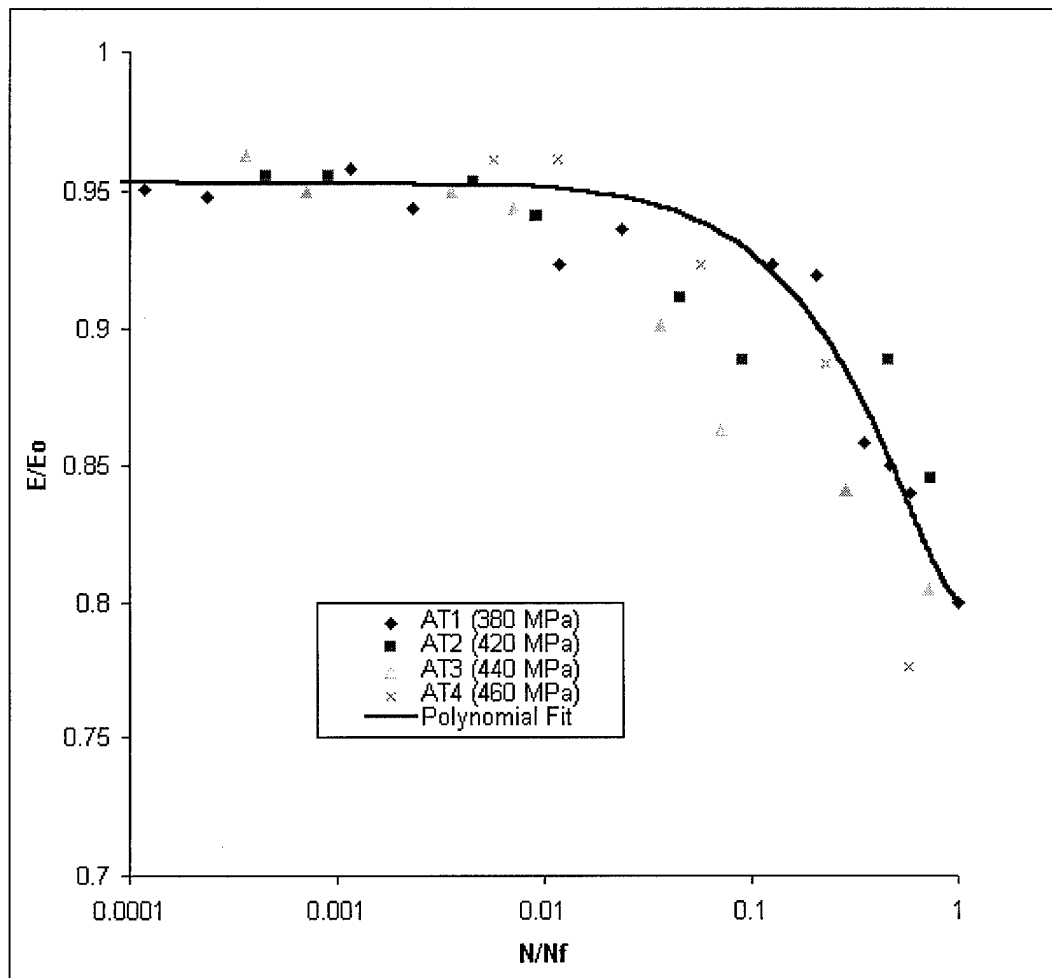
Figure 41. AT Specimens Normalized Modulus vs Normalized Cycles

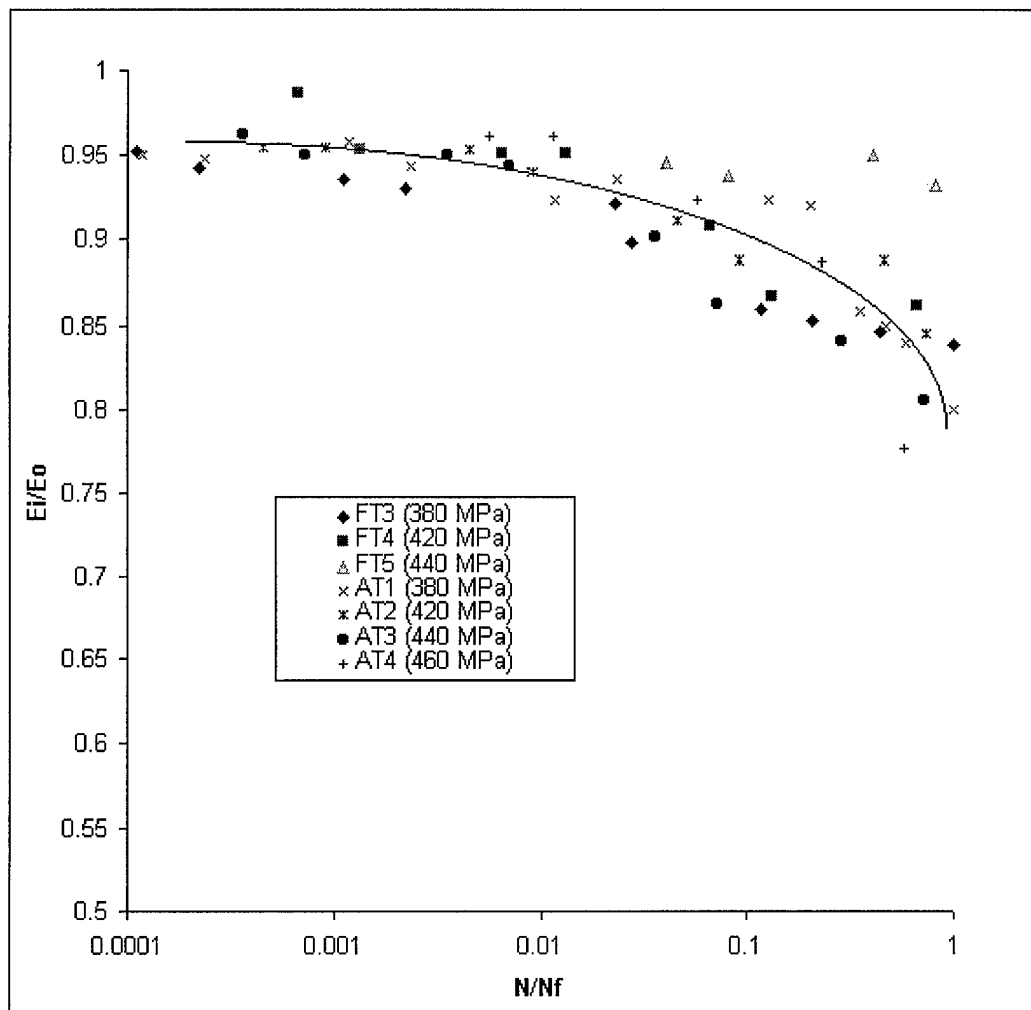
Figure 42. Normalized Modulus vs Normalized Cycles on Larger Scale

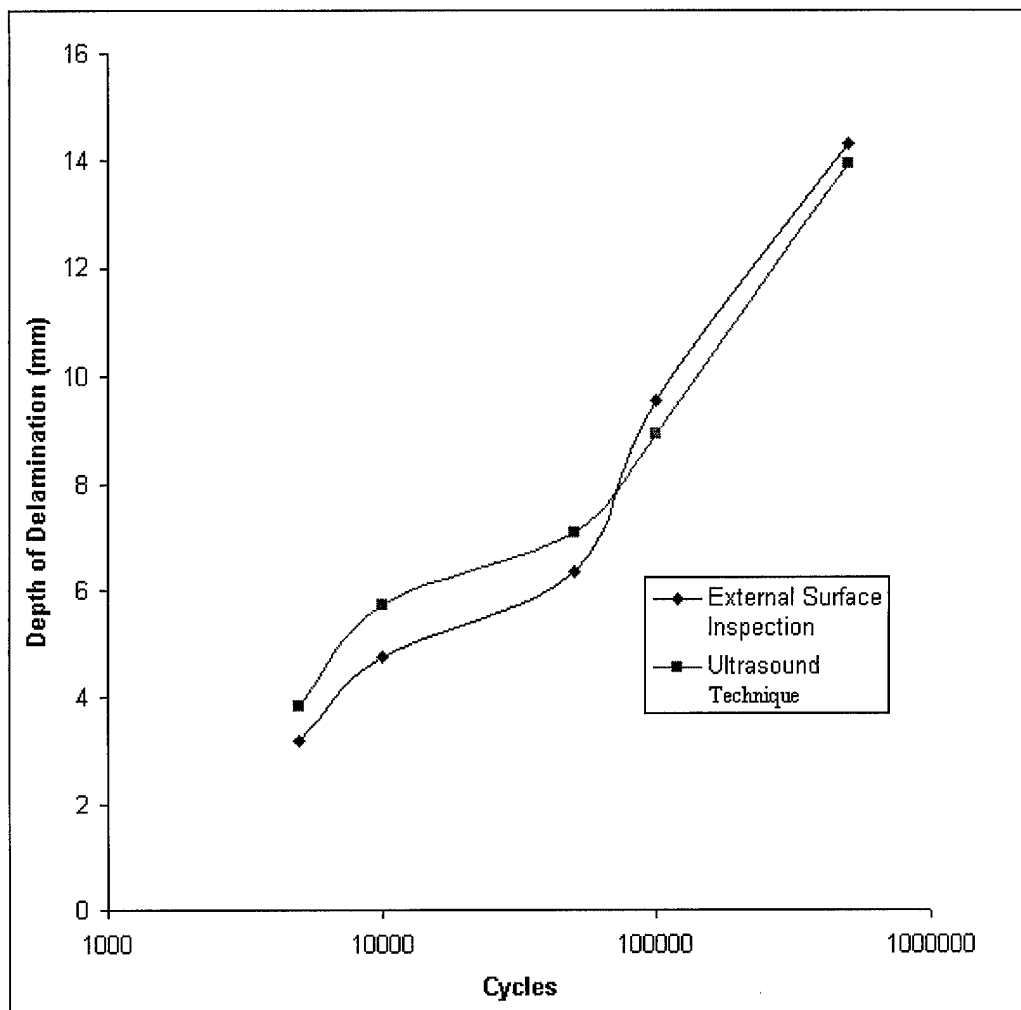
Figure 43. Comparison of External Surface and Ultrasound Inspection Methods - Specimen FT6

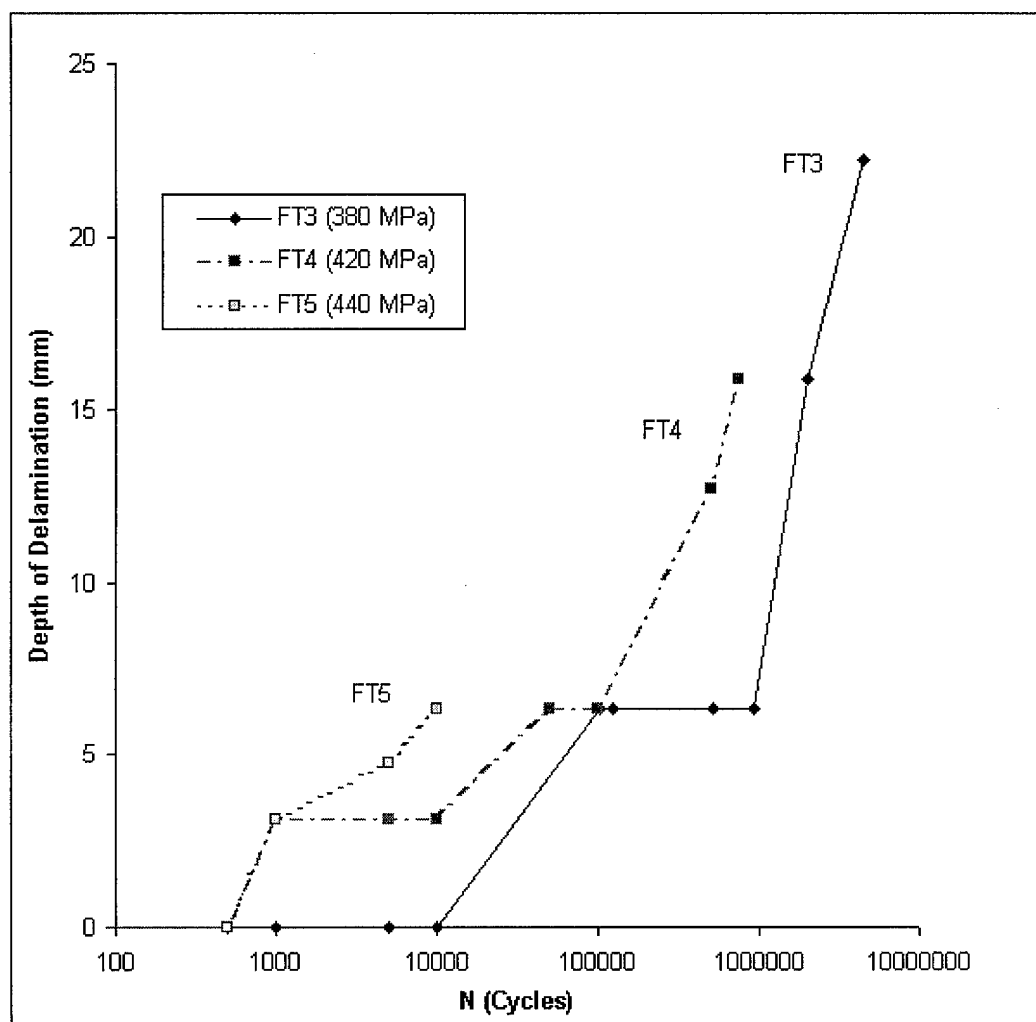
Figure 44. Depth of Delamination vs Cycles - FT Specimens

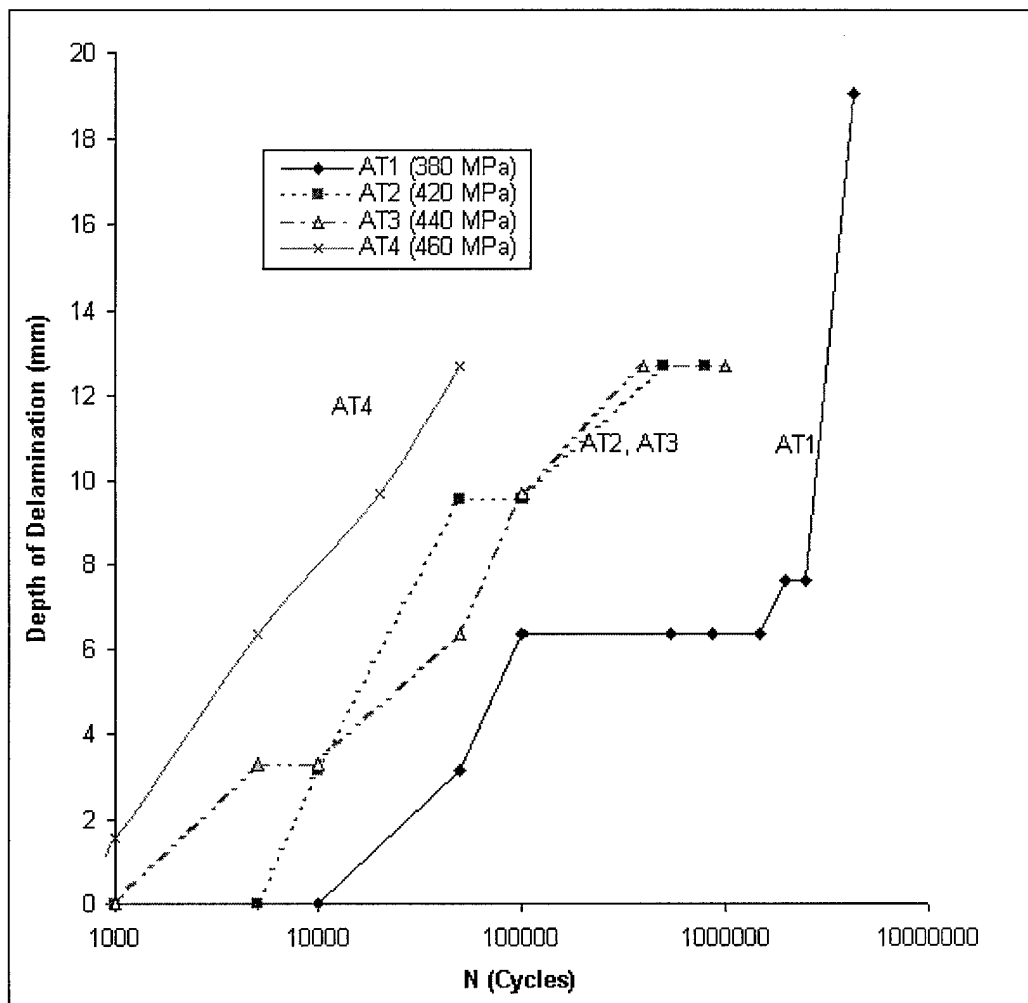
Figure 45. Depth of Delamination vs Cycles - AT Specimens

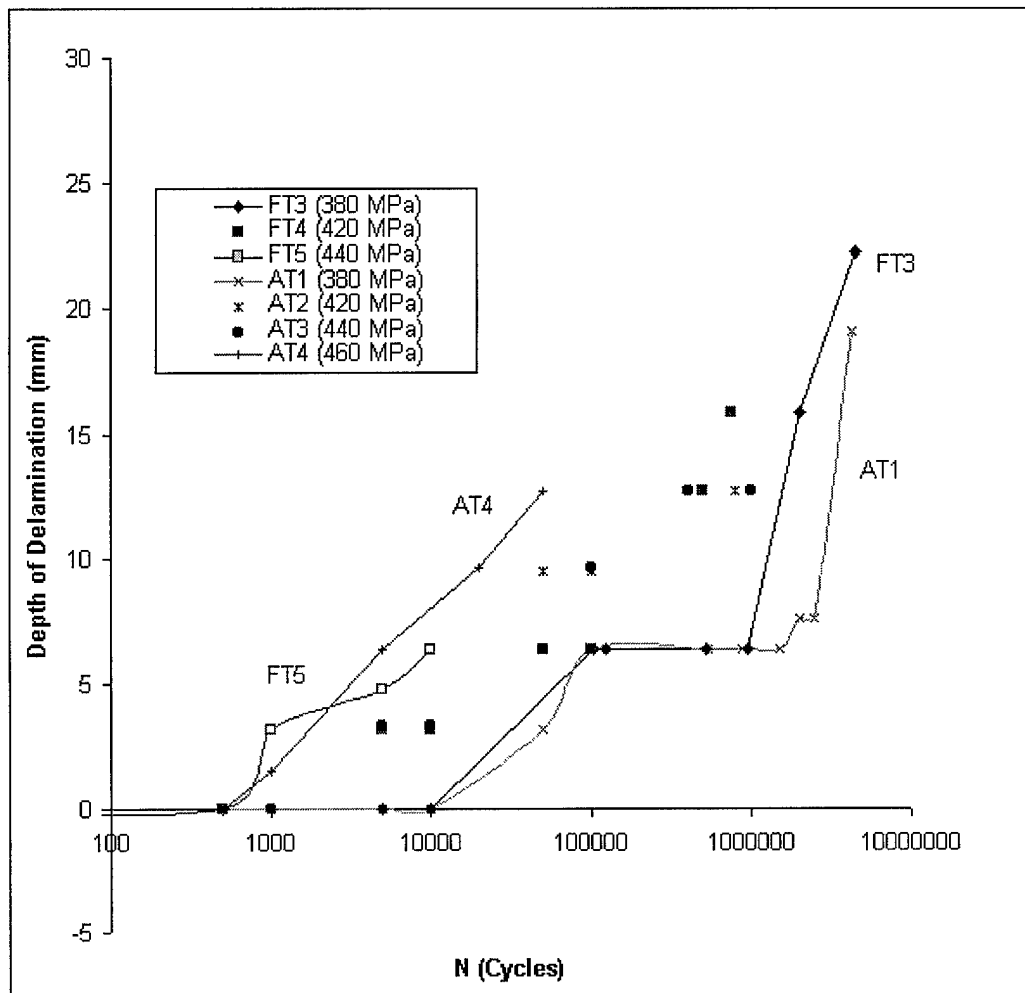
Figure 46. Depth of Delamination vs Cycles for All Specimens

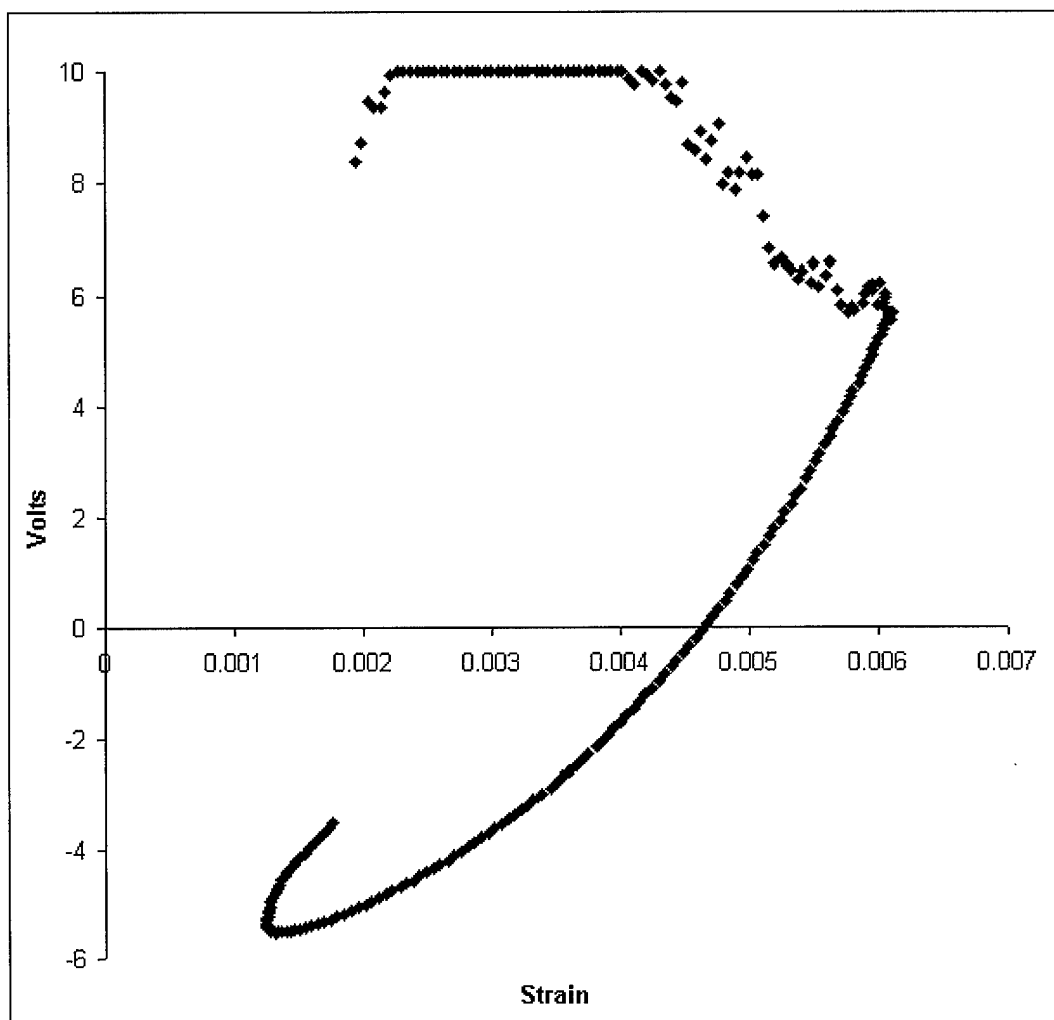
Figure 50. Output Voltage vs Strain - Specimen AT1, Cycle 1, (380 MPa)

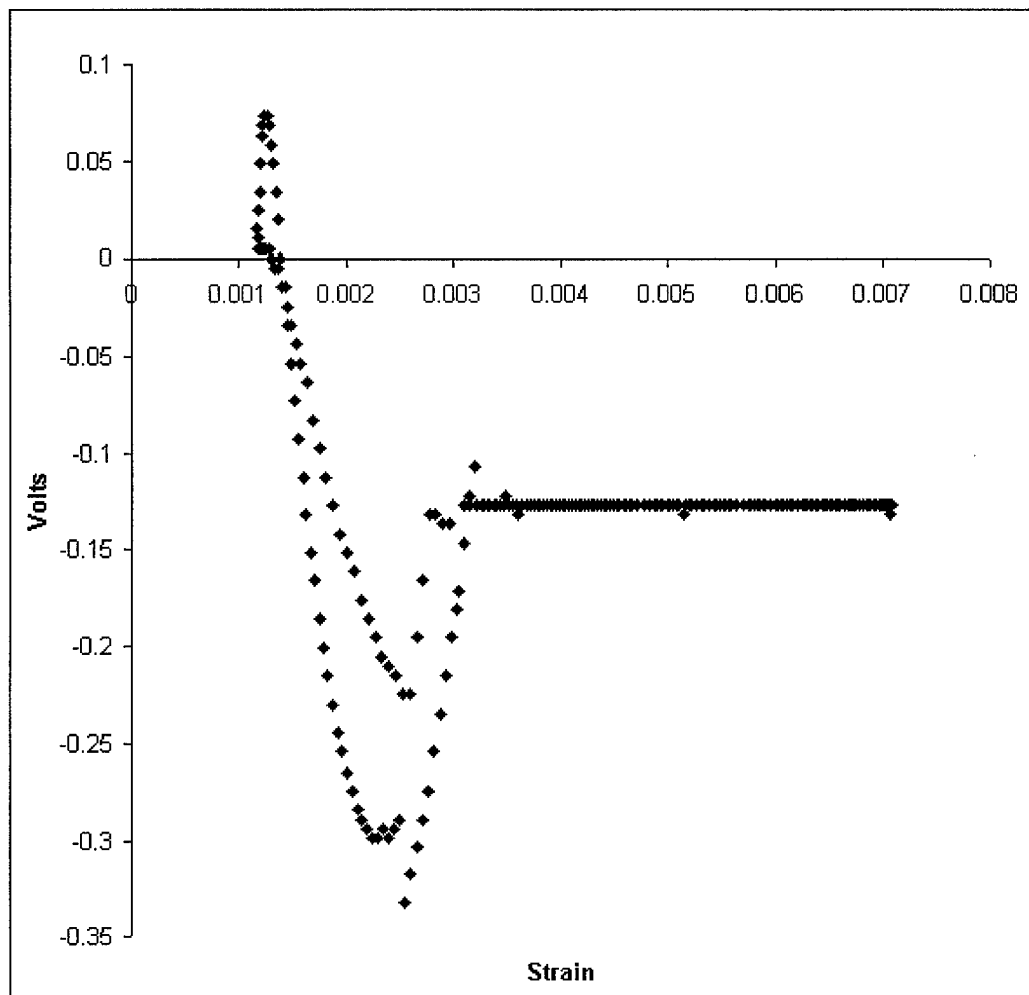
Figure 51. Output Voltage vs Strain - Specimen AT1, Cycle 10,000. (380 MPa)

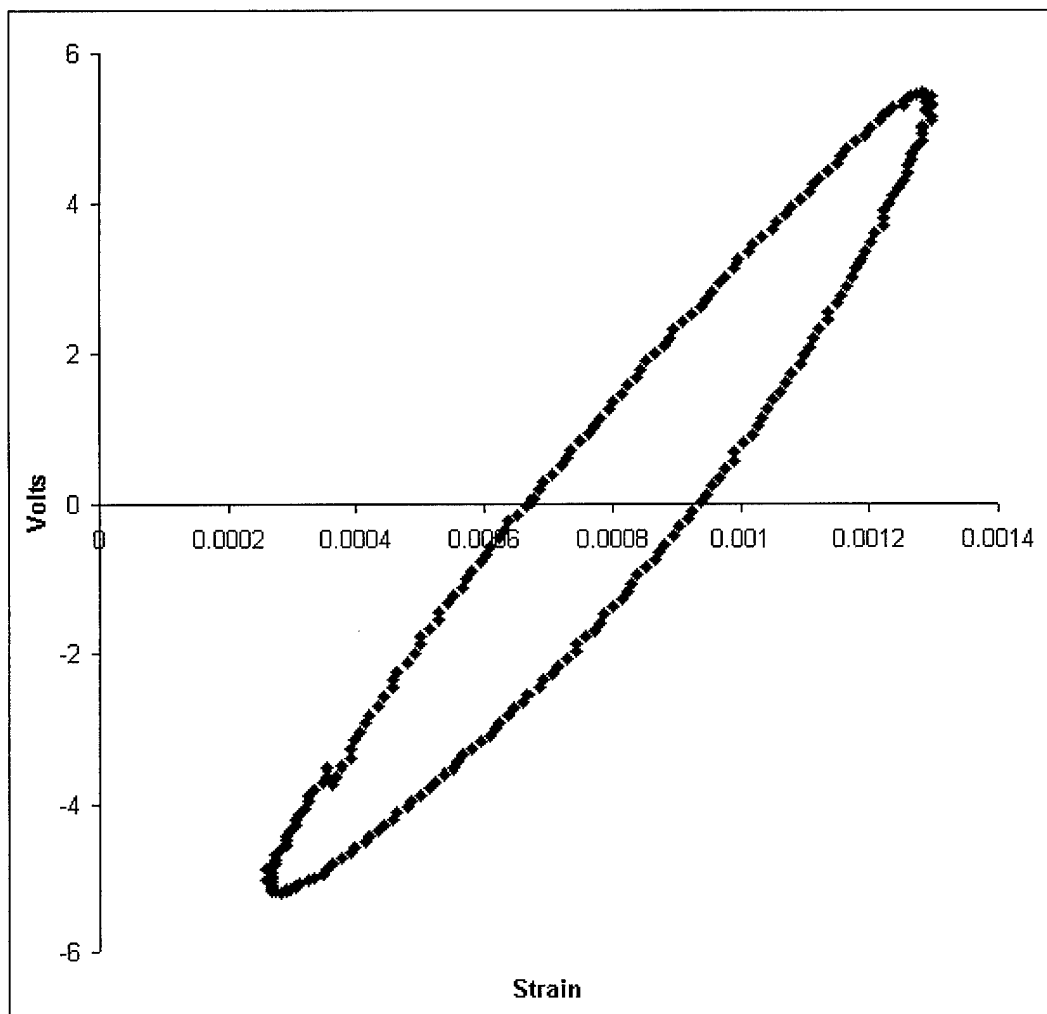
Figure 52. Output Voltage vs Strain - Specimen AT1, Cycle 1 (60 MPa)

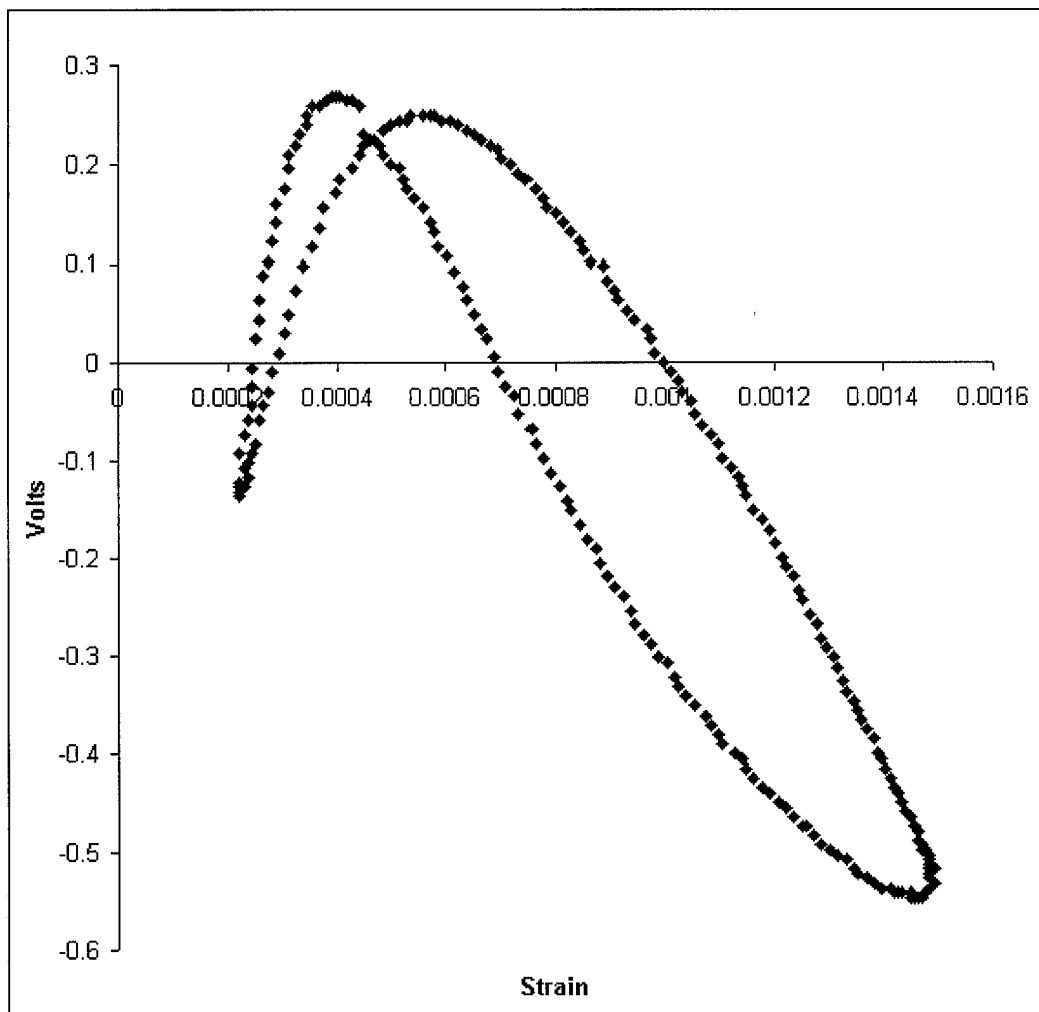
Figure 53. Output Voltage vs Strain - Specimen AT1, Cycle 500 (76 MPa)

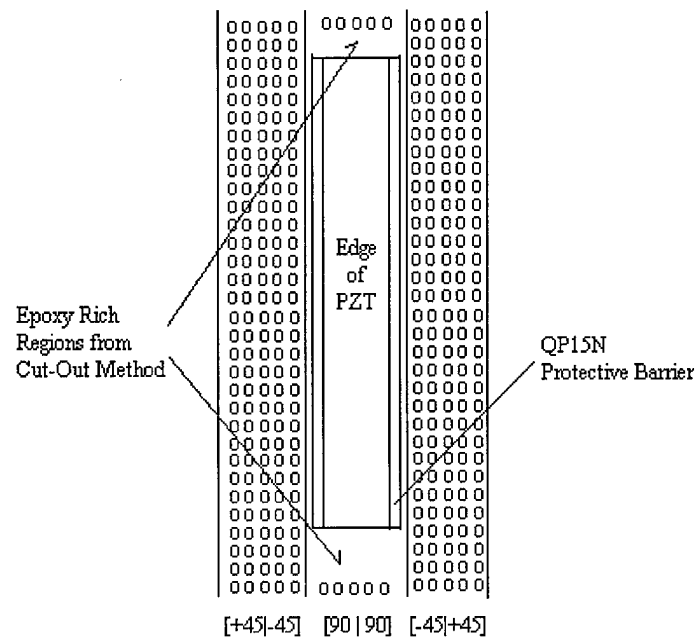
Figure 54. Schematic Edge View of Specimen AT5 with the Embedded PZT at the Edge

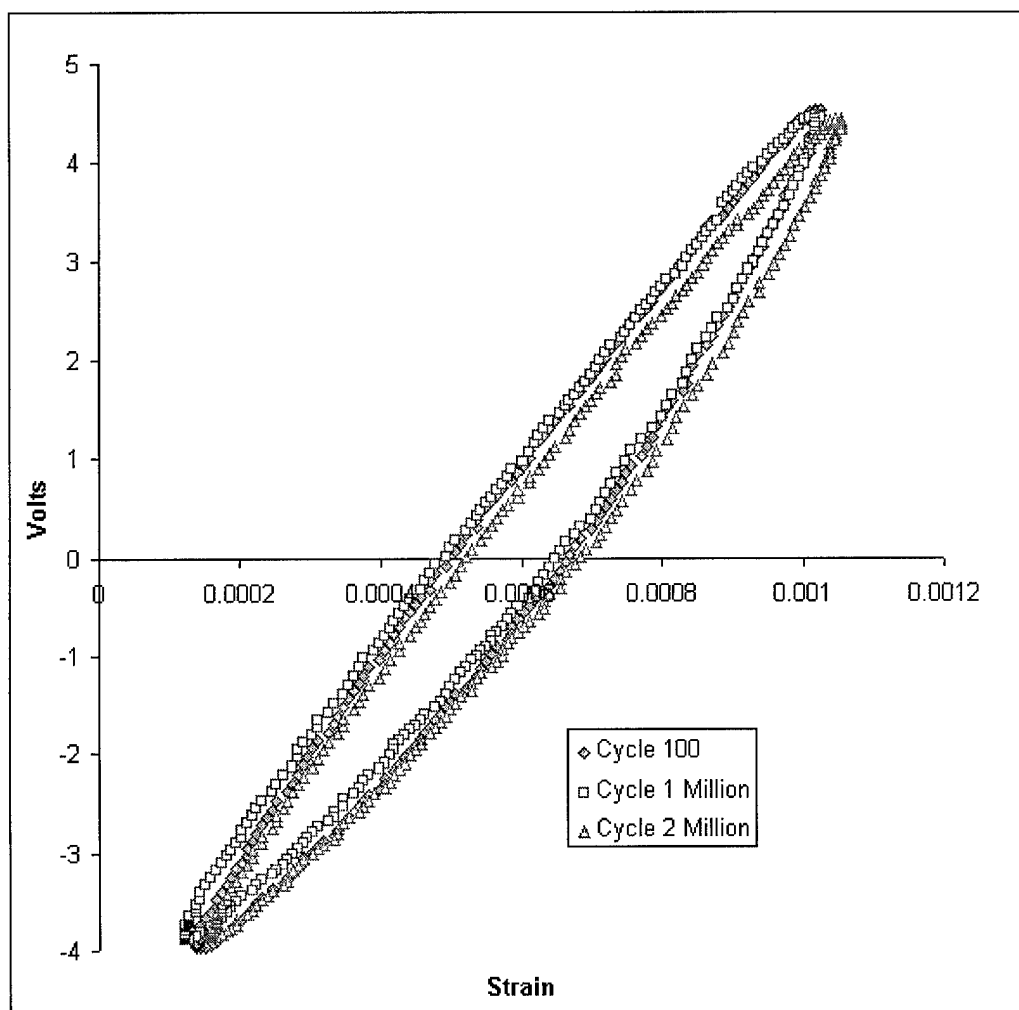
Figure 55. Voltage vs Strain - Specimen AT5 , Comparison of Output at 1000  $\mu\epsilon$

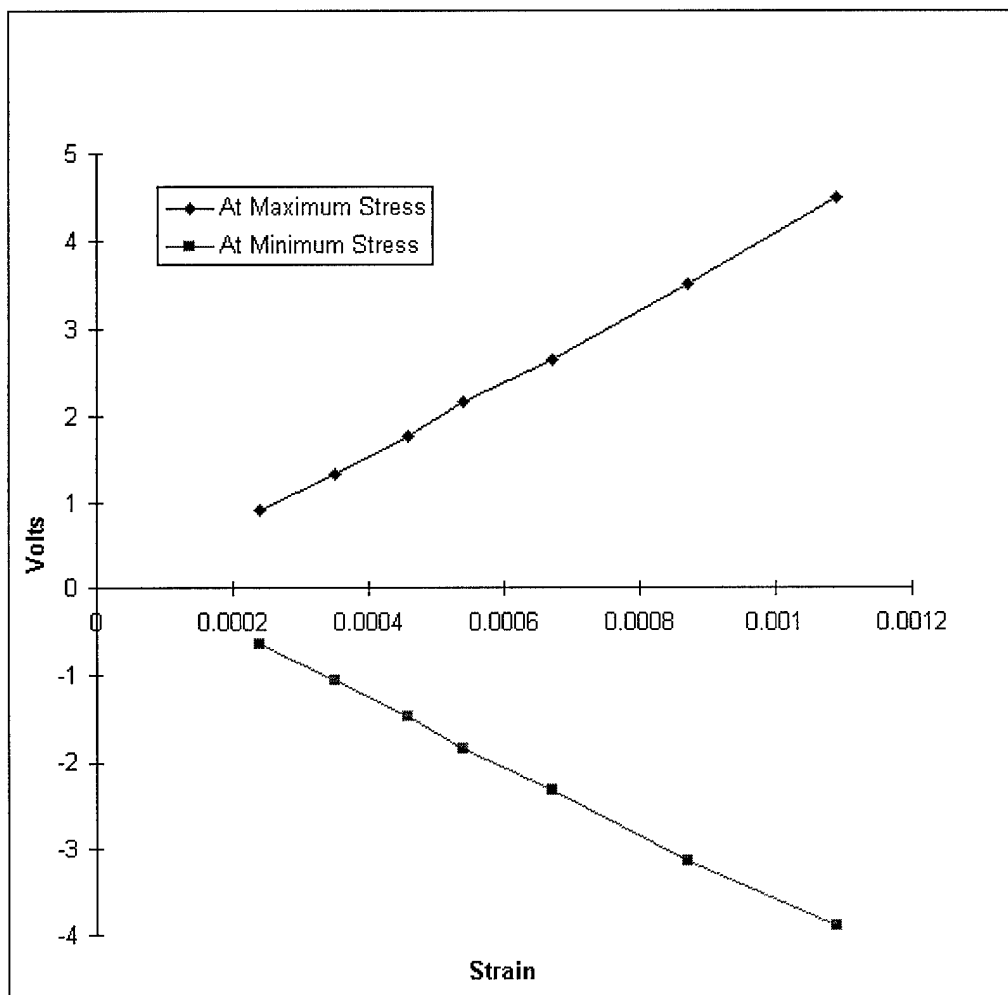
Figure 58. Voltage Output vs Strain Calibration During Cycling - Specimen AT5

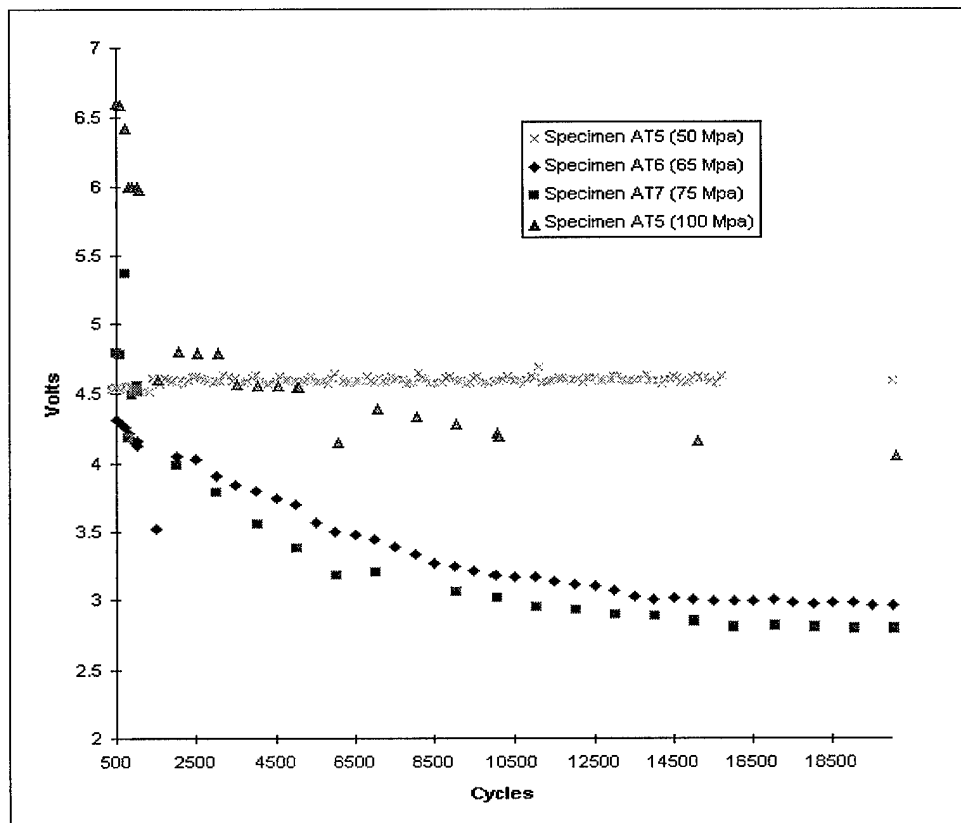
Figure 59. Voltage Degradation vs Cycles

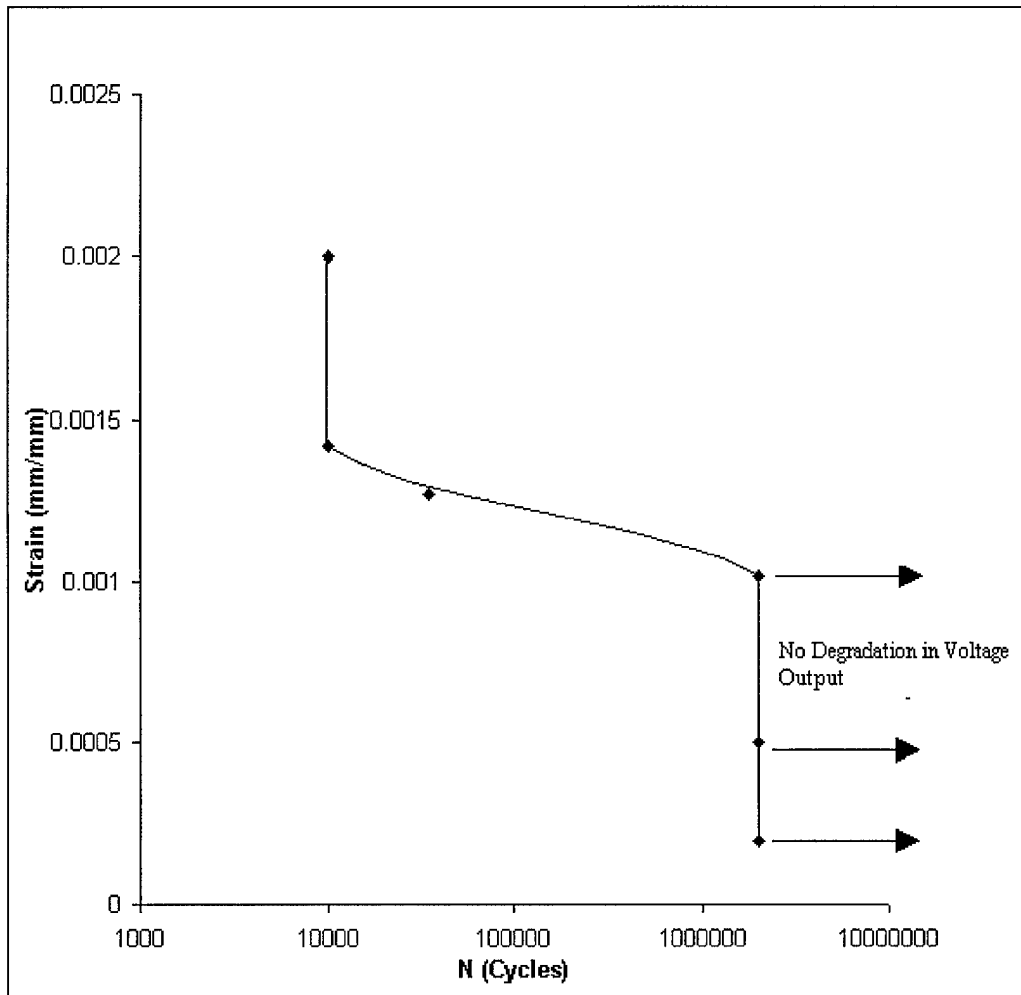
Figure 60. Strain vs Cycles to Sensor Failure, Based on 40 % Reduction of Voltage Output

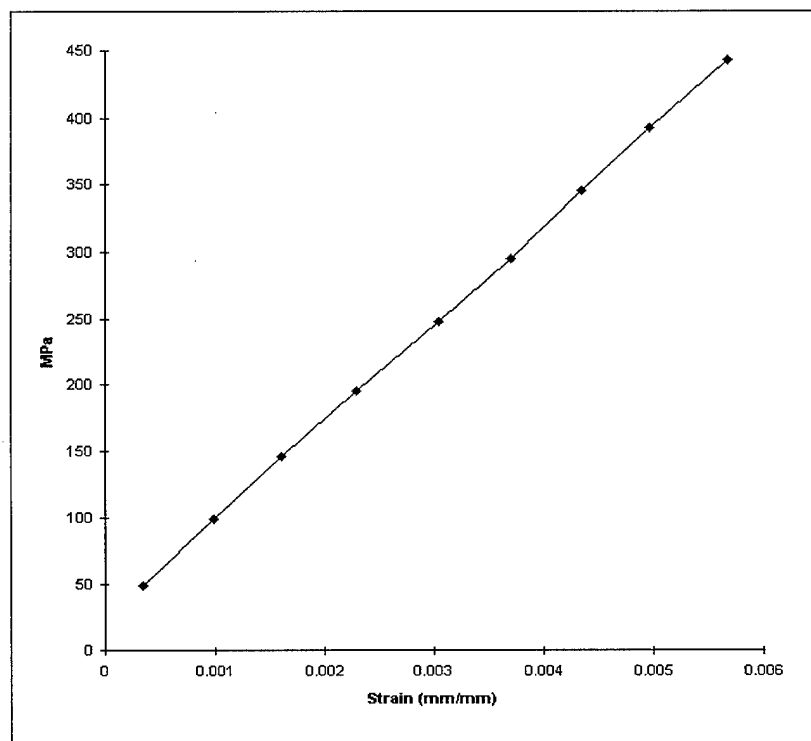
Figure 61. Stress-Strain Curve for AAT2

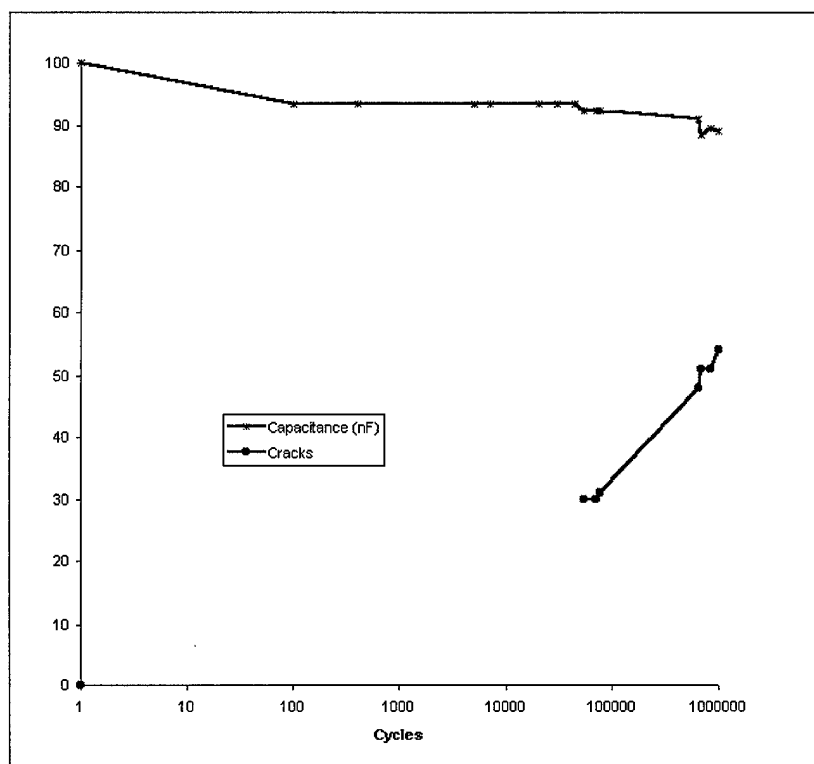
Figure 62. Specimen AAT2 Capacitance & Cracks vs Cycles

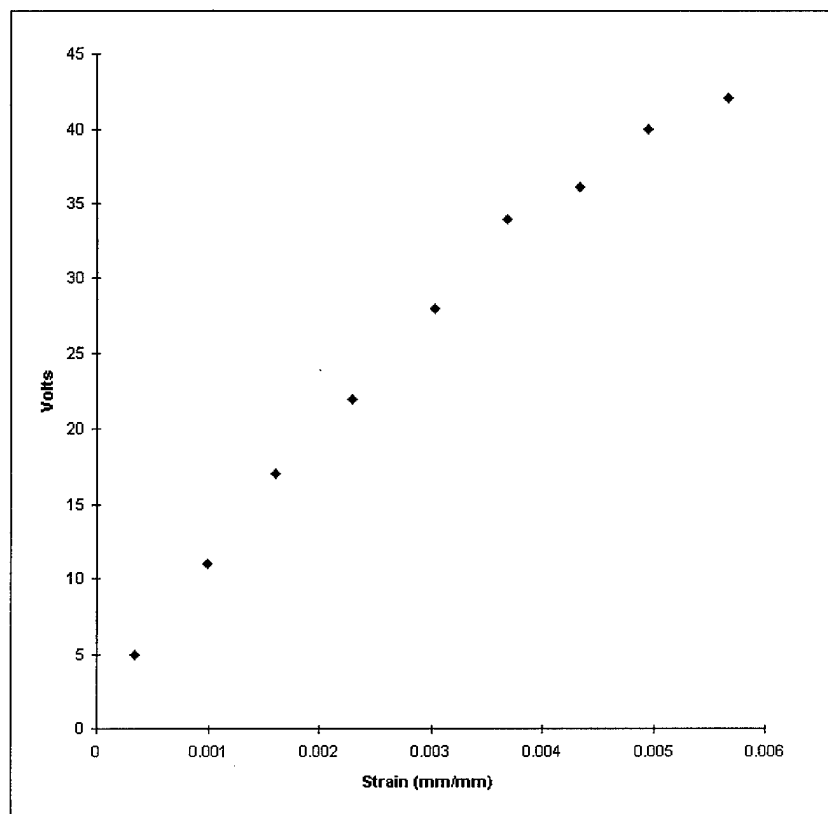
Figure 63. Specimen AAT2 Voltage Output vs Strain

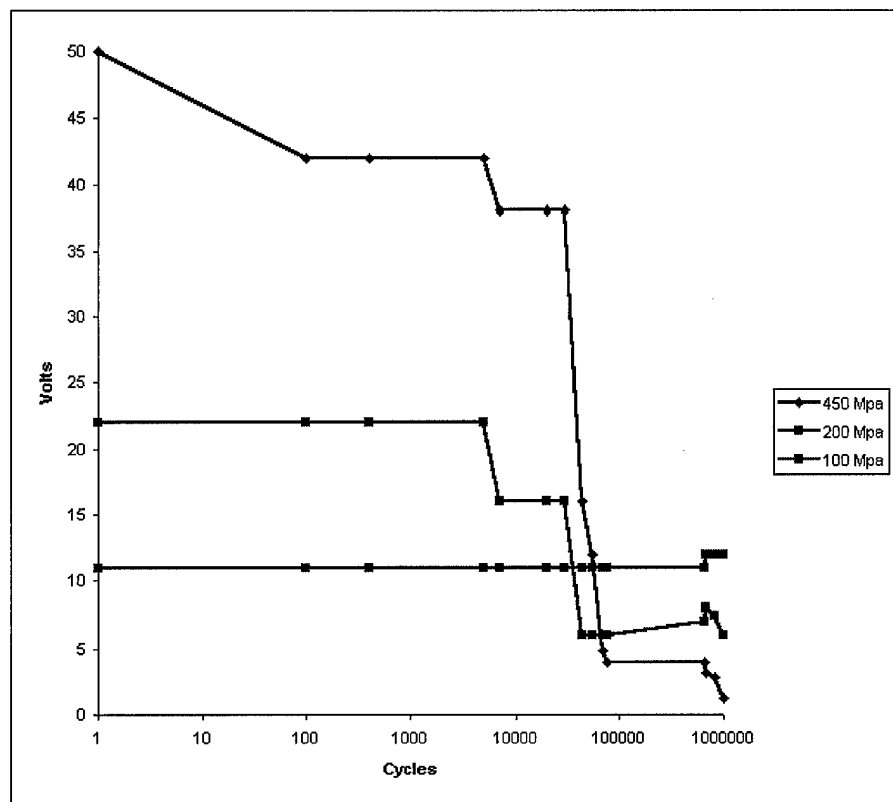
Figure 64. Specimen AAT2 Degradation of Voltage Output at Various Applied Stress Levels

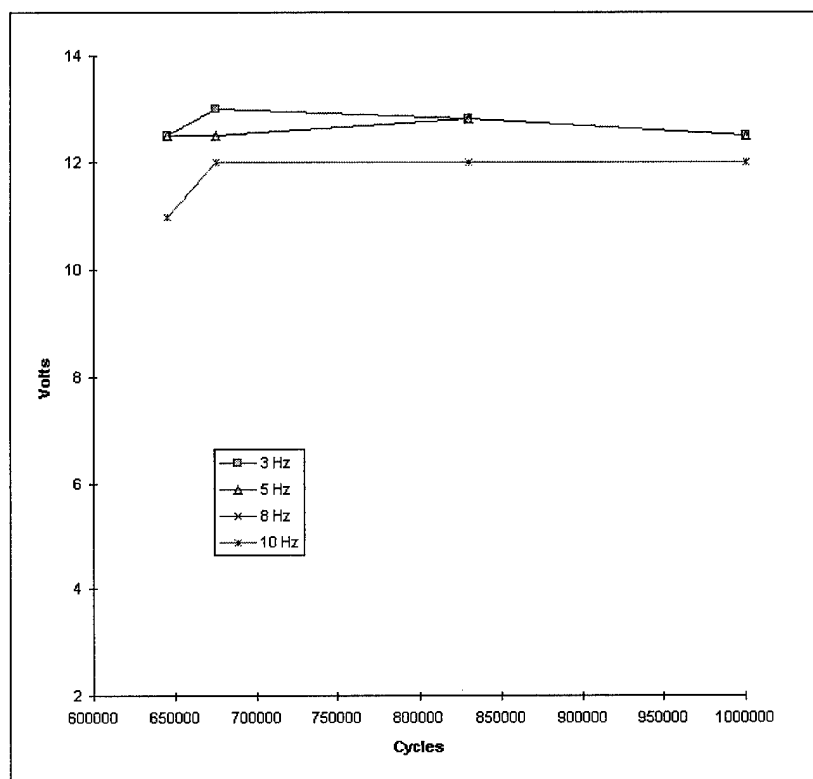
Figure 65. Frequency Effects on Voltage Output at 100 MPa

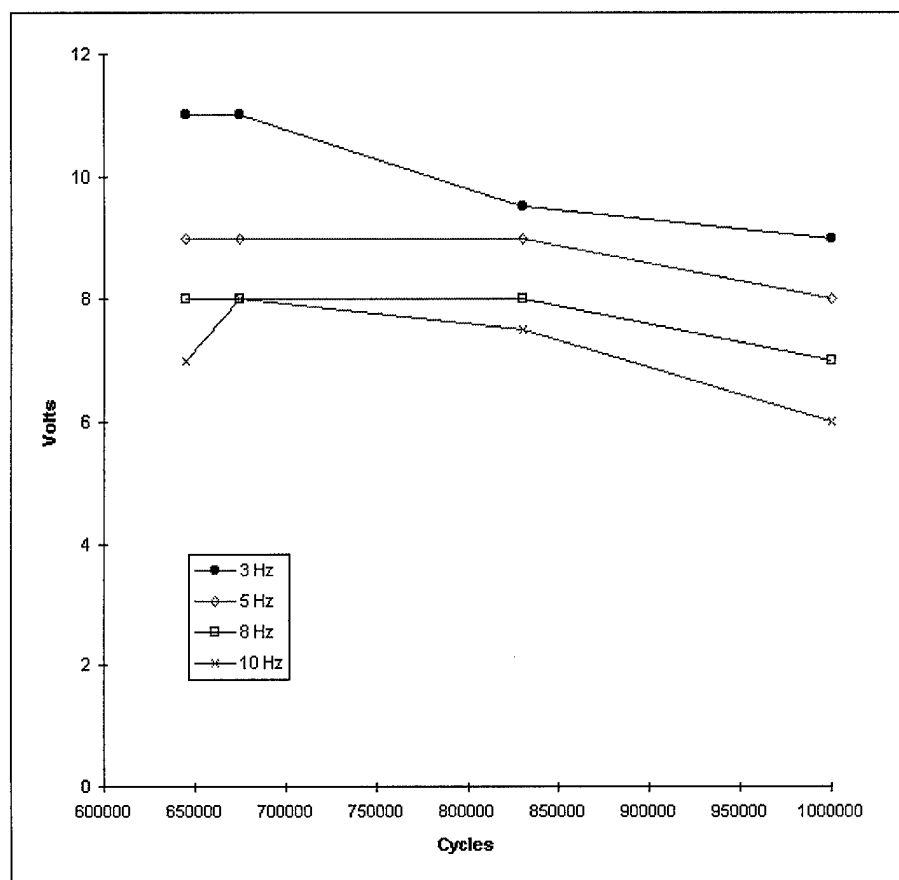
Figure 66. Frequency Effects on Voltage Output at 200 MPa

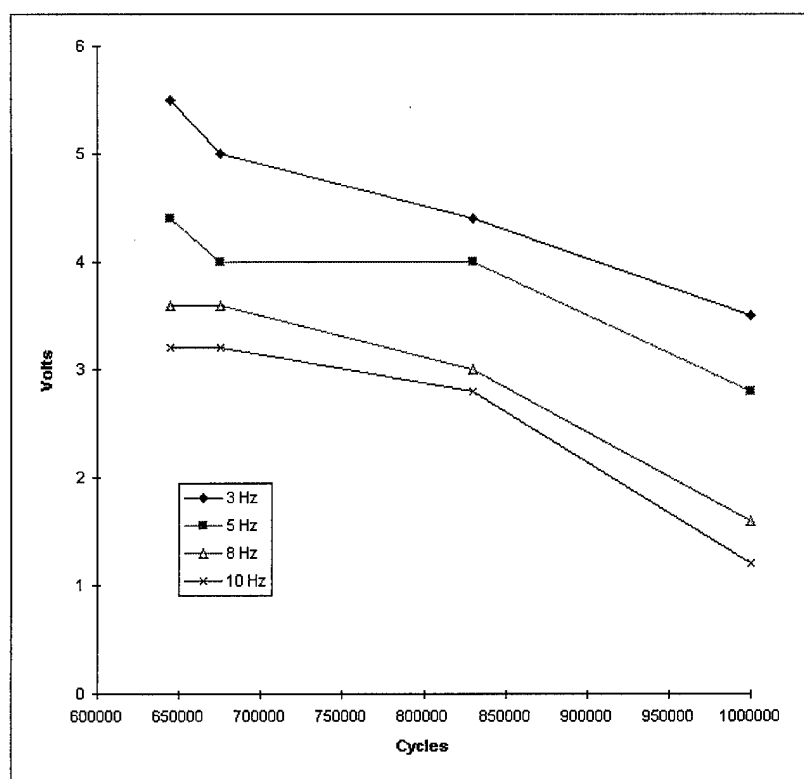
Figure 67. Frequency Effects on Voltage Output at 450 MPa
