Electro-Mechanical Fatigue Behavior of a Quasi-Isotropic Laminate with an Embedded Piezoelectric Actuator

AFIT/GAE/ENY/98S-02.

Thesis

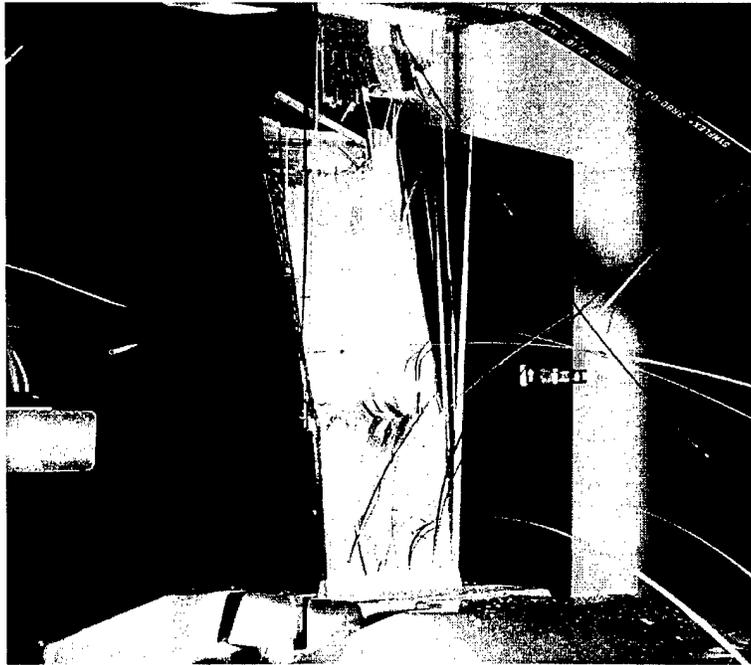
Figure 50. Specimen MAF2 Failure under Tension-Tension Loading, $\sigma = 740$ MPa

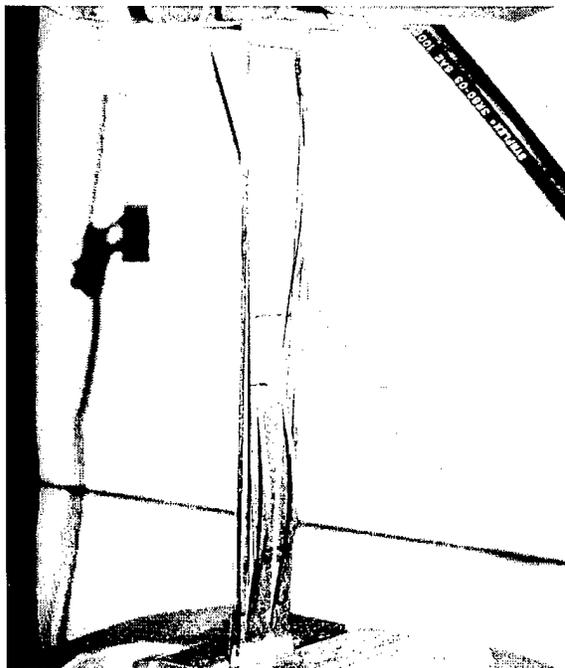
Figure 53. Specimen MF4 at 5,000 cycles
