## **Stress/Strain Ratio Effects on Fatigue Response of a SCS-6/ Ti-15-3 Metal Matrix Composite at Elevated Temperature**

THESIS

AFIT/GAE/ENY/95D-14

DEPARTMENT OF THE AIR FORCE  
AIR UNIVERSITY  
**AIR FORCE INSTITUTE OF TECHNOLOGY**

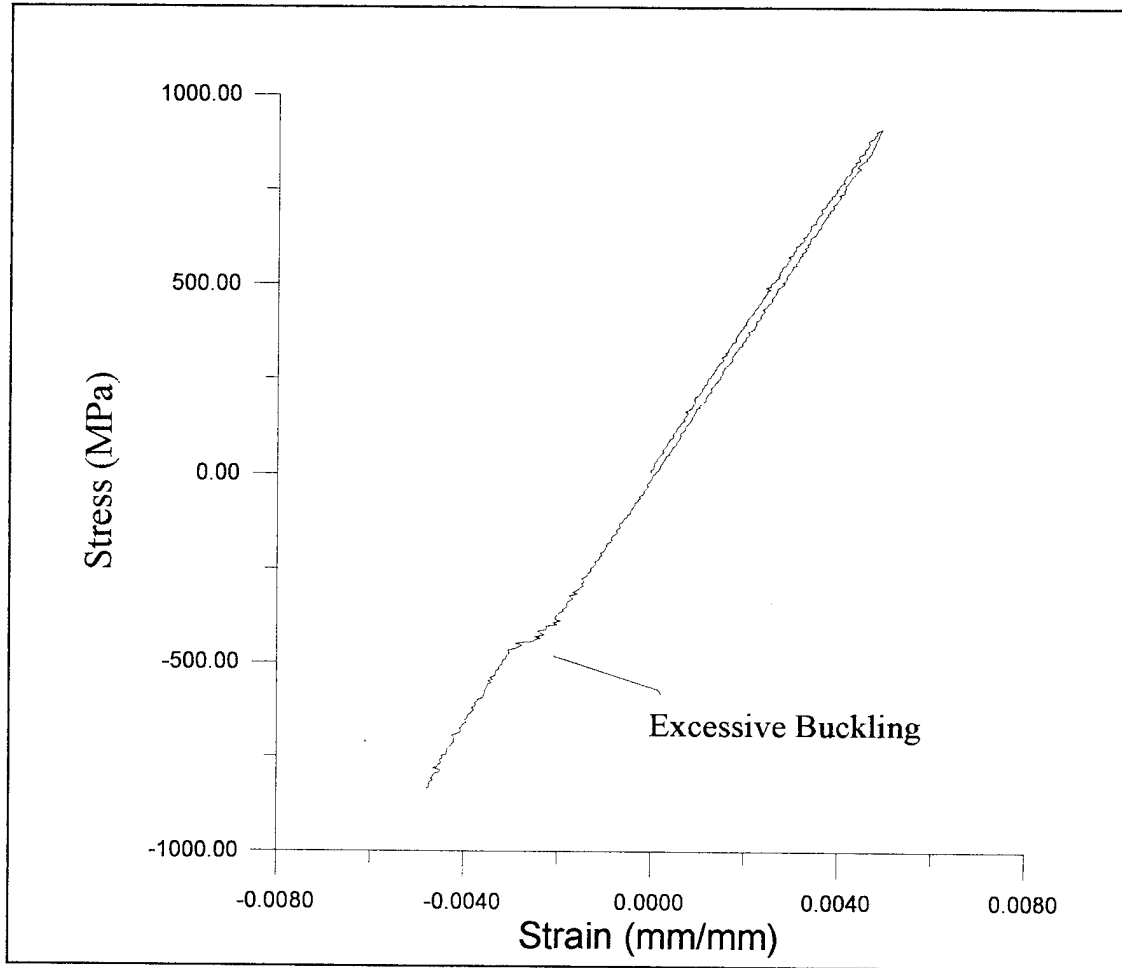
**Figure 15. Excessive Buckling**

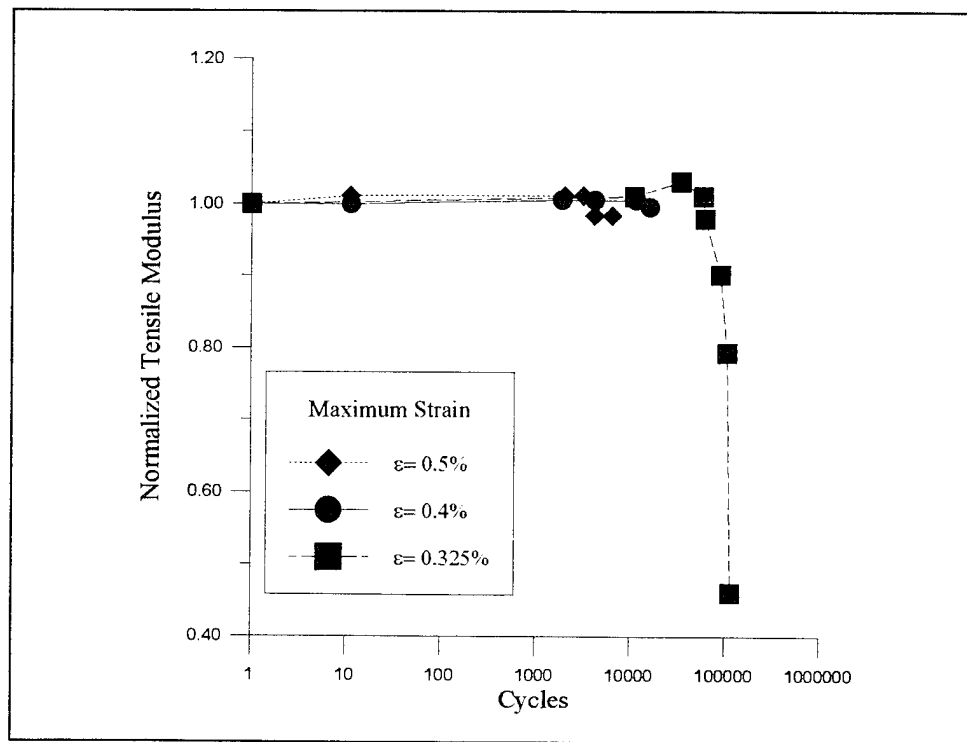
**Figure 18a. Tension-Compression ( $R_c = -1$ ) Tensile Modulus Histories: Normalized Fatigue Life**

**Figure 18b. Tension-Compression ( $R_\epsilon = -1$ ) Modulus History: Cycles**

The normalized modulus history for all three tension-compression tests is shown in Figures 18a and 18b. The normalized modulus is calculated by dividing the current modulus by the initial modulus. Similarly, the normalized fatigue life is calculated by dividing the current cycle by the fatigue life of the specimen. Significant reduction in the modulus is generally a sign of damage in the specimen. Previous studies have shown that fiber cracking generally does not result in modulus degradation unless the crack opening displacement is on the order of two to three fiber diameters [18:13]. Therefore, any reduction in modulus is generally a sign that matrix damage has occurred. This will be

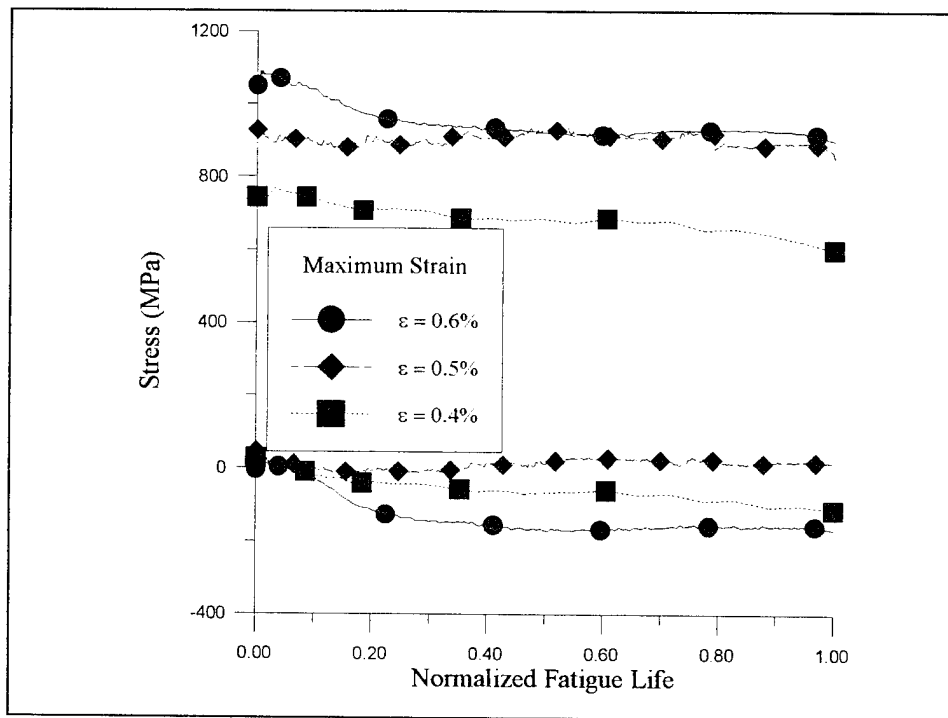
Figure 22b. Tension-Tension ( $R_\epsilon = 0$ ) Stress Histories: Normalized Fatigue Life

The trends in the maximum and minimum stresses for the three tests conducted under the strain control mode at  $R_\epsilon = 0$  are shown in Figures 22a and 22b. The stress

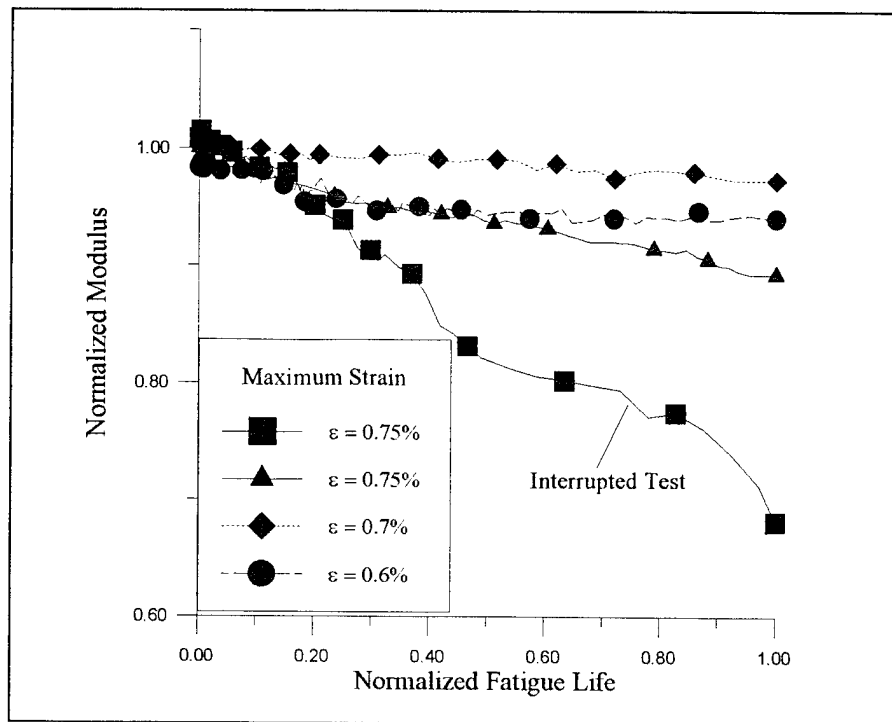
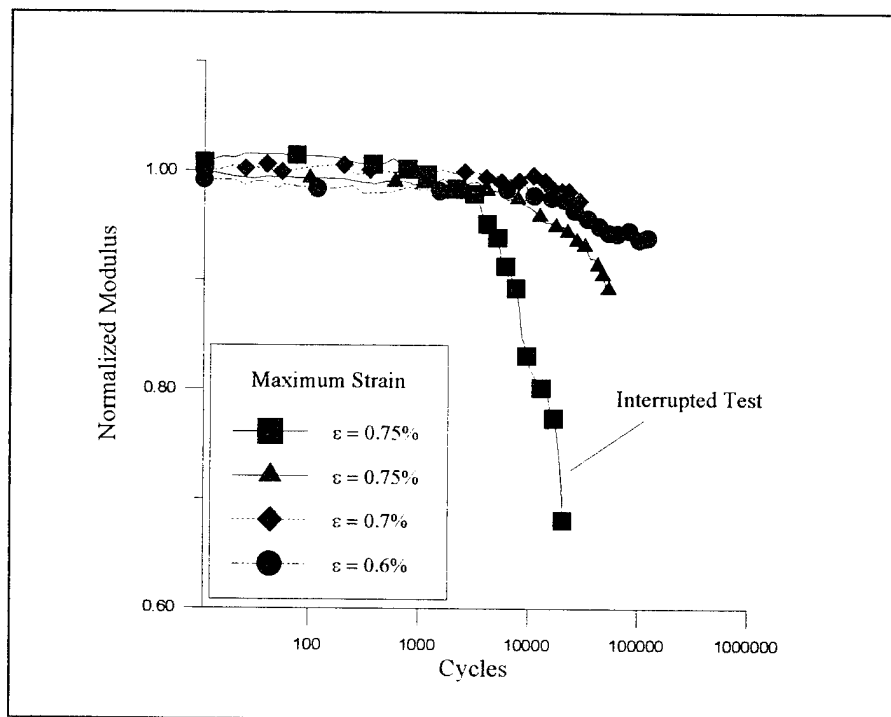
**Figure 23a. Tension-Tension ( $R_\epsilon = 0.5$ ) Modulus Histories: Normalized Fatigue Life**

**Figure 23b. Tension-Tension ( $R_\epsilon = 0.5$ ) Modulus Histories: Cycles**

The modulus for the tests conducted at a maximum strain of 0.7% and 0.6% showed different trends than the previous case. The modulus for the test conducted at a maximum strain of 0.7% revealed little degradation while the test conducted at a
