Investigation of Tension-Compression Fatigue Behavior of a Cross-Ply Metal Matrix Composite at Room and Elevated Temperatures

THESIS

Presented to the Faculty of the Graduate School of Engineering
of the Air Force Institute of Technology

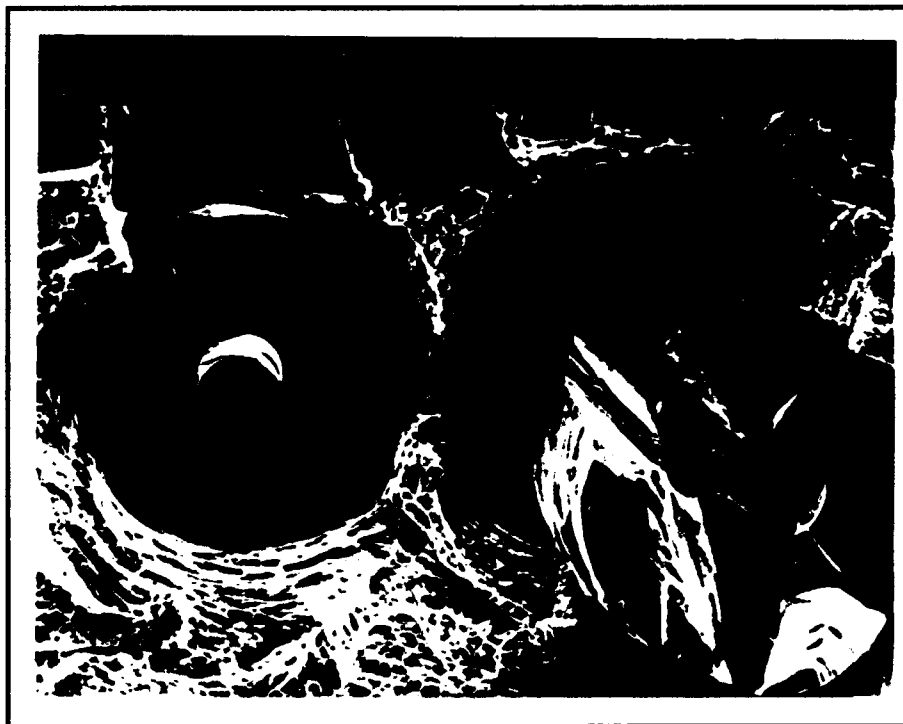
Figure 37. 445 TC RT: Brittle Cleavage and Ductile Void Coalescence (300x)

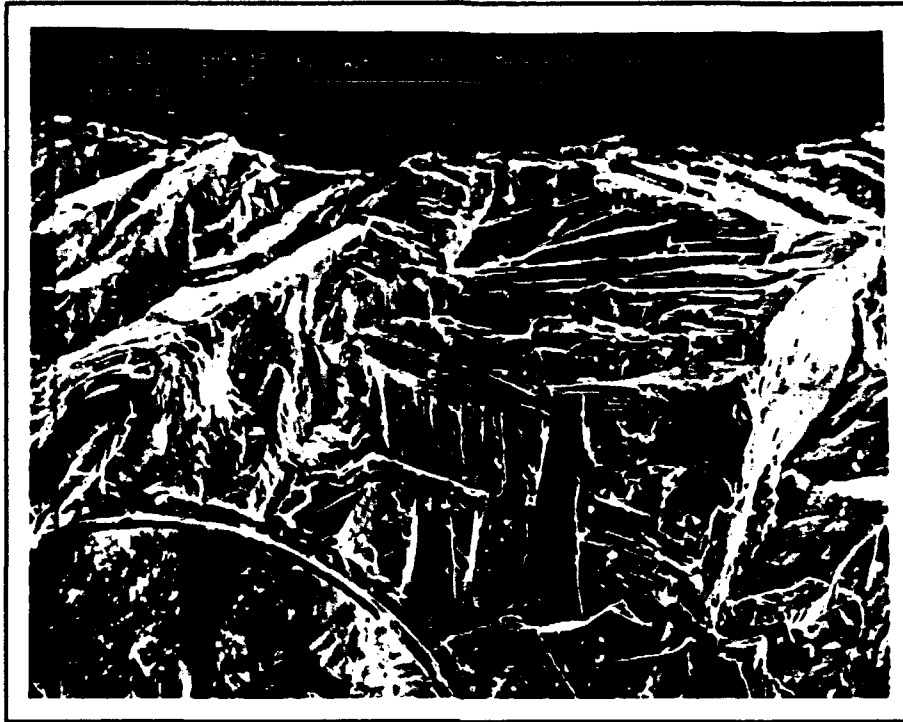
Figure 43. 175 TC RT: Close-up of Faceted Surface (750x)

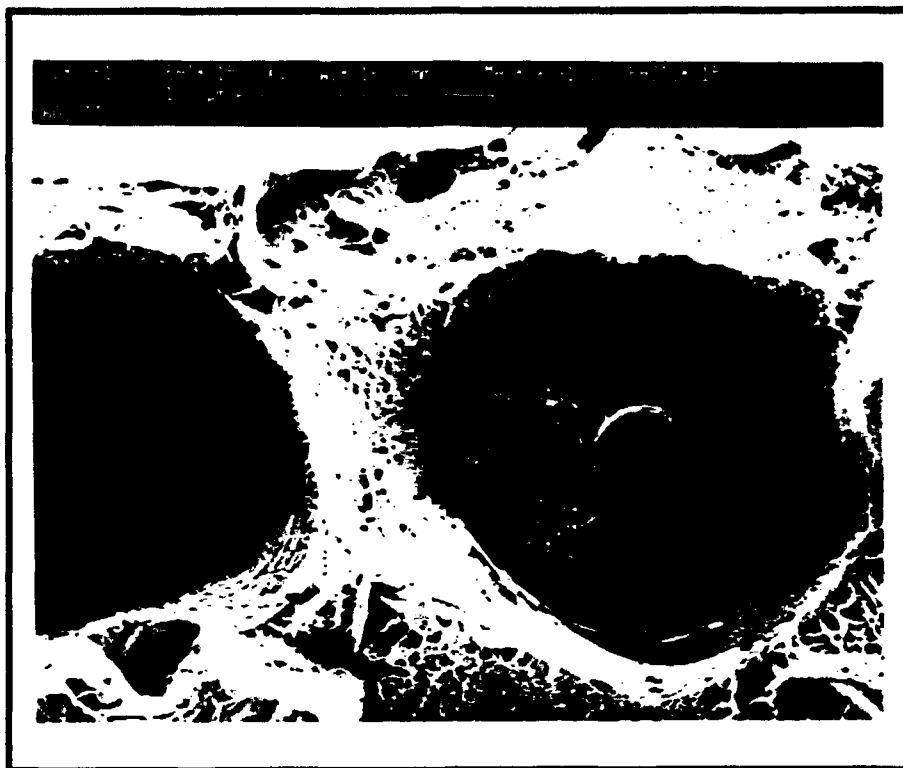
Fractography for this specimen revealed the tensile-overload type of failure which characterizes a fiber-dominated fatigue failure. Although some cleavage type areas existed, the dominant surface morphology was the dimpled surface of ductile void coalescence. In these regions, matrix necking between the failed 0° fibers is clearly seen (Figs. 56 and 57).

Figure 57. 600 TT RT: Ductile Void Coalescence and Necking (313x)

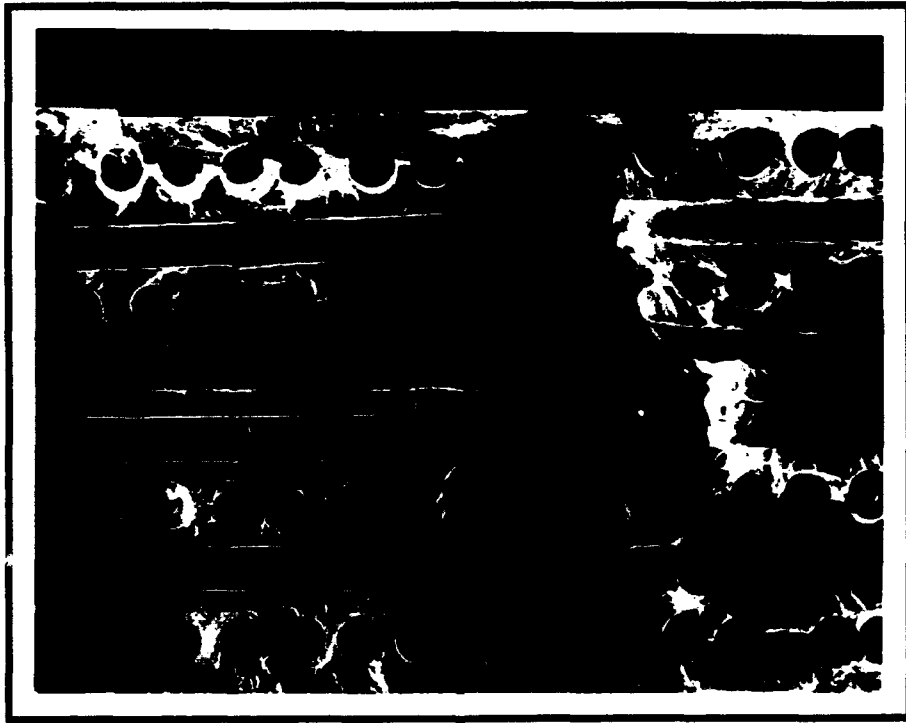
Examination of the fracture surface reveals that a mixed mode failure occurred. The increased amount of flat, or cleavage, areas make it evident that much more matrix cracking occurred in this test than in the Regime 1 test. In addition, the multi-leveled fracture surface in conjunction with the many dimpled areas also reveal that some pre-failure fiber damage occurred during the specimen life (Figs. 58 and 59).

Figure 58. 450 TT RT: Fracture Surface (45x)

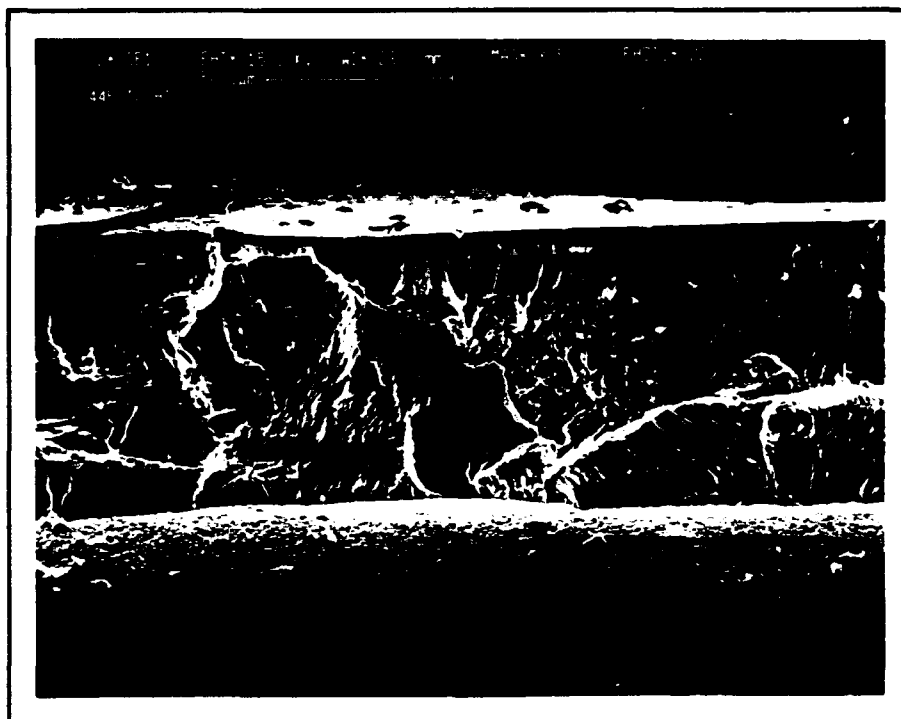
Figure 76. 445 TC HT: Striations on Fracture Surface Between 90° Fibers (500x)
