Investigation of Compressive Behavior for Metal Matrix Composites with a Circular Hole

THESIS

Janet L. Gooder, Captain, USAF

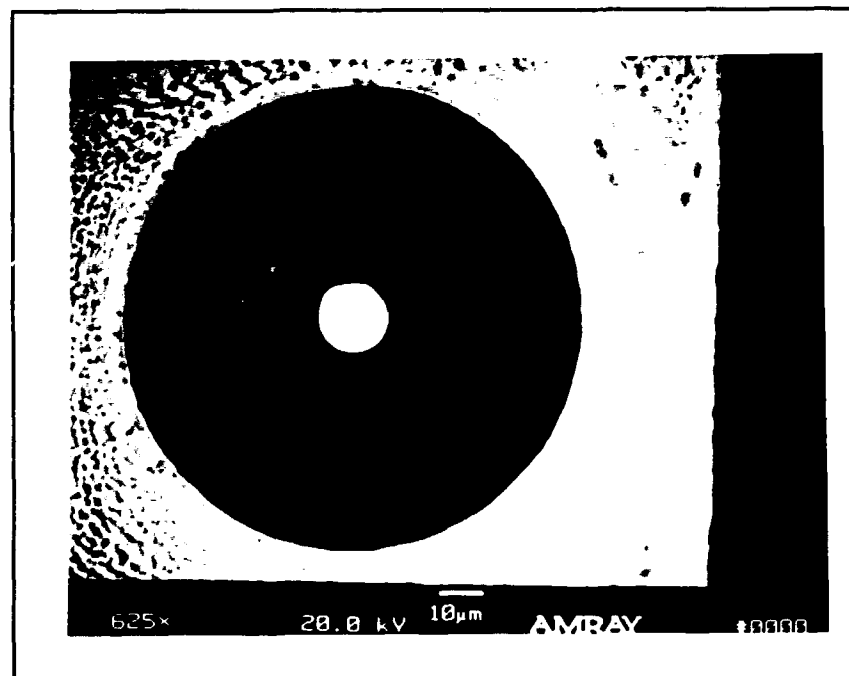
Figure 6. Sigma/Beta 21S, Polished Edge, 625X

For the purpose of replication of the edge surface, the edges of selected specimens were polished to a very fine finish (Figs. 5 and 6). The Metlap #8 wheel was used with 15 micron, and then 6 micron, diamond suspension to remove surface flaws. The specimens were polished using Perfrmat cloths saturated with 15 micron smaller diamond particles. The Perfrmat step was repeated with progressively smaller diamond suspension. The specimens were polished until the largest flaw was 1 micron. One micron clarity was necessary to detect damage in edge replicas.

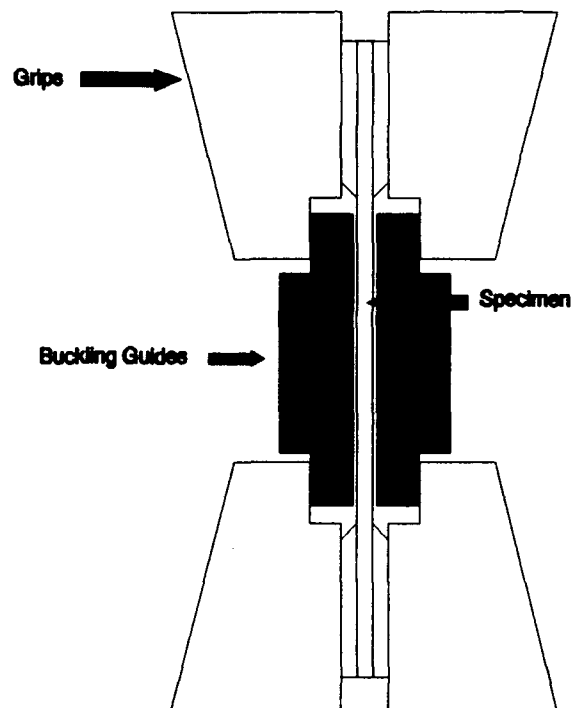
**Figure 7. Room Temperature Compression
Fixture**

The test apparatus used for all tests was based on the Battelle compression fixture, including buckling guides (Fig. 7). The Battelle design restricted buckling of the specimen allowing failure to occur in axial compression. The guides were required to prevent the specimen's lateral movement outside of the designed buckling allowance. This crucial feature was not achievable with the original design, due to the relatively large specimen dimensions and extreme loads necessary to reach failure. To prevent excessive

lateral movement, the buckling guides were redesigned to support the large specimen under an extreme load. The new design employed a reinforcement spar along the outside of the guide. The design effectively prevented lateral movement beyond 100 μm .

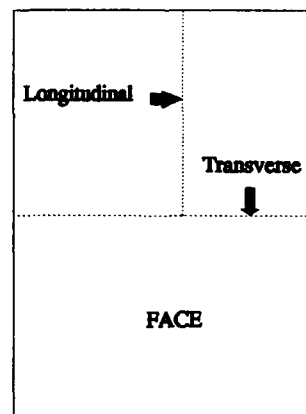
Figure 9. Sectioning Pattern

Sectioning. For post-mortem analysis, the specimen was divided into small sections for close examination. The gage section was cut from the tab section using a low speed diamond saw. Some gage sections were then carefully sectioned such that the longitudinal, transverse and face sections of the specimen could be observed (Fig. 9).

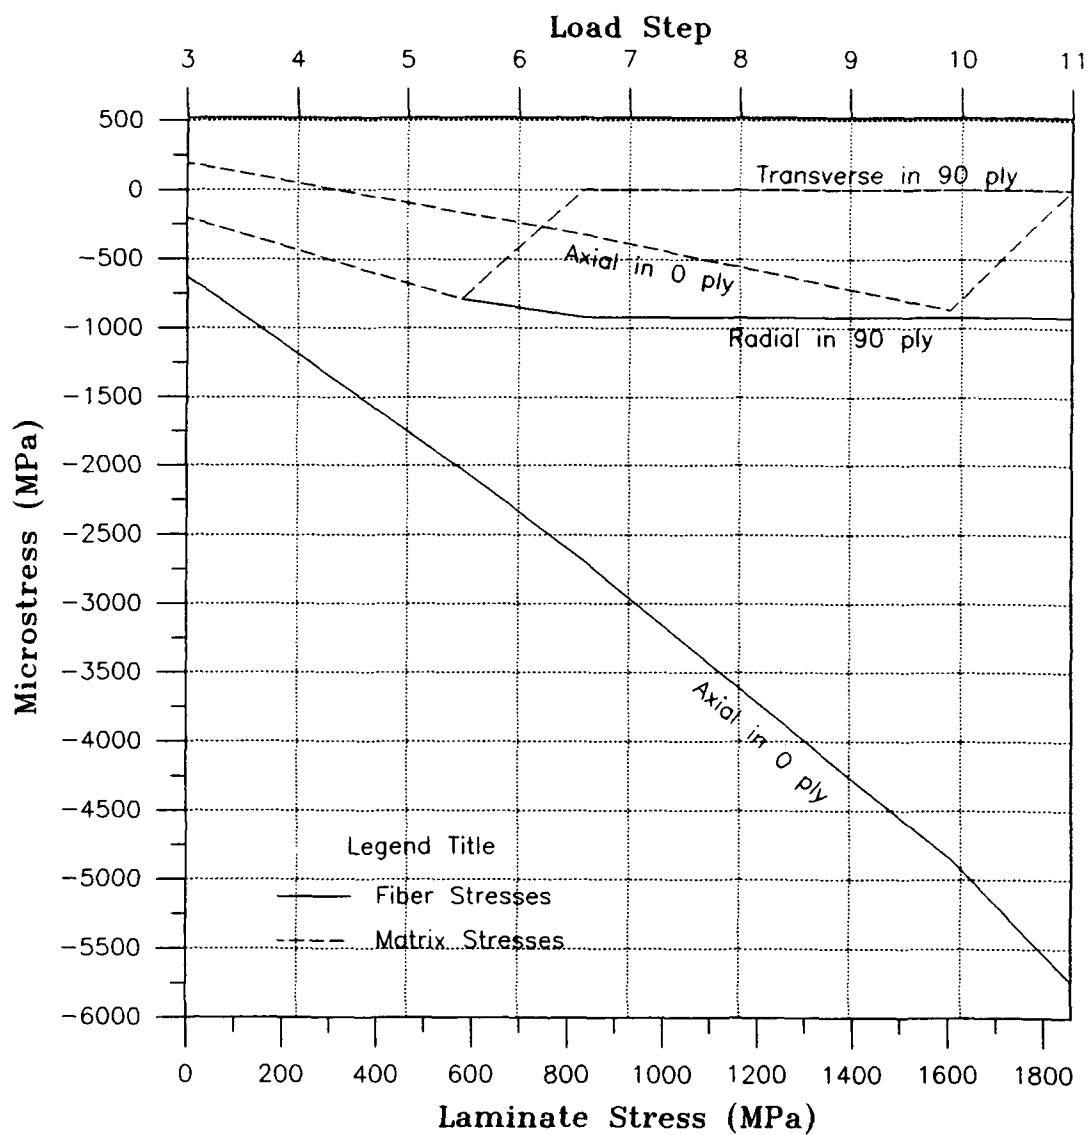
Figure 10. METCAN Predictions for Room Temperature Sigma/Beta 21S

The investigation of simulated damage progression began by plotting the maximum stresses in each ply against the current load step, beginning with the last thermal load step. The room temperature simulation for Sigma/Beta 21S showed that matrix yielding may occur in the 90° plies at 600-800 MPa of applied stress (Fig. 10). Matrix yielding may occur in the 0° plies at 1600-1800 MPa of applied stress. The fibers would not break at 2000 MPa of

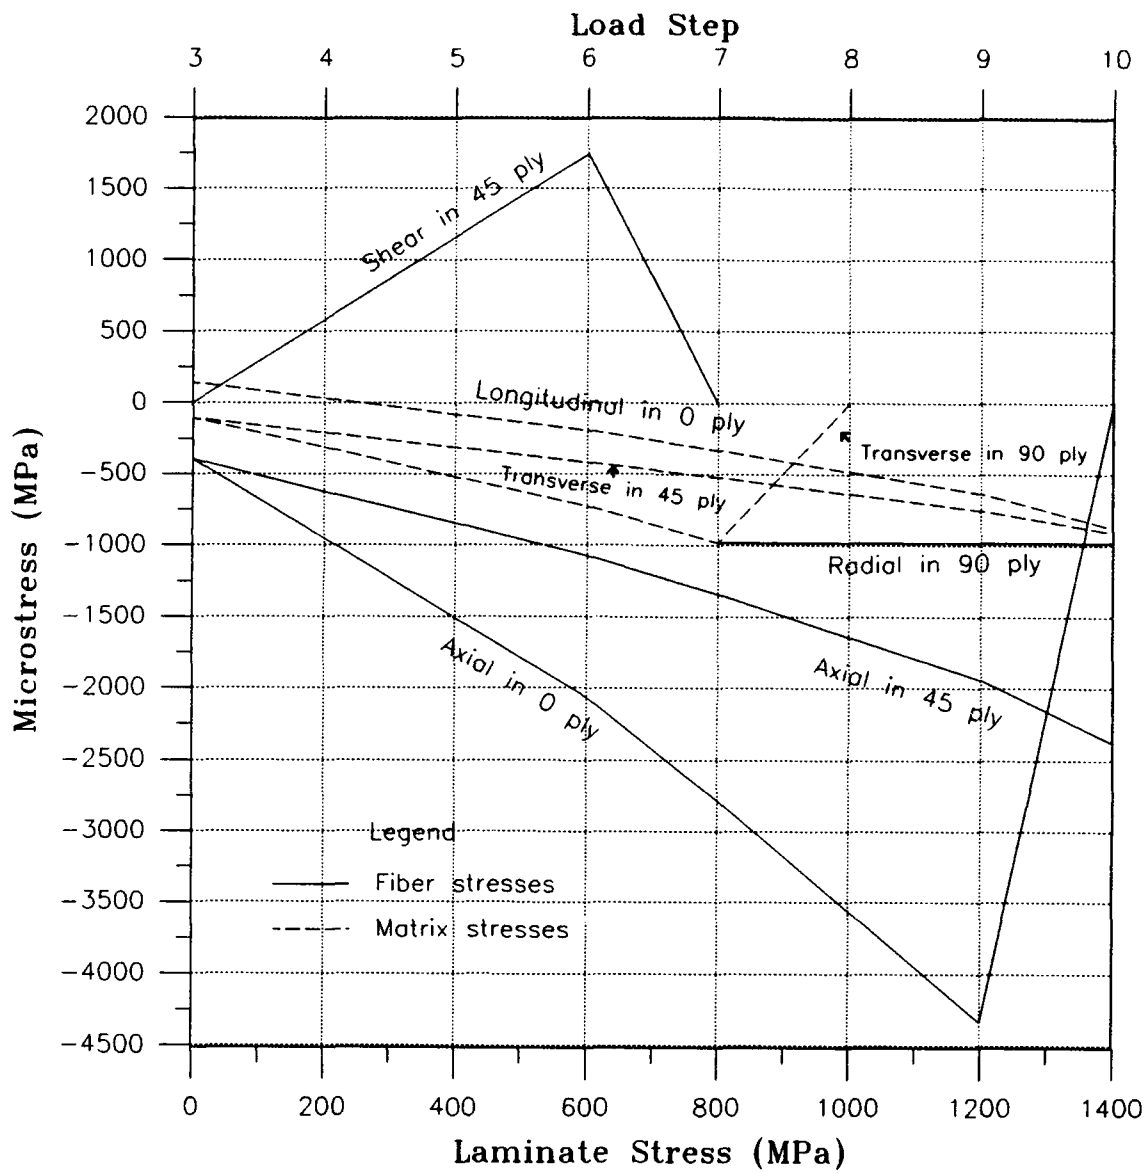
Figure 11. METCAN Predictions for Room Temperature SCS-6/Beta 21S

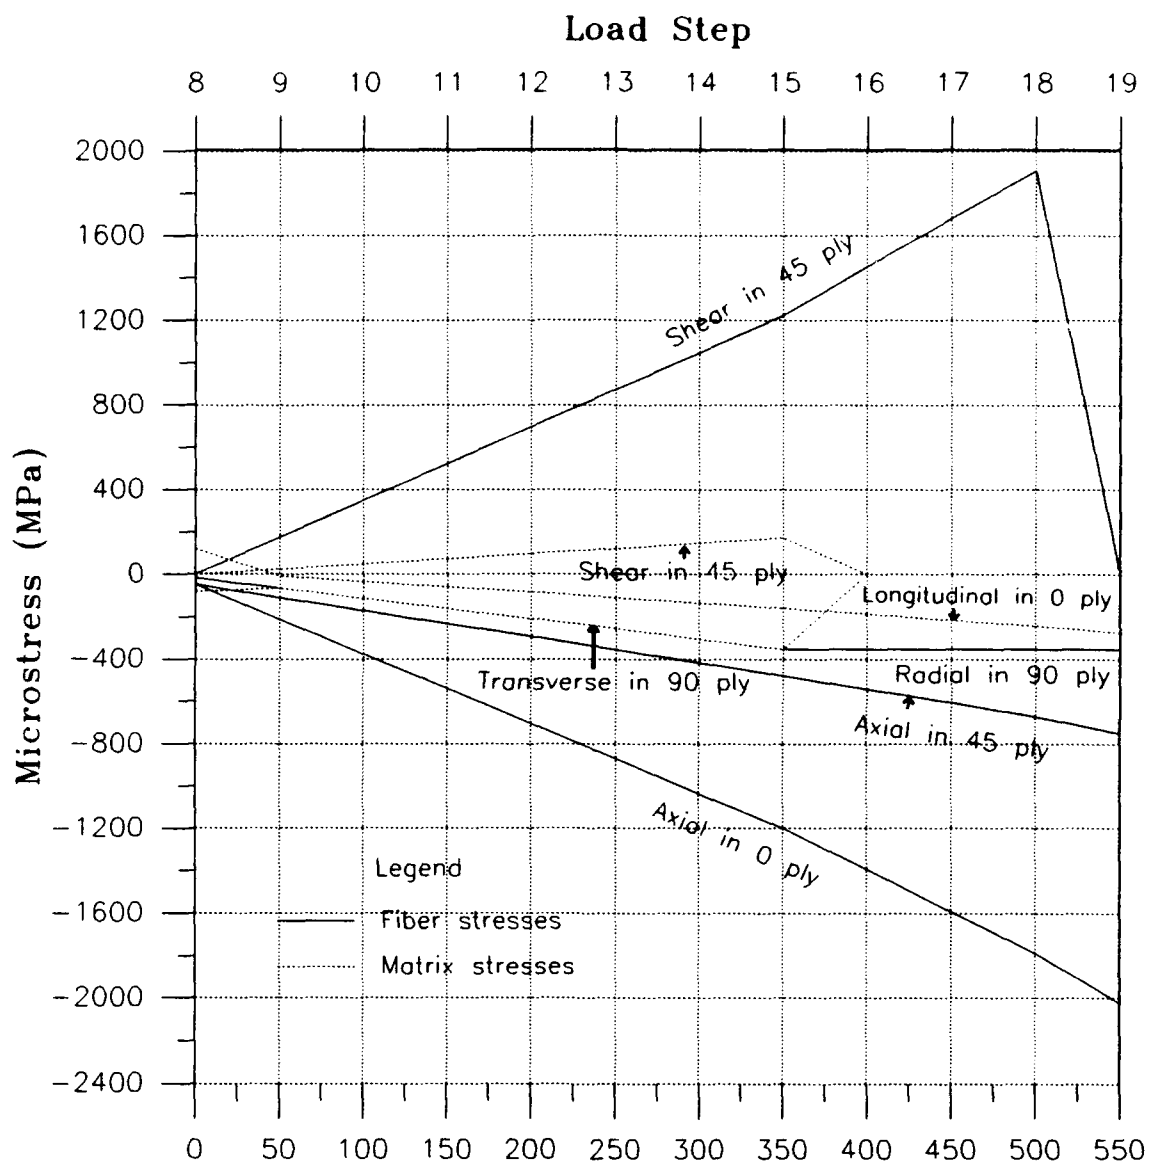
Figure 12. METCAN Predictions for Elevated Temperature SCS-6/Beta 21S

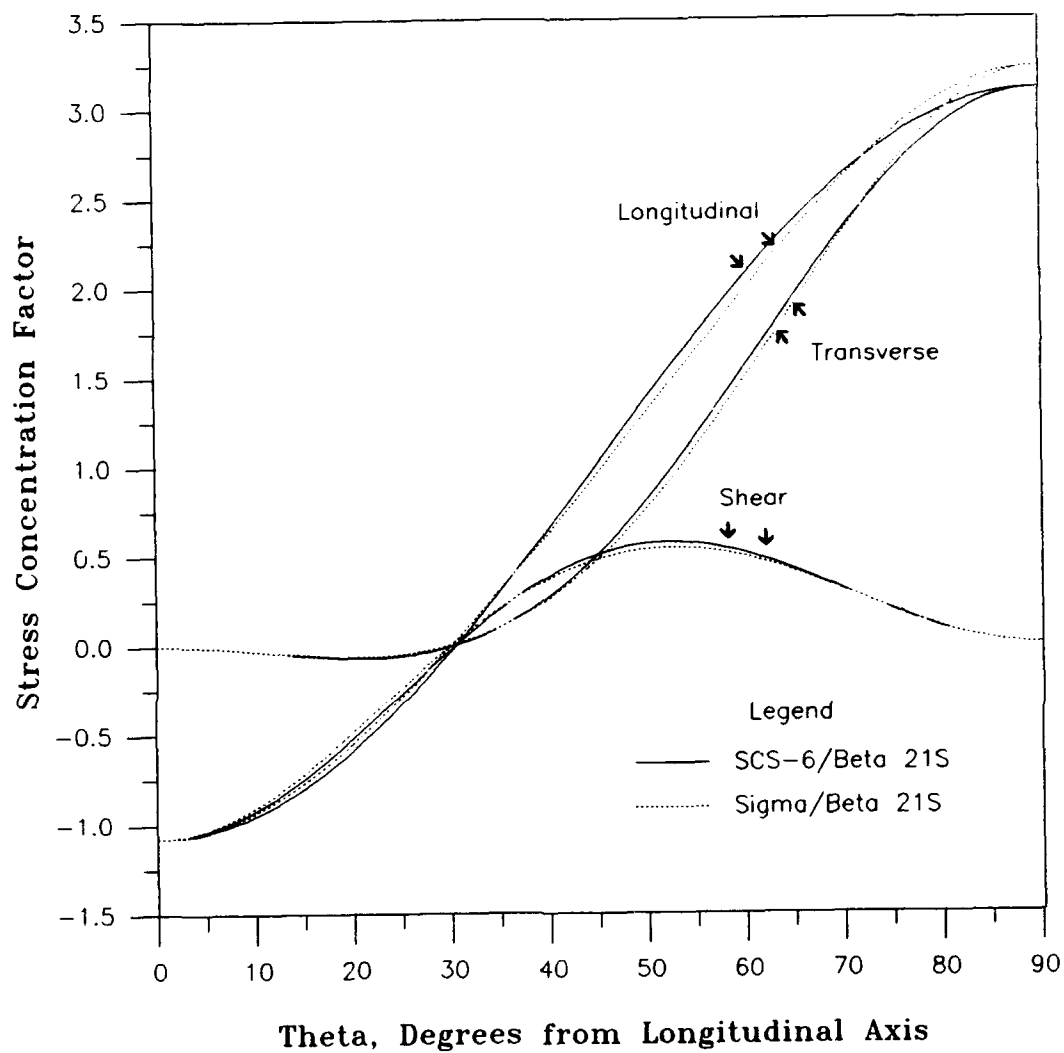
Figure 13. STRESS Routine Output, Stress Concentration Factors for $d/w=0.167$

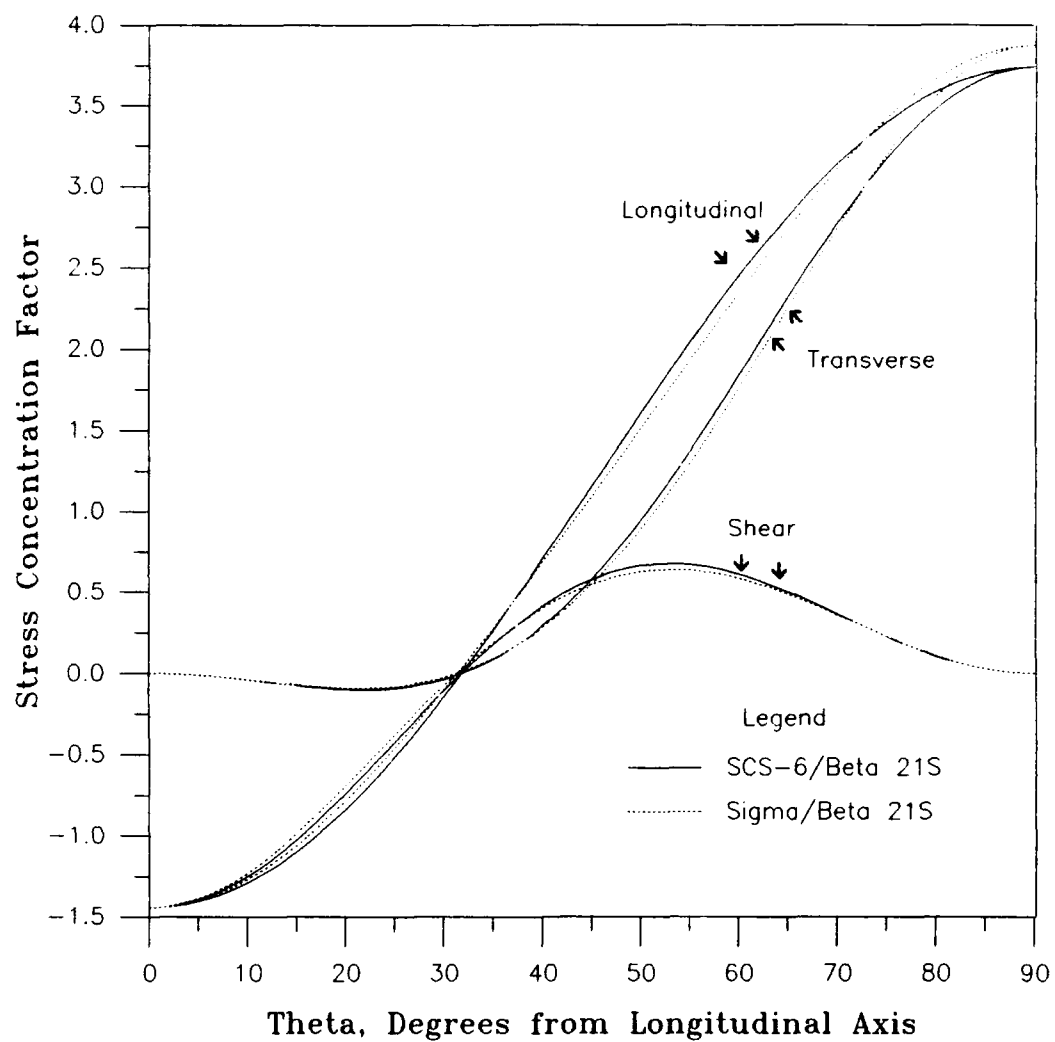
Figure 14. STRESS Routine Output, Stress Concentration Factors for $d/w=0.4$

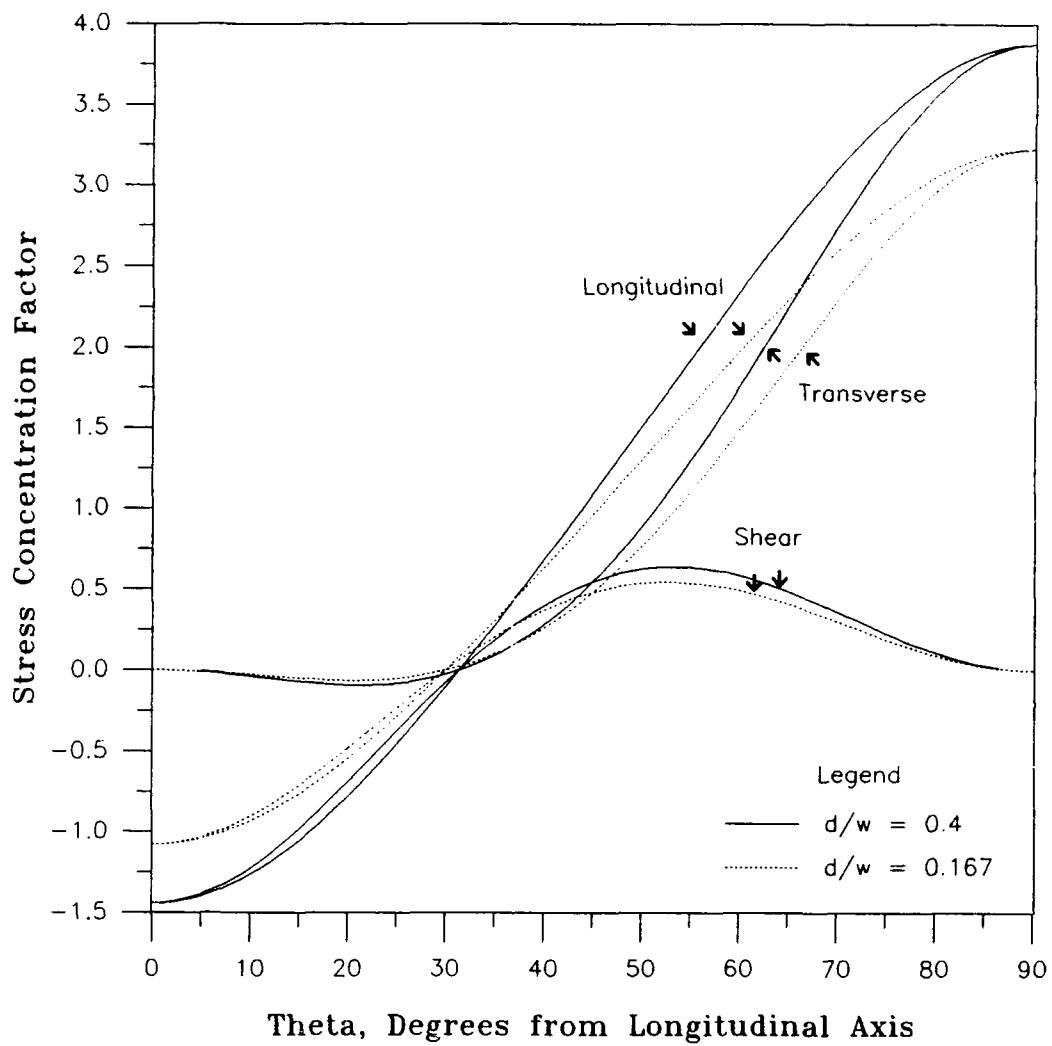
Figure 15. STRESS Routine Output, Stress Concentration Factors for $d/w=0.167$ and $d/w=0.4$, Sigma/Beta 21S

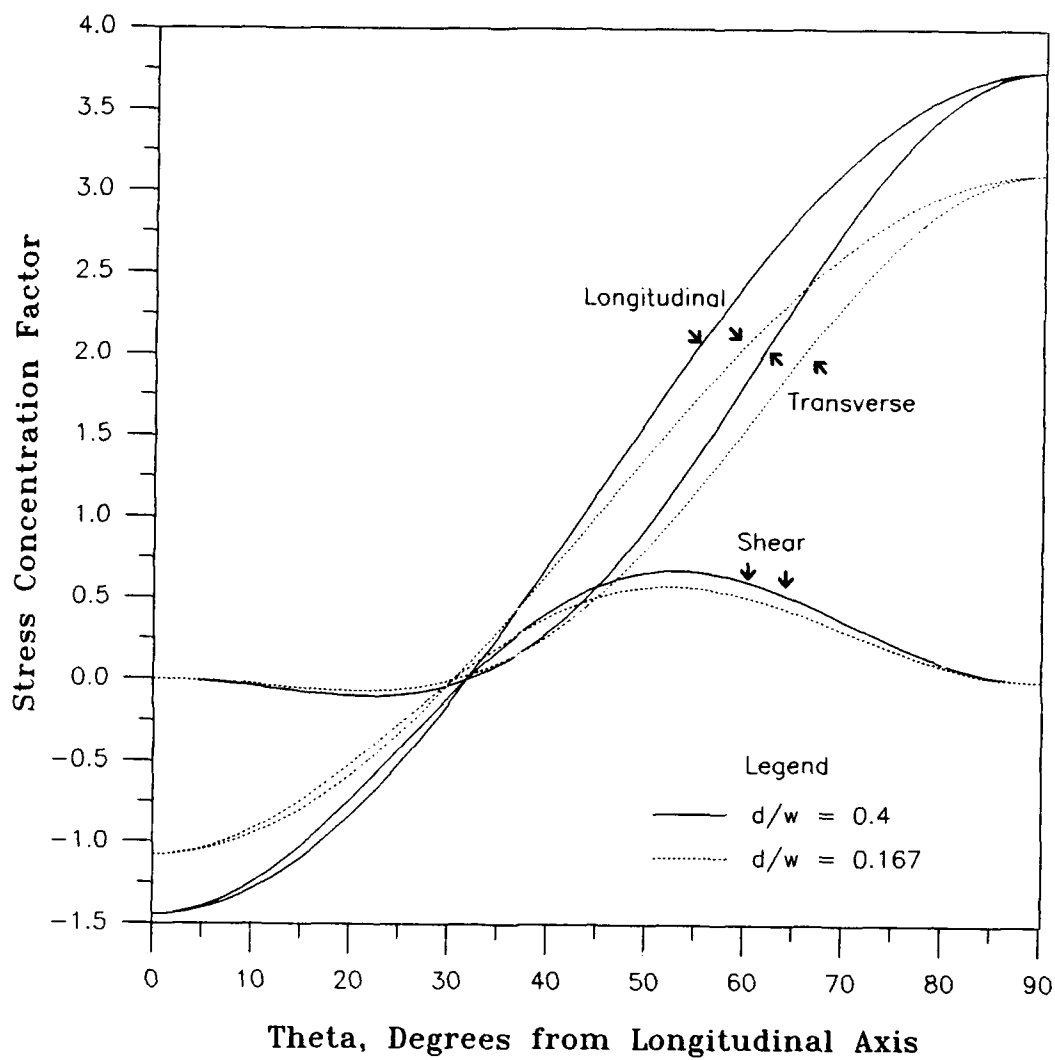
Figure 16. STRESS Routine Output, Stress Concentration Factors for $d/w=0.167$ and $d/w=0.4$, SCS-6/Beta 21S

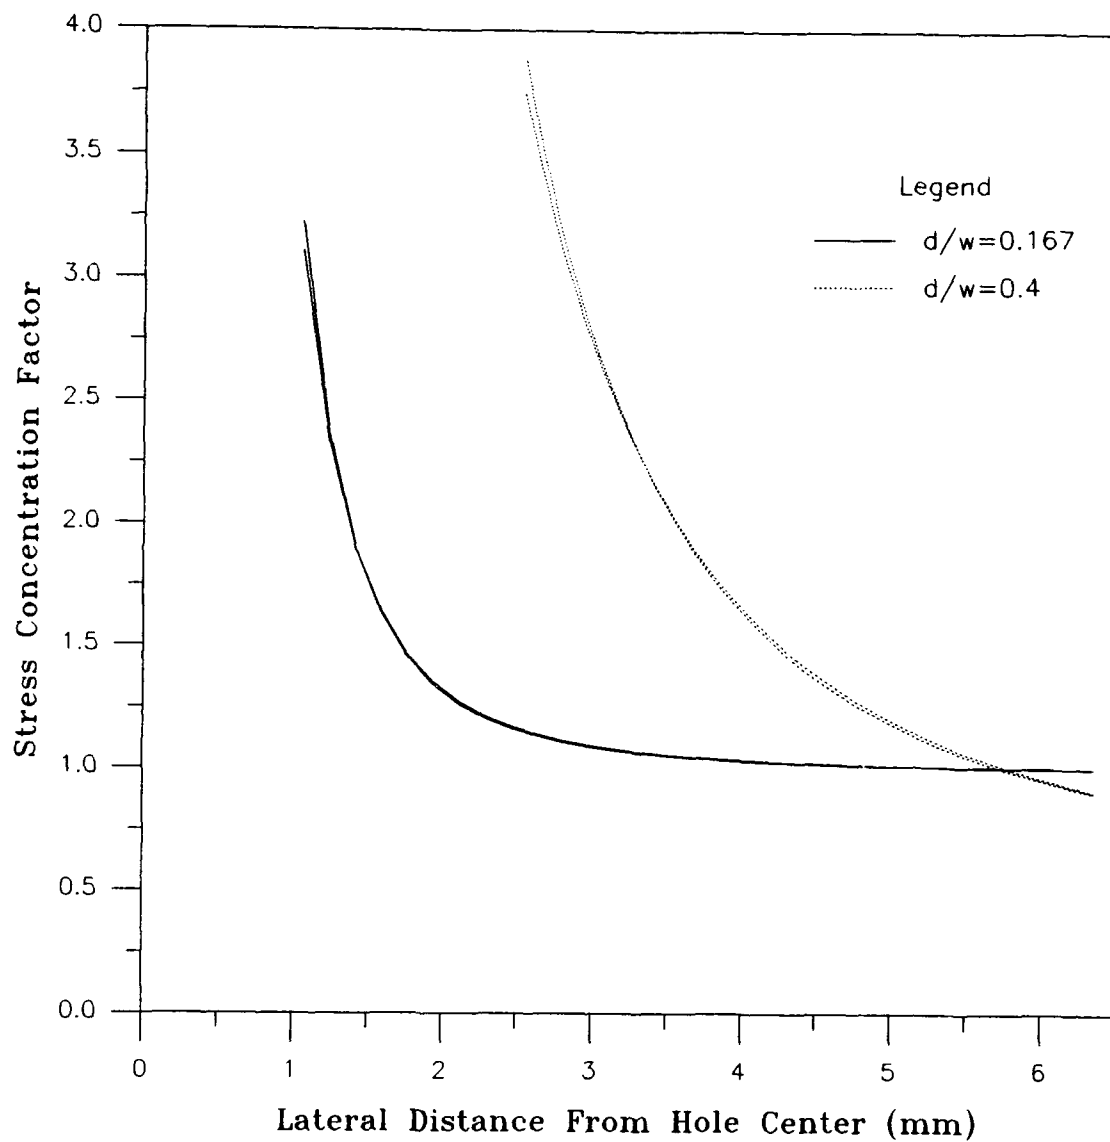
Figure 17. Stress Concentration for SCS-6/Beta 21S and Sigma/Beta 21S, $d/w=0.167$ and $d/w=0.4$

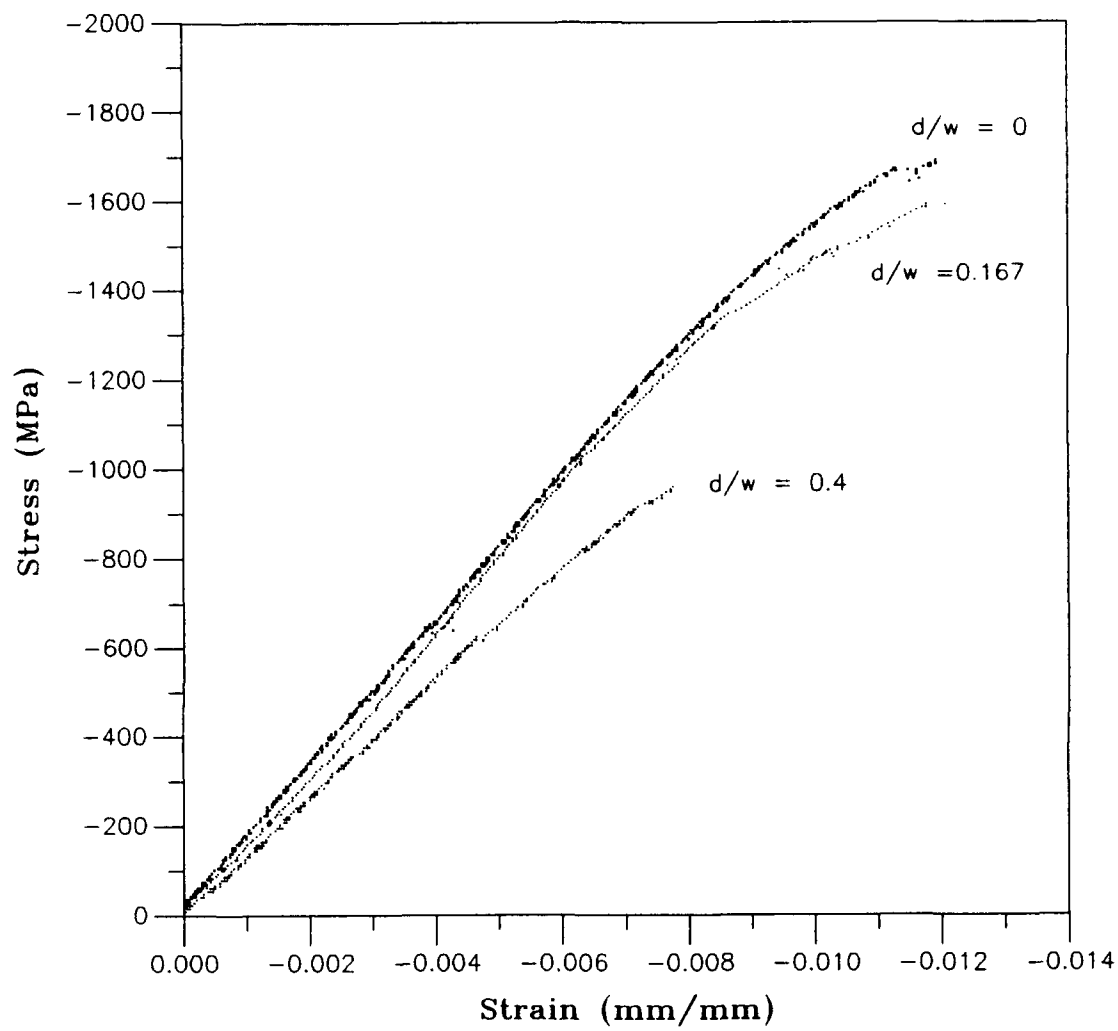
Figure 18. Room Temperature Compression, Sigma/Beta 21S

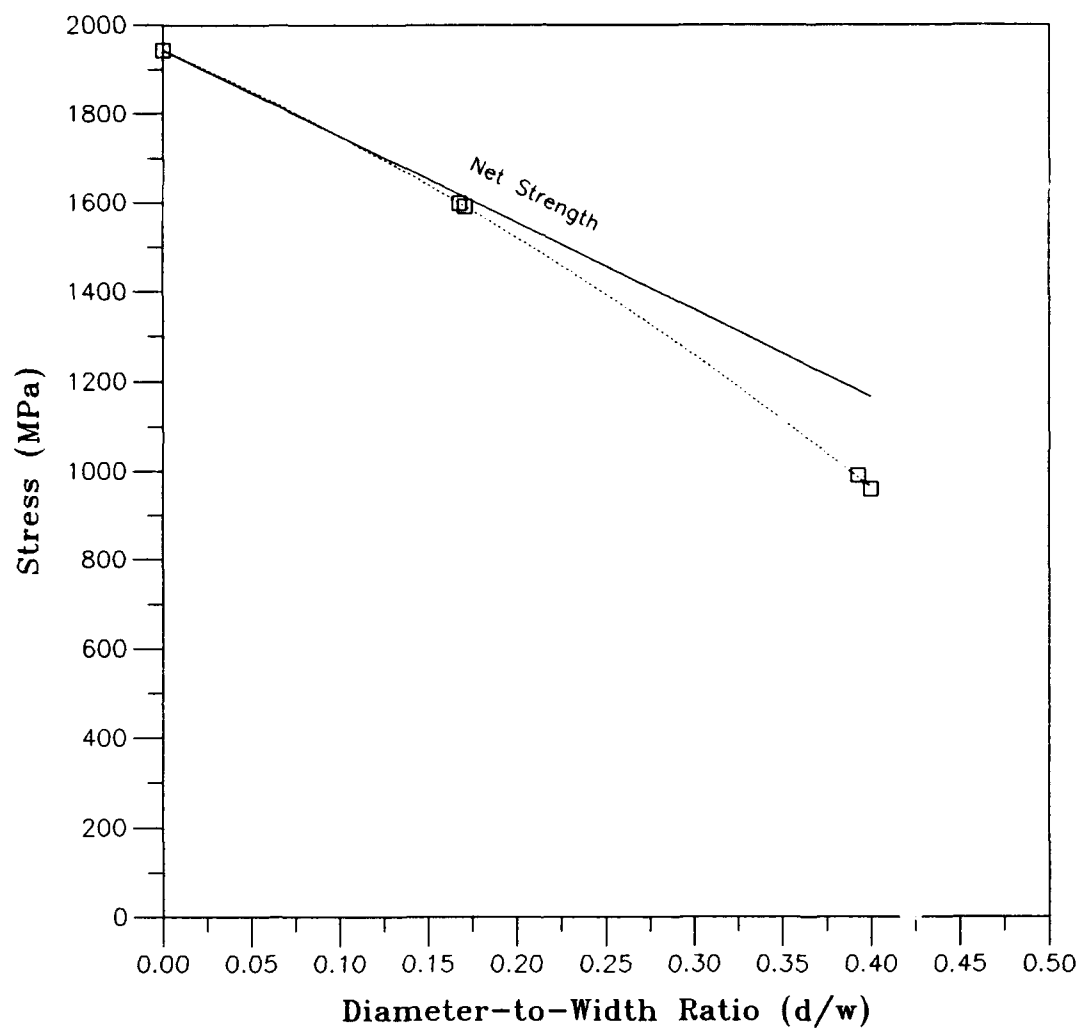
Figure 19. Room Temperature Compression Strength, Based on Remote Area, Sigma/Beta 21S

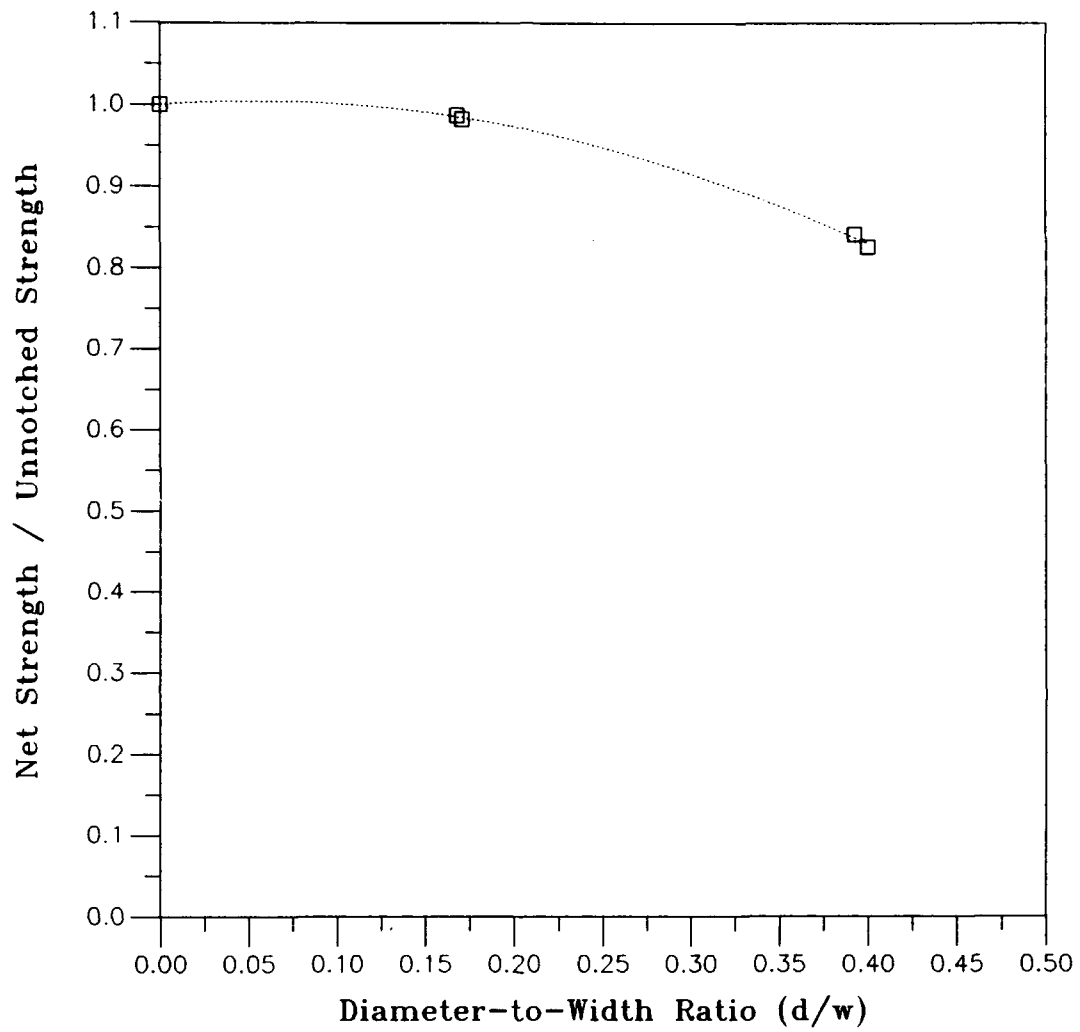
Figure 20. Normalized Strength, Room Temperature Compression, Sigma/Beta 21S

The normalized strength of the laminate was calculated for each experimental ultimate compressive strength, using Equation (6). The normalized strengths were displayed in a graph as a function of diameter-to-width ratio (Fig. 20). The data points showed the same divergent trend in notch sensitivity

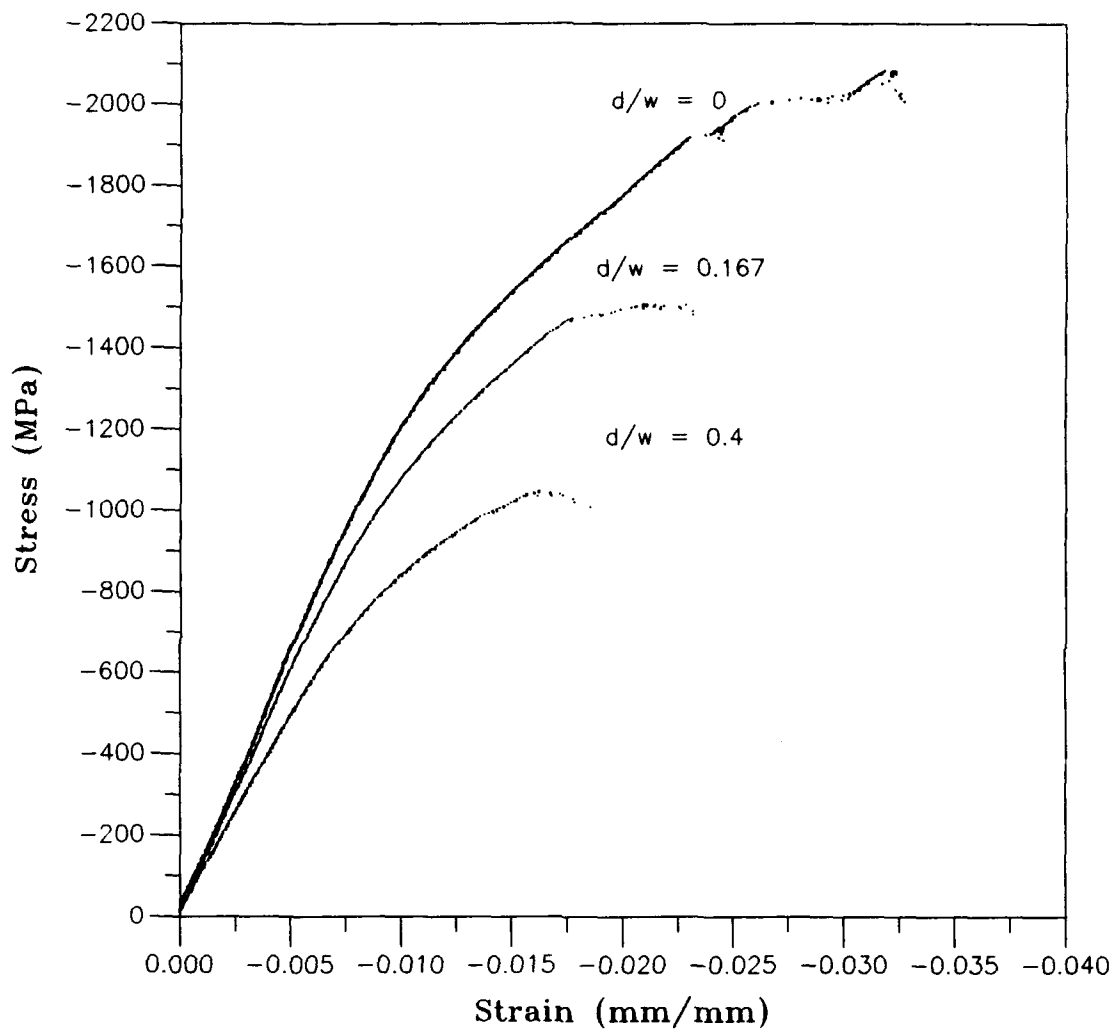
Figure 21. Room Temperature Compression, SCS-6/Beta 21S

Stress-strain curves for unnotched and notched SCS-6/Beta 21S specimens were plotted on one graph to show the variations due to the circular hole (Fig. 21). The reduction in elastic modulus was attributed to the use of the extensometer over the gage length encompassing the hole. The curves were initially linear, indicating elastic deformation. In the last 50-60% of the loading the curves were non-linear, indicating plasticity and damage. The strength

reduction due to the hole can be clearly seen in the graph.

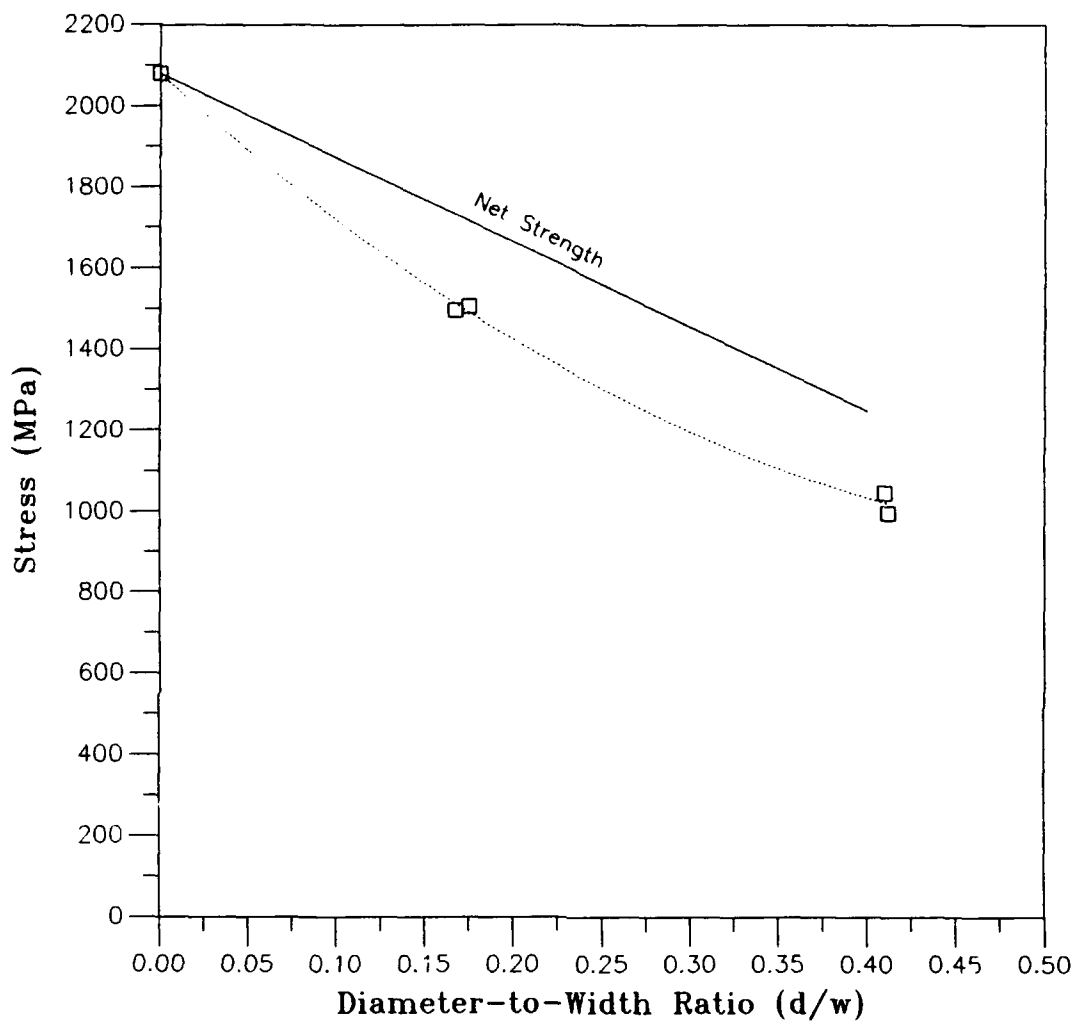
Figure 22. Room Temperature Compressive Strength, Based on Remote Area, SCS-6/Beta 21S

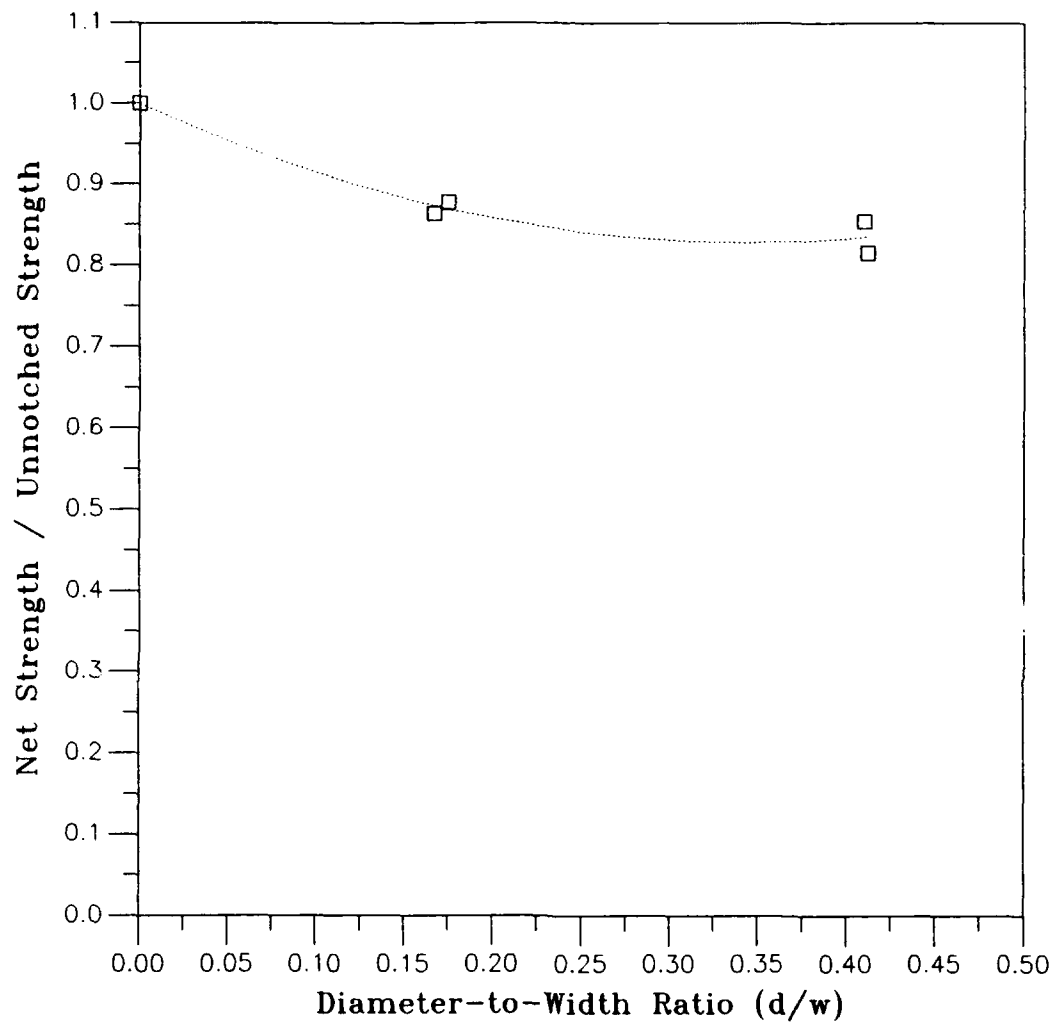
Figure 23. Normalized Strength, Room Temperature Compression, SCS-6/Beta 21S

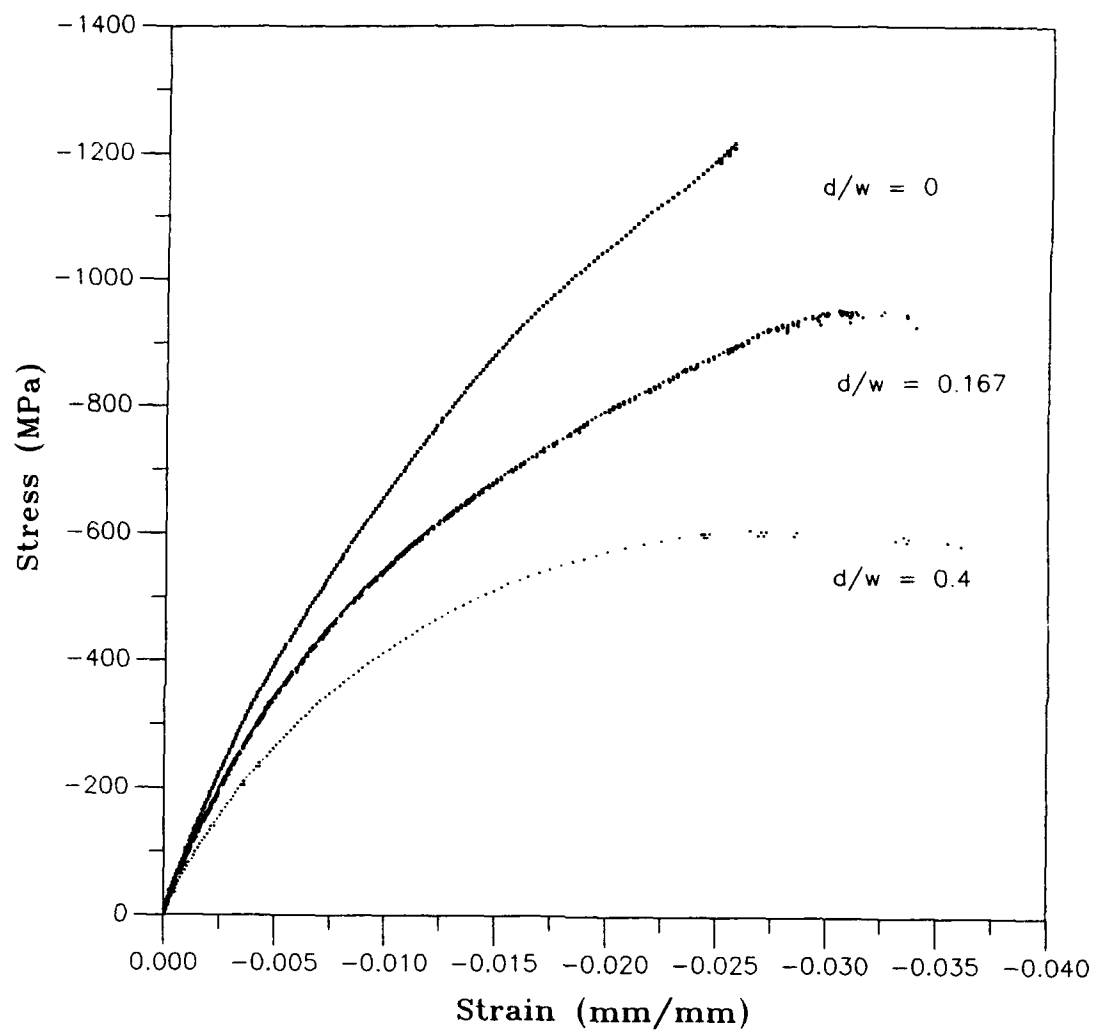
Figure 24. Elevated Temperature Compression, SCS-6/Beta 21S

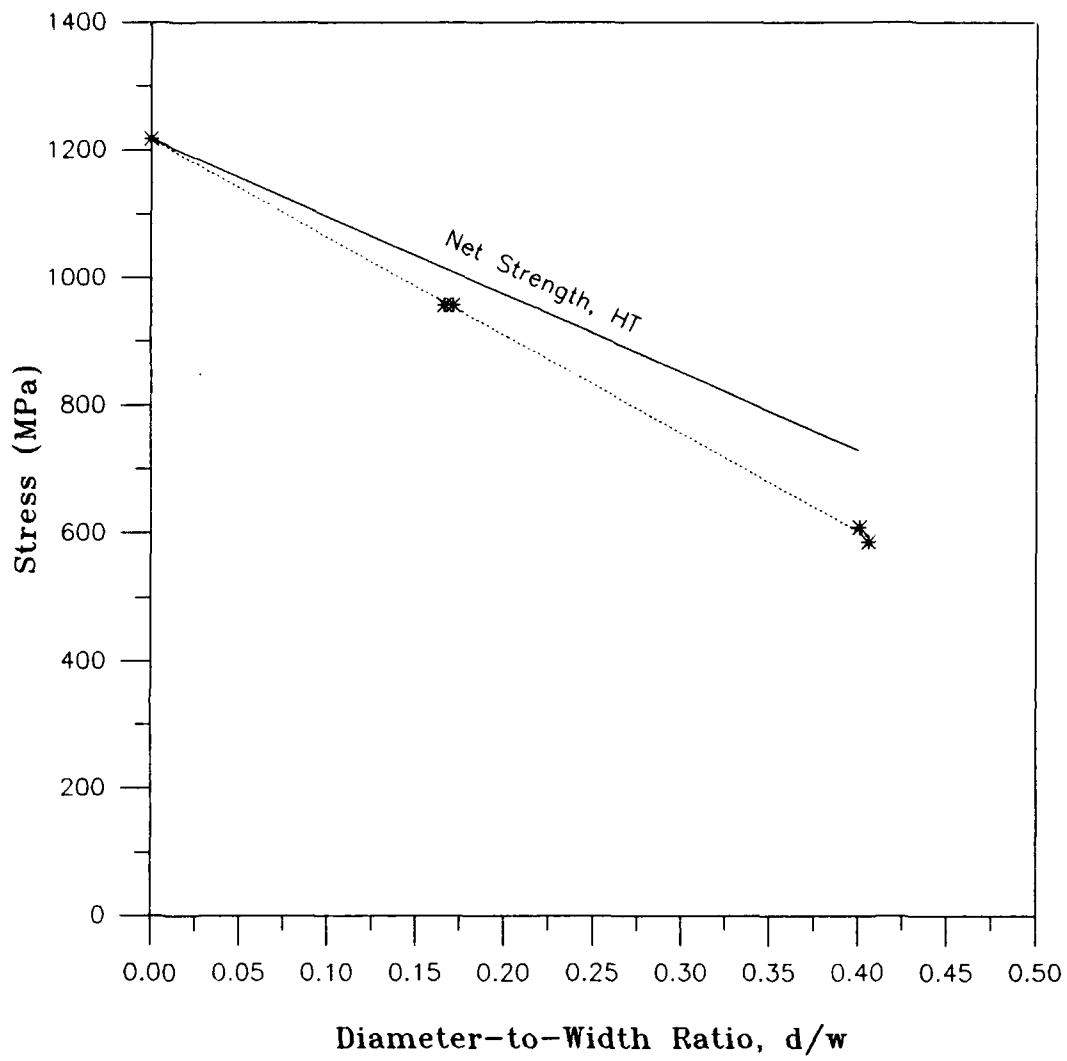
Figure 25. Elevated Temperature Compressive Strength, Based on Remote Area, SCS-6/Beta 21S

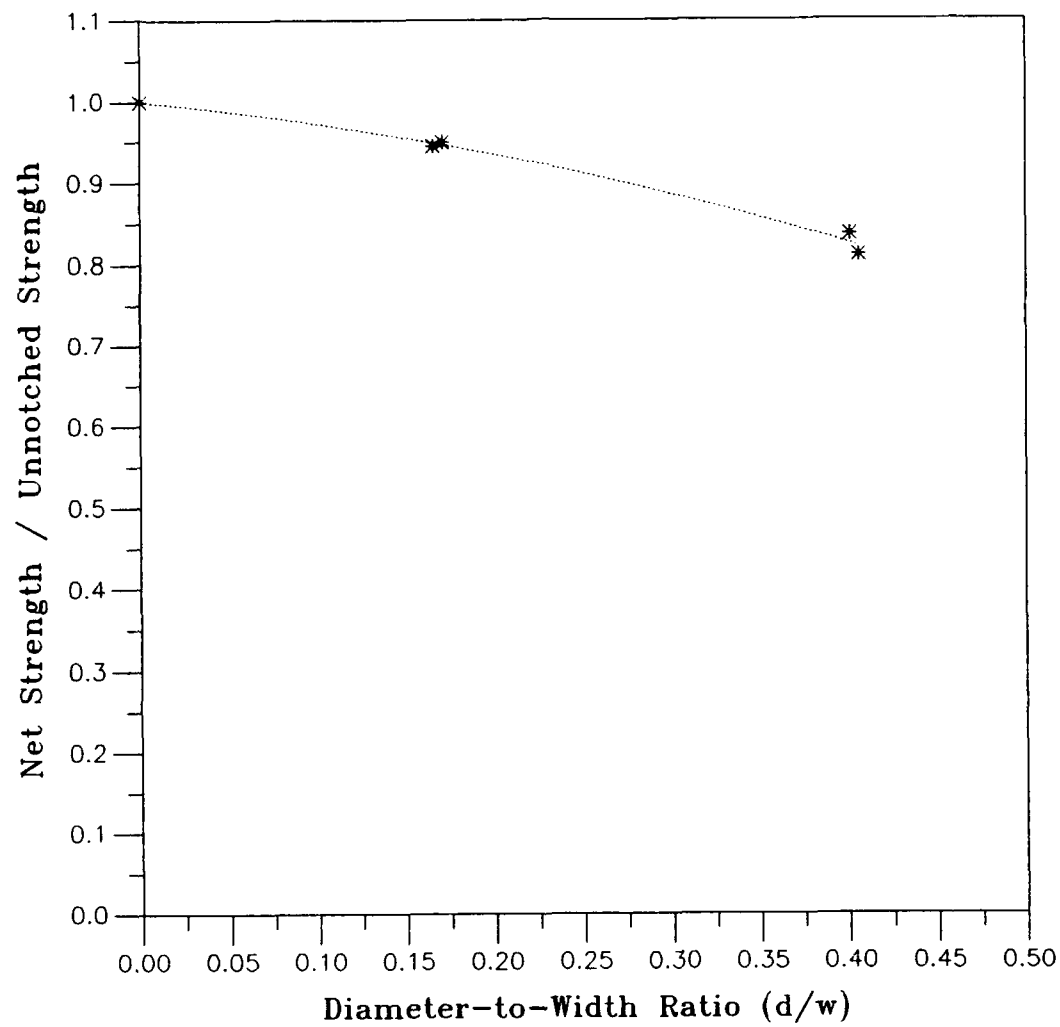
Figure 26. Normalized Strength, Elevated Temperature Compression, SCS-6/Beta 21S

The normalized strength of the laminate was calculated for each experimental ultimate compressive strength, using Equation (6). The normalized strengths were displayed in a graph as a function of diameter-to-width ratio (Fig. 26). The data points showed the same trend of notch sensitivity, linearly

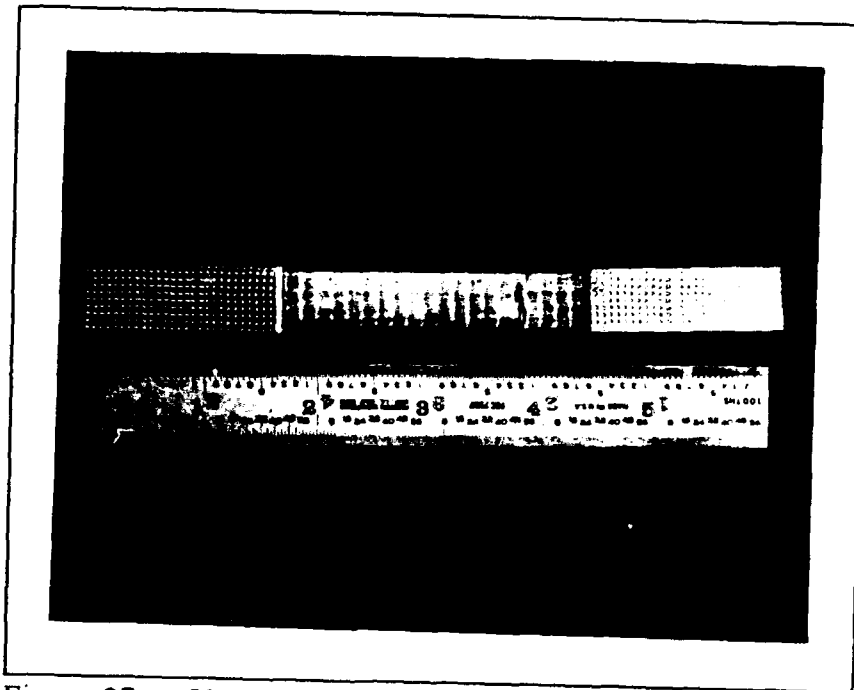
Figure 27. Unnotched Sigma/Beta 21S Compression Failure
