Investigation of Compressive Behavior for Metal Matrix Composites with a Circular Hole

THESIS

Janet L. Gooder, Captain, USAF

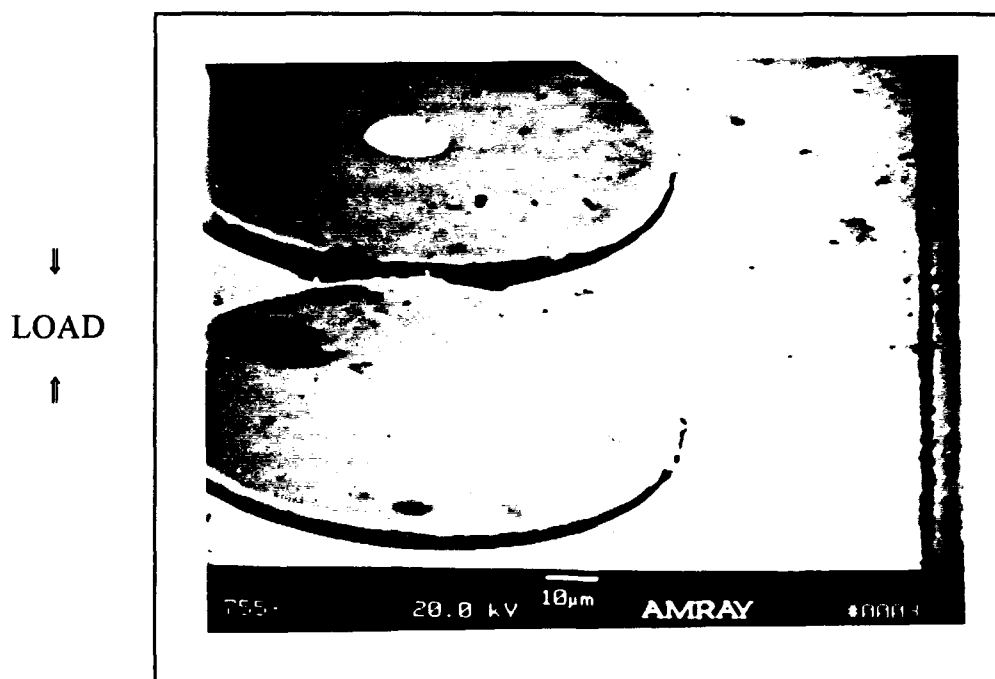
Figure 30. Sigma/Beta 21S, Polished Edge of a Specimen Tested to 25% of Ultimate Strength, 750X

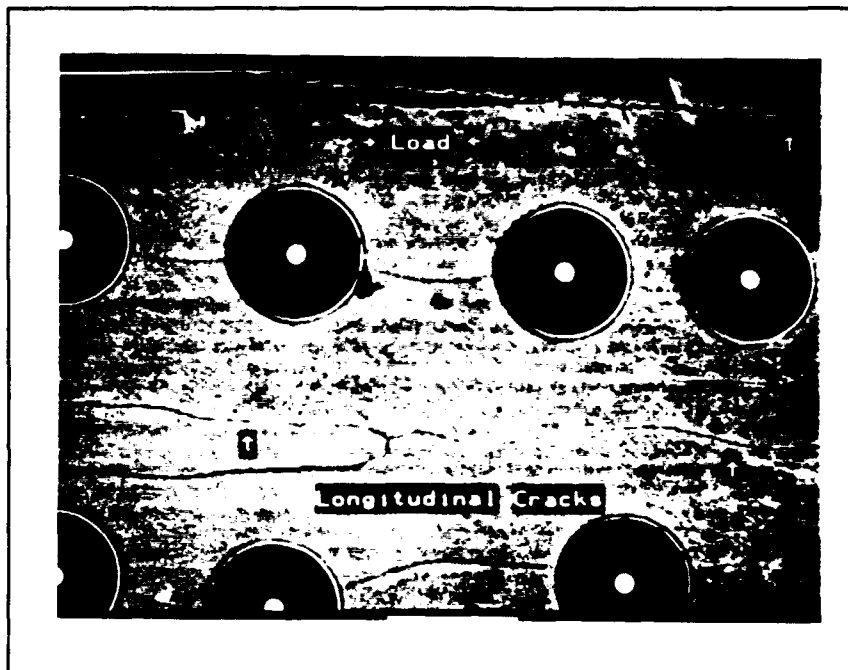
Figure 31. Sigma/Beta 21S, Longitudinal Matrix Cracks at 0° Fibers, 186X

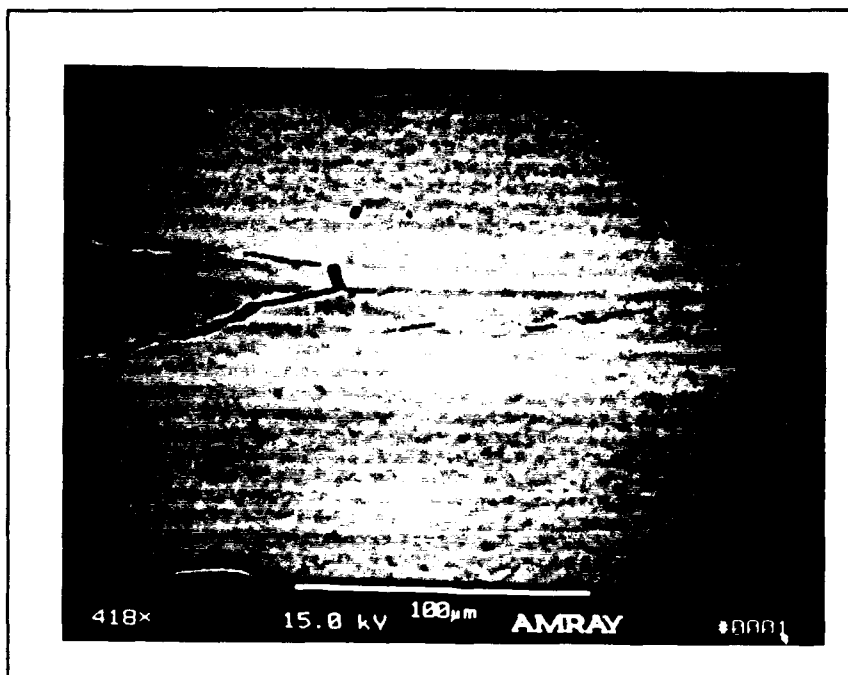
Figure 32. Sigma/Beta 21S, Longitudinal Matrix Cracks at 0° Fibers, 418X

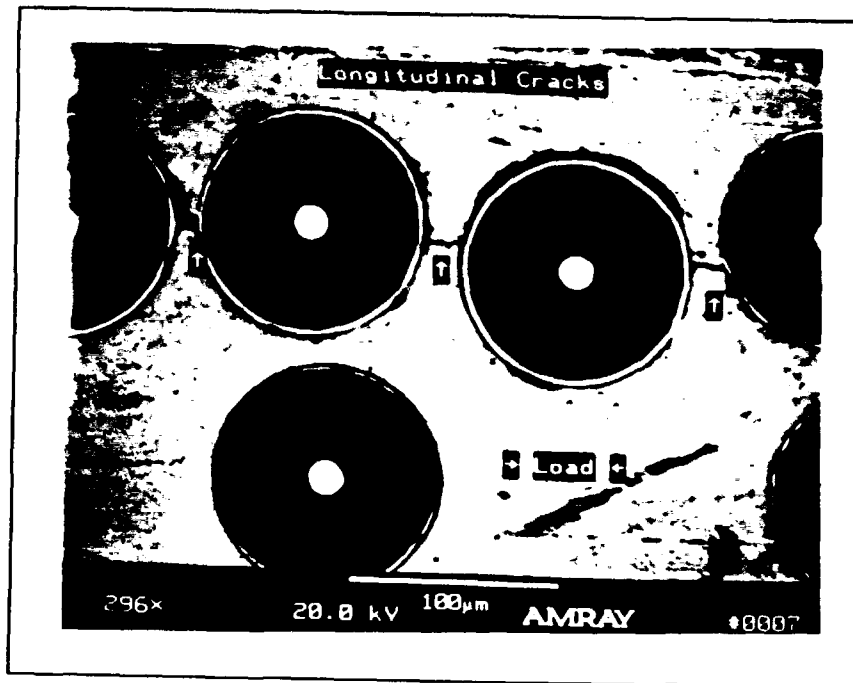
Figure 33. Sigma/Beta 21S, Longitudinal Matrix Cracks between 90° Fibers, 296X

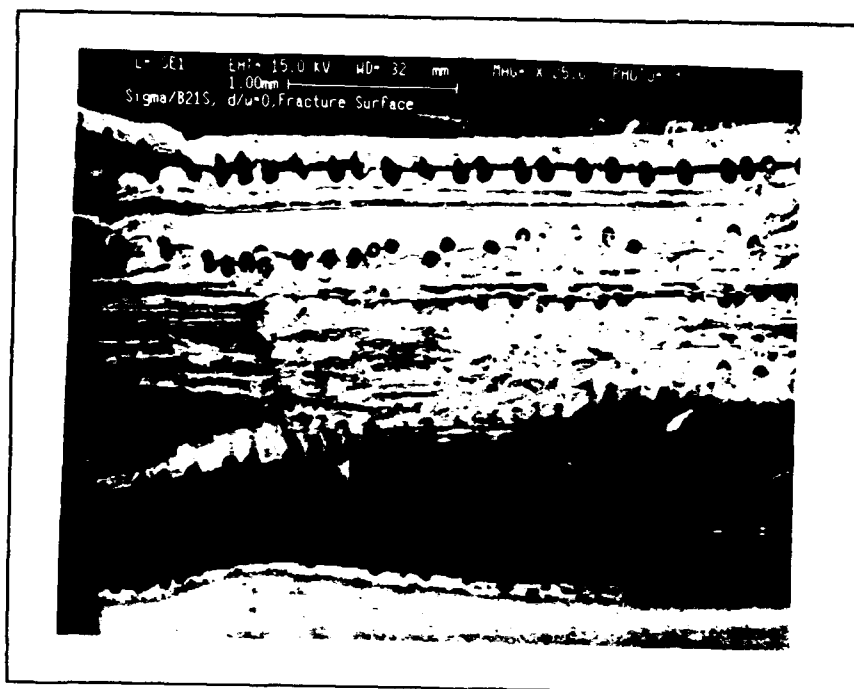
Figure 34. Unnotched Sigma/Beta 21S, Fracture Surface, 25X

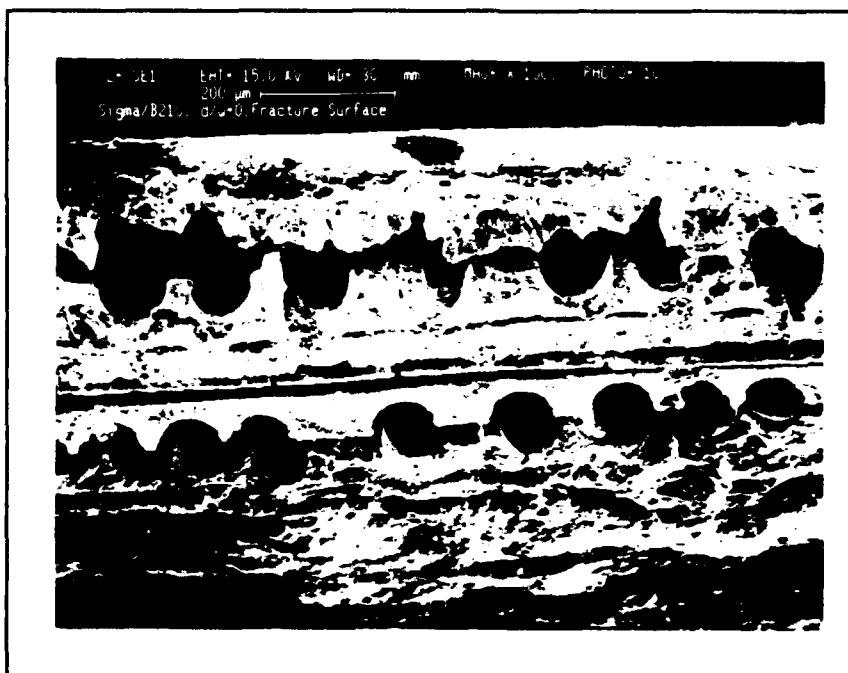
Figure 35. Unnotched Sigma/Beta 21S, Fracture Surface, 100X

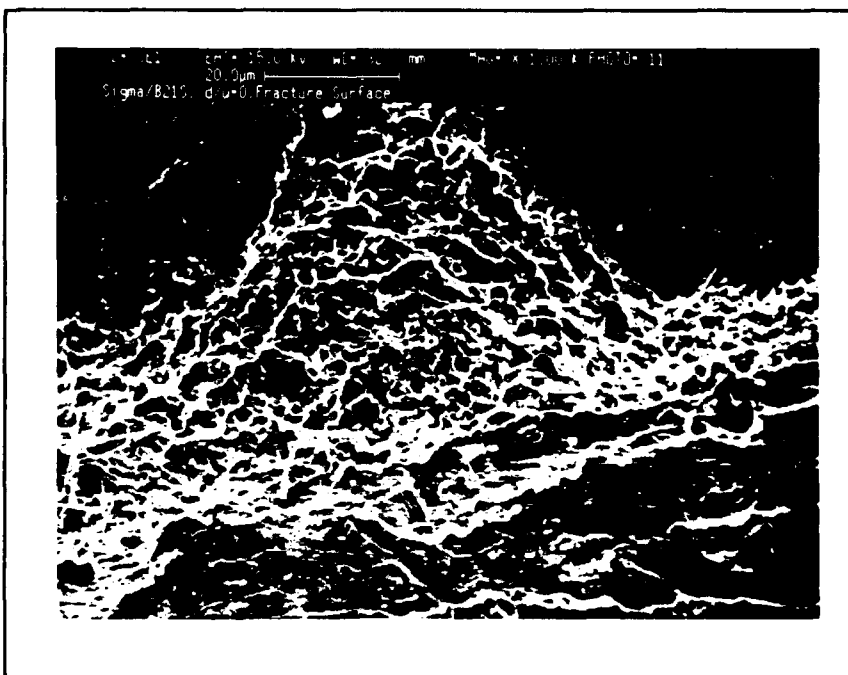
Figure 36. Unnotched Sigma/Beta 21S, Fracture Surface, Showing Matrix Plasticity, 1000X

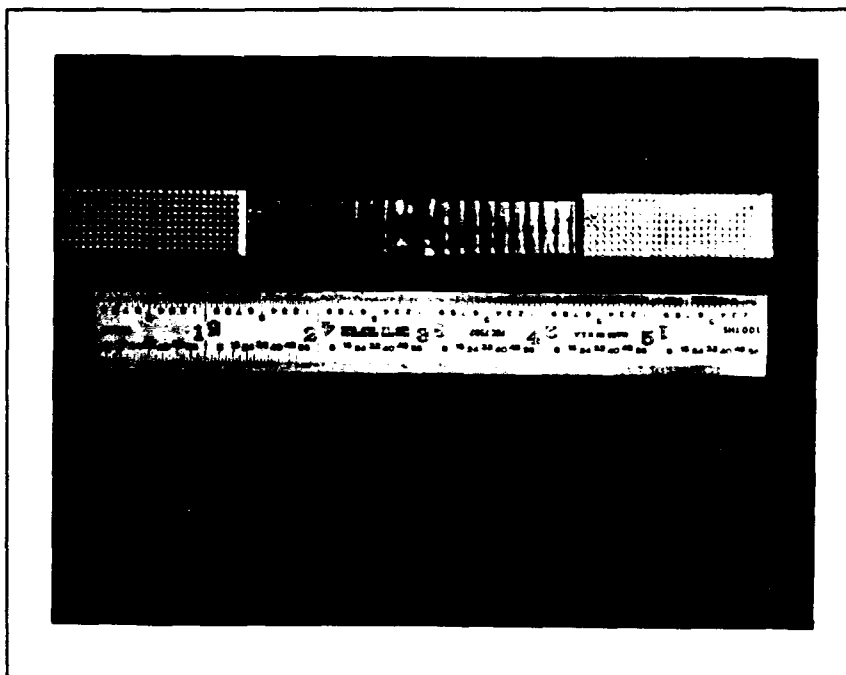
Figure 38. Notched Sigma/Beta 21S, Room Temperature Compression Failure, $d/w=0.4$

The notched Sigma/Beta 21S specimens consistently failed at 90° to the loading axis (Figs. 37 and 38). Prior to the 90° (transverse) failure, the specimens with a hole of diameter-to-width ratio equal to 0.4 failed parallel to the loading axis (longitudinally). The longitudinal failure was observed at 90%

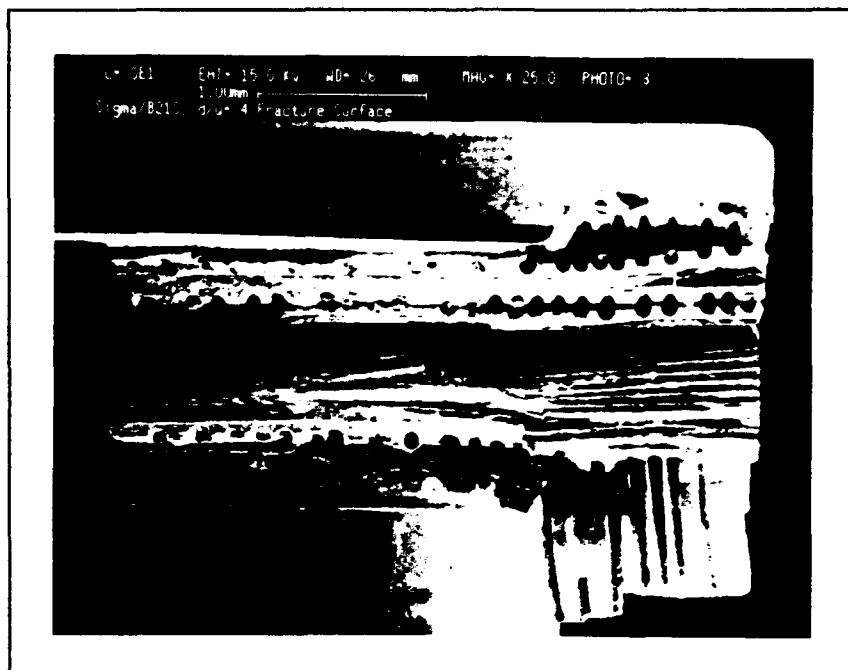
Figure 39. Notched Sigma/Beta 21S, Fracture Surface, 25X

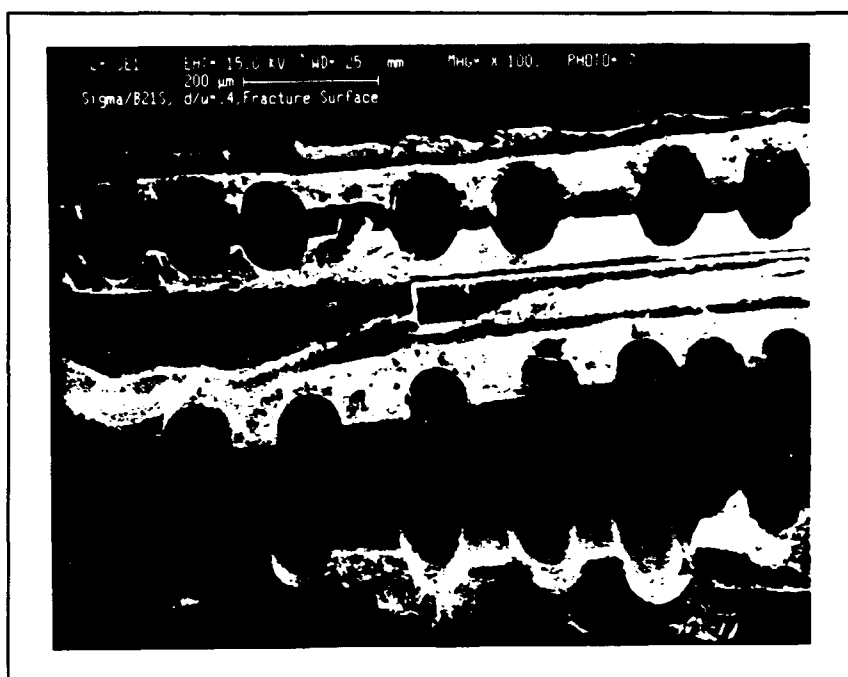
Figure 40. Notched Sigma/Beta 21S, Fracture Surface, 100X

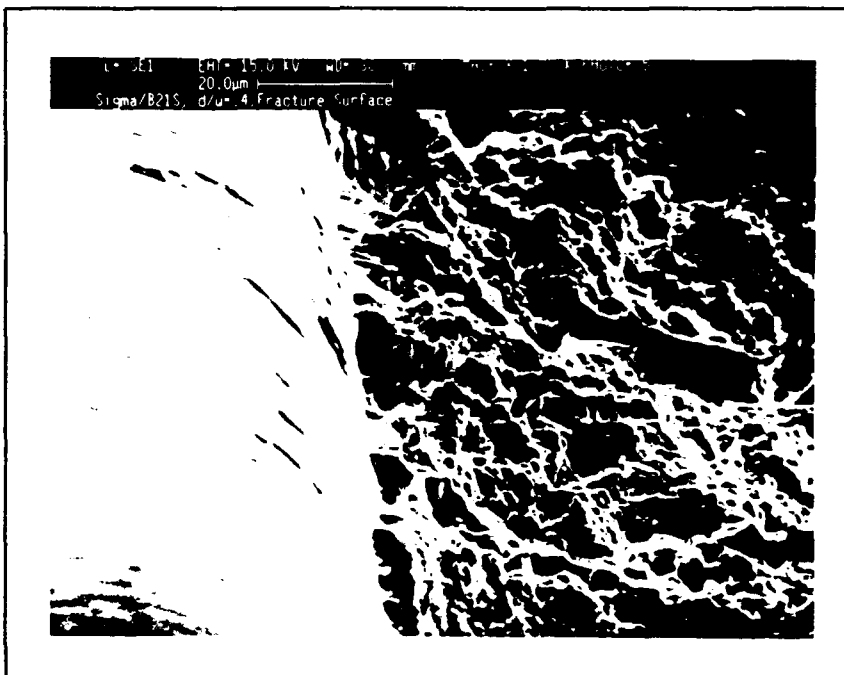
Figure 42. Notched Sigma/Beta 21S, Longitudinal Fracture Surface, 1000X

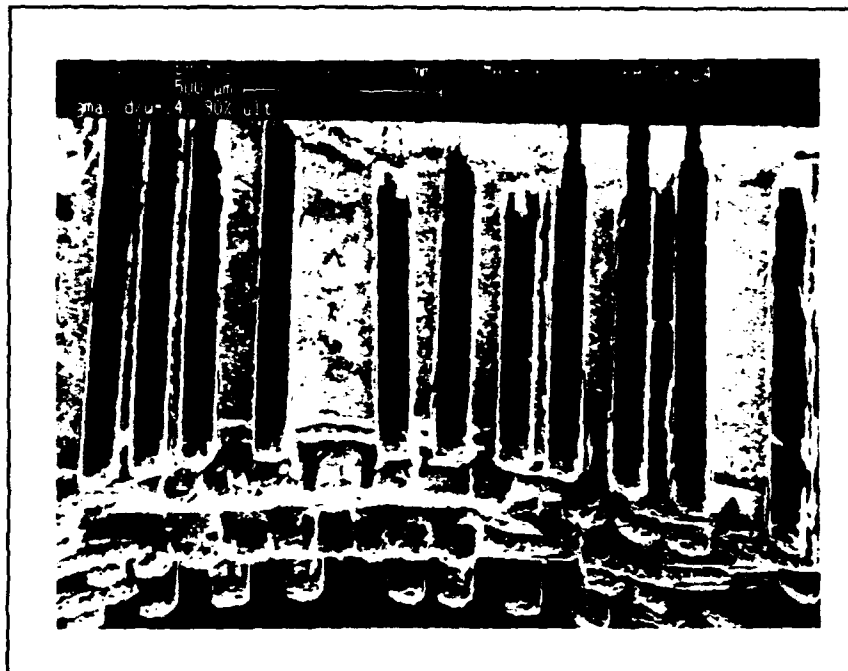
Figure 45. Notched Sigma/Beta 21S, Etched Face, Top of Hole, Showing Matrix Cracking, 50X

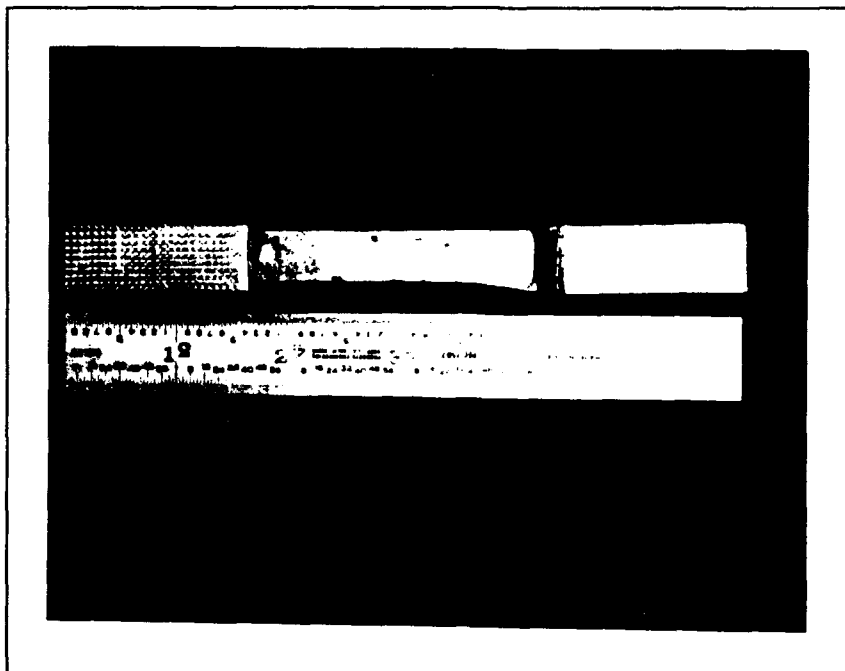
Figure 48. Unnotched SCS-6/Beta 21S, Room Temperature Compression Failure

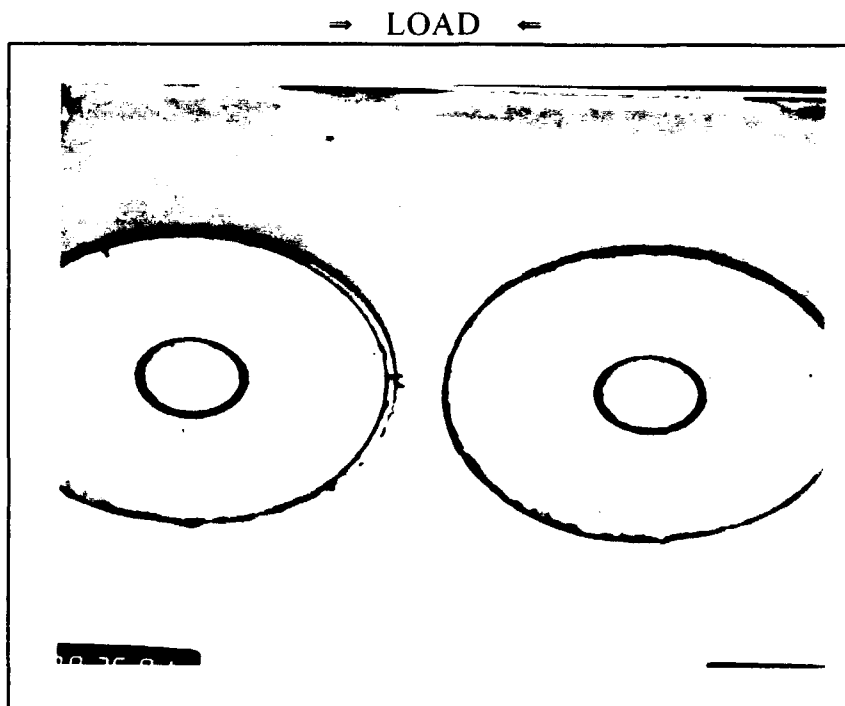
Figure 52. SCS-6/Beta 21S, 45° Fibers Tested to 40% of Ultimate Strength, Showing Matrix Plasticity, 300X

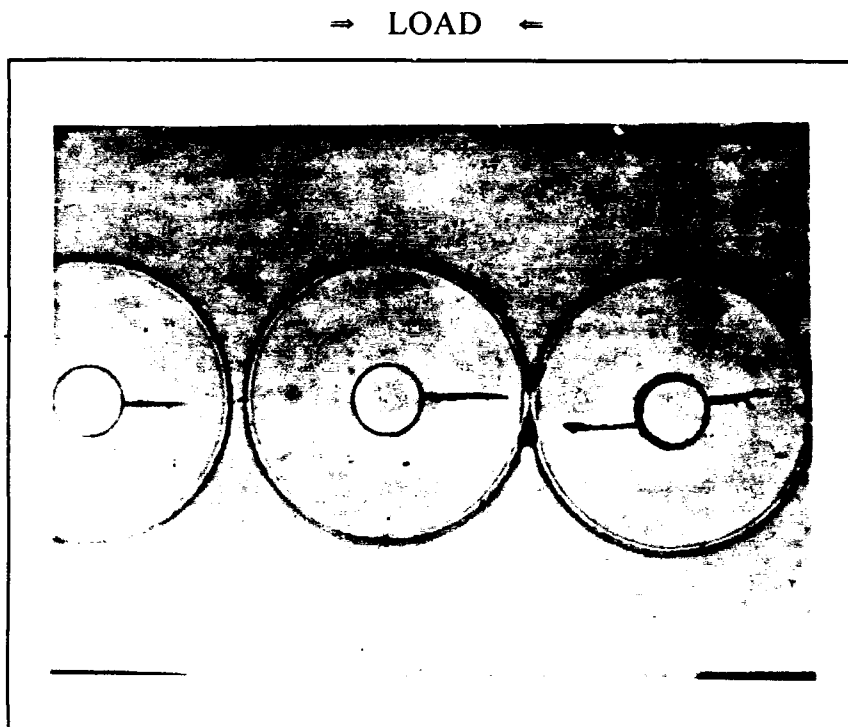
Figure 53. SCS-6/Beta 21S, Edge Replica of 90° Fibers, 50% of Ultimate Strength, Showing Radial Cracks, 300X

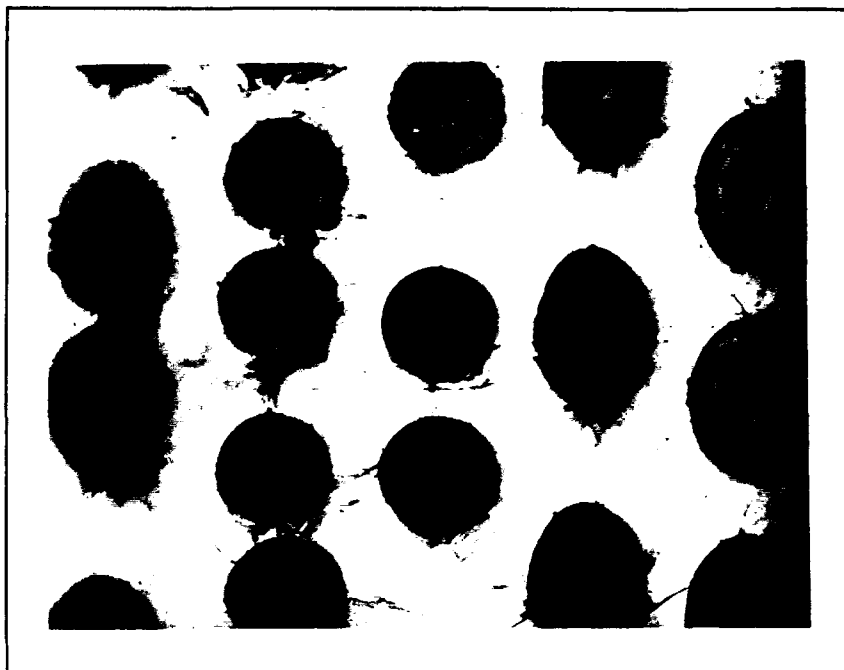
Figure 54. SCS-6/Beta 21S, Polished Edge of a Failed Room Temperature Specimen, 100X

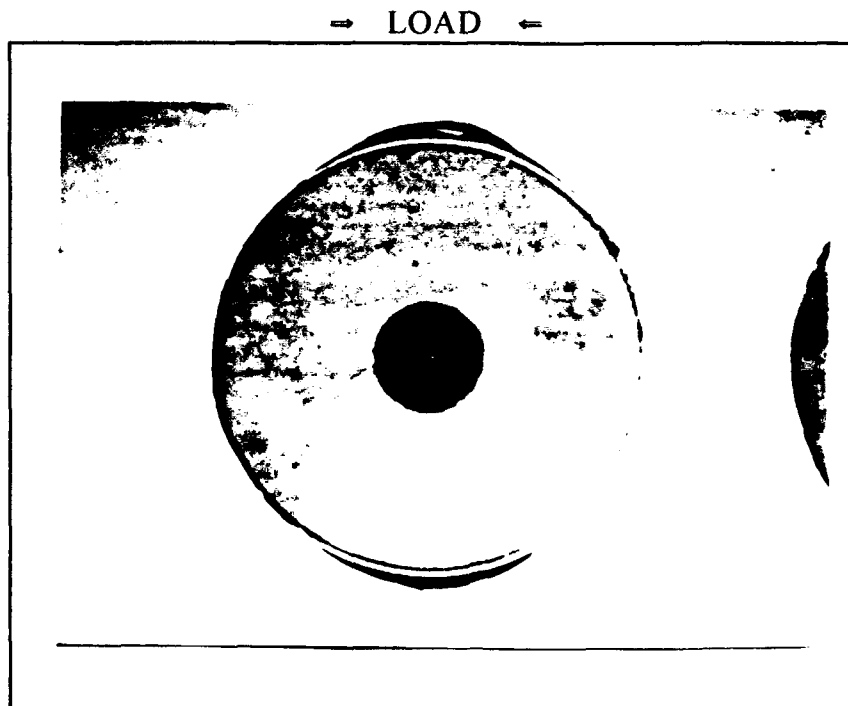
Figure 56. SCS-6/Beta 21S, Room Temperature Specimen, Showing Matrix Deformation, 350X

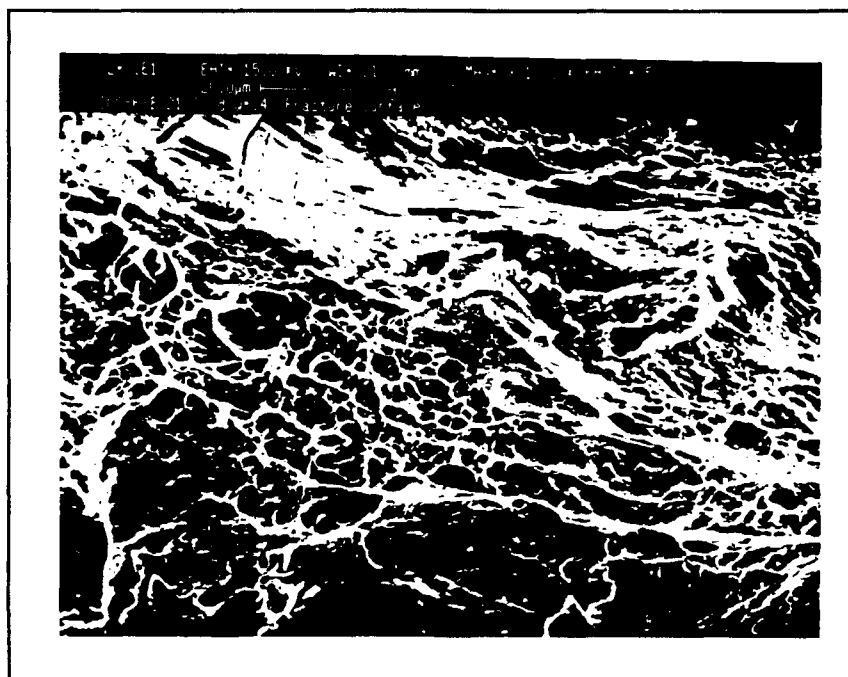
Figure 57. Unnotched SCS-6/Beta 21S, Fracture Surface, Showing Matrix Plasticity, 1000X

Matrix plasticity appeared as dimples on the fracture surface of the failed SCS-6/Beta 21S specimens (Fig. 57). The bulged cross section suggests the possibility that fiber microbuckling occurred, preceded by matrix yielding,

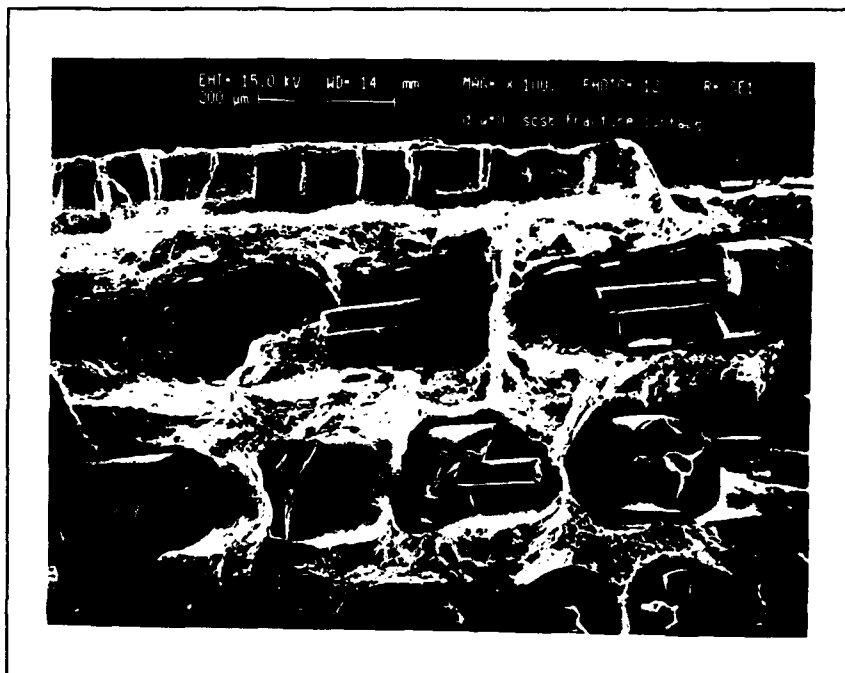
Figure 59. Unnotched SCS-6/Beta 21S, Fracture Surface, 100X

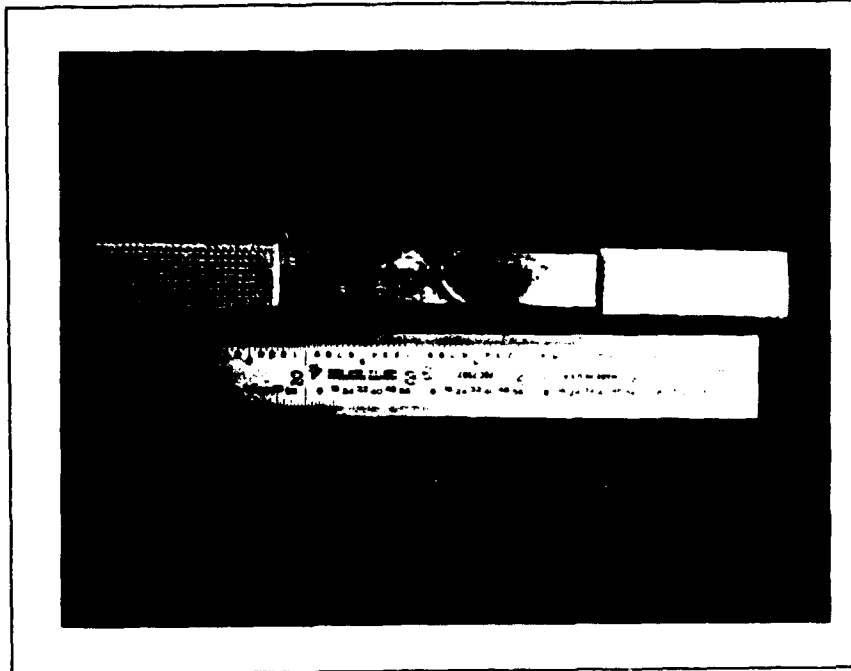
Figure 60. Notched SCS-6/Beta 21S, Room Temperature Compression Failure, $d/w=0.167$

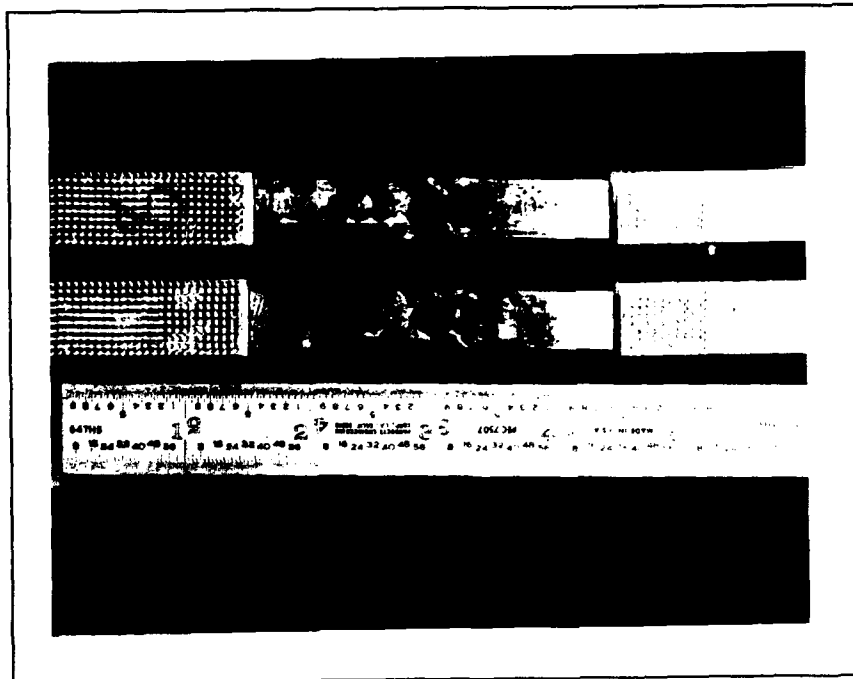
Figure 61. Notched SCS-6/Beta 21S, Room Temperature Compression Failure, $d/w=0.4$

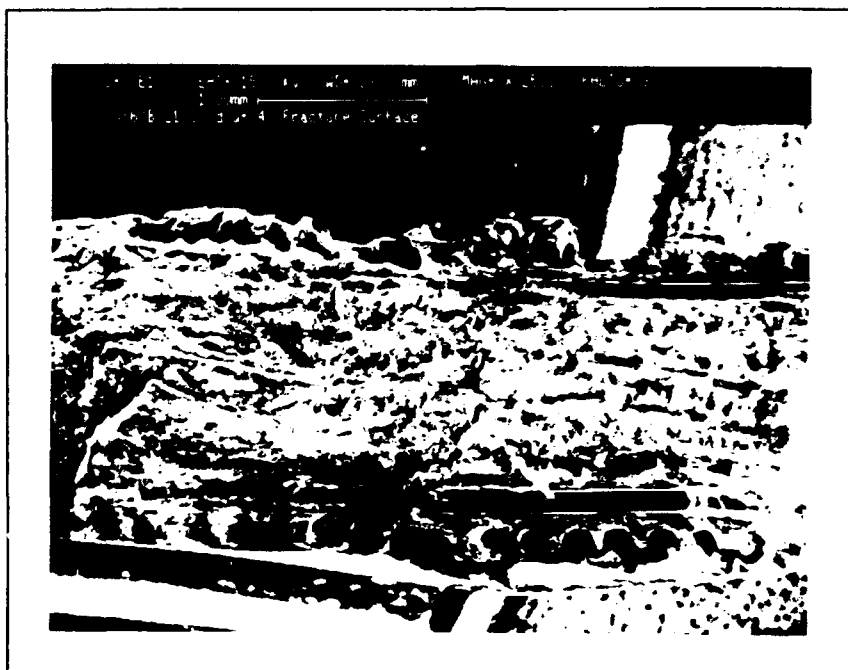
Figure 62. Notched SCS-6/Beta 21S, Fracture Surface of Room Temperature Specimen, 25X

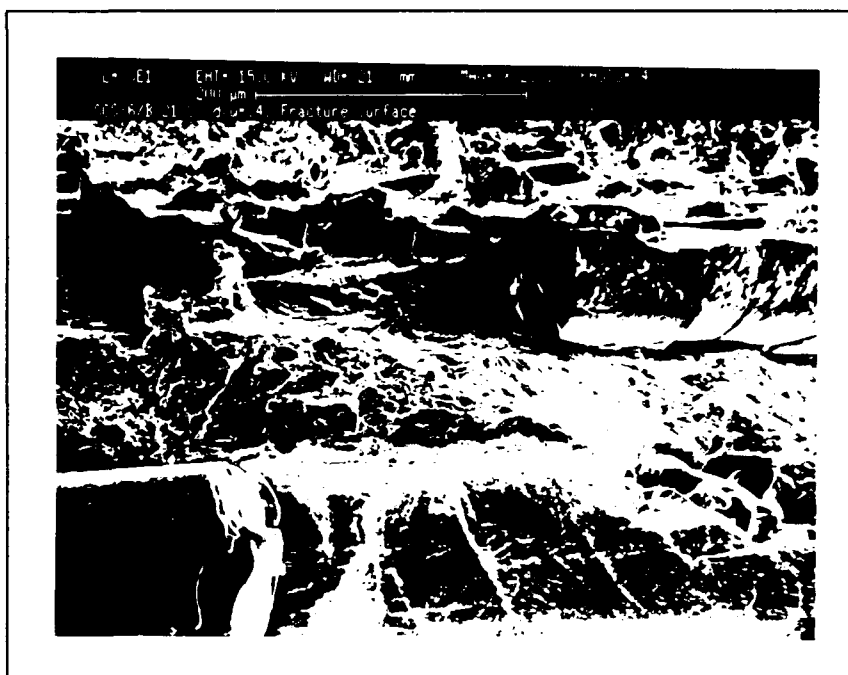
Figure 63. Notched SCS-6/Beta 21S, Fracture Surface of Room Temperature Specimen, 200X

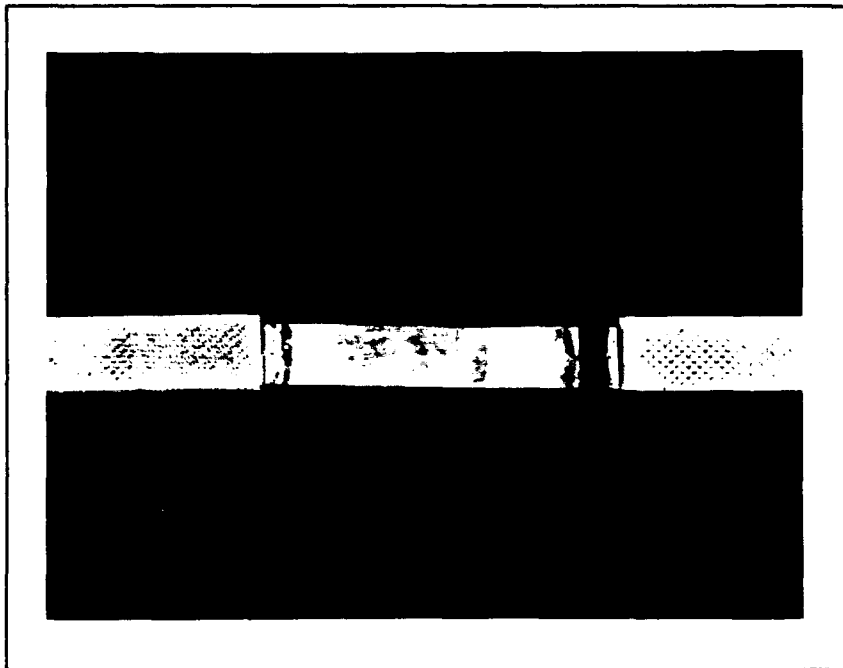
Figure 64. Unnotched SCS-6/Beta 21S, Elevated Temperature Compression Failure

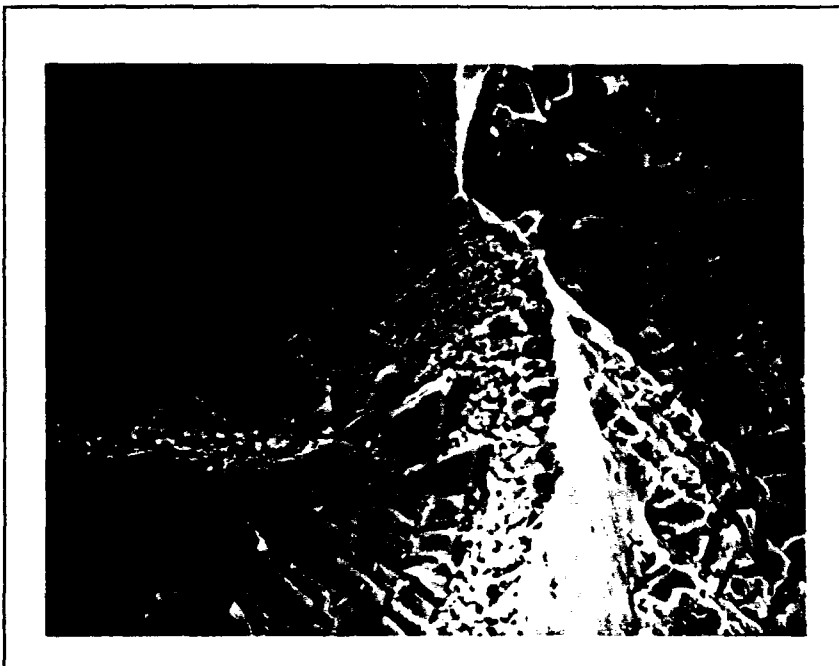
Figure 71. Unnotched SCS-6/Beta 21S, Fracture Surface of Elevated Temperature Specimen, Showing Separated C/TiB₂ Fiber Coating, 1000X

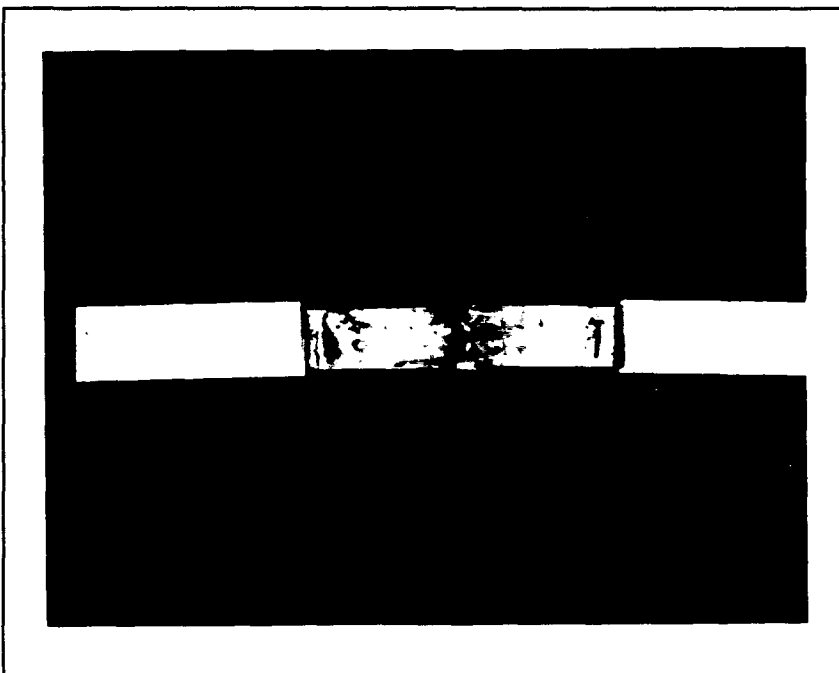
Figure 72. Notched SCS-6/Beta 21S, Elevated Temperature Failure Specimen, $d/w=0.167$

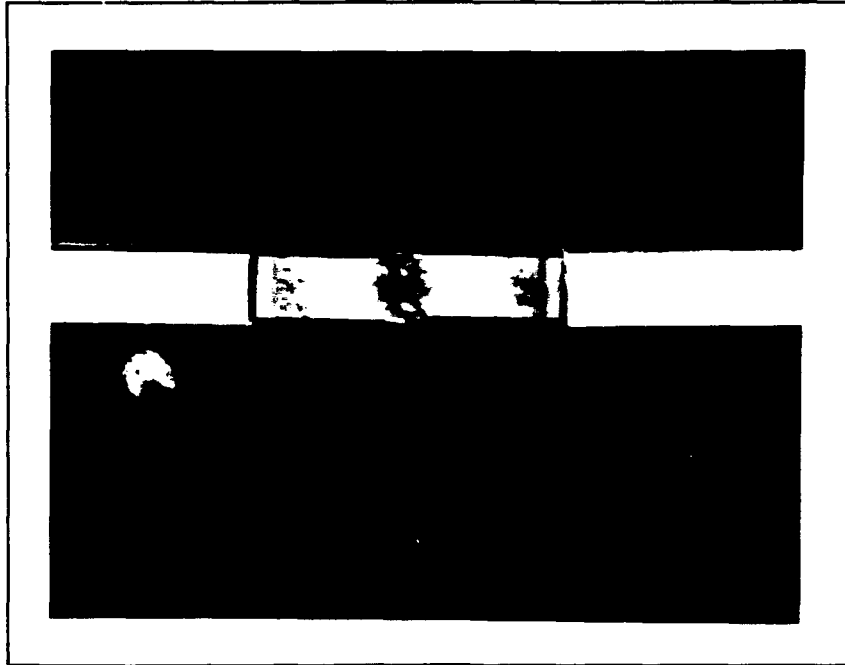
Figure 73. Notched SCS-6/Beta 21S, Elevated Temperature Failure Specimen, $d/w=0.4$

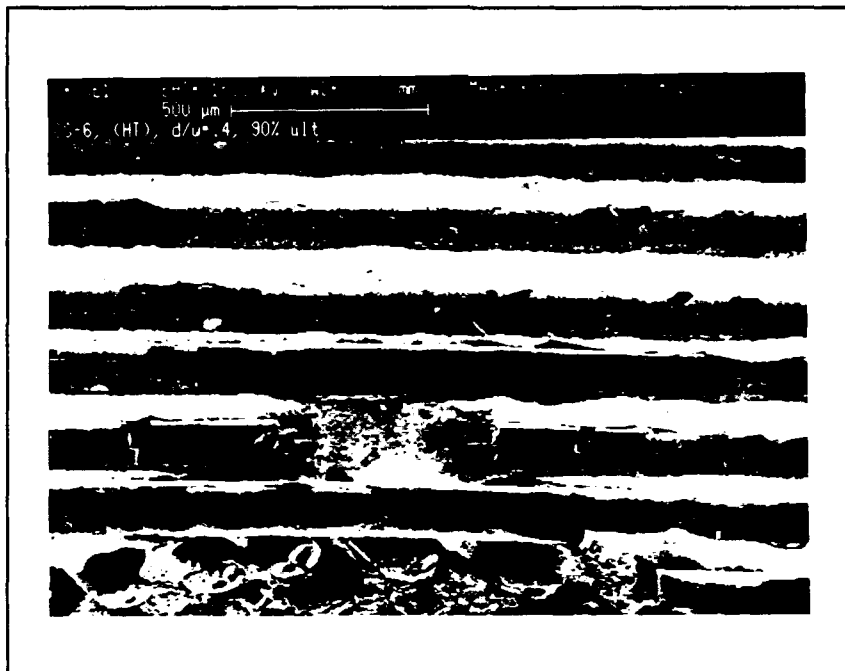
Figure 74. Notched SCS-6/Beta 21S, Etched Face of Elevated Temperature Specimen, 0° Fibers at 90% of Ultimate Strength, $d/w=0.4$, 50X

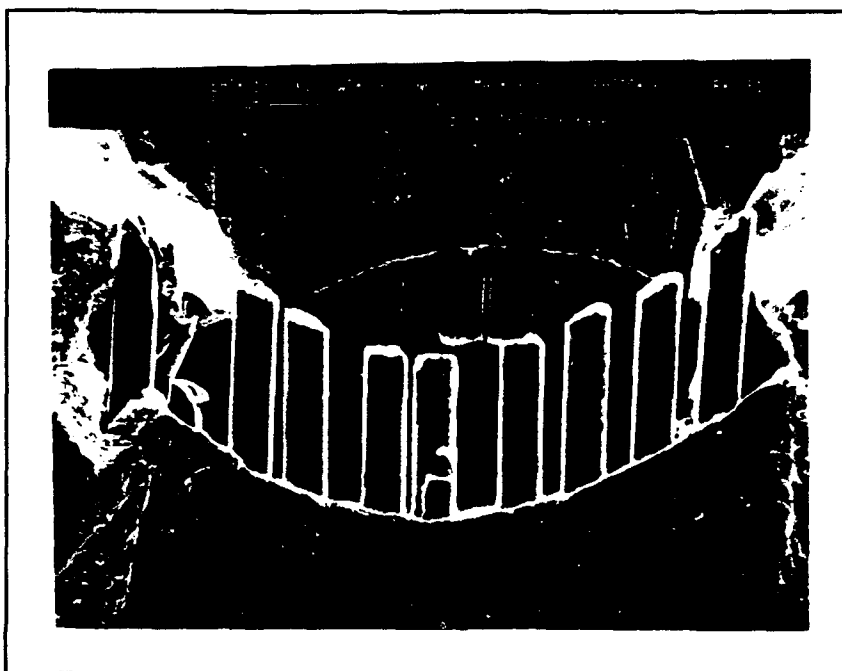
Figure 75. Notched SCS-6/Beta 21S, Face of Failed Elevated Temperature Specimen, $d/w=0.167$, Showing 0° Fiber Debonding Near the Hole, 50X

The face of a failed notched specimen with $d/w = 0.167$ was examined in the SEM. The 0° fibers at the top and bottom of the hole were protruding into the space of the hole, indicating a great amount of fiber debonding (Fig. 75).

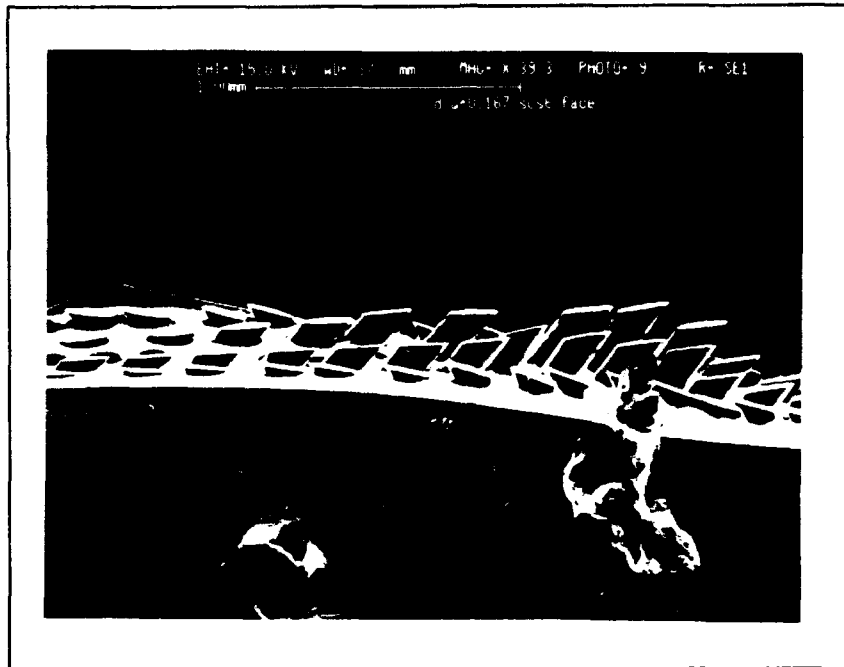
Figure 76. Notched SCS-6/Beta 21S, Elevated Temperature $d/w = 0.167$ Specimen, Showing 45° Fiber Debonding, 39X

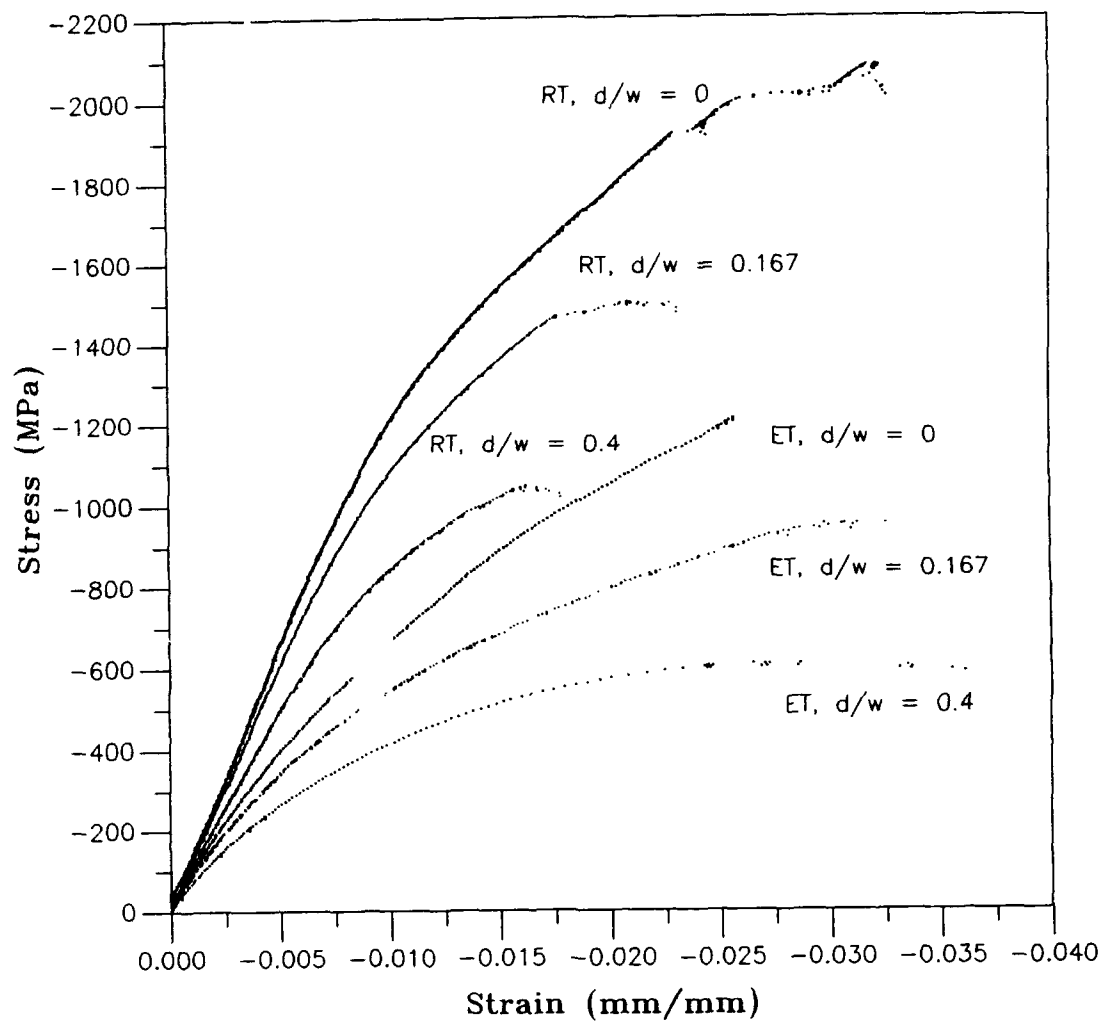
Figure 80. Room and Elevated Temperature Compression, SCS-6/Beta 21S

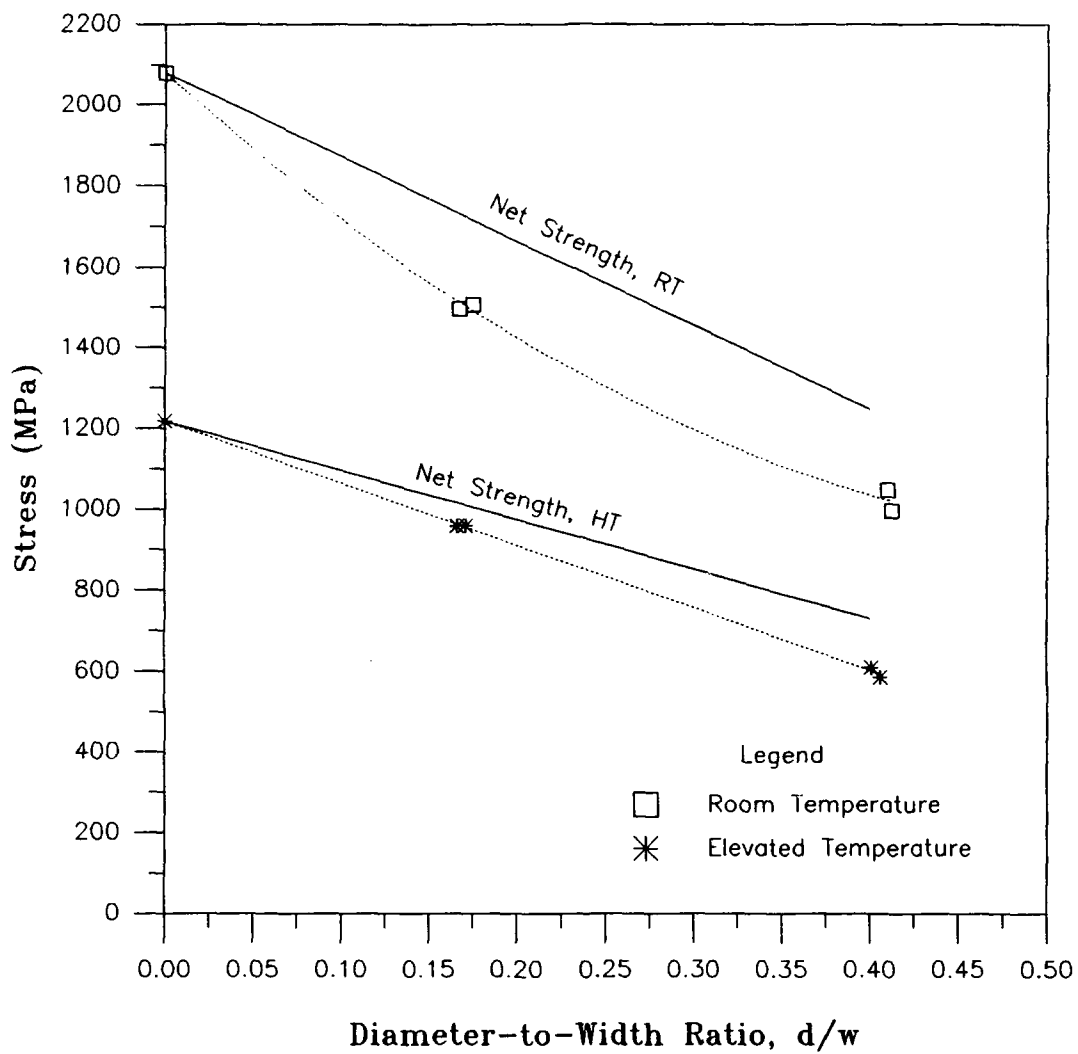
Figure 81. Room and Elevated Temperature Compressive Strength, Based on Remote Area, SCS-6/Beta 21S

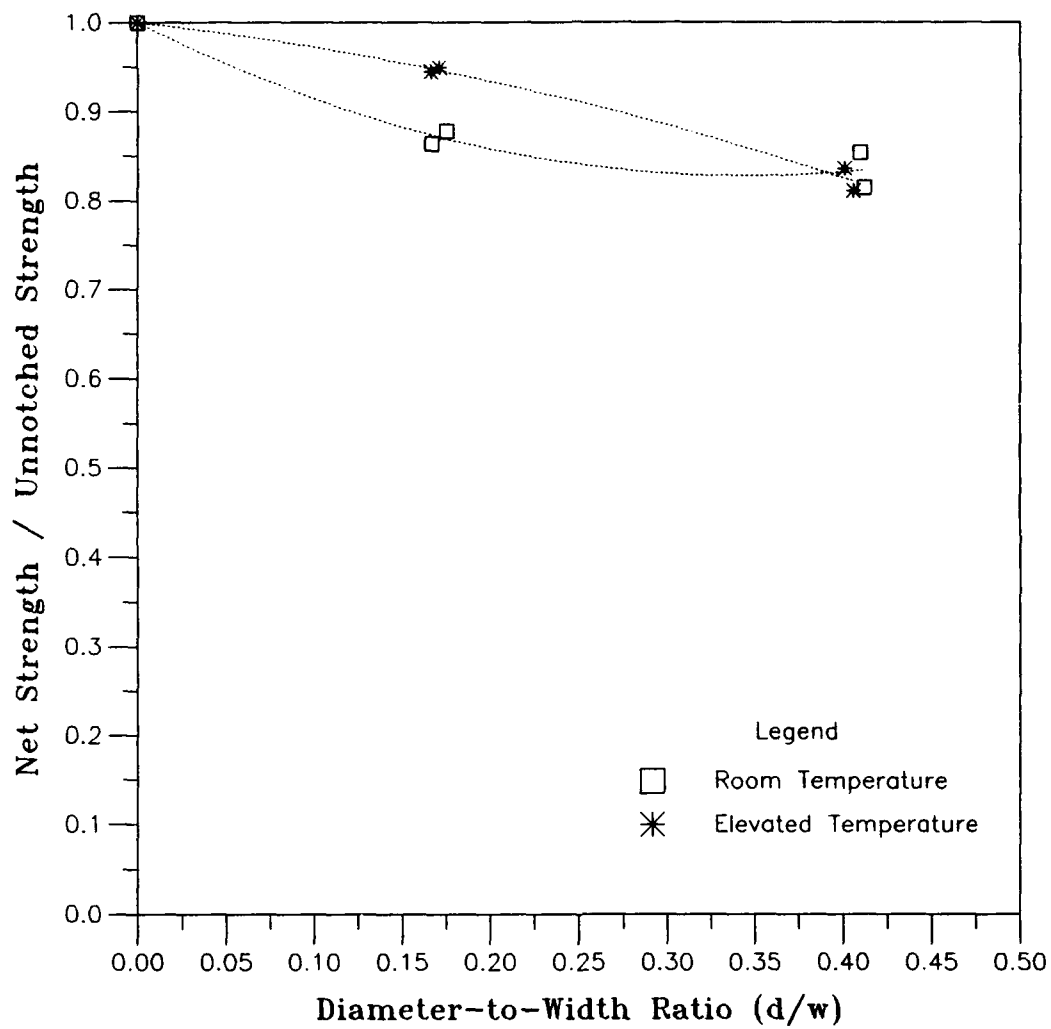
Figure 82. Normalized Strength, Room and Elevated Temperature Compression, SCS-6/Beta 21S

Notch Sensitivity. The effect of temperature on the notch sensitivity of SCS-6/Beta 21S was assessed through the use of net strength and normalized strength curves. The net strength line for each temperature was graphed as a theoretical prediction for notched strength (Fig. 81). The graph shows a slight decrease in notch sensitivity at elevated temperature. The same temperature effect may be illustrated using the normalized strength curve (Fig. 82).
