## Fatigue Behavior of a Cross-Ply Ceramic Matrix Composite at Elevated Temperatures Under Tension-Tension Loading

AFIT/GAE/ENY/93D-28

FATIGUE BEHAVIOR OF A CROSS-PLY CERAMIC  
MATRIX COMPOSITE AT ELEVATED TEMPERATURES  
UNDER TENSION-TENSION LOADING

Richard J. Tuznik  
Captain, USAF  
AFIT/GAE/ENY/93D-28

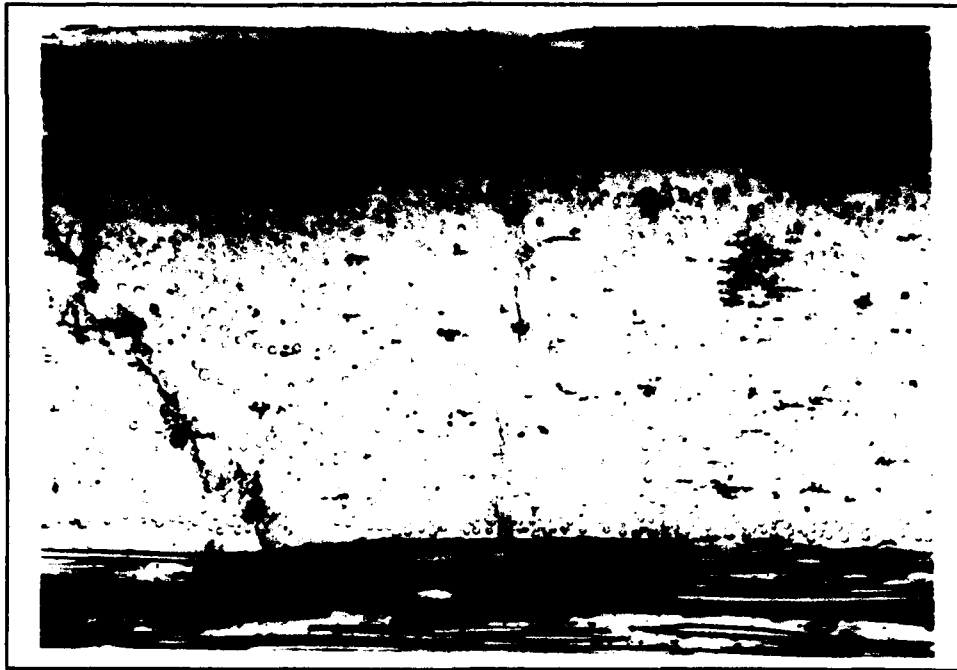
Figure 47. Interrupted Test, 850° C, 109 Cycles, 50X.

Figures 45 through 47 show the edge damage recorded in the specimen tested at 850° C. Significantly less damage occurred on the first cycle compared to the 700° C interrupted test. No pattern of damage accumulation in this series of edge replicas was evident. It was observed that the transverse cracks in the 90° plies did not grow into the 0° plies after 109 cycles as was clearly seen during the 700° C interrupted test. These findings, while incomplete, do support the damage mechanisms discussed in Sections A through D that ultimate failure in tension-tension fatigue loading at temperatures up to 700° C resulted from an accumulation of damage to the matrix.
