Creep of Nextel 720/Alumina Ceramic Matrix Composite with Diamond-Drilled Effusion Holes at 1200°C in Air and in Steam

THESIS

Megan L. Harkins, Major, USAF

AIR FORCE INSTITUTE OF TECHNOLOGY

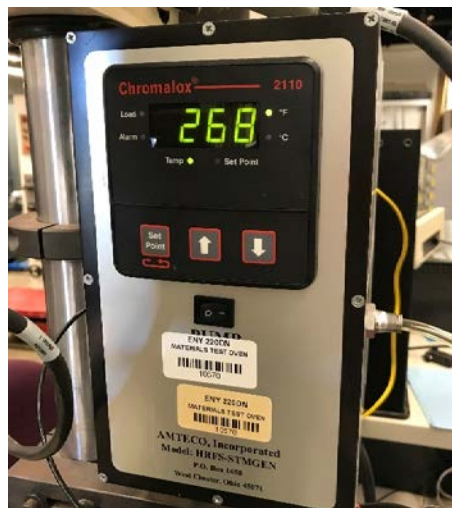
In order to produce a near 100% steam environment, an alumina susceptor was specifically designed to house the gage section of the specimen while providing an opening for a steam feeding tube and slots for the two extensometer extension rods (Figure 12). Steam was provided to the susceptor from an AMTECO HRFS-STMGEN steam generation system (Figure 13) in a continuous flow at a rate sufficient to displace the dry air and create a near 100% steam environment around the specimen gage section.

Figure 13: AMTECO steam generation system

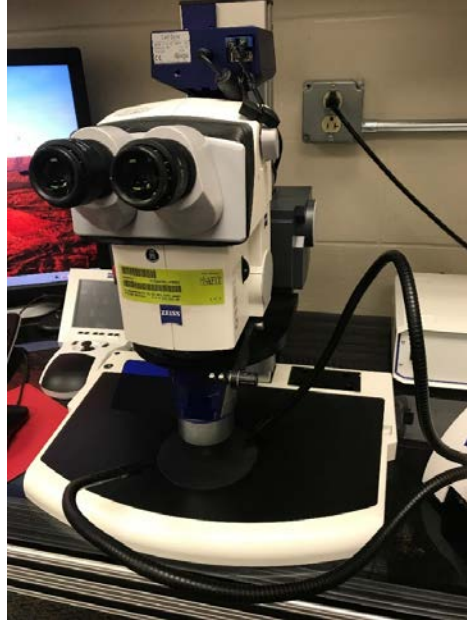
A ZEISS SteREO Discovery.V12 optical microscope (Figure 15), equipped with an AxioCam HRc digital camera and AxioVision software (version 4.8) was used before and after testing to examine the microstructure surrounding a few randomly selected holes as well as the post-test fracture surfaces.

Figure 15: ZEISS optical microscope

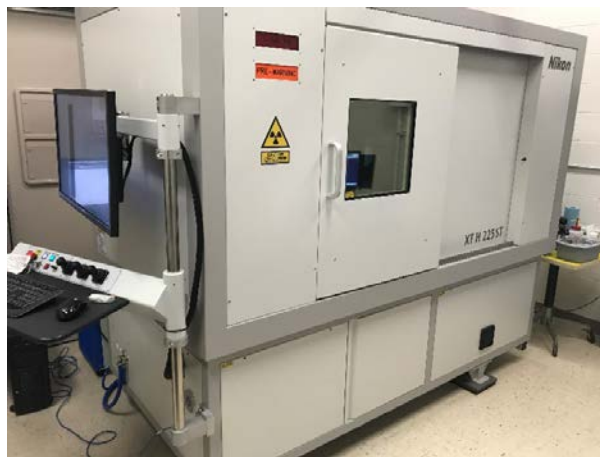
A Nikon XT H 225 ST Computed Tomography (CT) scanner (Figure 16) was used to examine specimens after testing to provide additional insight into interior damage zone penetration that may not be captured via optical microscopy.

Figure 16: Nikon CT scanner

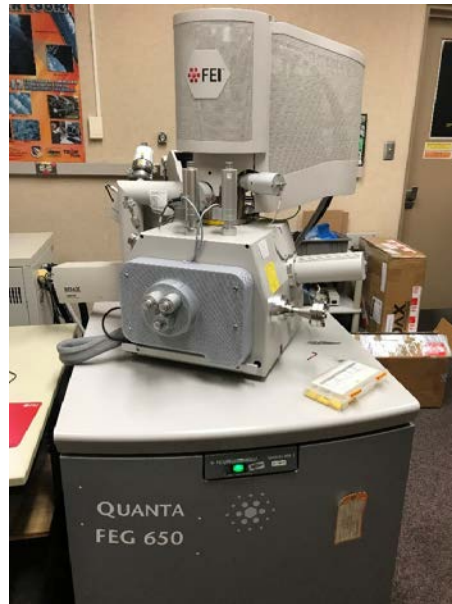
A Quanta FEG 650 (Figure 17) and MAIA3 Triglav TESCAN SEM (Figure 18) were used to further characterize the microstructure of the material by examining the fracture surfaces. Unlike the optical microscope, the SEM can achieve a resolution on

Figure 17: Quanta FEG SEM

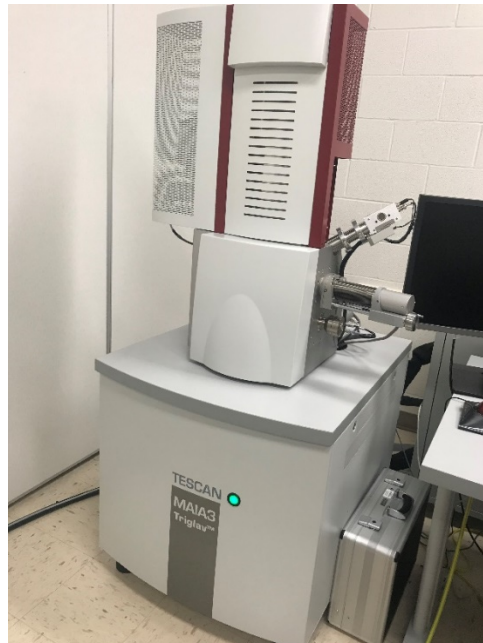
Figure 18: MAIA3 TESCAN SEM

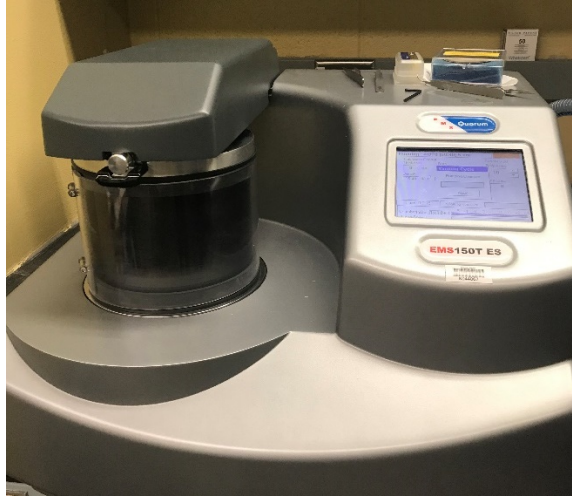
the order of nanometers; however, the specimen must have conductive properties for a clear image to be collected. Considering that the N720/A constituents are both poor conductors, an EMS Quorum sputtering machine (Figure 19) was used to coat the fracture surfaces with a gold-palladium (Au-Pd) alloy prior to SEM examination.

Figure 19: EMS Quorum sputtering machine

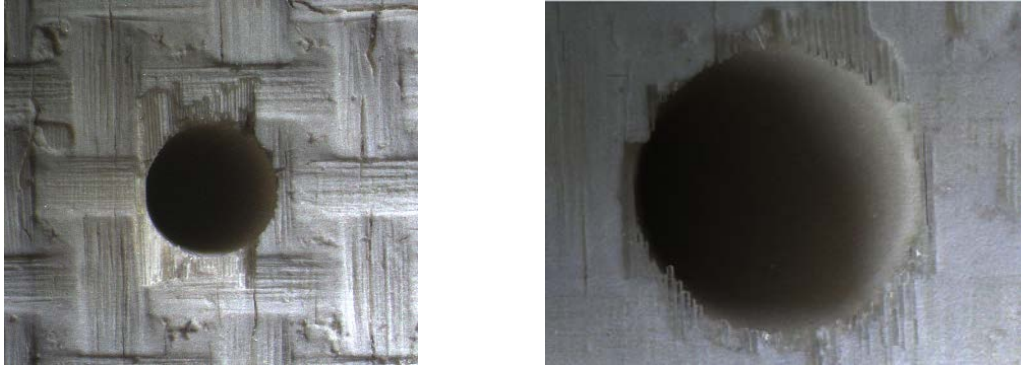
Figure 37: Pre-test optical micrographs of N720/A specimens with diamond-drilled holes showing material in the vicinity of randomly selected holes

Similarly, this effort sought to use optical micrographs to characterize the composite microstructure in the area surrounding the DD holes. Figures 37-39 show representative optical micrographs of composite microstructure for untested DD specimens (Figure 37), and DD specimens tested in creep at 1200°C in air (Figure 38) and in steam (Figure 39). The key takeaway from this analysis is the lack of a glassy phase in the vicinity of any DD hole. Additionally, there appears to be more fiber pull-out and less fiber-matrix bonding relative to optical micrographs of LD holes (Figure 40)

[3]. These observations suggest that the diamond drilling process is less damaging to the composite microstructure than laser drilling.

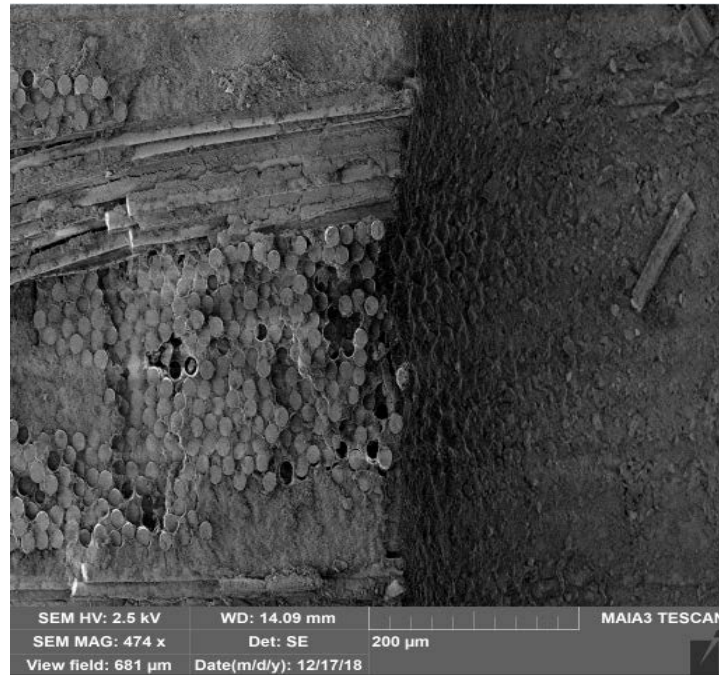
Figure 52: Fracture surface of an N720/A specimen with diamond-drilled holes tested in creep at 1200°C in steam ($\sigma_{cr} = 93$ MPa, $t_f = 6.05$ h)

Representative SEM micrographs obtained in this work are shown in Figures 48-53. Note that some SEM images were produced with the Quanta FEG 650 SEM and some with the MAIA3 TESCAN SEM. Figures 48-50 present typical features of a fracture surface obtained from creep tests performed at 1200°C in air, and Figures 51-53, similarly capture features from creep tests performed at 1200°C in steam.

These micrographs consistently show a grainy surface on the hole interior, where both fibers and matrix are readily discernable. Additionally, both air and steam fracture surfaces show signs of fiber pull-out in the vicinity of the holes, with little matrix remaining bonded to the exposed fibers. The lower magnification micrographs also show more regions of coordinated fiber failure for specimens tested in steam, which ultimately contributes to the more planar fracture surface. While matrix sintering is not a distinct feature that can be measured via SEM, it is the presumed cause for the correlated fiber failures in steam based unnotched creep results [11, 12, 14].

The SEM micrographs obtained in this work (Figures 48-53) differ significantly from those obtained by Minor for specimens with LD holes [3]. Specifically, Minor estimated that the laser drilling process caused a damage zone close to 1 mm in diameter around each hole. As seen in Figure 54 reproduced from Minor [3], SEM micrographs of the LD specimens identified this damage as a glassy phase covering the hole interior, as

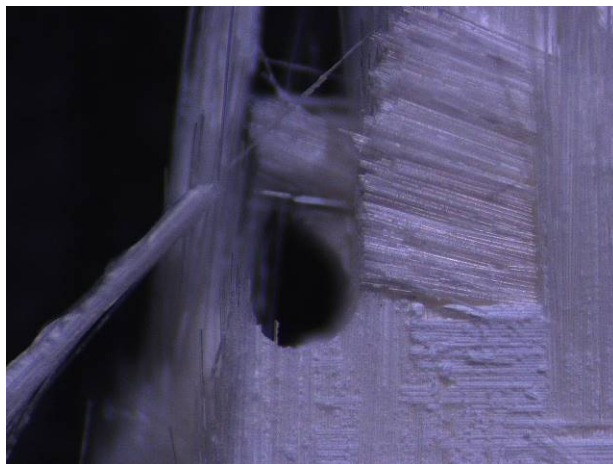
Figure A. 4: Fracture surface of specimen #3, tested in tension to failure at 1200°C in air

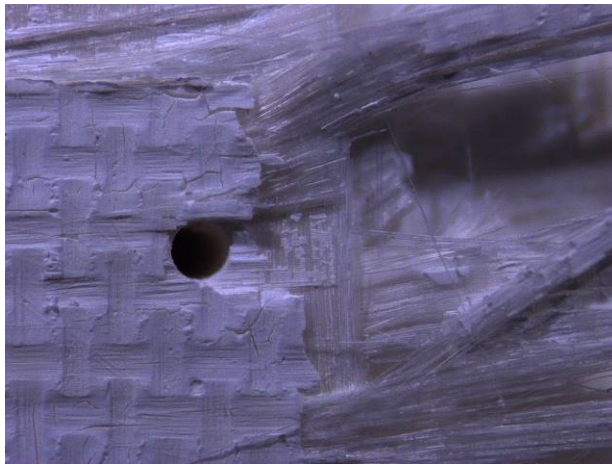
Figure A. 10: Fracture surface of specimen #3, tested in tension to failure at 1200°C in air

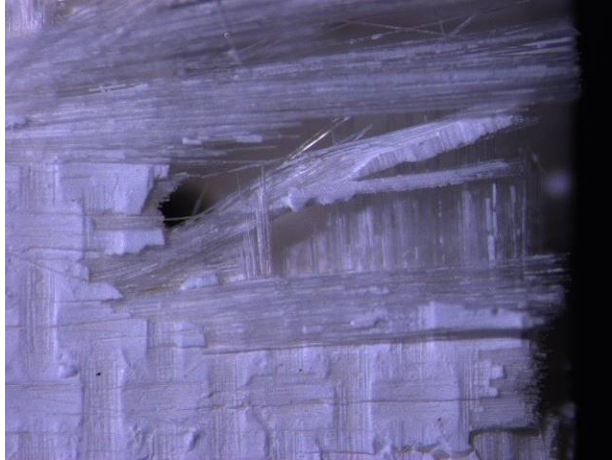
Figure A. 11: Fracture surface of specimen #3, tested in tension to failure at 1200°C in air

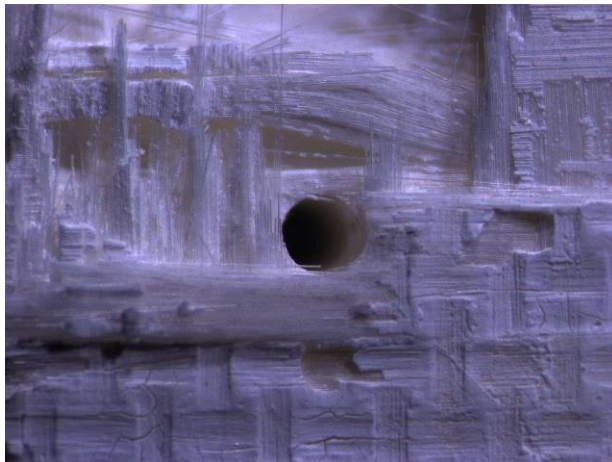
Figure A. 13: Fracture surface of specimen #3, tested in tension to failure at 1200°C in air

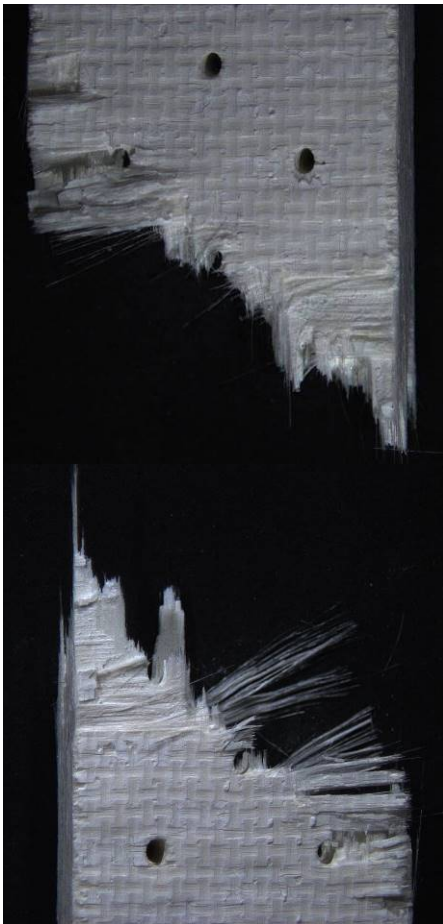
Figure A. 15: Top and bottom fracture surfaces of specimen #7, tested in tension to failure following 100 h creep at 46 MPa at 1200°C in air

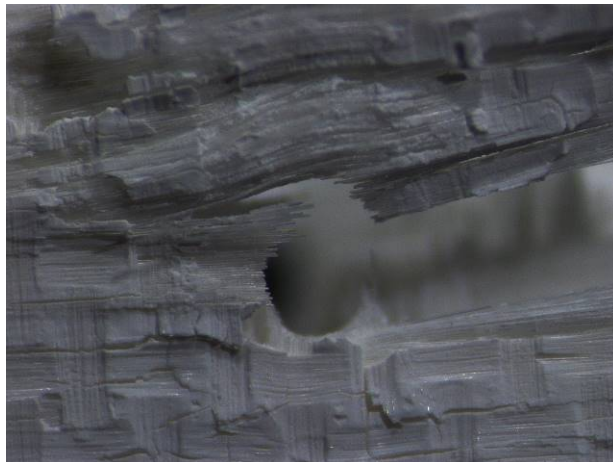
Figure A. 21: Fracture surface of specimen #7, tested in tension to failure following 100 h creep at 46 MPa at 1200°C in air

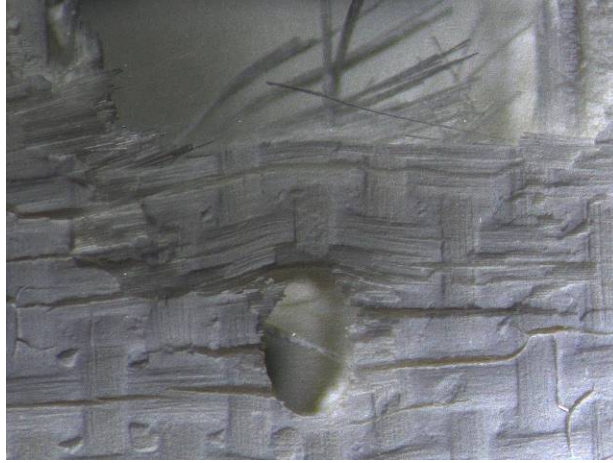
Figure A. 24: Fracture surface of specimen #6, tested in creep at 1200°C in air ($\sigma_{cr} = 69$ MPa, $t_f = 30.95$ h)

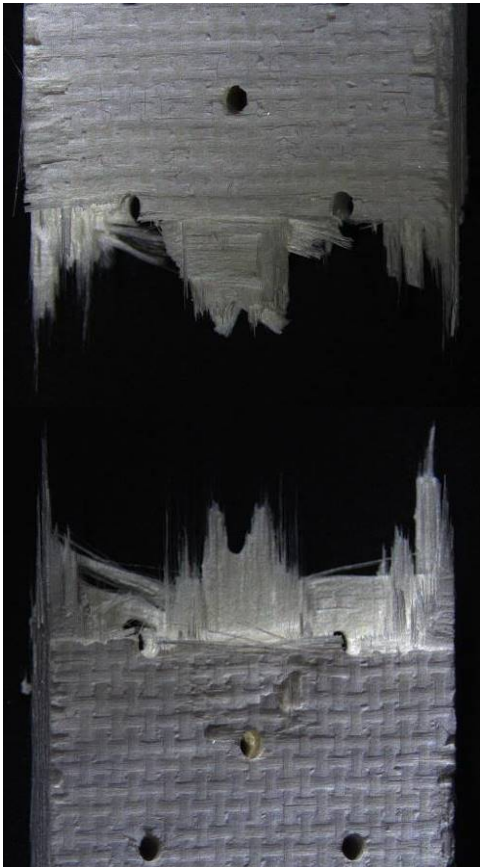
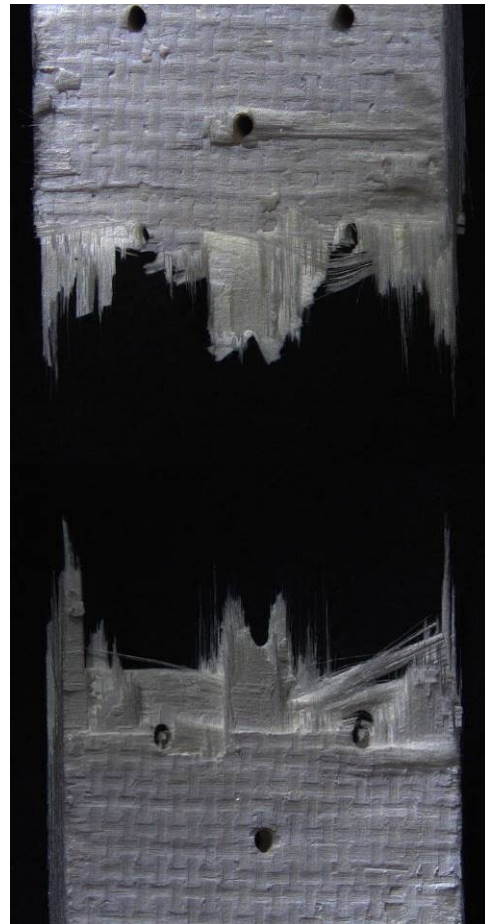
Figure A. 25: Top and bottom fracture surfaces of specimen #5, tested in creep at 1200°C in air ($\sigma_{cr} = 94$ MPa, $t_f = 6.55$ h)

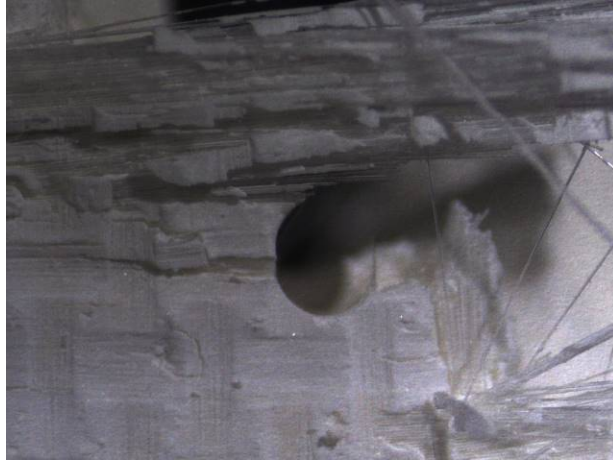
Figure A. 28: Fracture surface of specimen #4, tested in creep at 1200°C in air ($\sigma_{cr} = 118$ MPa, $t_f = 0.59$ h)

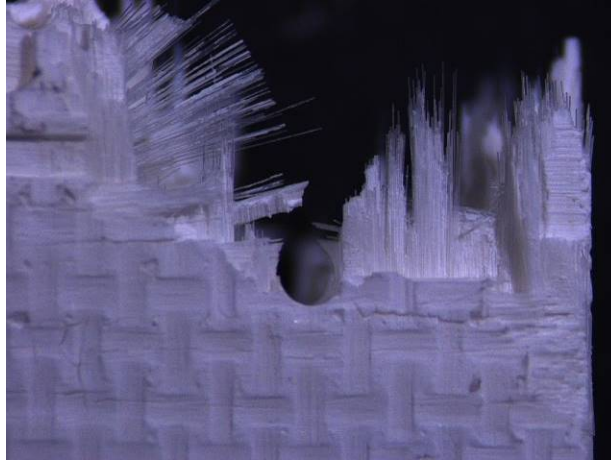
Figure A. 42: Fracture surface of specimen #12, tested in tension to failure following 100 h creep at 46 MPa at 1200°C in steam

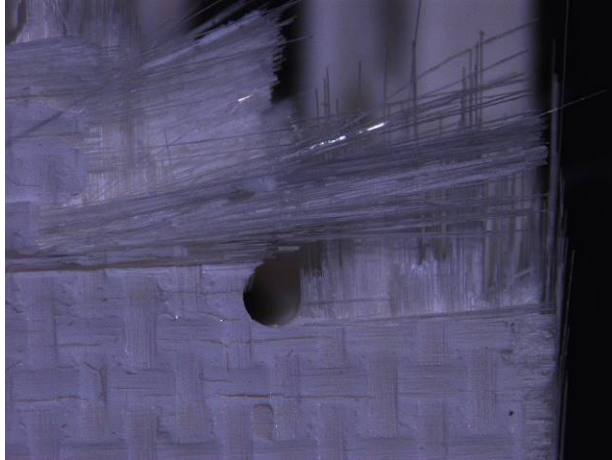
**Figure A. 50: Fracture surface of specimen #9, tested in creep at 1200°C in steam
($\sigma_{cr} = 116$ MPa, $t_f = 0.61$ h)**

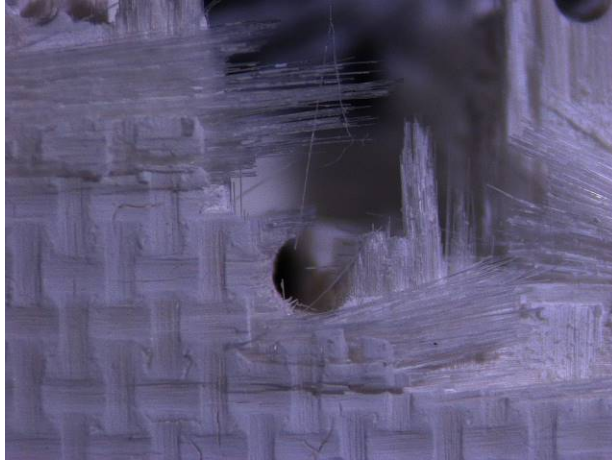
**Figure A. 53: Fracture surface of specimen #9, tested in creep at 1200°C in steam
($\sigma_{cr} = 116$ MPa, $t_f = 0.61$ h)**

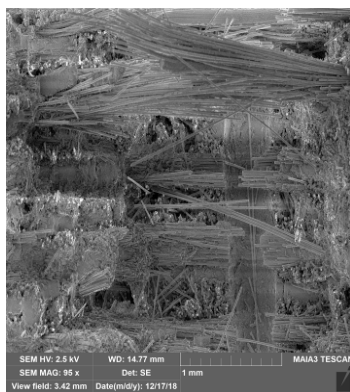
Figure D. 15: Fracture surface of specimen #12 (Area 1), tested in tension to failure following 100 h creep at 46 MPa at 1200°C in steam: (a) 95X, (b) 387X, (c) 1kX

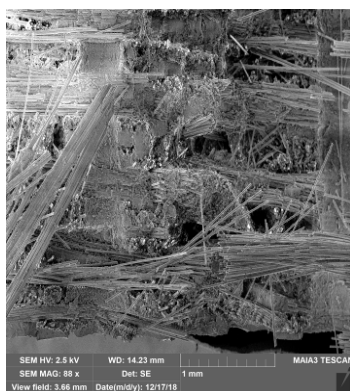
Figure D. 16: Fracture surface of specimen #12 (Area 2), tested in tension to failure following 100 h creep at 46 MPa at 1200°C in steam: (a) 88X, (b) 811X, (c) 2.5kX

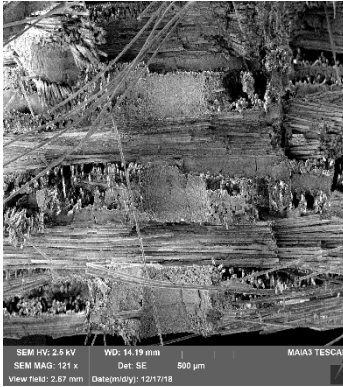
Figure D. 22: Fracture surface of specimen #10 (left hole, Area 1 & 2), tested in creep at 1200°C in steam ($\sigma_{cr} = 93$ MPa, $t_f = 6.05$ h): (a) 121X, (b) 585X, (c) 611X

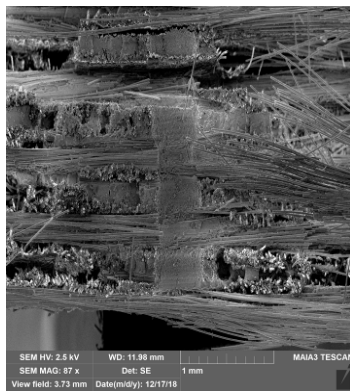
Figure D. 28: Fracture surface of specimen #11 (Area 1), tested in creep at 1200°C in steam ($\sigma_{cr} = 150$ MPa, $t_f = 0.04$ h): (a) 87X, (b) 479X, (c) 1.4kX
