## Damage Detection Analysis Using Lamb Waves in Restricted Geometry for Aerospace Applications

THESIS

Roman T. Underwood, Captain, USAF

AFIT/GAE/ENY/08-M29

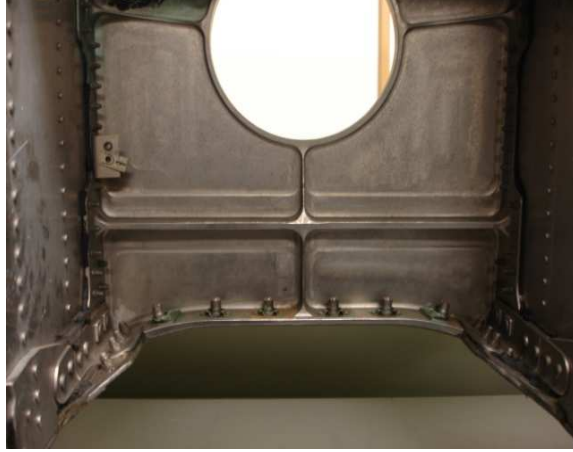
Figure 1.1: USAF aircraft bulkhead known to suffer fatigue cracks [7]

The United States Air Force (USAF) has aircraft with internal support structures, known as bulkheads, known to suffer from fatigue cracks. The bulkheads identified by the USAF have complex and restrictive geometries, see Figure 1.1. Because the aircraft must be disassembled in order to access the bulkhead shown, lengthy inspection times are required to check for damage. The aircraft systems known to suffer from these identified fatigue cracks are forced to endure the lengthy inspections to ensure the operational safety of the aircraft, which means the readiness of the these aircraft is reduced. An attached SHM system installed at bulkhead locations of known fatigue cracks could reduce the lengthy inspection times, increasing the readiness of the aircraft and reporting the structural health of the aircraft.
