Damage Detection Using Lamb Waves for Structural Health Monitoring

THESIS

AFIT/GA/ENY/07-M05

AIR FORCE INSTITUTE OF TECHNOLOGY

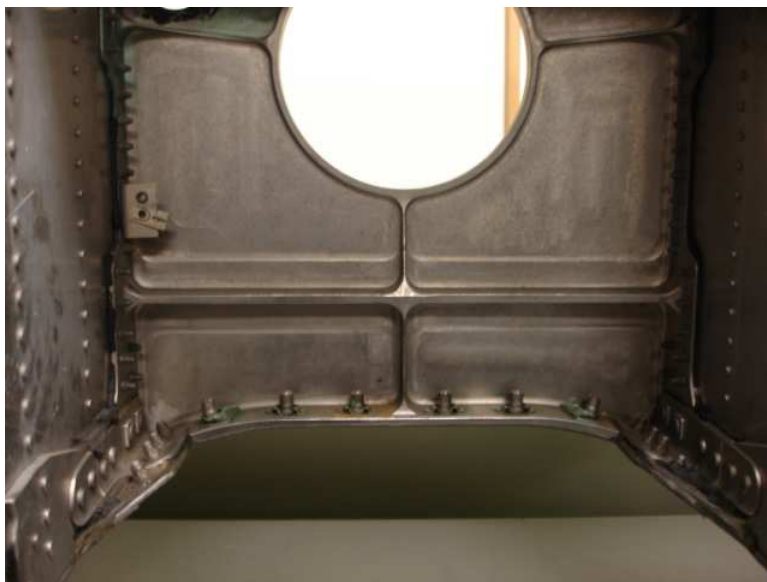
Figure 1.4 F-15 bulkhead: undamaged bulkhead provided to AFIT

The final experiment implemented the testing procedures developed using the MPP on a realistic SHM issue. Recall from Chapter 1, the SHM problem chosen was a F-15 bulkhead provided to AFIT by Robins AFB (see Figures 1.1 through 1.4). It is not acceptable to damage the actual bulkhead; therefore, a test article was milled out of aluminum based on dimensions from the undamaged bulkhead. We instrumented the test article using the same procedures as the MPP. A series of EDM cuts were made to simulate a crack representative to the actual damage. Differences in pitch-catch measurements characterize healthy and damaged states.

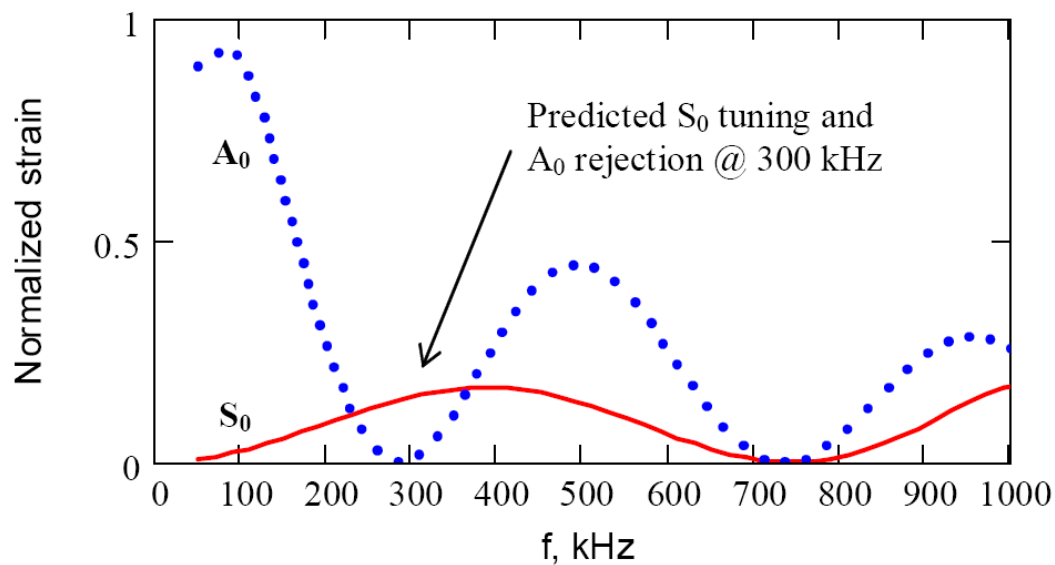
Figure 1.9 Theoretical Lamb wave response of a 1.6 mm aluminum plate [4]

We were able to clearly identify the A_0 and S_0 waves in the healthy response from the edge reflections. However, according to the tuning curves, Figure 1.9, at

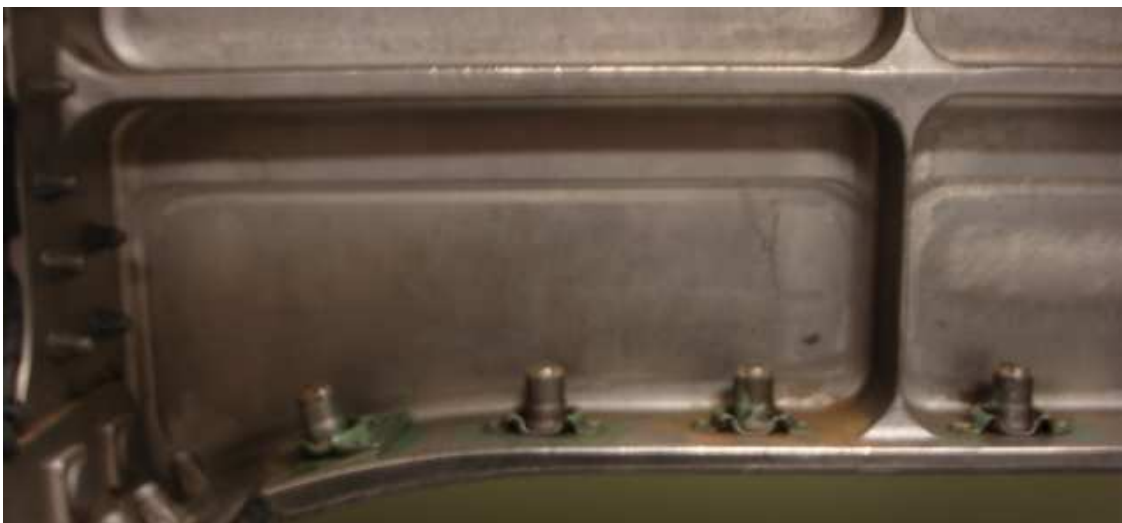
Figure 2.12 F-15 bulkhead: closeup of undamaged bulkhead where damage occurred

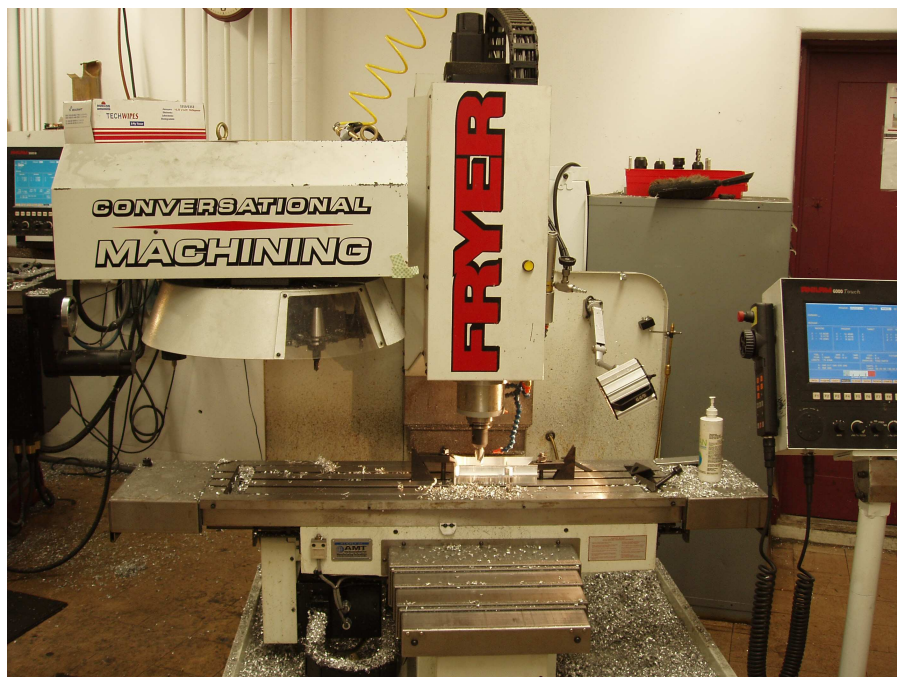
Figure 2.13 F-15: milling using Fryer MB-10

2.4.1 Milling Process. The F-15 bulkhead is made of a titanium alloy, but we choose aluminum due to similar dispersive properties (Figures 1.11 and 1.12), availability, and cost. Figure 2.11 shows the dimensions of the scaled F-15 drawing that was provided to AFIT's model fabrication shop for the milling. Sensor 3 through 6 were placed as shown. A closeup of the F-15 section is shown in Figure 2.12. Three test articles were milled from Al 6061-T6 using a Fryer MB-10 CNC Mill, see Figure 2.13.

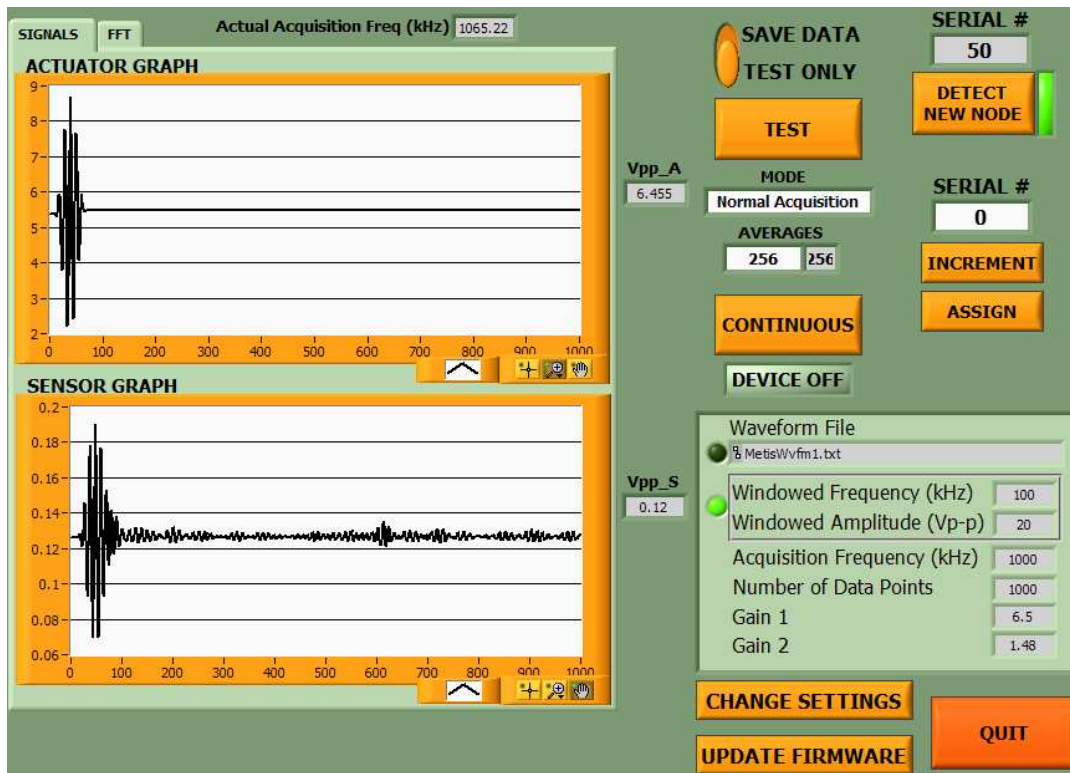
Figure 3.1 Small plate: MD3 Demo program with excitation of 100 kHz
