Mechanical Properties and Performance of a Novel Nano-Engineered Unitized Composite for Aerospace Systems

THESIS

AFIT-ENY-MS-21-M-306

AIR FORCE INSTITUTE OF TECHNOLOGY

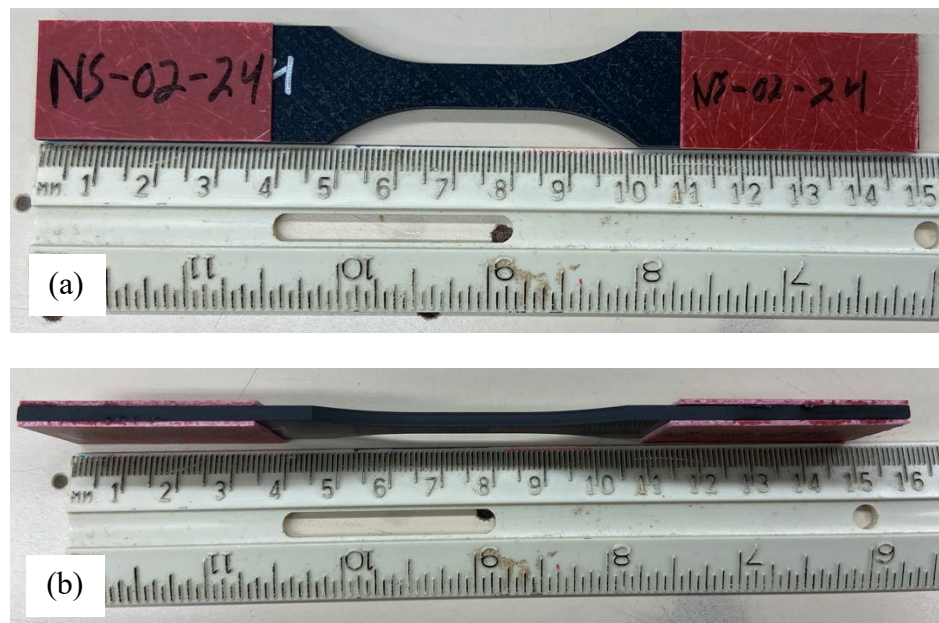
Figure 8: (a) Top and (b) side view of specimen with fiberglass tabs applied

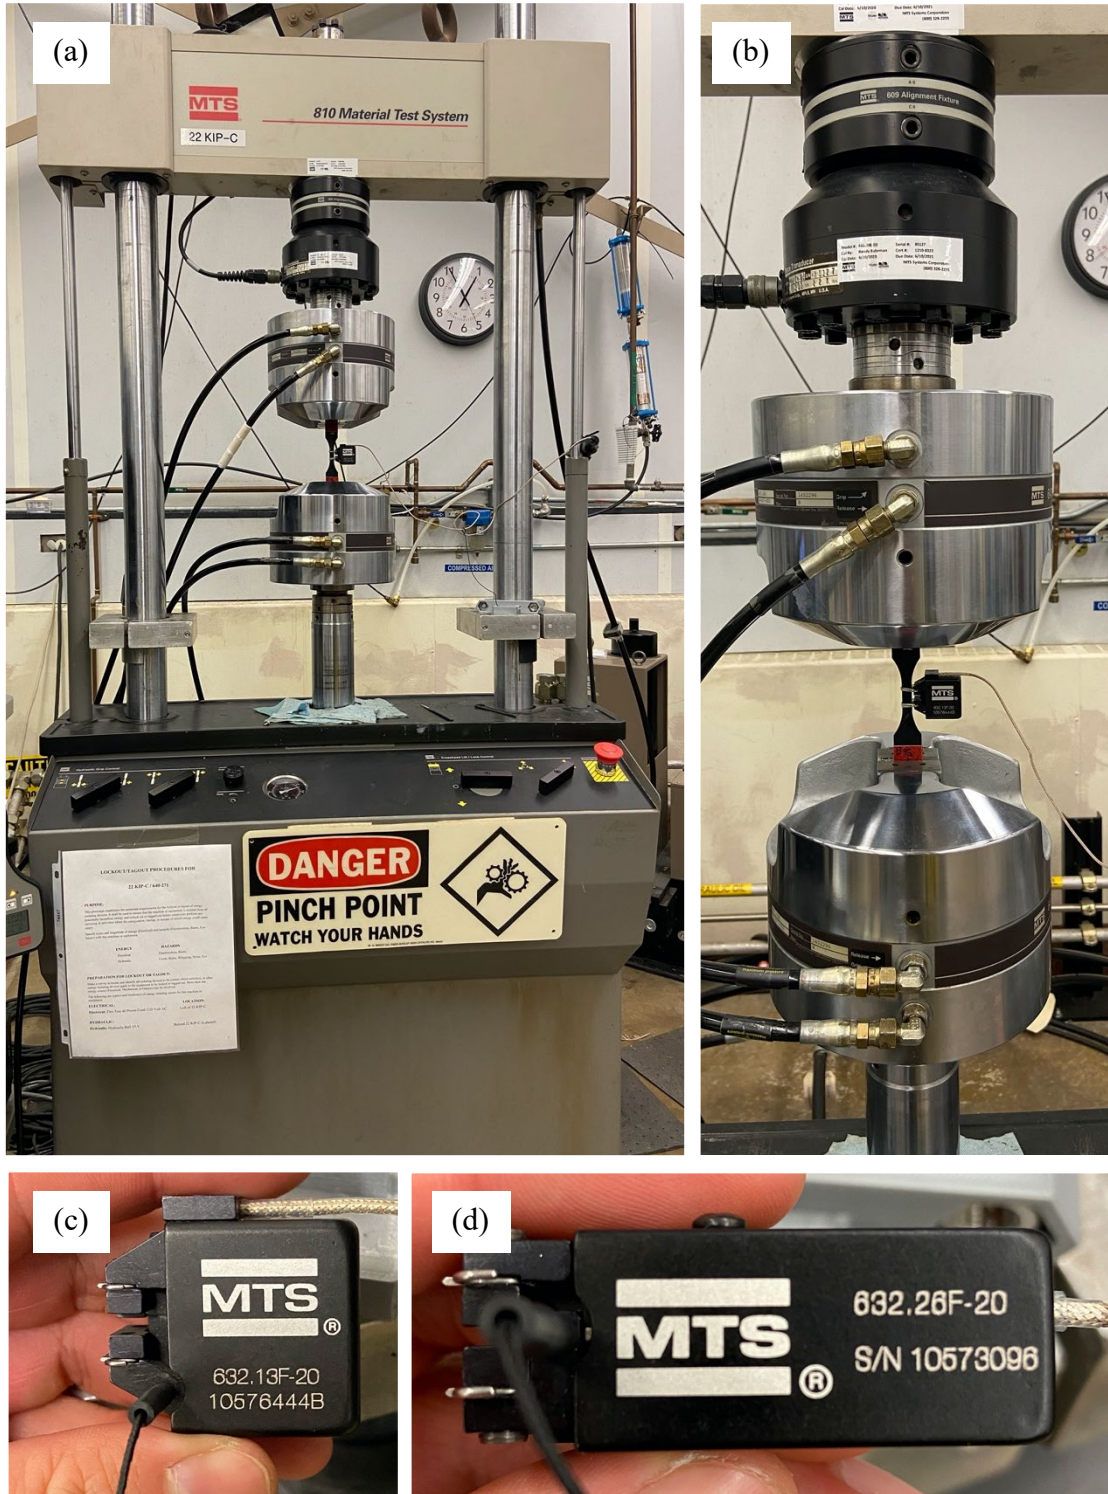
Figure 9: Picture of the: (a) MTS testing unit used to test samples, (b) load cell with sample, (c) 10-mm gauge Extensometer, (d) 8-mm gauge Extensometer.

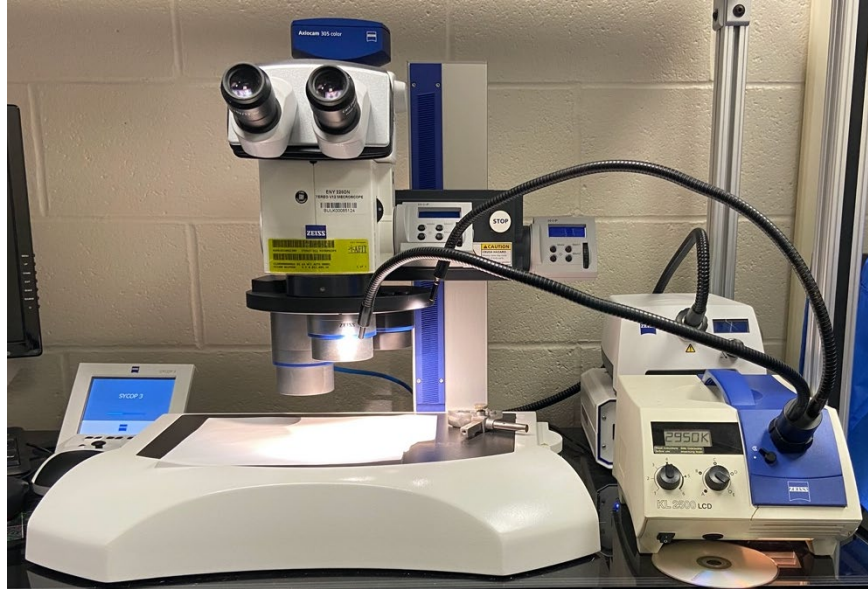
Figure 11: Zeiss SteREO optical microscope and associated equipment
